June 8, 2020

Re: Monthly Report Summary #30 for the South Orange County Reliability Enhancement (SOCRE) Project

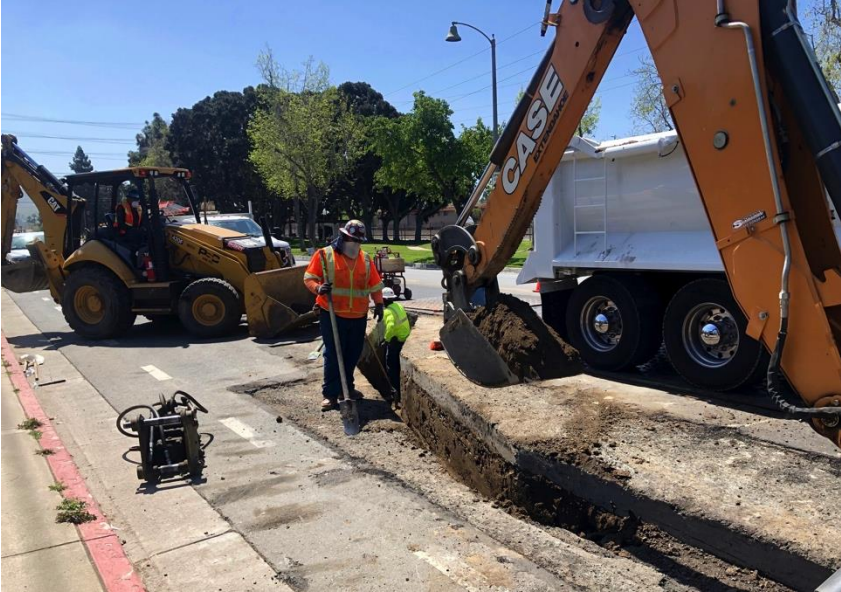
| REPRESENTATIVE SITE PHOTOGRAPHS | | | |
|---|---|---|--|
| 04/03/20 | San Juan Capistrano Substation | | Photo 2 – Trenching within Camino Capistrano. Photo facing south. |

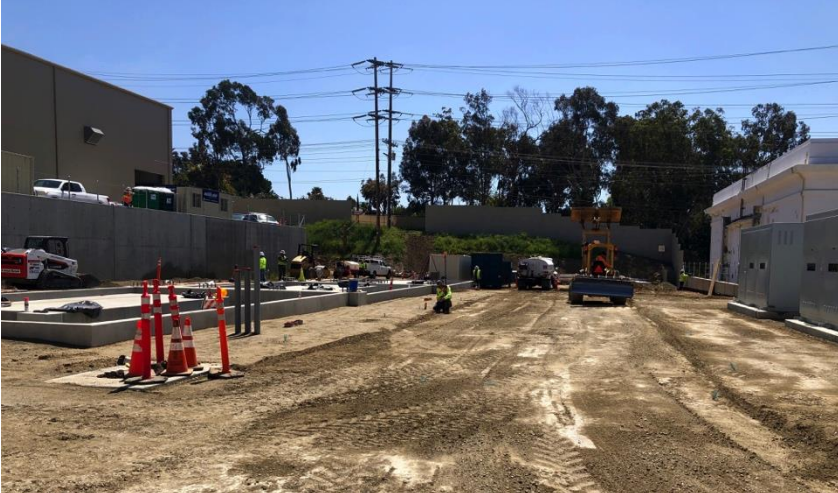
A majority of the underground work has been completed around the switch racks and the transformer foundations; crews were delivering road base to the area and compacting it (Photo 4).

| Date | Location | Photo | Description |
|---|---|--|--|
| 04/03/20 | San Juan Capistrano Substation | | <p>Photo 4 – Road base being transported into the area around the switch racks and the transformer foundations. Photo facing south.</p> |

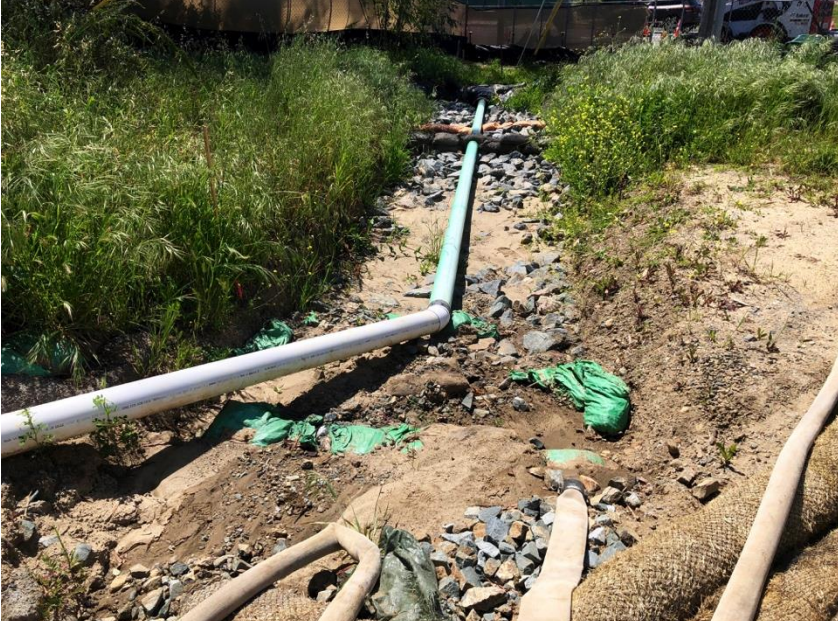
| Date | Location | Photo | Description |
|---|---|--|--|
| 04/03/20 | San Juan Capistrano Substation | | <p>Photo 5 – Rock-filled catch basin located at the southwestern corner of the substation showing sediment nearly filling the catch basin. Photo facing southwest.</p> |

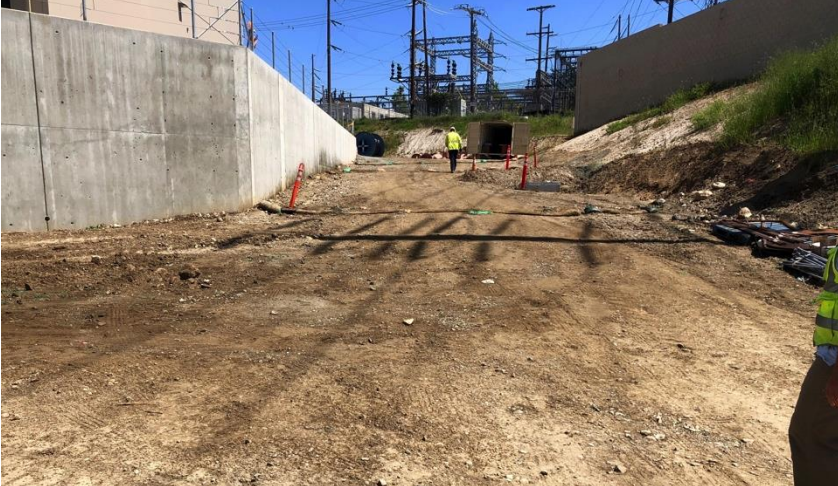
The project road east and upslope from the catch basin had some worn straw wattles across it; it was noted that these were to be replaced with new wattles before crews leave at the end of the day (Photo 6).

| Date | Location | Photo | Description |
|---|---|--|--|
| 04/03/20 | San Juan Capistrano Substation | | <p>Photo 6 – BMPs along this portion of the southern access road will be upgraded with new straw wattles. Photo facing north.</p> |

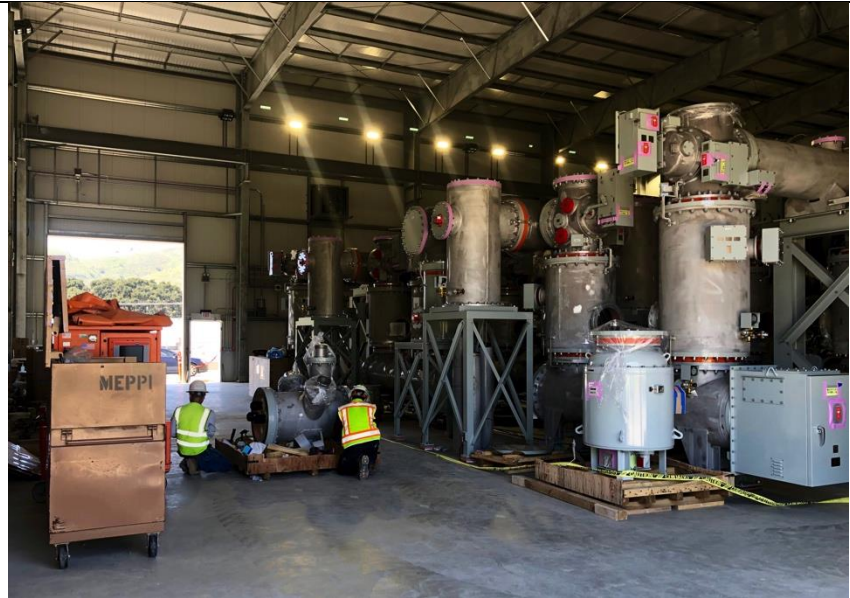
I observed that equipment installation continues within the 138-kilovolt (kV) gas-insulated substation (GIS) building (Photo 7).

| Date | Location | Photo | Description |
|---|---|---|---|
| 04/03/20 | San Juan Capistrano Substation | A large industrial building with a high ceiling and concrete floor. In the foreground, a worker in a yellow safety vest is kneeling next to a large metal cabinet labeled 'MEPPI'. In the background, several large, cylindrical gas-insulated switchgear (GIS) units are mounted on metal frames. A forklift is visible near the open bay door on the left. | Photo 7 – Inside the 138-kV GIS building. Photo facing west. |

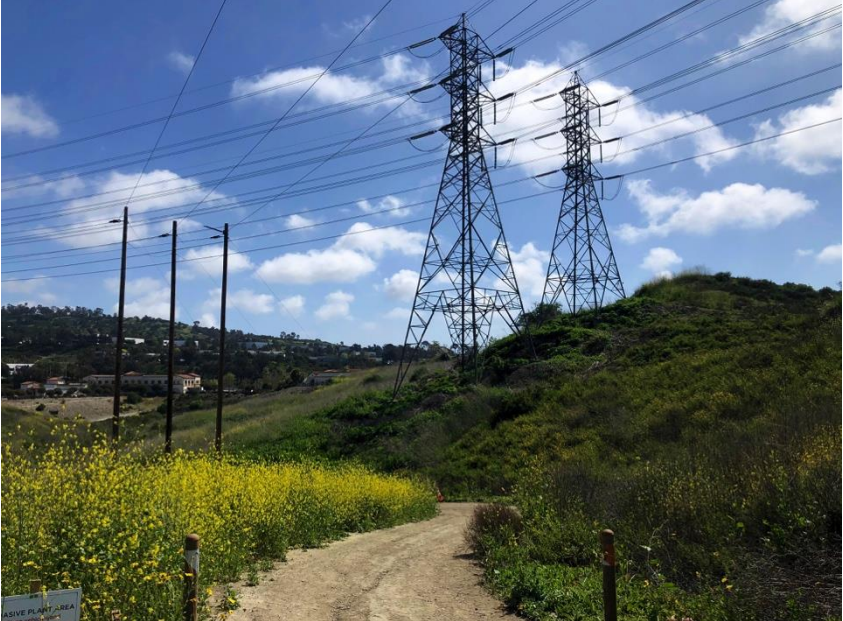
| Date | Location | Photo | Description |
|---|---|--|--|
| 04/03/20 | SOCRE transmission corridor | | Photo 9 – Tower location 34. Photo facing south. |

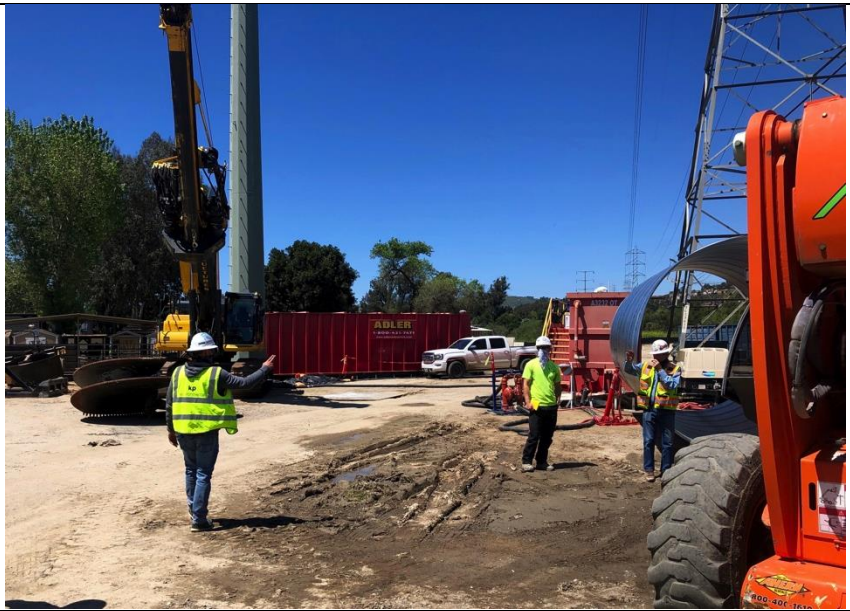
The LEI and I travelled in separate vehicles to the transmission corridor work sites. We stopped at tower location 10 where crews were beginning to drill the tower foundation hole (Photo 8). The foundation hole will be large, requiring extra measures to ensure its integrity. The approved extra workspace was being utilized by three large baker tanks and the drill equipment. A large metal culvert pipe has been staged onsite; it will be used to stabilize the hole while the drilling is conducted. One of the baker tanks was used to mix the drilling muds (Photo 9). Silt fencing lines the edge of the riparian corridor. The area was very dusty, so I recommended dust control measures around the work area and parking area.

| Date | Location | Photo | Description |
|---|--|--|--|
| 04/15/20 | Transmission line route, tower location 10 | | Photo 8 – Tower location 10, where crews have delivered the drilling equipment and baker tanks. Photo facing northeast. |

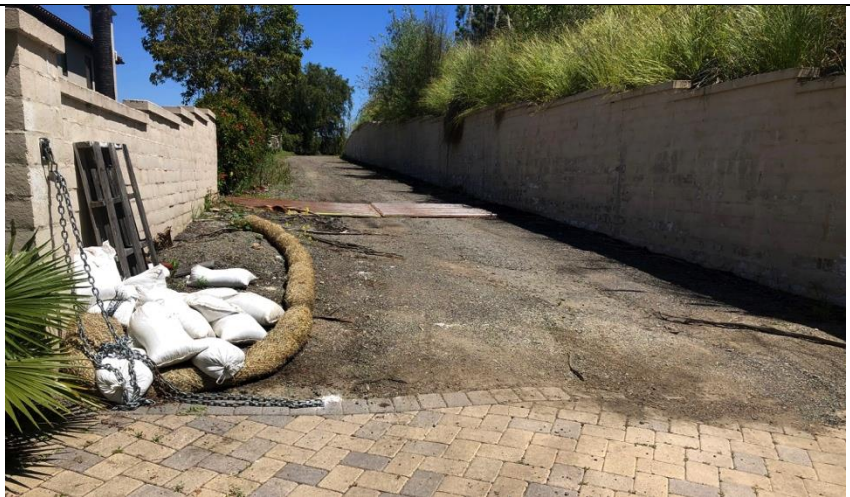
The LEI and I travelled to the access road and laydown area for tower locations 11 and 12. The access road runs through a gated community and then enters a dirt road, which has rumble plates, sandbags, and wattles installed (Photo 10). The laydown area was being mowed (Photo 11) and, according to the LEI, two biologists had inspected the area for wildlife earlier that day. I walked through a portion of the area to be mowed and found no wildlife or nesting birds.

| Date | Location | Photo | Description |
|---|--|--|--|
| 04/15/20 | SOCRE transmission corridor | | Photo 10 – Rumble plate, sandbags and wattles were placed within the access road to tower locations 11 and 12. Photo facing southeast. |

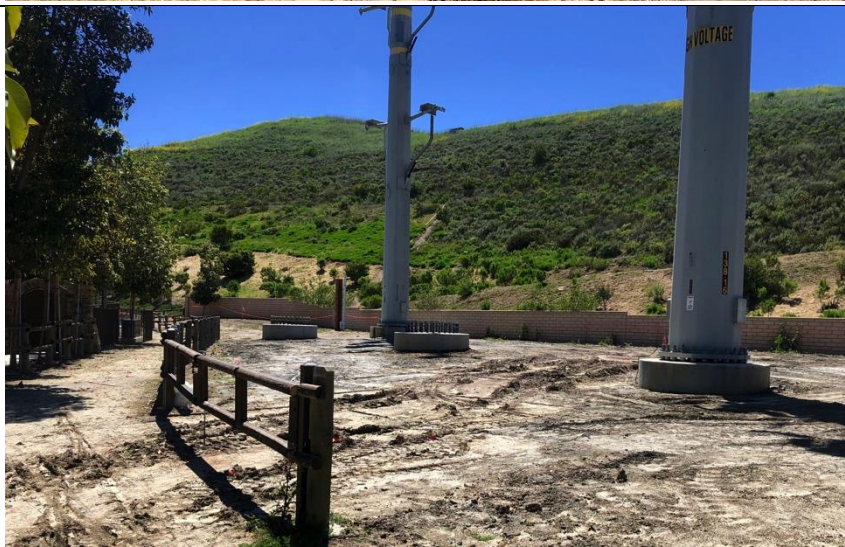
We inspected the work being performed at tower locations 16 and 17, where the foundations have been set and poured (Photo 13). The LEI pointed out the approximate location of a new California gnatcatcher (*Polioptila californica*) nest recently discovered on the slope between tower location 15 and tower locations 16 and 17.

| Date | Location | Photo | Description |
|---|---|--|--|
| 04/15/20 | SOCRE transmission corridor | | Photo 13 – New foundations for tower locations 16 and 17. Photo facing southwest. |

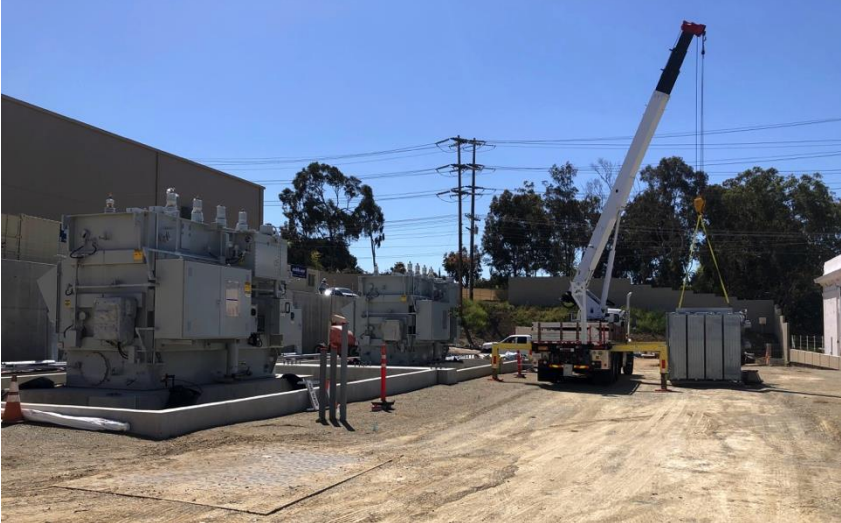
Within the substation, the transformers are now on foundations (Photo 3). The refrigeration units for the top of the transformers still need to be installed. Materials are now being stockpiled along the southern access road and, according to the Environmental Inspector (EI), the project entrance will change to the southern gate (Photo 4). Equipment installation continues within the 138-kilovolt (kV) gas-insulated substation (GIS) building (Photo 5).

| REPRESENTATIVE SITE PHOTOGRAPHS | | | |
|---|---|--|--|
| 04/22/20 | San Juan Capistrano Substation | | Photo 3 – Installation of transformers. Photo facing south. |

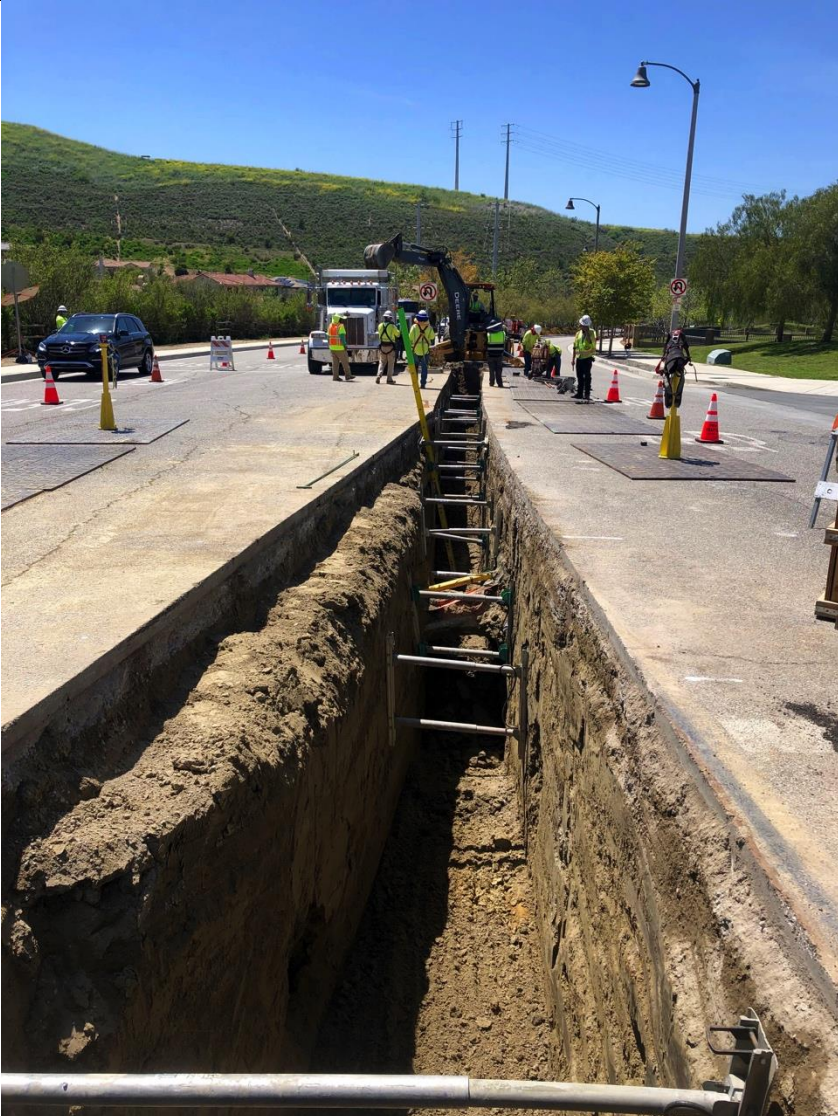
The work at Stallion Ridge Road included trenching down the middle of the road (Photo 13). Cultural resource monitors were onsite observing the trenching activity. Some additional tie-in work was being completed near Stallion Ridge Road, close to tower locations 16 and 17 (Photo 14). I observed a known bushtit (*Psaltriparus minimus*) nest near this tie-in and noted birds coming from and going to the nest. An avian biologist was onsite due to the number of bird nests in the area. I also examined tower locations 18 and 19, where the foundations had been poured and one former tower had been removed (Photo 15). The EI requested additional BMP work at this site.

| Date | Location | Photo | Description |
|---|---|---|--|
| 04/22/20 | SOCRE transmission corridor | A photograph showing a deep, narrow trench being dug into a paved road. Several workers in high-visibility vests are standing around the trench. A large excavator is visible in the background, and a white truck is parked nearby. The scene is set on a road with hills in the background. | Photo 13 – Trenching within Stallion Ridge Road. Photo facing west. |

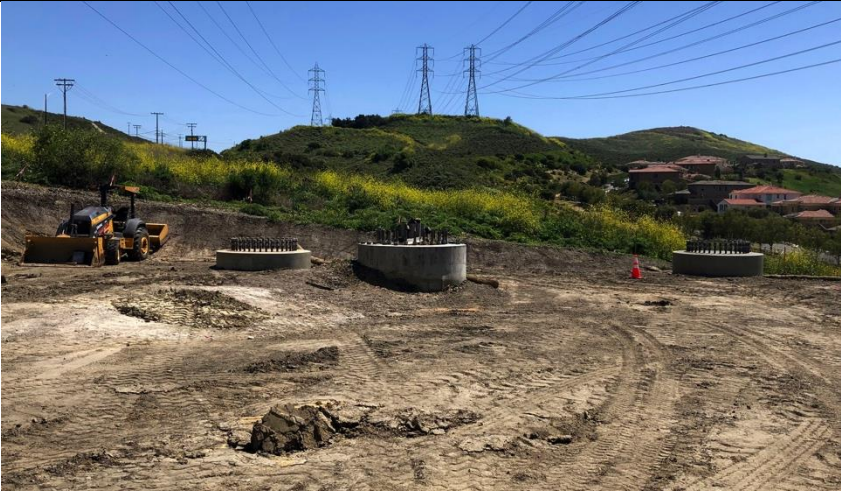
| REPRESENTATIVE SITE PHOTOGRAPHS | | | |
|---|---|--|---|
| 04/22/20 | SOCRE transmission corridor | | Photo 15 – Tower locations 18 and 19, where both foundations have been poured and a former tower was removed. Photo facing south. |

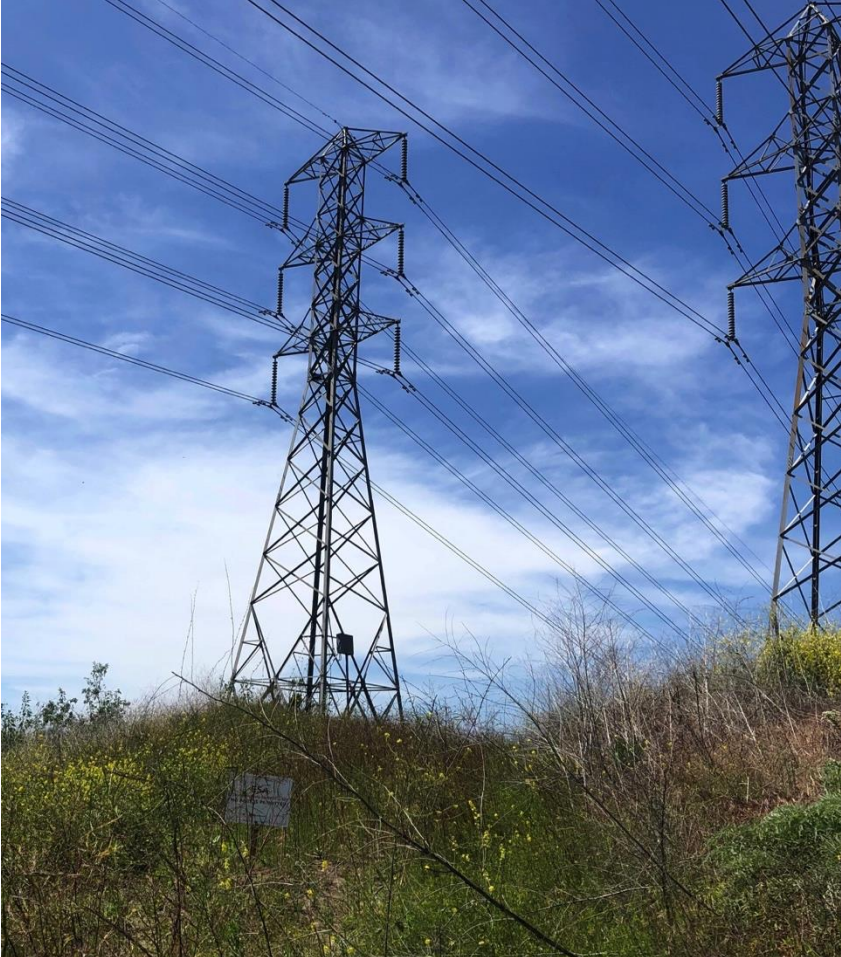
My final stop was at tower locations 21 and 22. The tower foundation for 22 had already been poured (Photo 16). A crew was grading the tower pad at tower location 21, while an avian biologist oversaw construction (Photo 17). According to the avian biologist, red-tailed hawk (*Buteo jamaicensis*) chicks were present in the nest and were not disturbed by the construction activities. A California gnatcatcher (*Polioptila californica*) was building a nest in a small tree southwest of the work area that is not visible from the construction site. Both nests have buffer boundaries delineated by signs (Photo 18). I suggested adding lath and flagging to this location.

| REPRESENTATIVE SITE PHOTOGRAPHS | | | |
|---|---|---|---|
| 04/22/20 | SOCRE transmission corridor | | Photo 18 – Red-tailed hawk nest in the far tower; the nest buffer is delineated by an ESA sign. Photo facing northwest. |

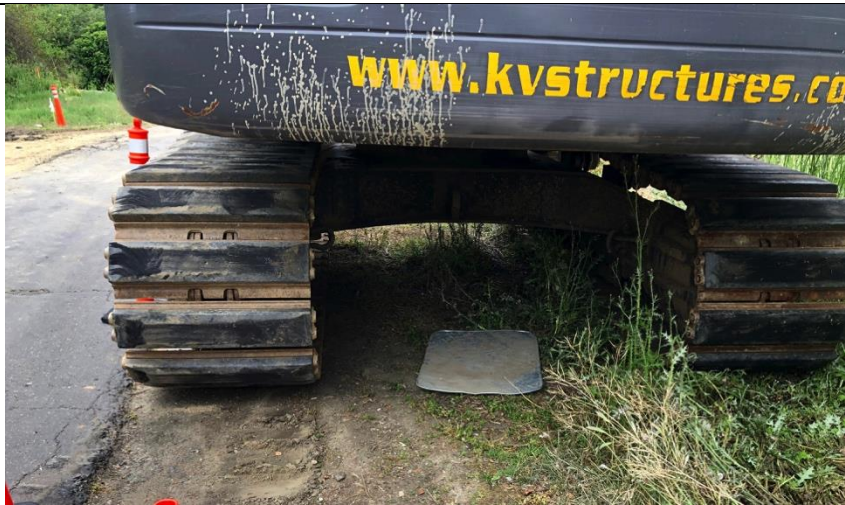
| Date | Location | Photo | Description |
|---|---|--|---|
| 04/29/20 | SOCRE transmission corridor | | Photo 9 – Parked equipment at tower location 9, with an inadequate drip pan. |

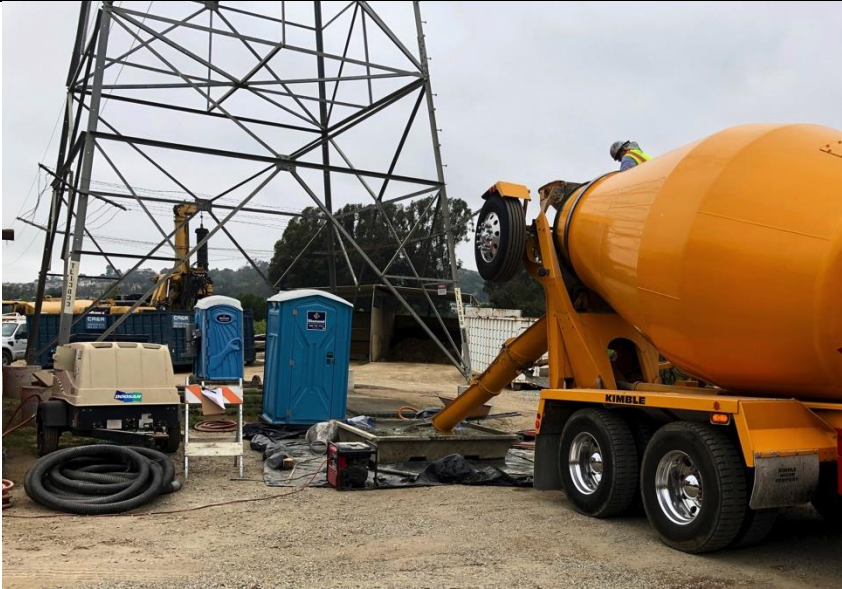
| REPRESENTATIVE SITE PHOTOGRAPHS | | | |
|---|--|--|--|
| 04/29/20 | Transmission line route, tower location 10 | | Photo 11 – Concrete washout at tower location 10. Photo facing northwest. |
