August 7, 2020

Re: Monthly Report Summary #32 for the South Orange County Reliability Enhancement (SOCRE) Project

This report provides a summary of the compliance monitoring activities that occurred during the period from **June 1 to 30, 2020**, for the South Orange County Reliability Enhancement (SOCRE) Project in Orange County, California. Compliance monitoring was performed four times between June 1 and 30, 2020, to ensure all project-related activities conducted by San Diego Gas and Electric (SDG&E) and its contractors were in compliance with the Final Environmental Impact Report (Final EIR) for the SOCRE Project, as adopted by the California Public Utilities Commission (CPUC) on December 15, 2016.

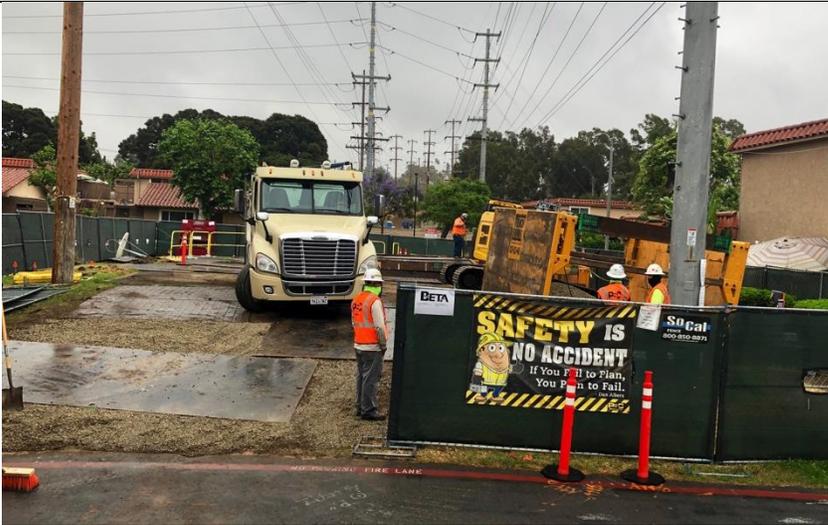
Photo 1 – The jack and bore exit hole west of the railroad tracks. Photo facing east.

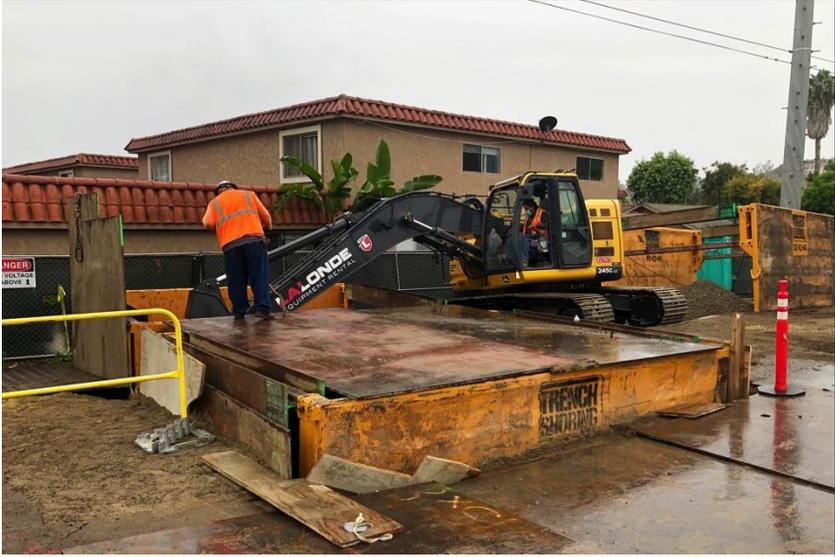
Photo 2 – Excess soil removed from the jack and bore exit hole. Photo facing south.
06/05/20	West of San Juan Capistrano Substation – jack and bore site

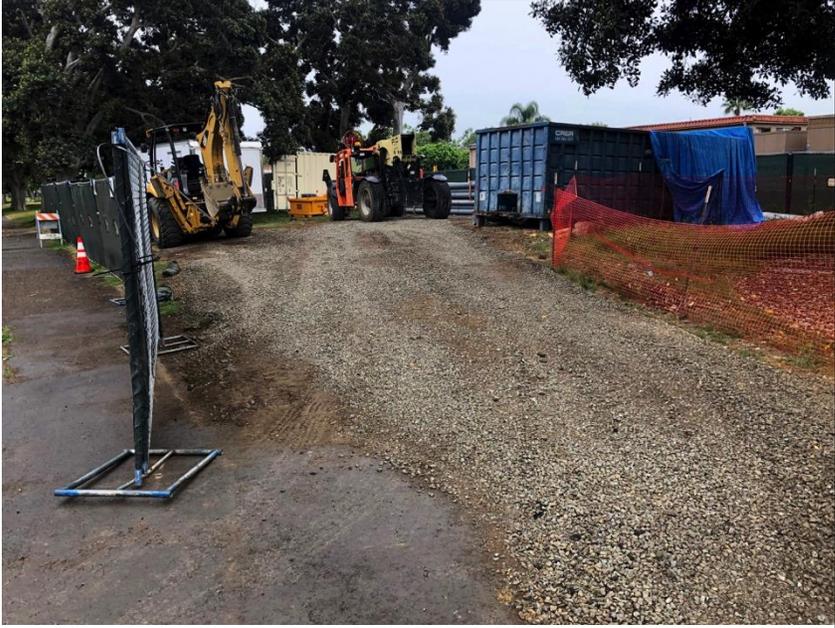
Photo 3 – Gravel placed on the jack and bore access road. Photo facing south.

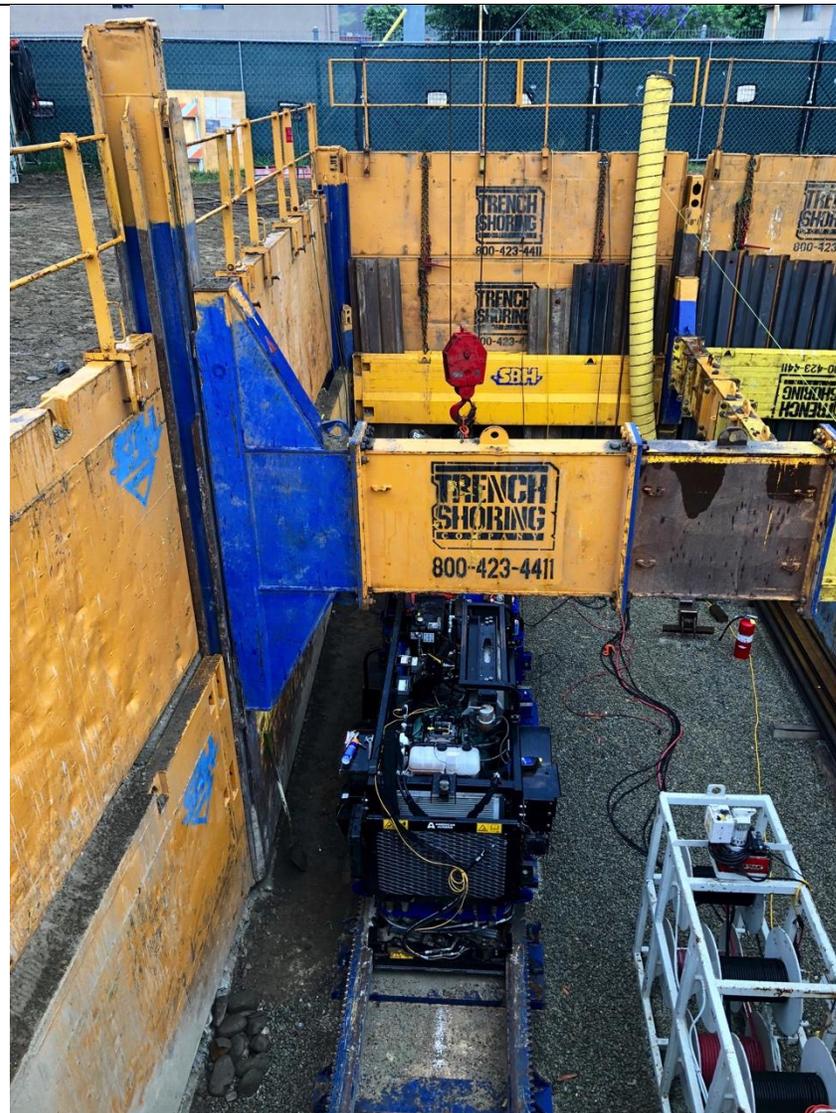
Photo 4 – Bore hole with the drill rig in place. Photo facing west.
06/05/20	San Juan Capistrano Substation

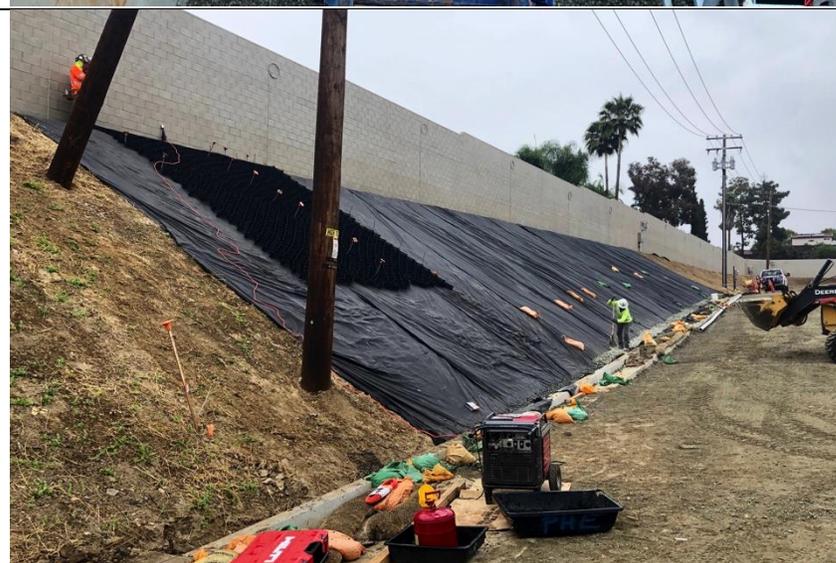
Photo 5 – Armoring the northern slope of the substation. Photo facing east.

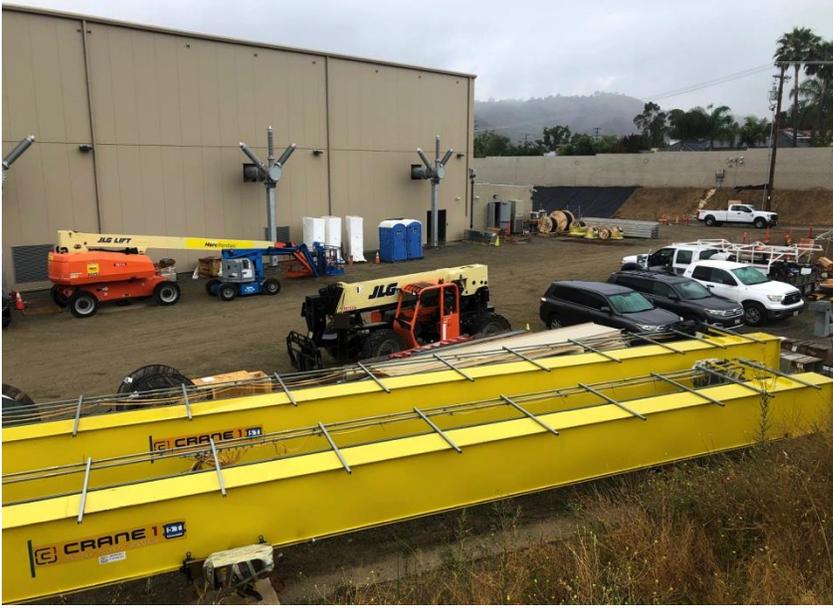
Photo 6 – The 138-kV GIS building with internal cranes waiting to be installed. Photo facing southwest.
06/05/20	San Juan Capistrano Substation

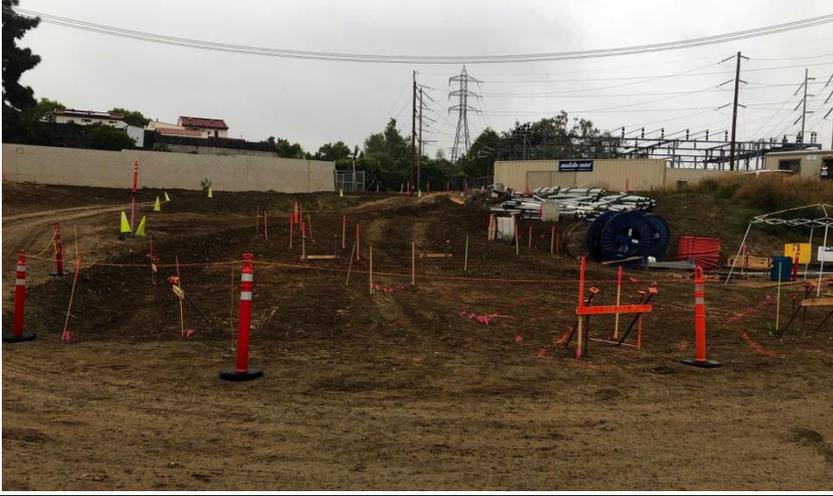
Photo 7 – Surveyed area in the northeast area of the substation. Photo facing east.

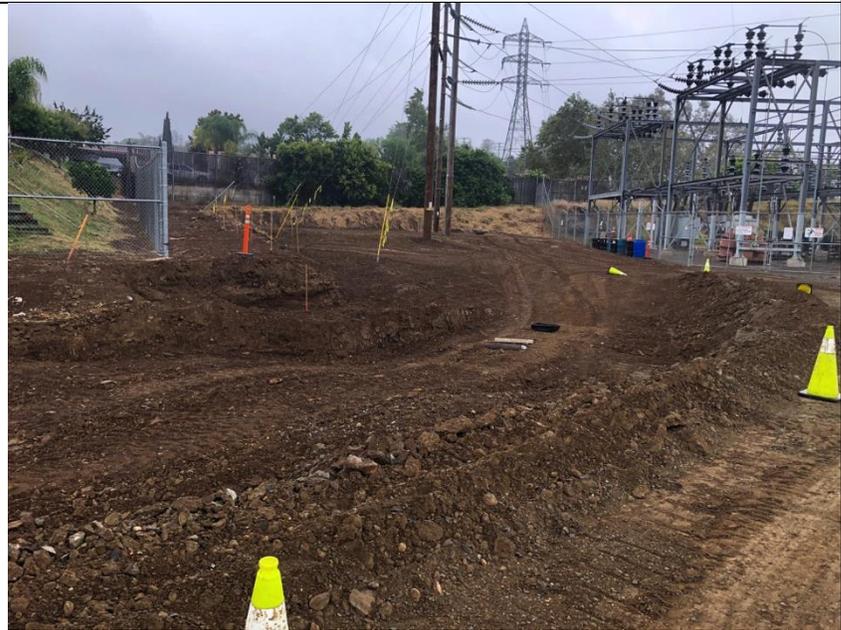
Photo 8 – Partially completed trench line earthwork leading to the existing 12-kV substation facility. Photo facing east.
06/05/20	SOCRE transmission corridor

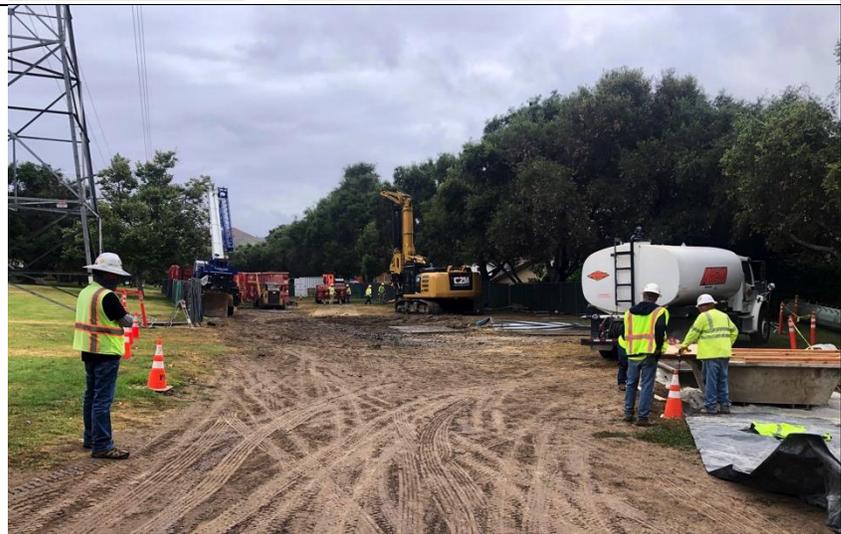
Photo 9 – Drilling work was completed at tower location 8. Photo facing south.

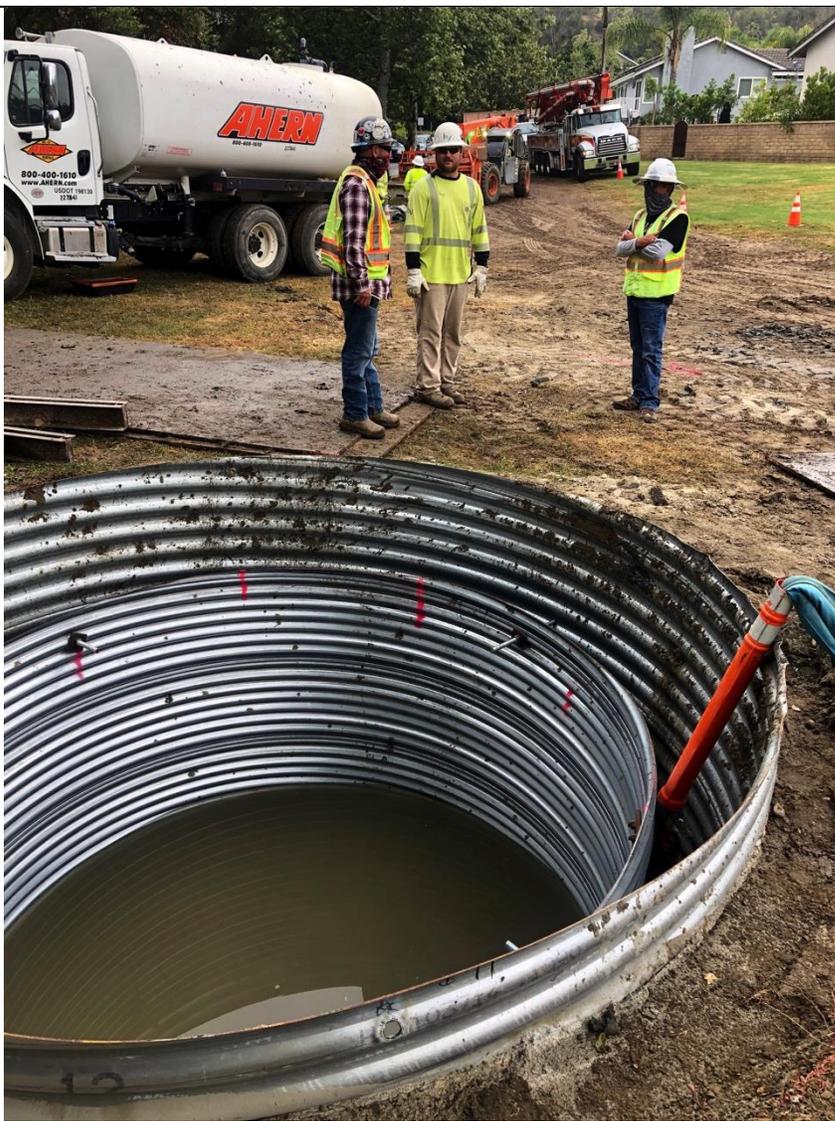
Photo 10 –
Stabilizing
culverts installed
at tower
location 8. Photo
facing northwest.

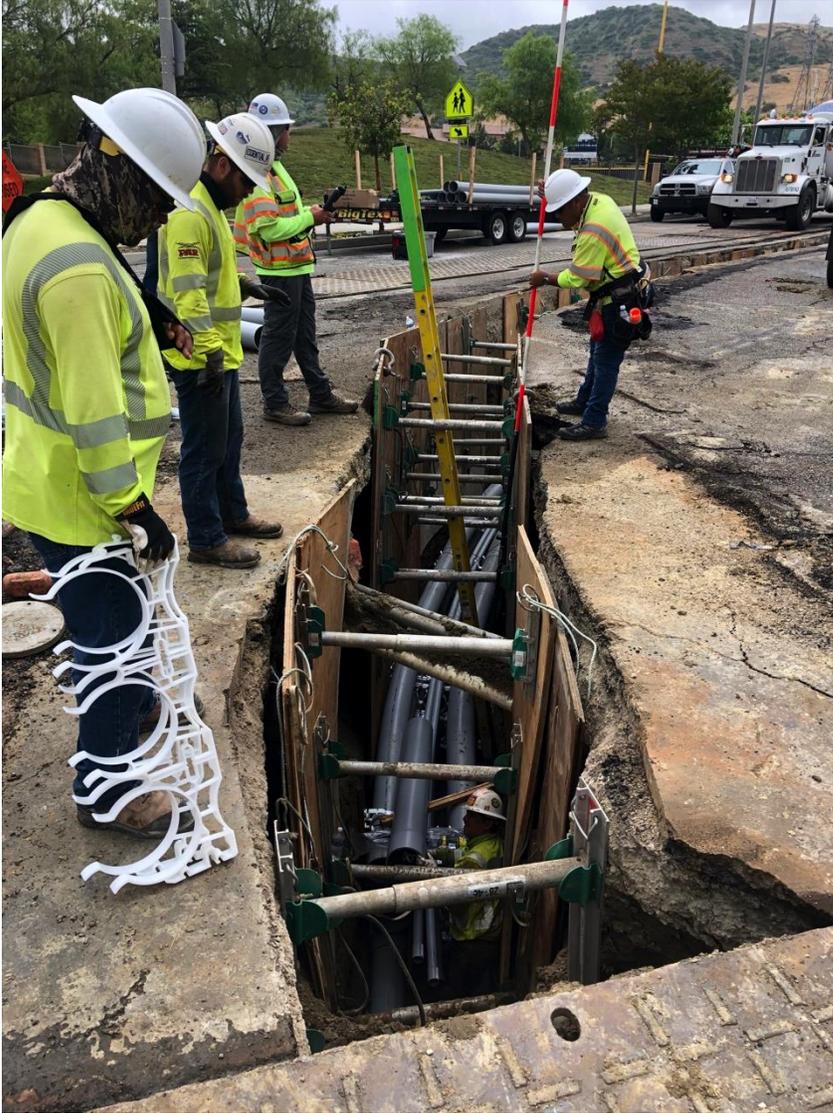
We inspected the Stallion Ridge Road area where a crew continued to install conduit within the roadway (Photo 11). I observed the American kestrel (*Falco sparverius*) nest site in the tower arm at tower locations 16 and 17 and was able to observe nest activity (Photo 12). The avian biologist was onsite due to the nearby conduit work.

Photo 11 – Conduit installation within Stallion Ridge Road. Photo facing east.

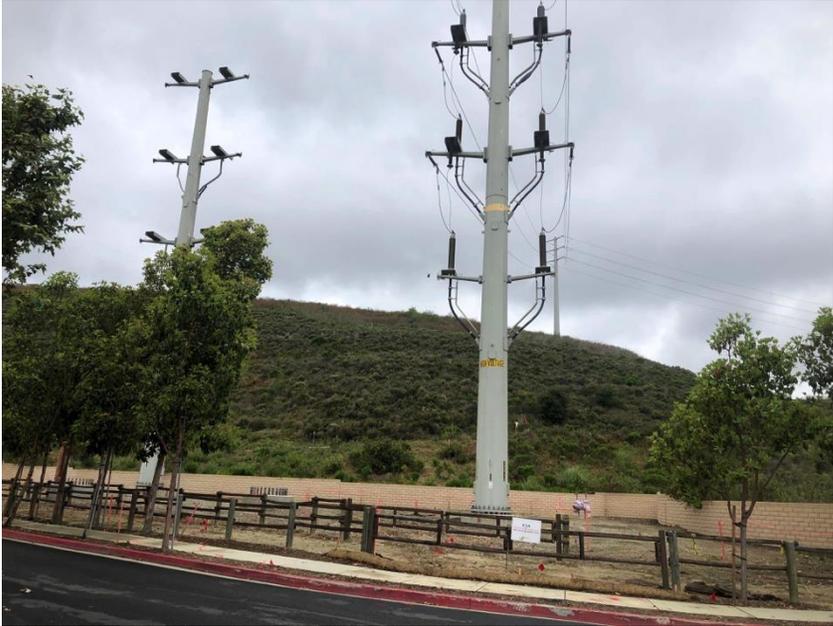
A photograph showing two utility towers in a landscape. The tower in the foreground is a tall, grey metal structure with multiple cross-arms and insulators. The tower in the background is shorter and also has cross-arms. The ground is a mix of dirt and sparse vegetation. In the foreground, there is a paved road with a red curb and a wooden fence. The background shows a hillside with green vegetation under a cloudy sky.	Photo 12 –Tower locations 16 and 17 where an American kestrel nest is located. Photo facing west.
06/05/20	SOCRE transmission corridor

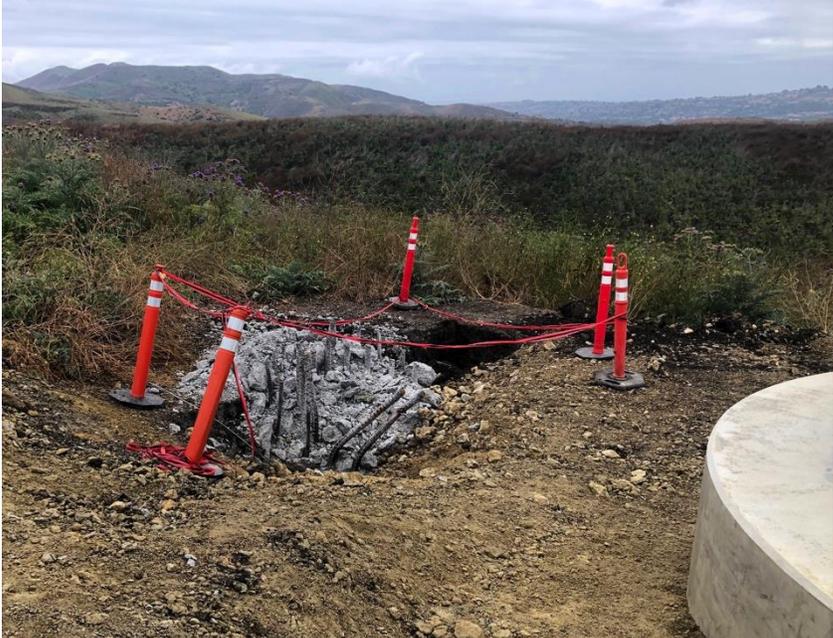
No work occurred at tower location 15 where a new kestrel nest had been observed. No additional work had been completed to remove the existing foundation since the discovery of the nest (Photo 13).

A photograph showing a construction site. In the foreground, there is a large, rectangular concrete foundation that has been partially removed, leaving a pile of rubble. The foundation is surrounded by orange and white striped safety cones and red caution tape. The ground is dirt and gravel. In the background, there is a landscape with hills and mountains under a cloudy sky.	Photo 13 – Existing foundation to be removed at tower location 15. Photo facing west.

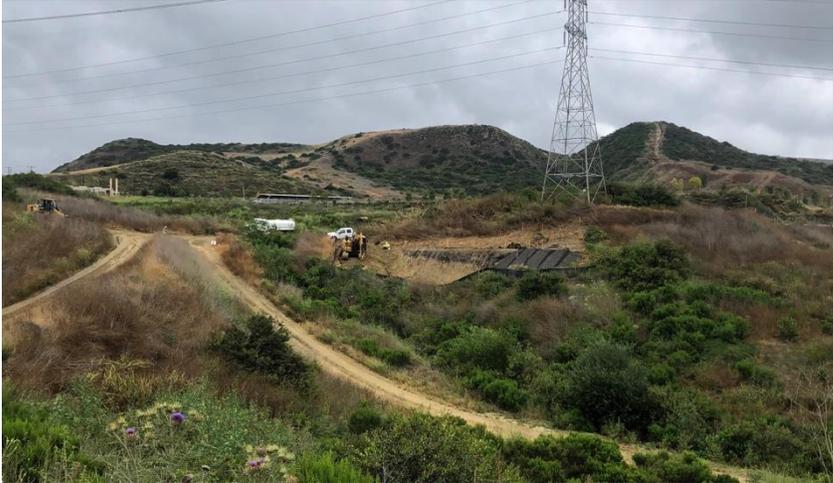
We stopped at tower location 23 where a crew was building a pad near the tower (Photo 14). A water truck was onsite and the work activity was being monitored by an avian biologist due to the nearby song sparrow (*Melospiza melodia*) nest. A foundation hole was being drilled at tower location 30 and the chippings were delivered to tower location 23 to be spread on the access road.

Photo 14 – Pad work at tower location 23. Photo facing east.
06/05/20	SOCRE transmission corridor

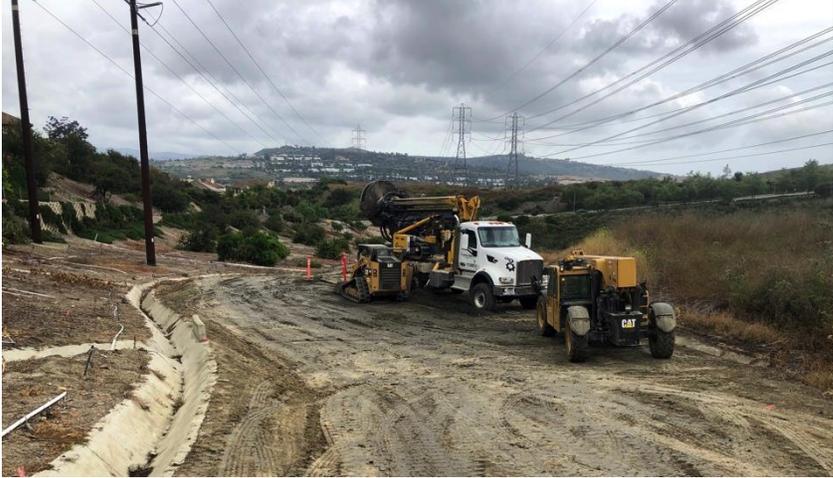
Photo 15 – Drilling work was completed at tower location 30. Photo facing south.

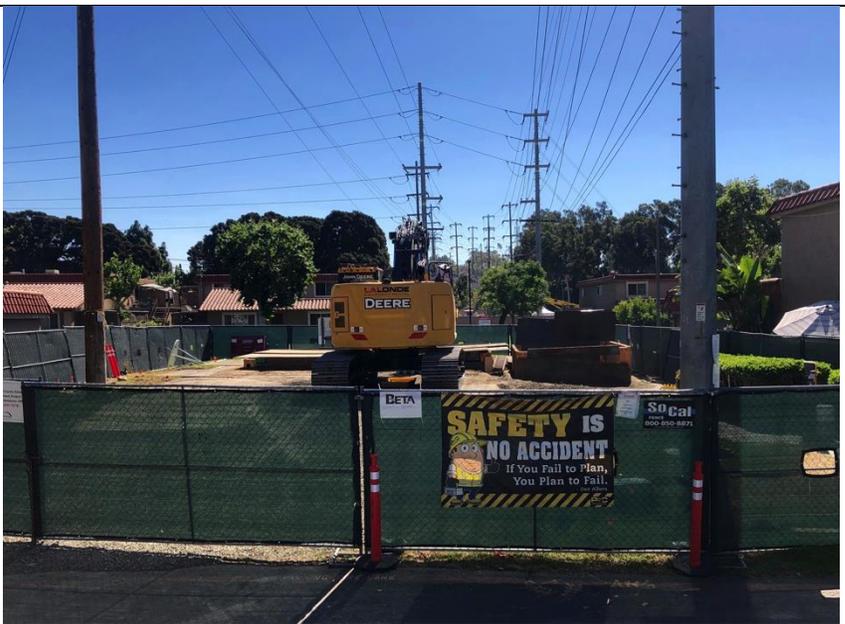
Photo 1 – The jack and bore exit hole west of the railroad tracks. Photo facing east.

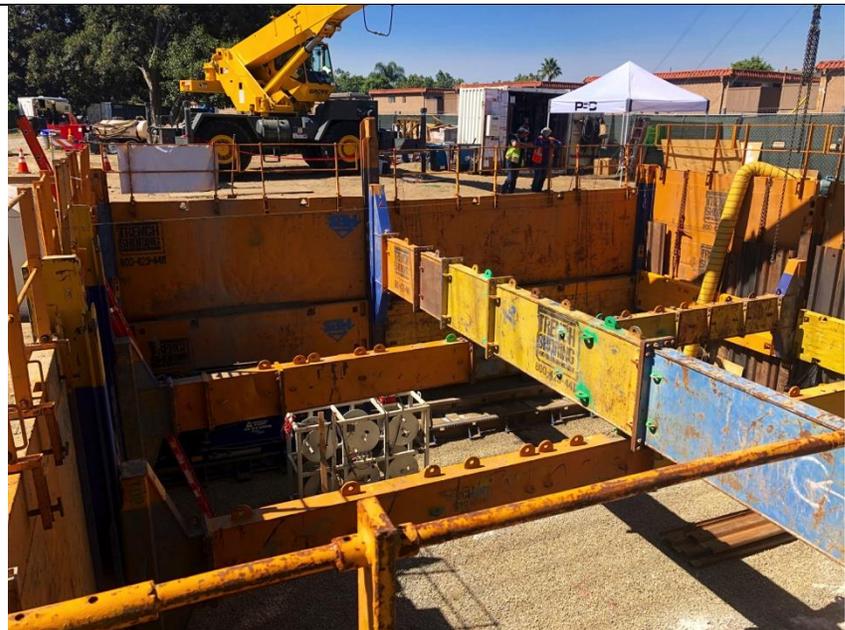
Photo 2 – The bore hole located east of the railroad tracks. Photo facing south.
06/10/20	West of San Juan Capistrano Substation – jack and bore site

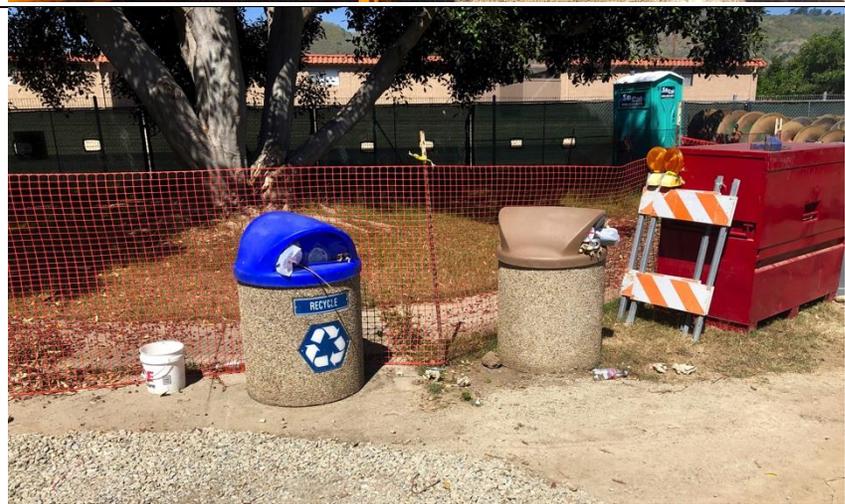
Photo 3 – Trash bins within the jack and bore yard were full and overflowing. Photo facing west.

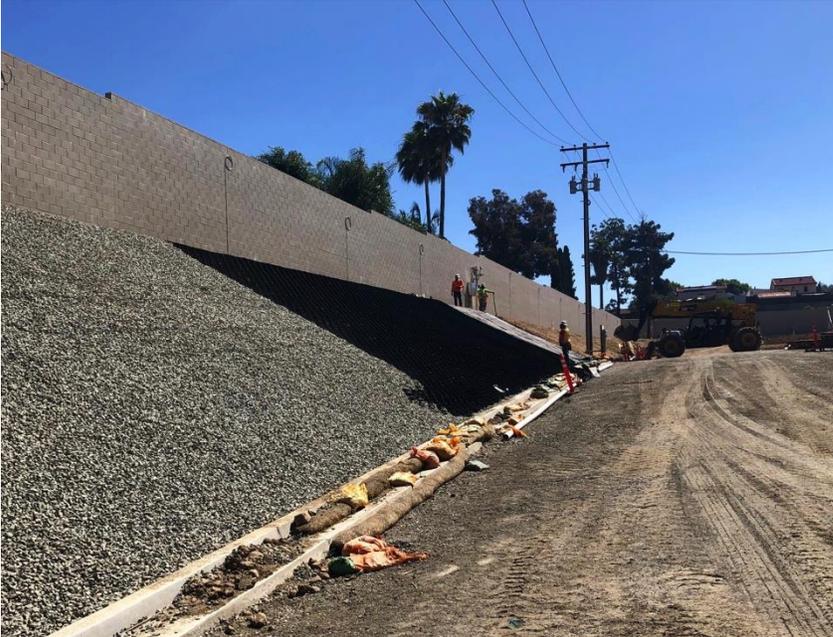
A photograph showing the northern slope of the San Juan Capistrano Substation. The slope is covered in grey gravel and is being armored with a concrete wall. A dirt road runs alongside the slope, and a utility pole is visible in the background under a clear blue sky.	Photo 4 – Armoring of the northern slope of the substation. Photo facing east.
06/10/20	San Juan Capistrano Substation

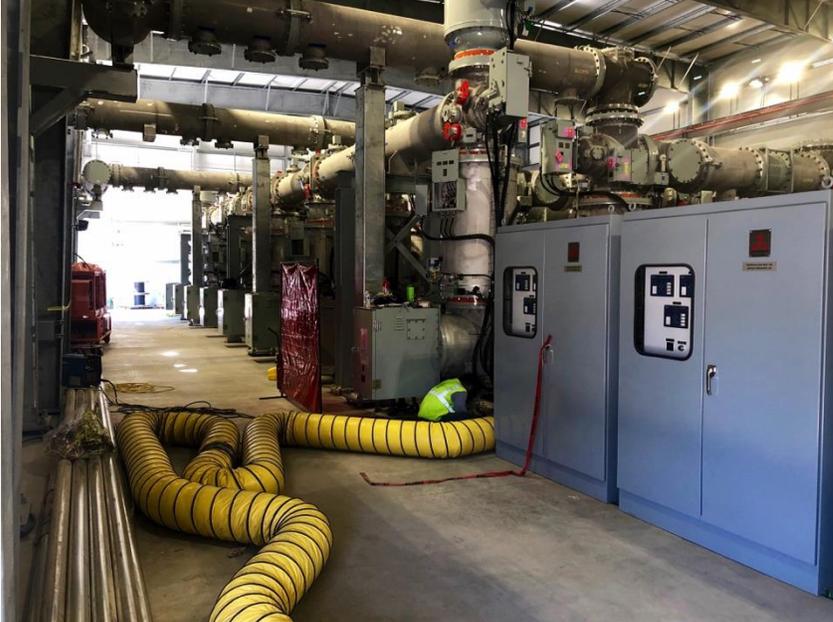
An interior photograph of the 138-kV GIS building. The room is filled with large, complex electrical equipment, including gas-insulated switchgear (GIS) units and control panels. Yellow flexible conduits are visible on the floor, and the overall environment is industrial and well-lit.	Photo 5 – Inside the 138-kV GIS building.

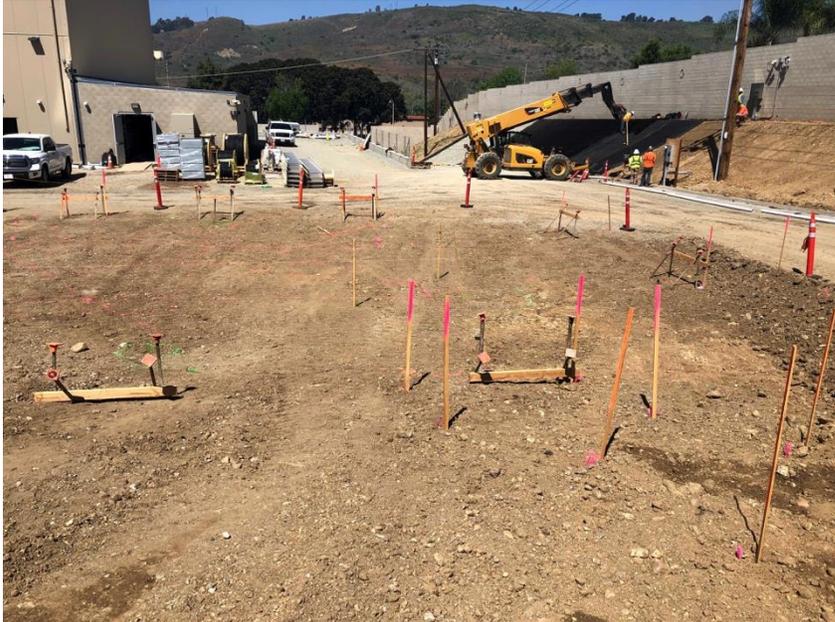
Photo 6 – Surveyed area near the northeast corner of the 138-kV GIS building. Photo facing west.
06/10/20	SOCRE transmission corridor

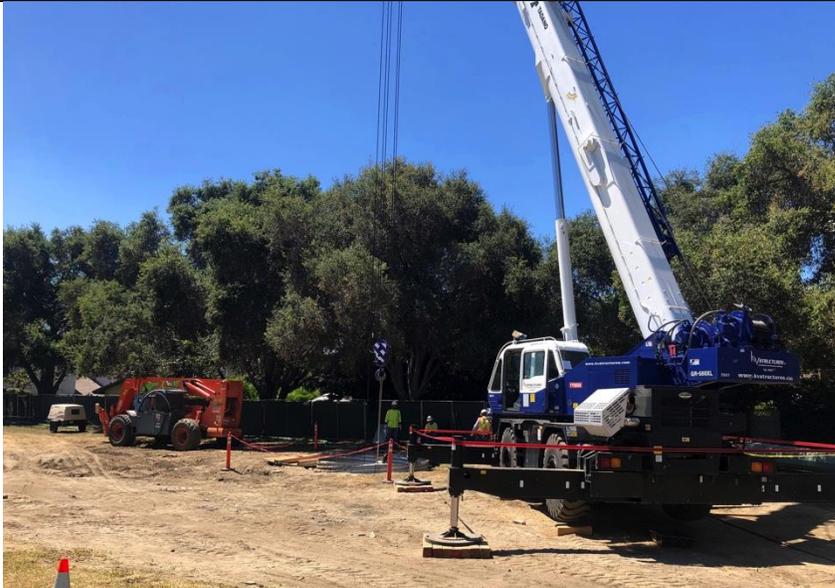
Along the transmission corridor I met with the EI at tower location 8 (Photo 7). The crew was pumping out water from the metal culvert (Photo 8). A large crane was being used because the foundation hole was nearly 80 feet deep. The water was pumped into baker tanks to be used at the next drill site. Some irrigation pipes within the parkway were damaged and water had flooded some of the construction area (Photo 9).

Photo 7 – Tower foundation work at tower location 8. Photo facing southwest.

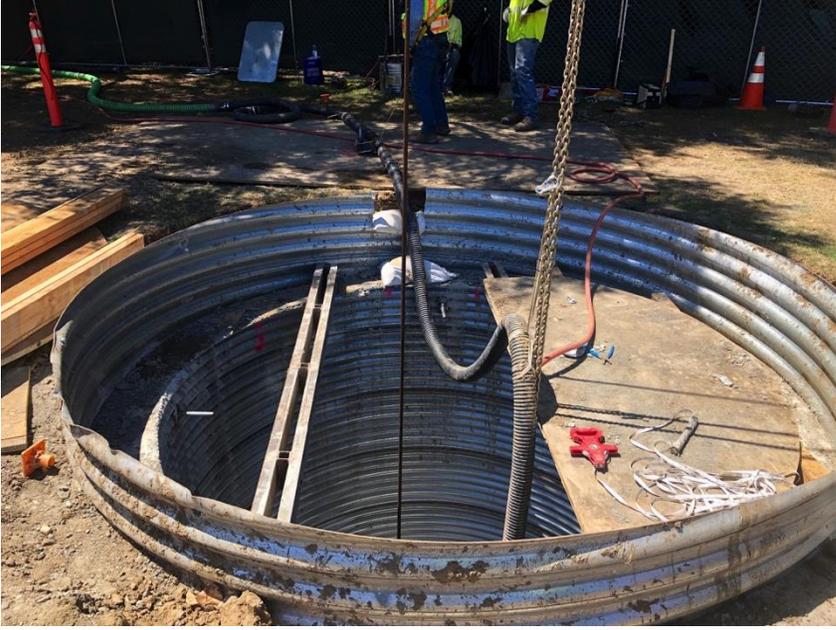
Photo 8 – Pumping water from the foundation hole at tower location 8.
06/10/20	SOCRE transmission corridor

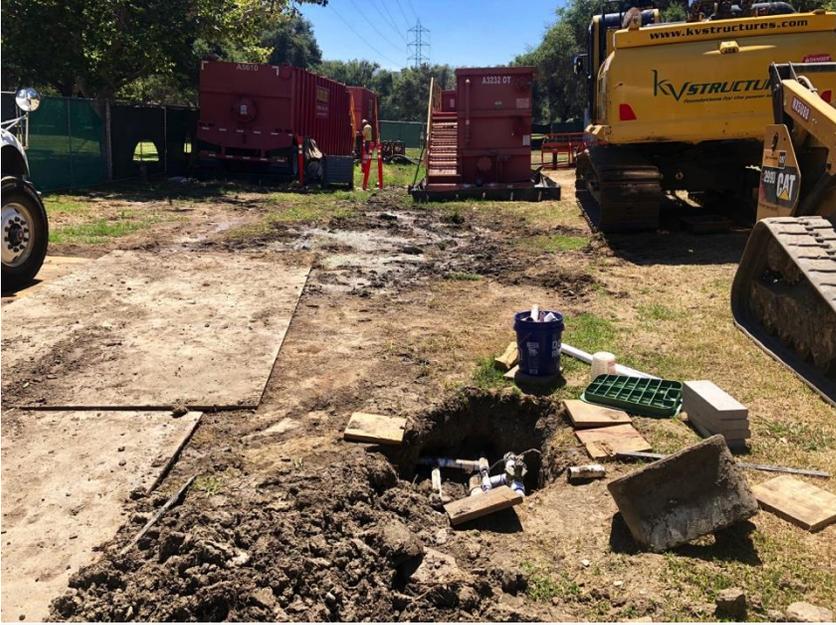
Photo 9 – Equipment within the parkway near tower location 8 where some irrigation pipes were damaged and water had flooded some of the construction area. Photo facing south.

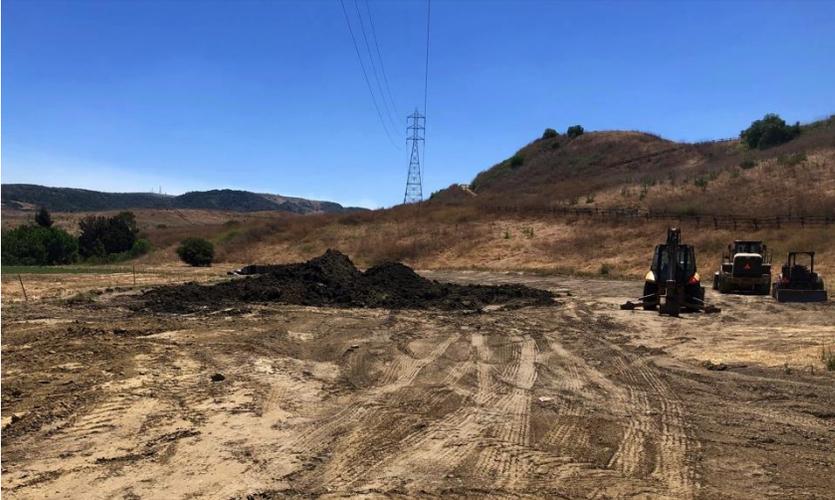
Photo 10 – Staging area near tower location 12 for excess soil from various foundation drillings. Photo facing south.
06/10/20	SOCRE transmission corridor

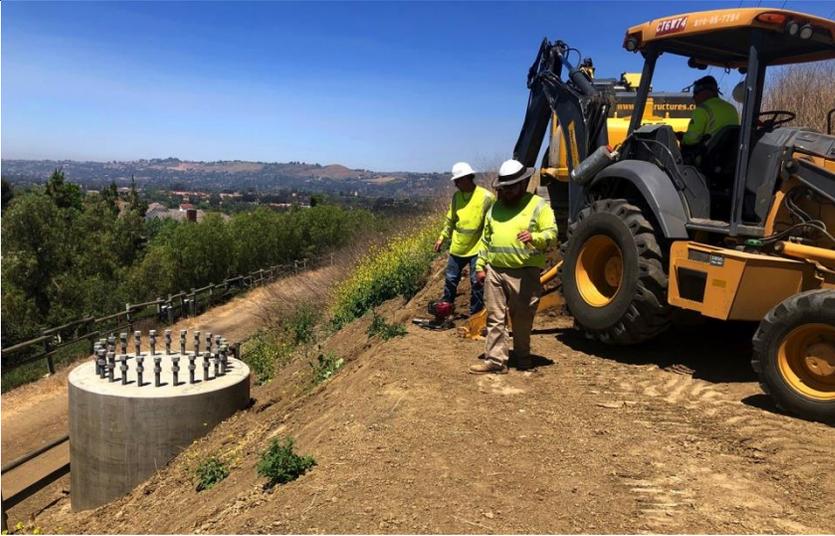
At tower location 12, a crew was installing the grounding rods on the new tower foundation (Photo 11). According to the EI, a crew was getting ready to begin work at tower location 13.

Photo 11 – Grounding rod installation at tower location 12. Photo facing north.
06/10/20	SOCRE transmission corridor

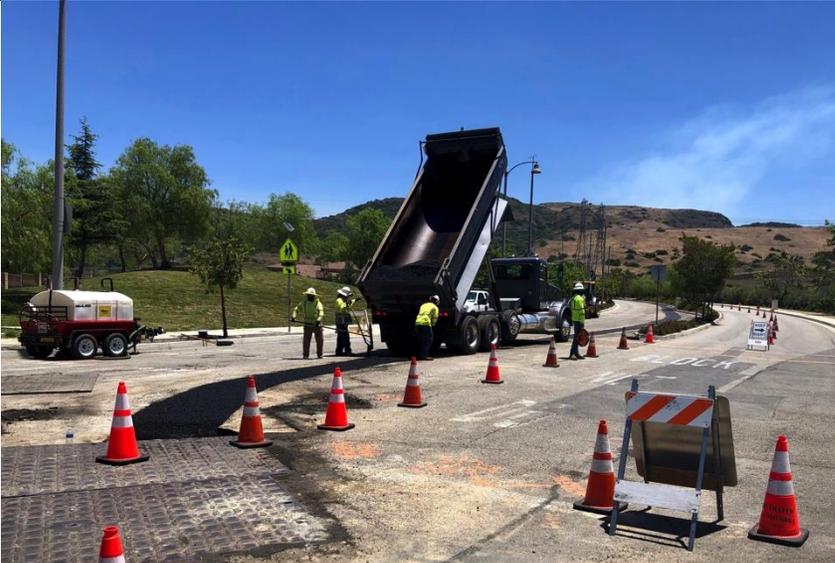
Photo 12 – Paving the conduit trench within Stallion Ridge Road. Photo facing east.

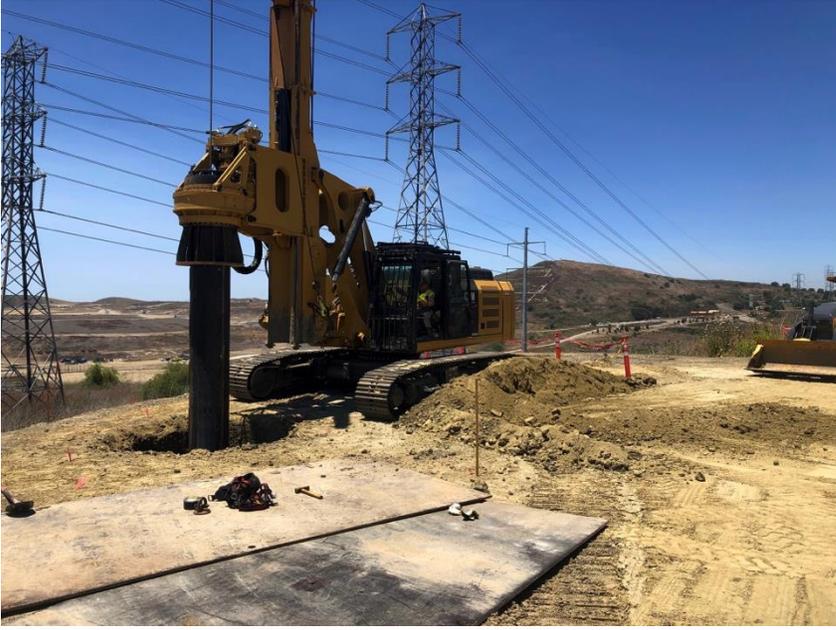
I stopped at the La Pata staging area and met with the Lead Environmental Inspector (LEI) in the construction trailers. I then proceeded to tower location 25 where a drill rig had started drilling the foundation (Photo 13). The foundation hole is to be 60 feet deep.

Photo 13 – Drilling the foundation hole at tower location 25. Photo facing northwest.
06/10/20	SOCRE transmission corridor

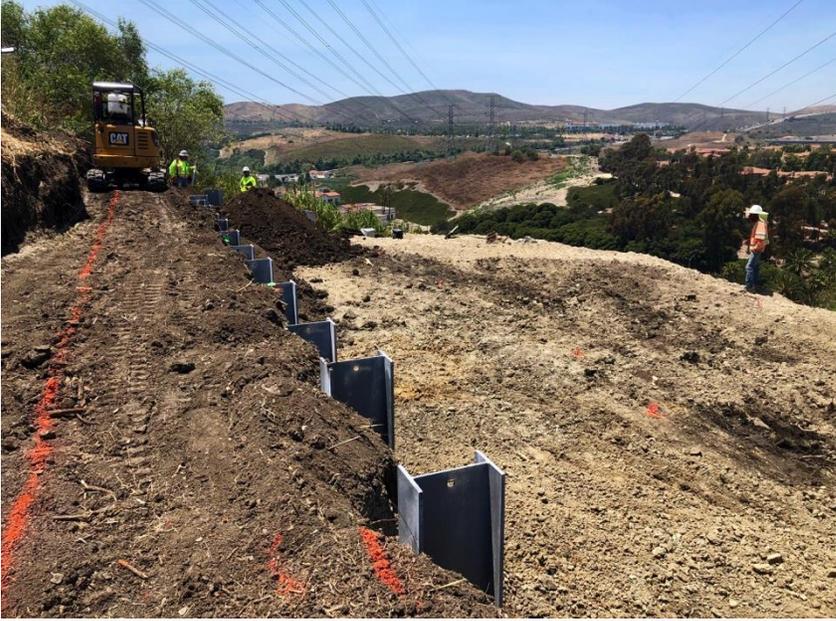
At tower location 36, the I-beams for the new wall were installed and excavators were working to remove soil on both sides of the beams (Photo 14). The roving paleontology/archaeology monitor was present at this location and we briefly discussed the monitoring activities and anything sensitive discovered; thus far, nothing of significance had been found.

Photo 14 – Wall and pad work at tower location 36 with a paleontology/ archaeology monitor onsite. Photo facing northwest.

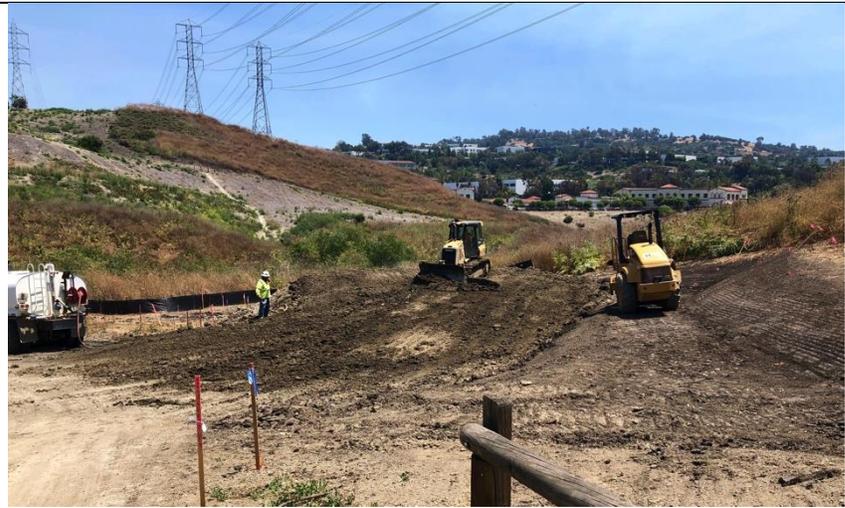
Photo 15 – Pad work being performed at tower location 34 with soil delivered from the pad work at tower location 36. Photo facing south.
06/10/20	SOCRE transmission corridor

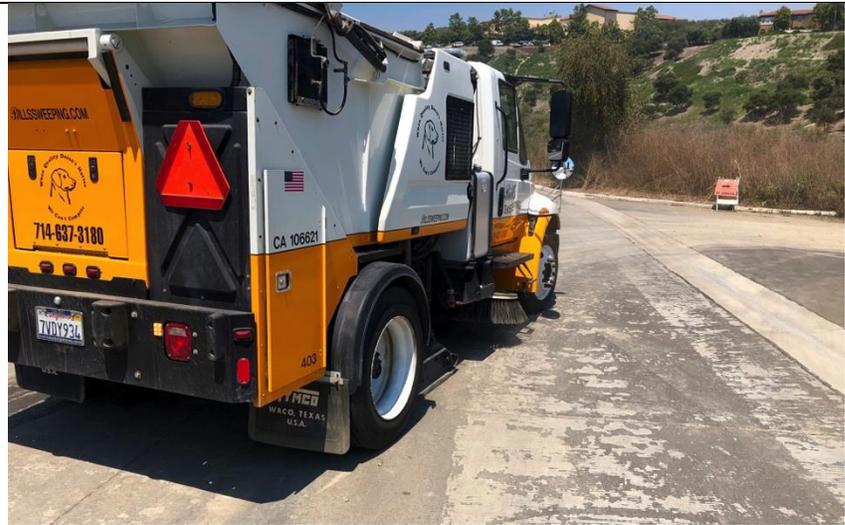
Photo 16 – Street sweeper cleaning the roadway near tower location 34.

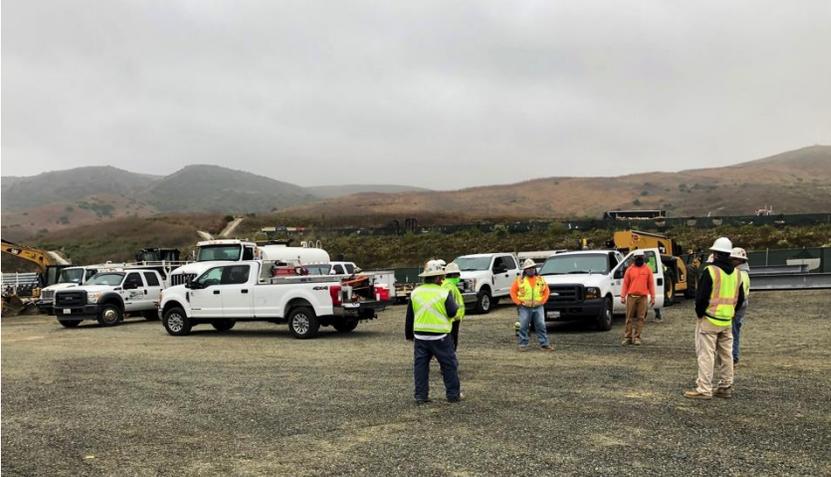
Photo 1 – Morning tailboard meeting at the La Pata staging area. Photo facing east.

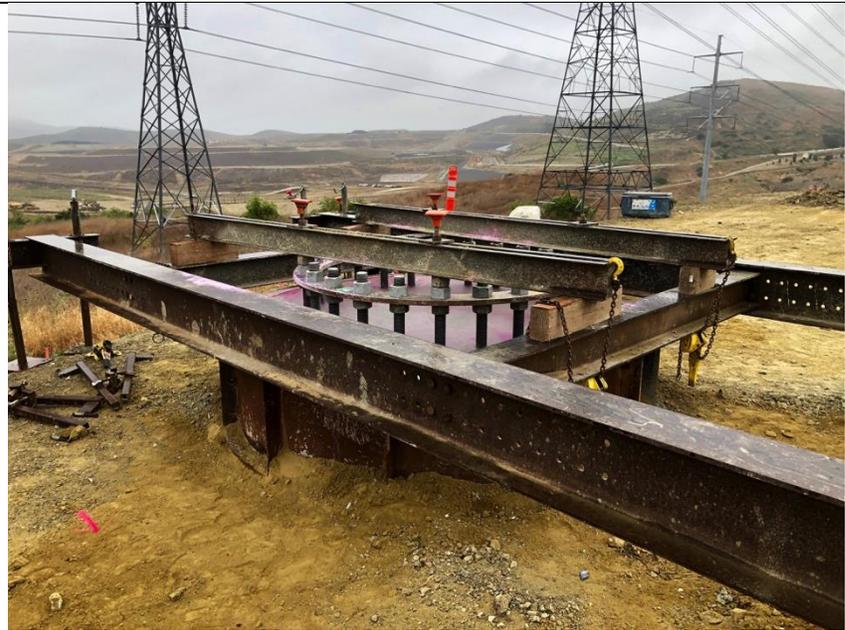
I walked to tower location 25 just outside of the La Pata staging area. The foundation had been poured and a crew was beginning to clean up the site before removing the forms (Photo 2).

Photo 2 – Newly poured foundation at tower location 25. Photo facing northwest.
06/18/20	SOCRE transmission corridor

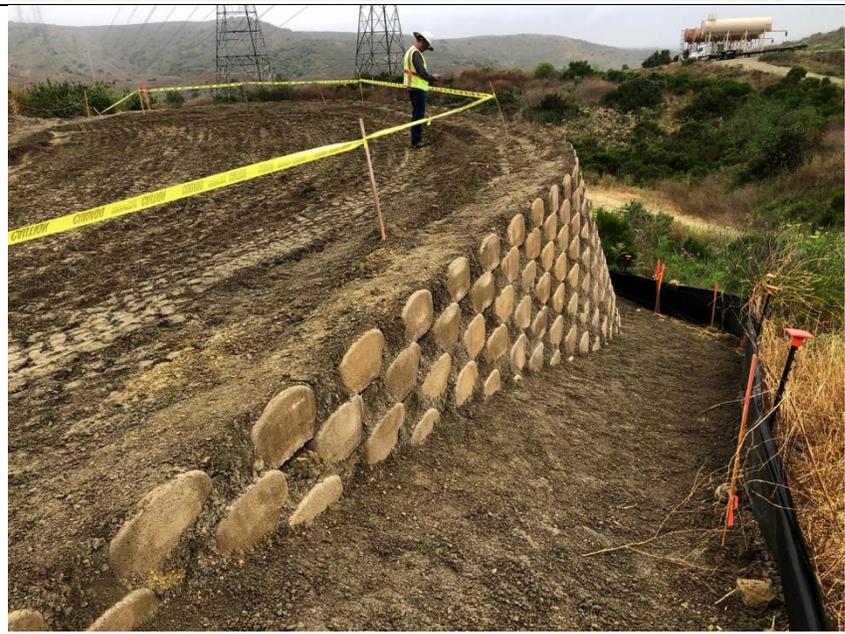
Photo 3 – Newly constructed wall at tower location 23. Photo facing southwest.

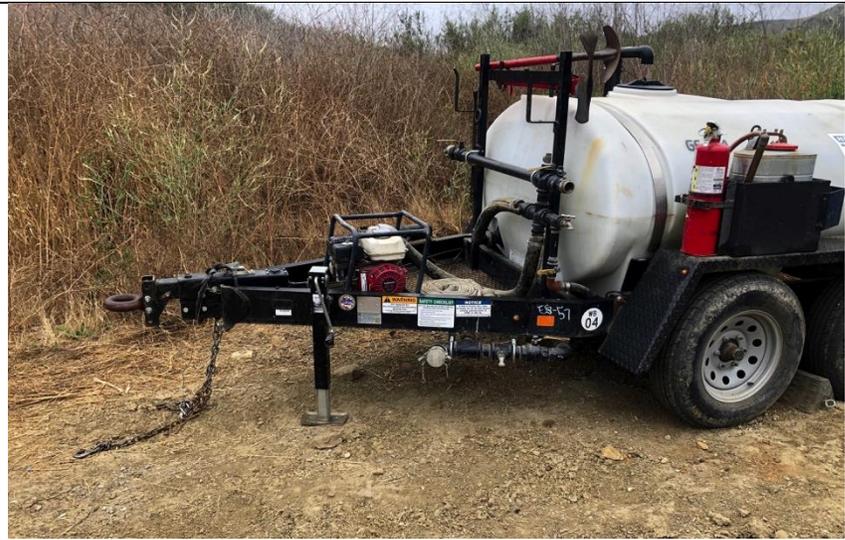
Photo 4 – Equipment without secondary containment.
06/18/20	SOCRE transmission corridor

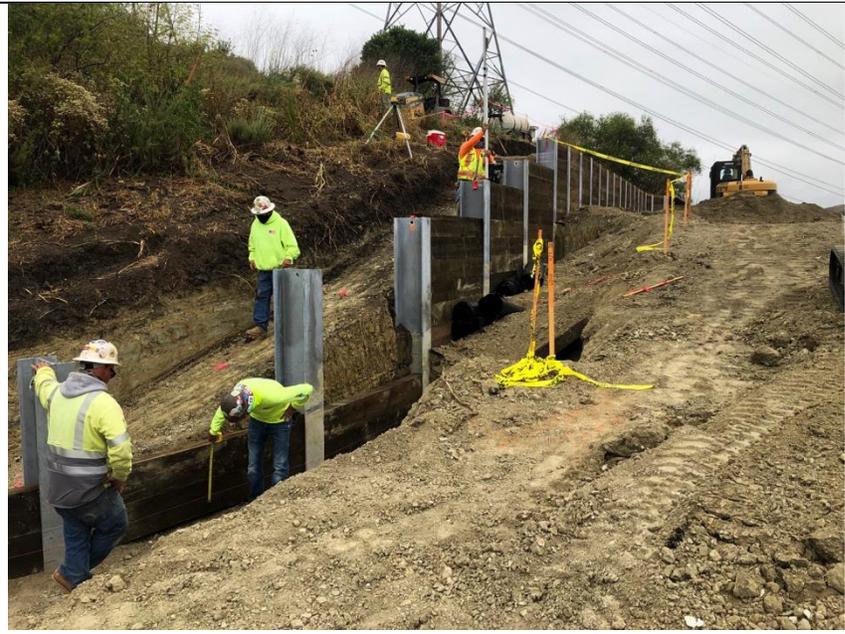
Photo 5 – Wall and pad work at tower location 36 with one biological monitor present. Photo facing southwest.

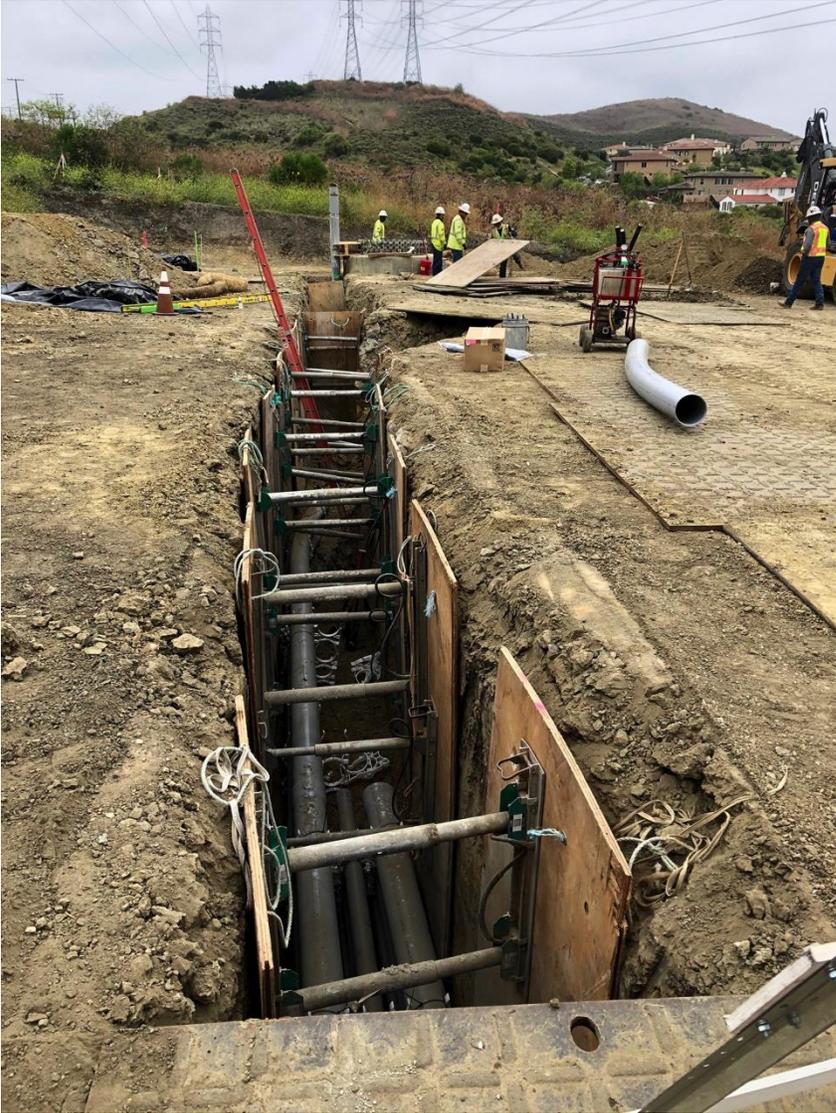
Photo 6 – Conduit installation in the area near tower locations 18 and 19. Photo facing south.
06/18/20	SOCRE transmission corridor

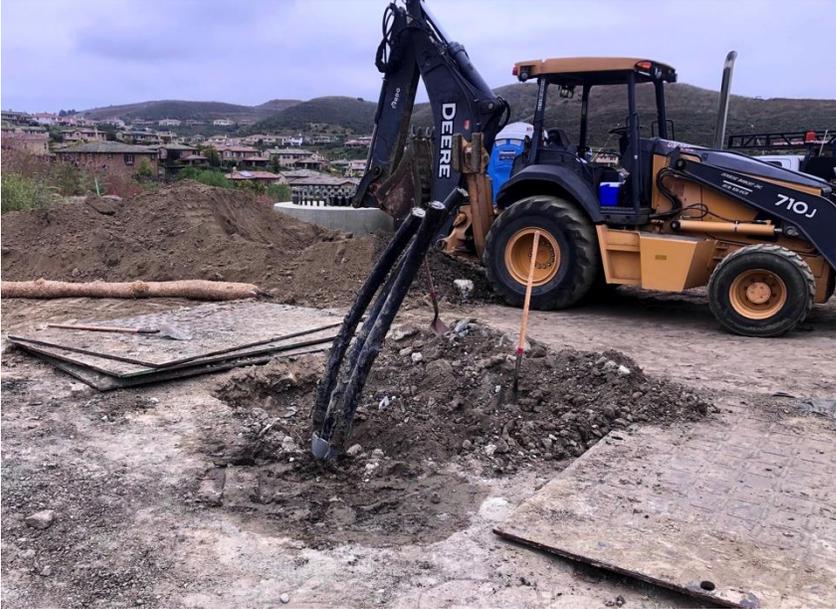
At Stallion Ridge Road, we observed the American kestrel nests (*Falco sparverius*) at tower locations 16 and 17 but did not see the birds. A small crew was doing some vault work within the roadway. A larger crew was working on conduit installation at tower locations 18 and 19 (Photo 6). The EI and I discussed the need to cover of the trench at the end of the day, which was later completed using steel plates. He said the monitoring team ensures any gaps between the plates are sealed with gravel bags or soil. The existing foundation had been removed to a depth of 2 feet below grade (Photo 7).

Photo 7 – Removal of the existing tower foundation had been completed at tower locations 18 and 19. Photo facing southwest.
