August 7, 2020

Re: Monthly Report Summary #32 for the South Orange County Reliability Enhancement (SOCRE) Project

This report provides a summary of the compliance monitoring activities that occurred during the period from **June 1 to 30, 2020**, for the South Orange County Reliability Enhancement (SOCRE) Project in Orange County, California. Compliance monitoring was performed four times between June 1 and 30, 2020, to ensure all project-related activities conducted by San Diego Gas and Electric (SDG&E) and its contractors were in compliance with the Final Environmental Impact Report (Final EIR) for the SOCRE Project, as adopted by the California Public Utilities Commission (CPUC) on December 15, 2016.

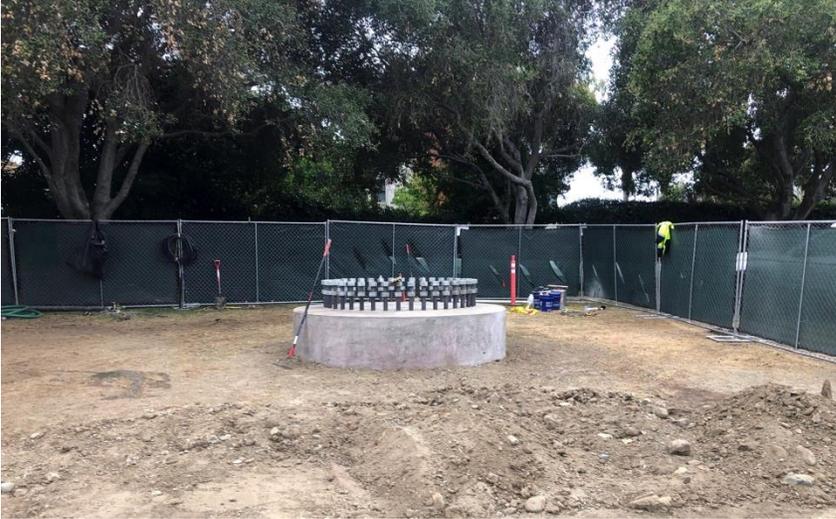
Photo 8 – The foundation was installed at tower location 8. Photo facing west.
06/18/20	SOCRE transmission corridor

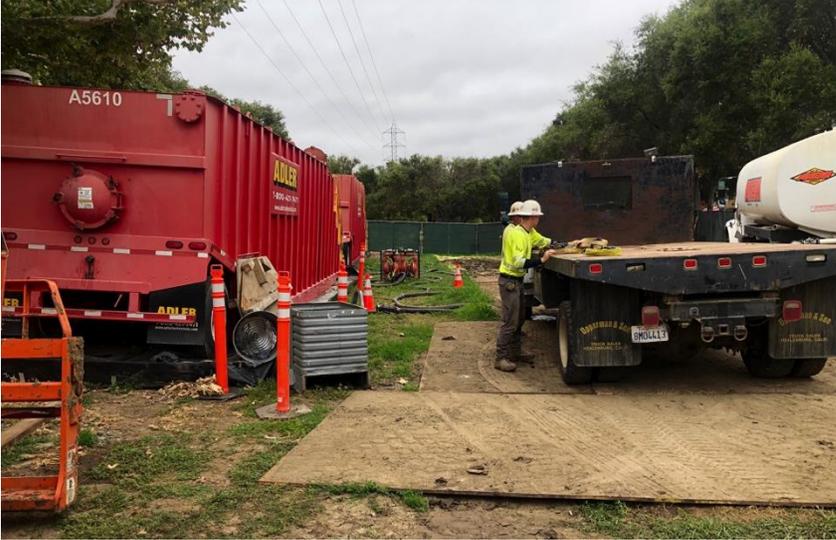
Photo 9 – Equipment being moved from the parkway near tower location 8. Photo facing south.
06/18/20	SOCRE transmission corridor

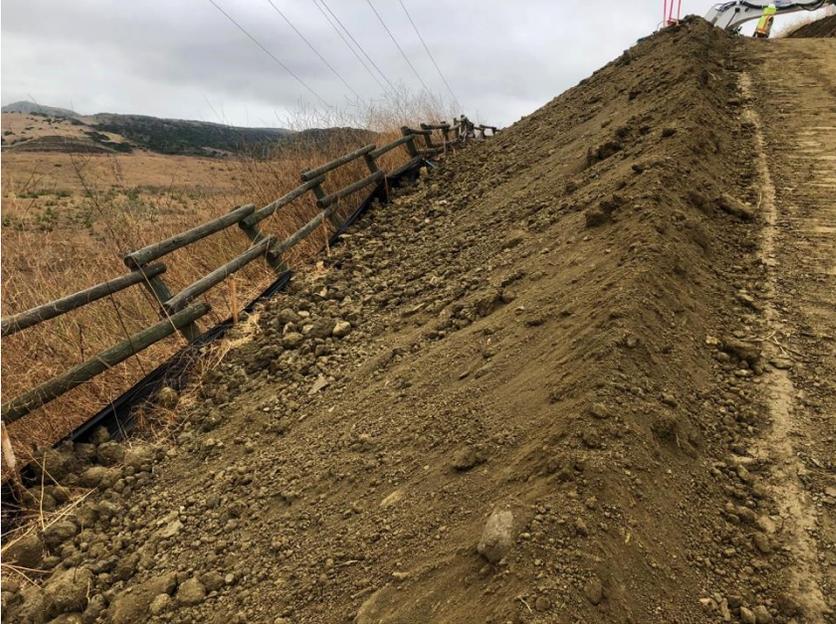
Photo 10 – Soil sloughing down from the new pad at tower location 13, overwhelming the silt fencing. Photo facing south.

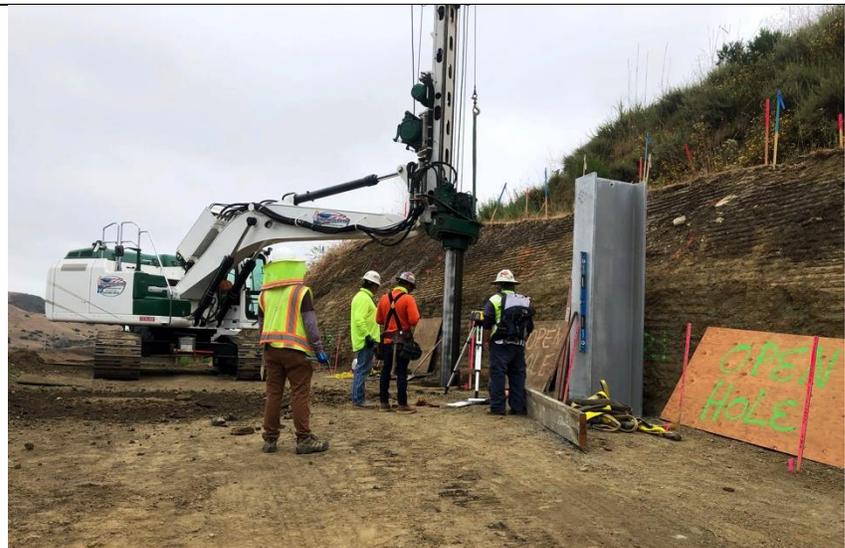
Photo 11 – Drilling for and installing the I-beams at tower location 13. Photo facing south.
06/18/20	SOCRE transmission corridor

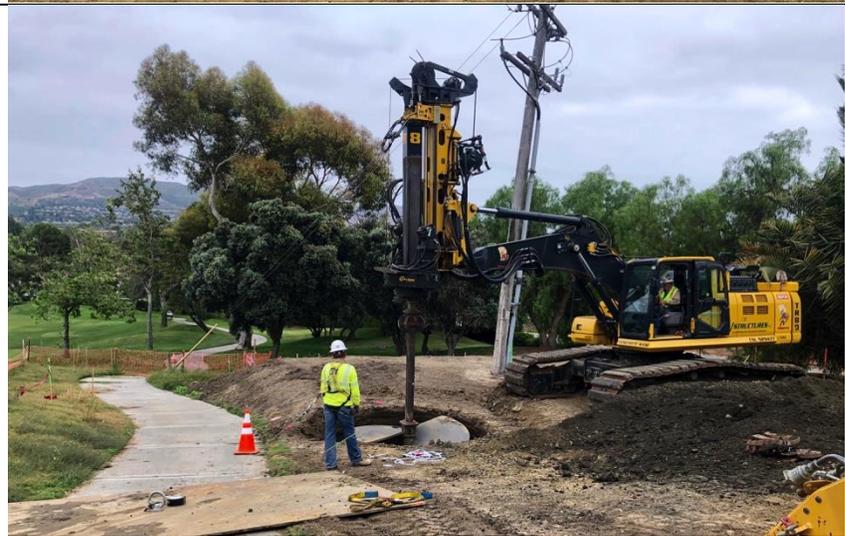
Photo 12 – Drilling the foundation hole at tower location 5. Photo facing south.
06/18/20	West of San Juan Capistrano Substation – jack and bore site

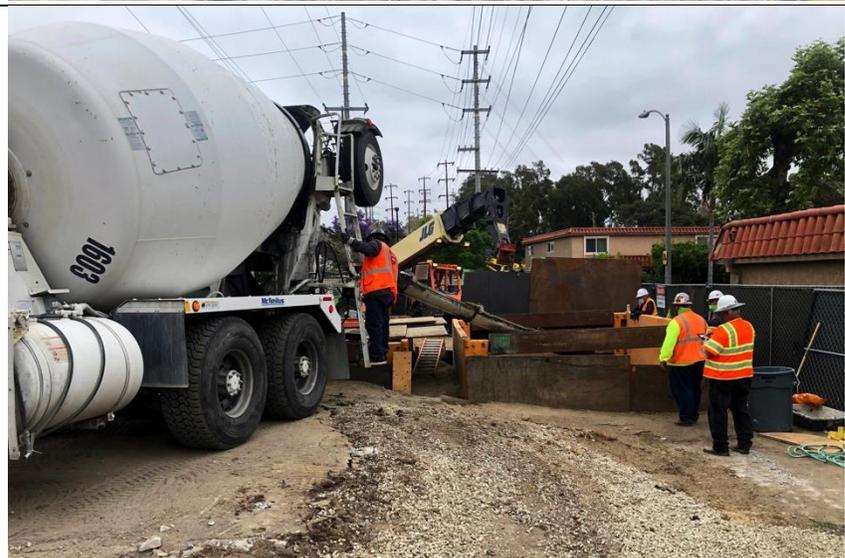
Photo 13 – Jack and bore exit hole work west of the railroad tracks. Photo facing east.

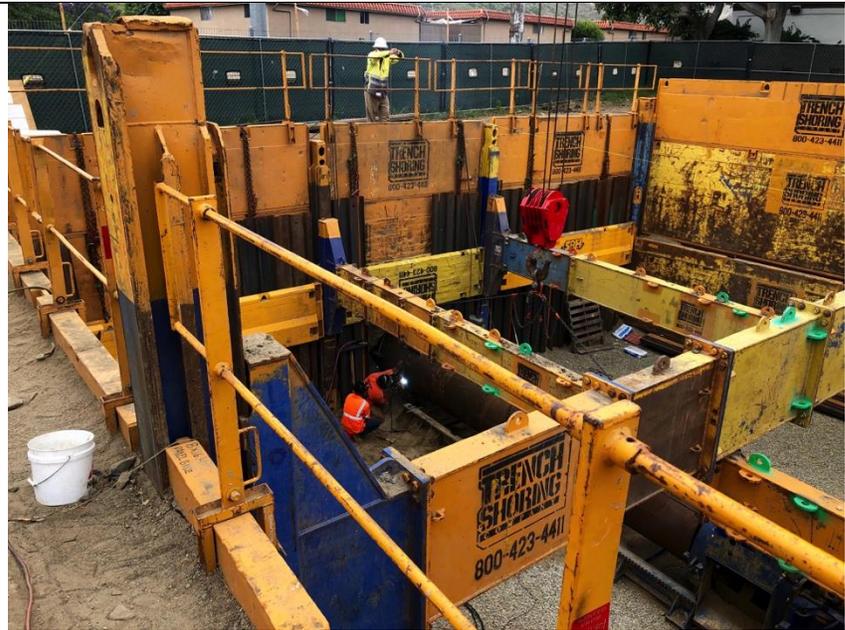
Photo 14 – The bore hole located east of the railroad tracks. Photo facing southwest.
06/18/20	San Juan Capistrano Substation

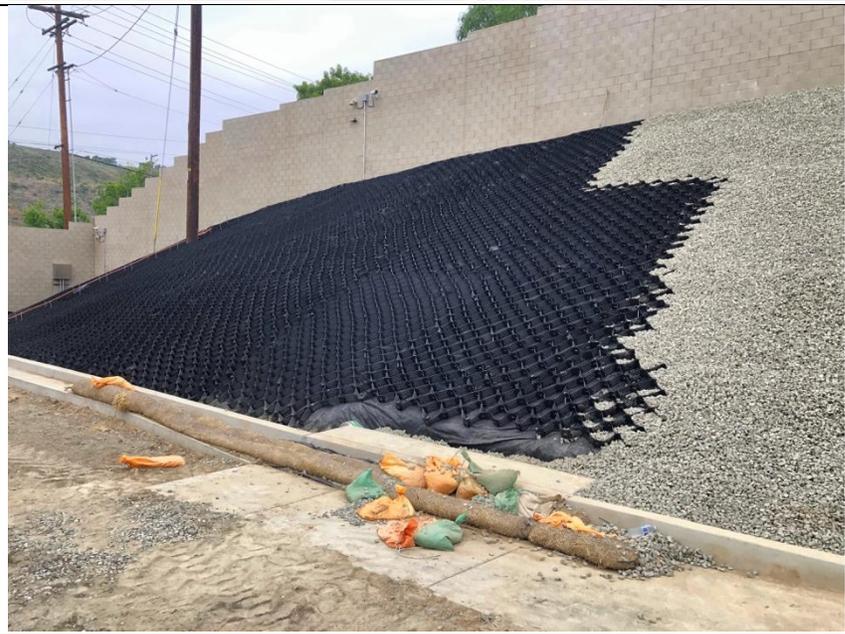
Photo 15 – Armoring the northern slope of the substation. Photo facing northwest.

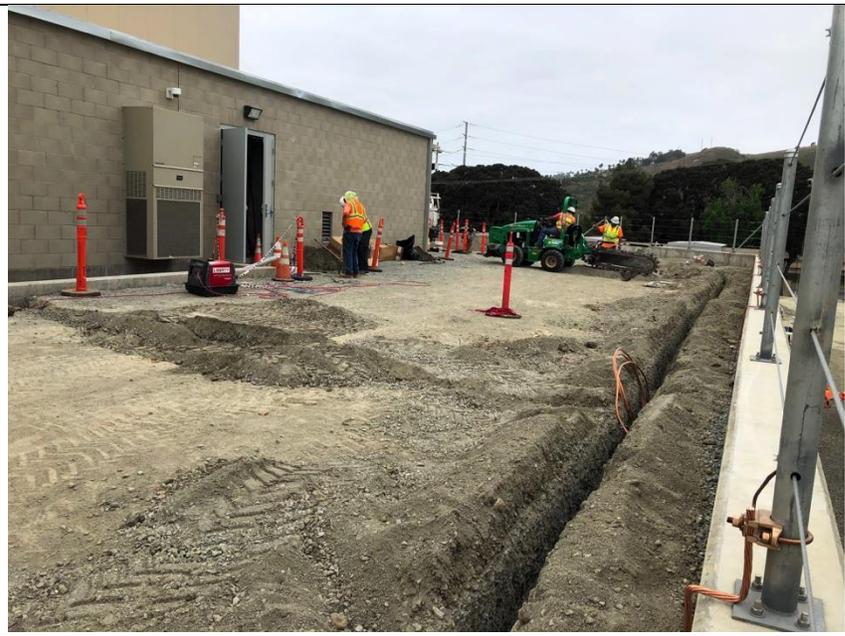
Photo 16 – Grounding wire installation north of the 138-kV GIS building. Photo facing west.
06/18/20	San Juan Capistrano Substation

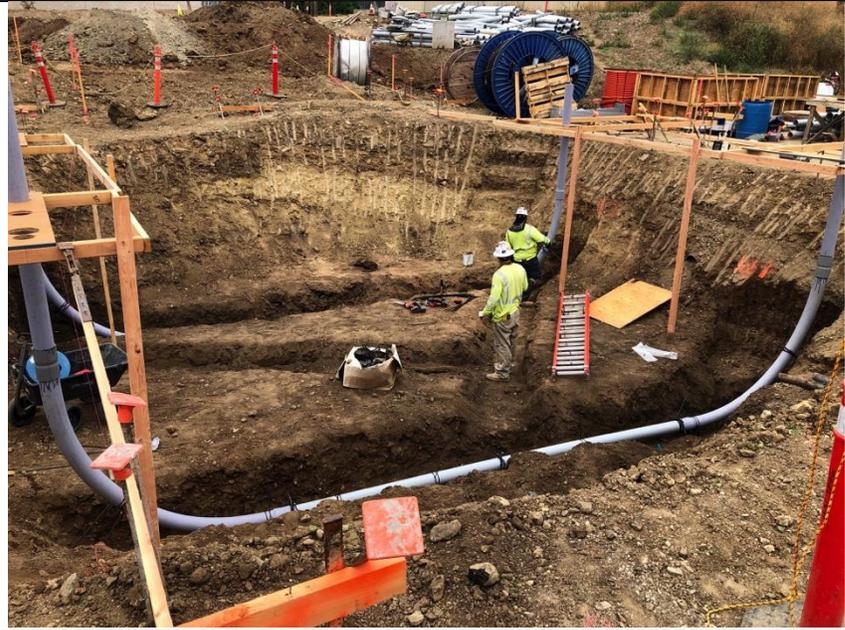
Photo 17 – Excavation and conduit installation in the area northeast of the 138-kV GIS building. Photo facing east.

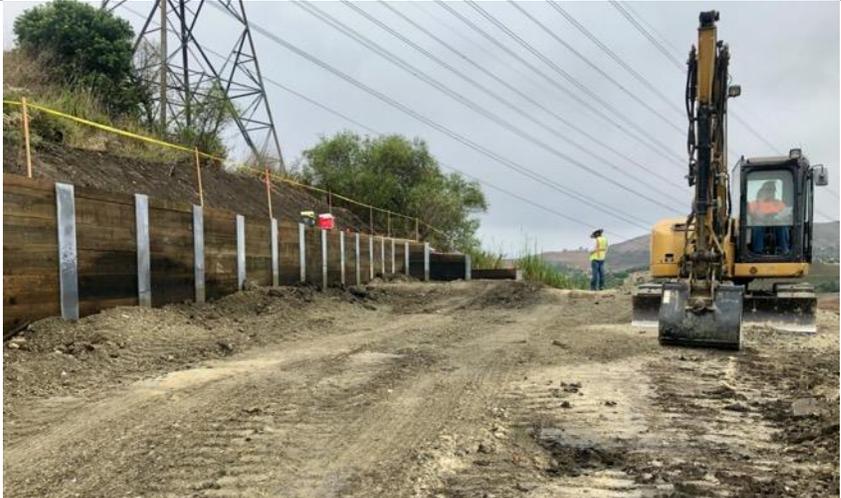
Photo 1 – Pad construction at tower location 36. Photo facing west.

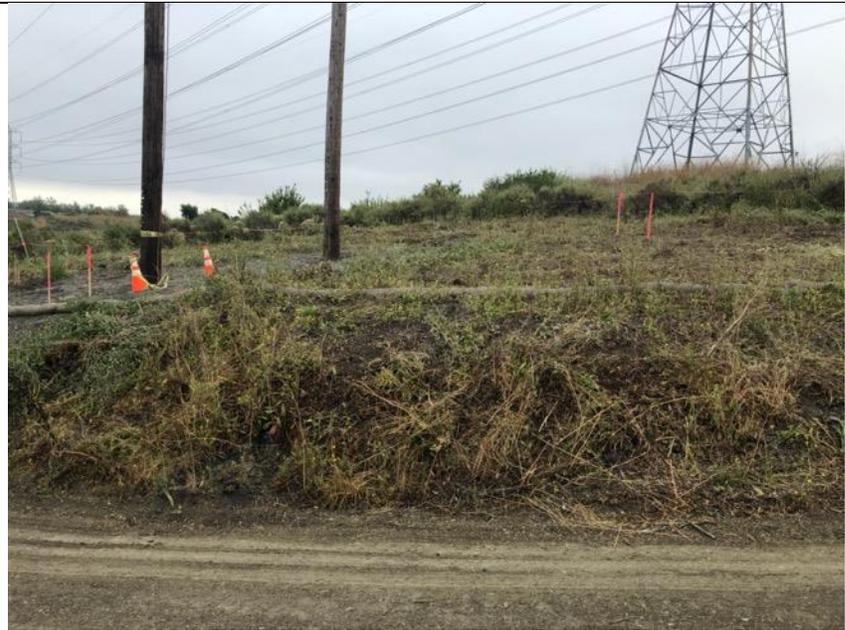
Photo 2 – Tower location 37 had been surveyed in preparation for grading the work pad. Photo facing south.
06/25/20	SOCRE transmission corridor

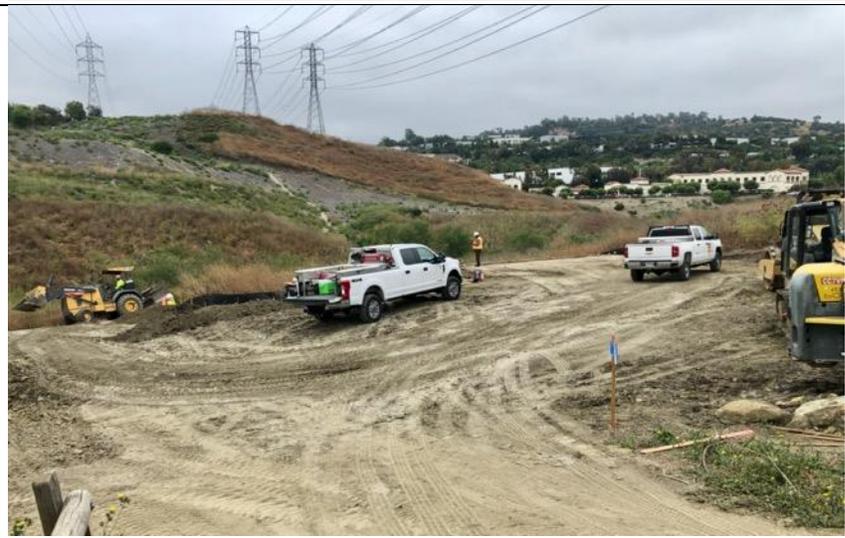
Photo 3 – Pad construction at tower location 34. Photo facing southeast.

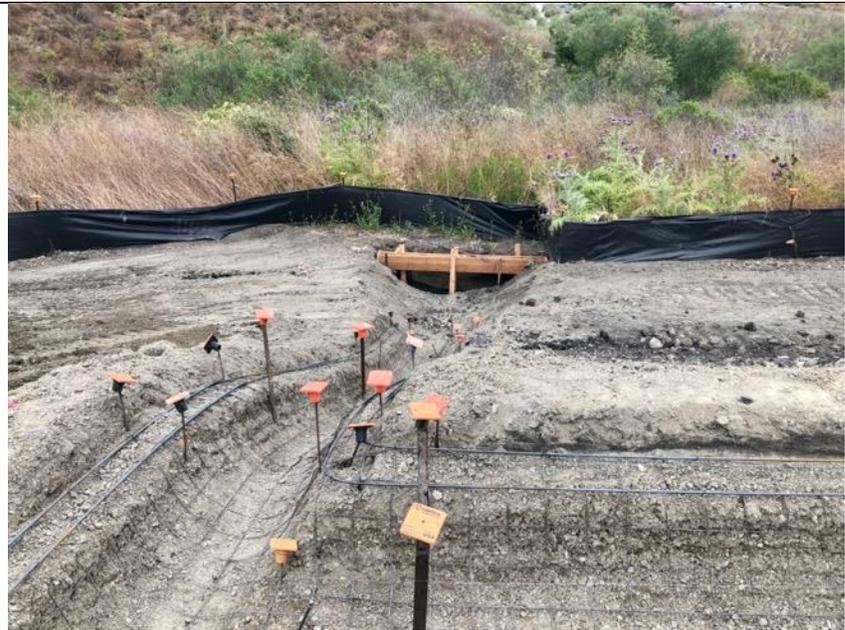
Photo 4 – Brow ditch construction at tower location 34.
06/25/20	SOCRE transmission corridor

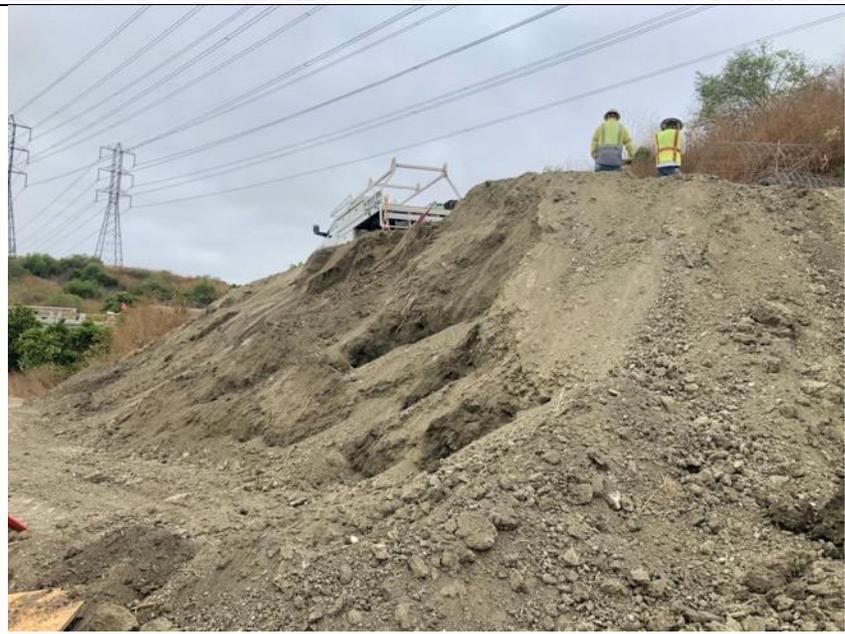
Photo 5 – Pad work at tower location 32. Photo facing southwest.

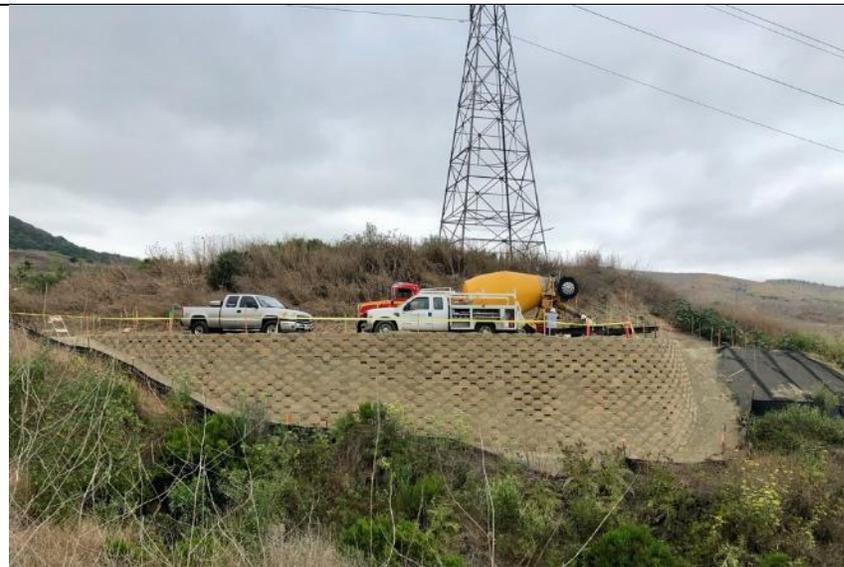
Photo 6 – Pouring the foundation for tower location 23. Photo facing east.
06/25/20	SOCRE transmission corridor

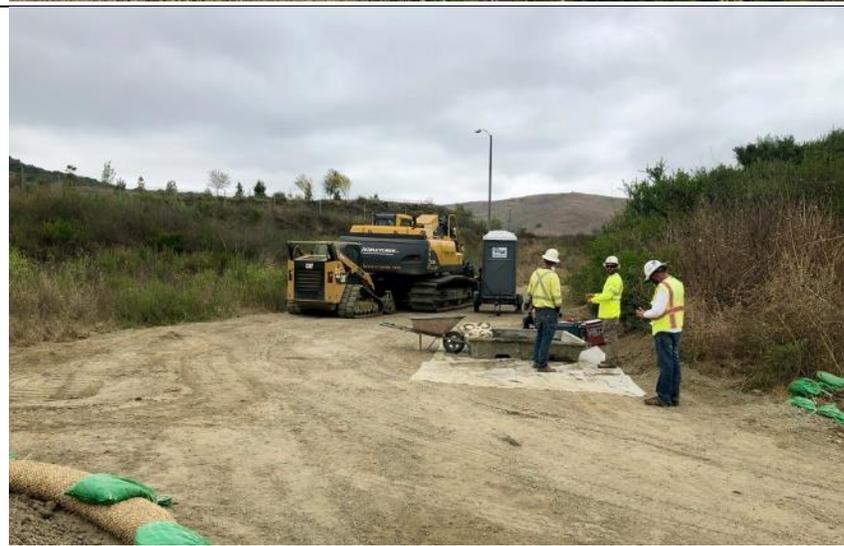
Photo 7 – Concrete washout station near tower location 23. Photo facing east.
06/25/20	SOCRE transmission corridor

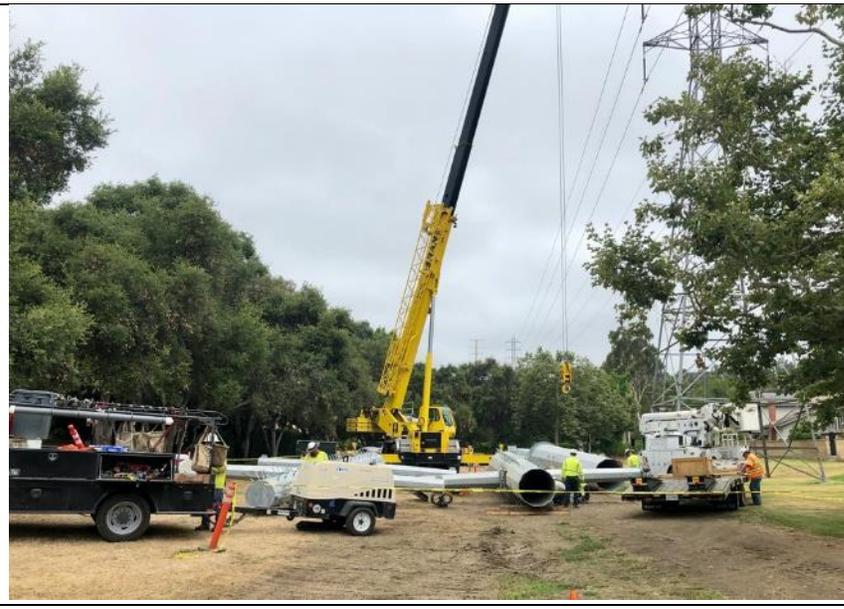
Photo 8 – TSP erection at tower location 8. Photo facing northwest.

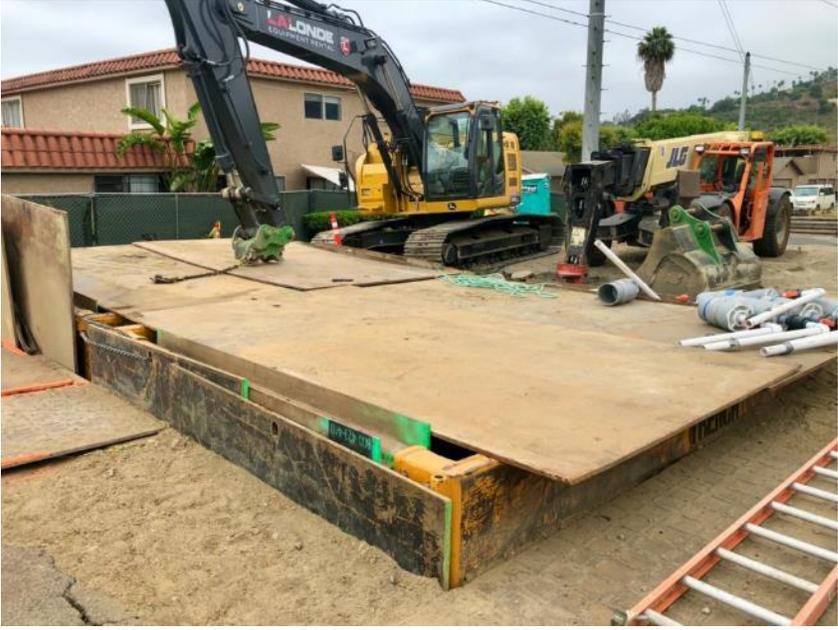
Photo 9 – Jack and bore exit hole west of the railroad tracks. Photo facing southwest.
06/25/20	West of San Juan Capistrano Substation – jack and bore site

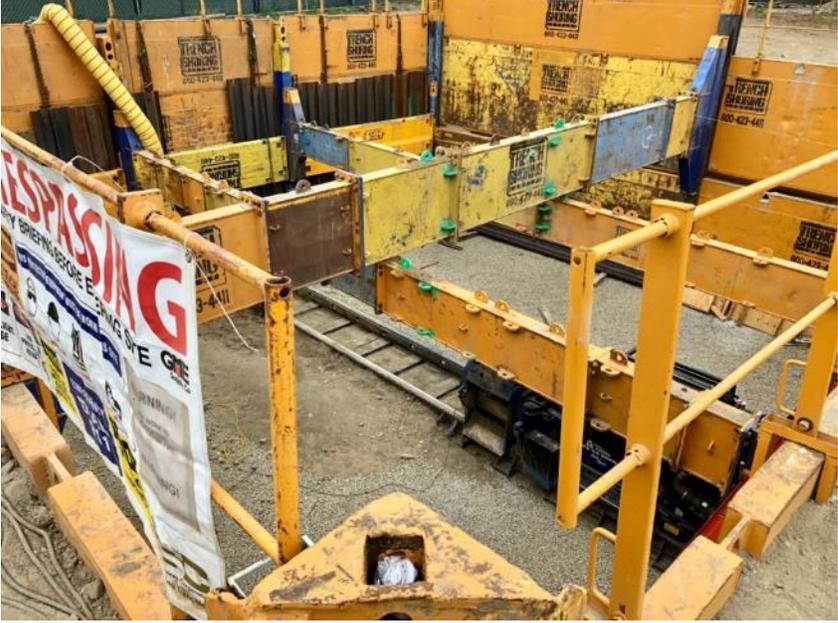
Photo 10 – Jack and bore entry hole east of the railroad tracks.

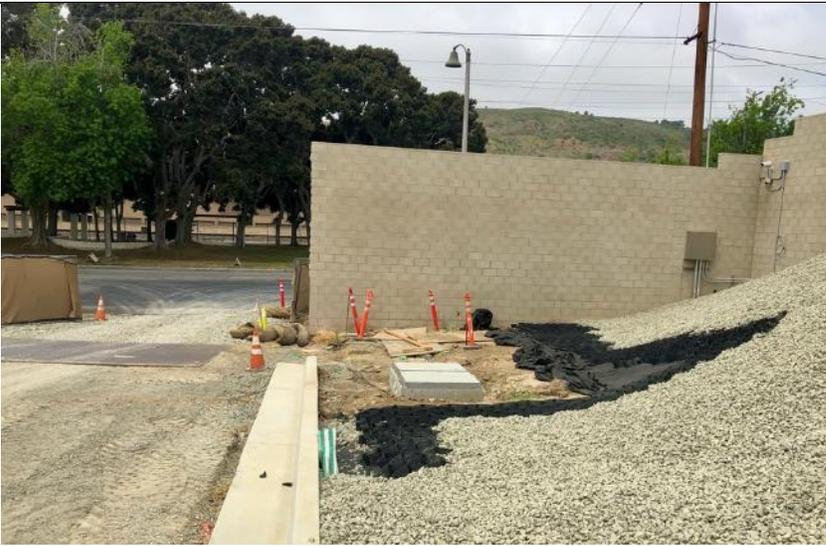
A photograph showing a construction site for the armoring of a northern slope. In the foreground, there is a concrete curb and a gravel area. A large, light-colored concrete wall is under construction, with several orange traffic cones placed around it. The background shows trees and a utility pole.	Photo 11 – Armoring of the northern slope in progress. Photo facing west.
06/25/20	San Juan Capistrano Substation

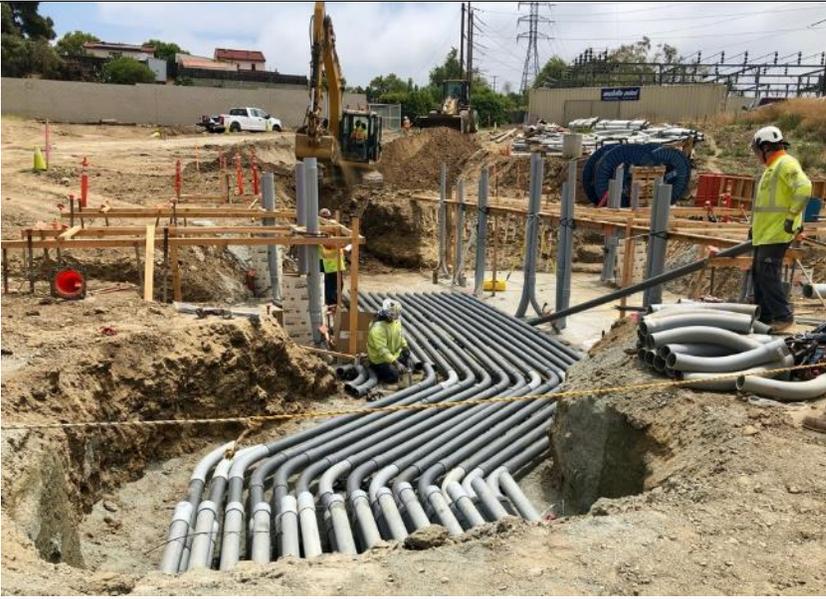
A photograph showing an excavation site for conduit installation. Numerous grey conduits are laid out in a trench. A worker in a yellow safety vest and white hard hat is visible in the background. The site is surrounded by construction equipment and materials.	Photo 12 – Excavation and conduit installation in the northeast corner of the substation near the 138-kV GIS building. Photo facing east.

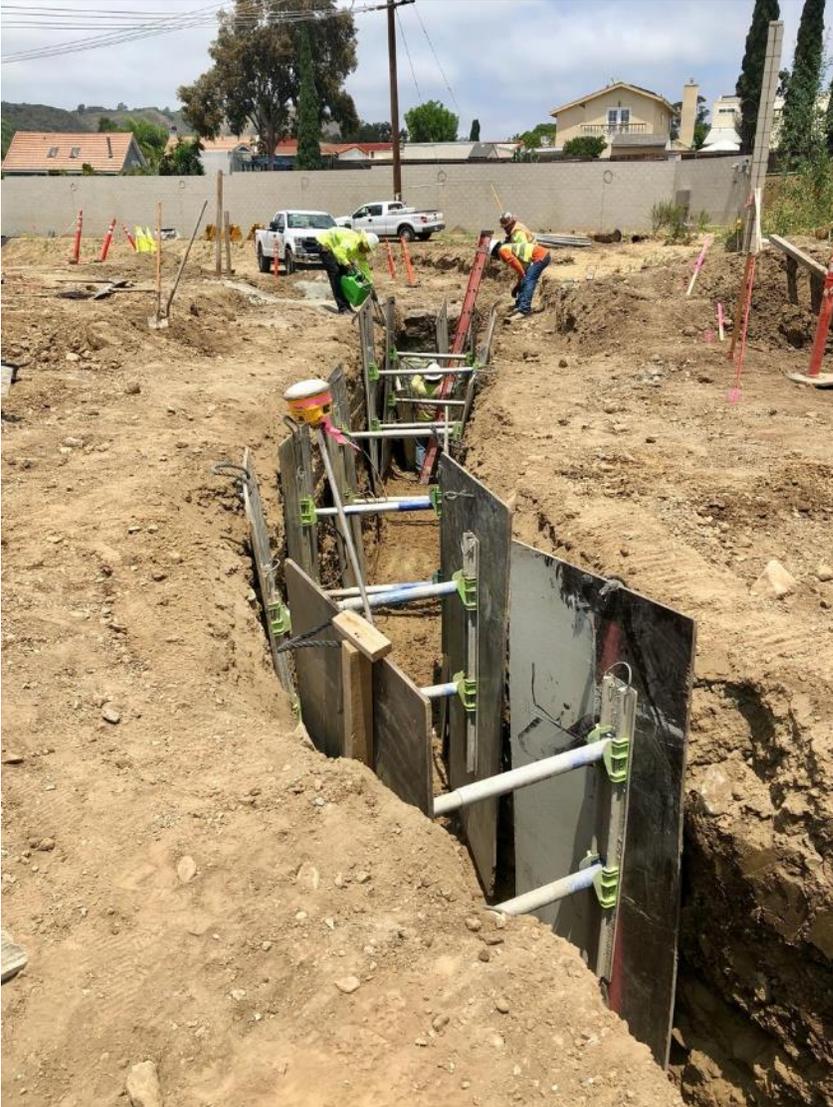
Photo 13 – Conduit trenching and installation. Photo facing north.

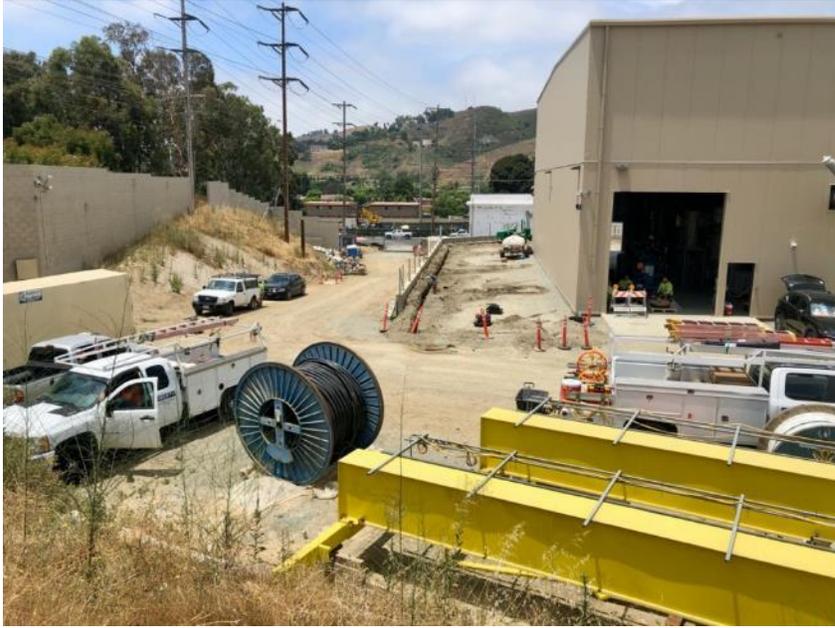
Photo 14 – Overview of the southern portion of the substation work. Photo facing west.
