August 26, 2020

**Re: Monthly Report Summary #33 for the South Orange County Reliability Enhancement (SOCRE) Project**

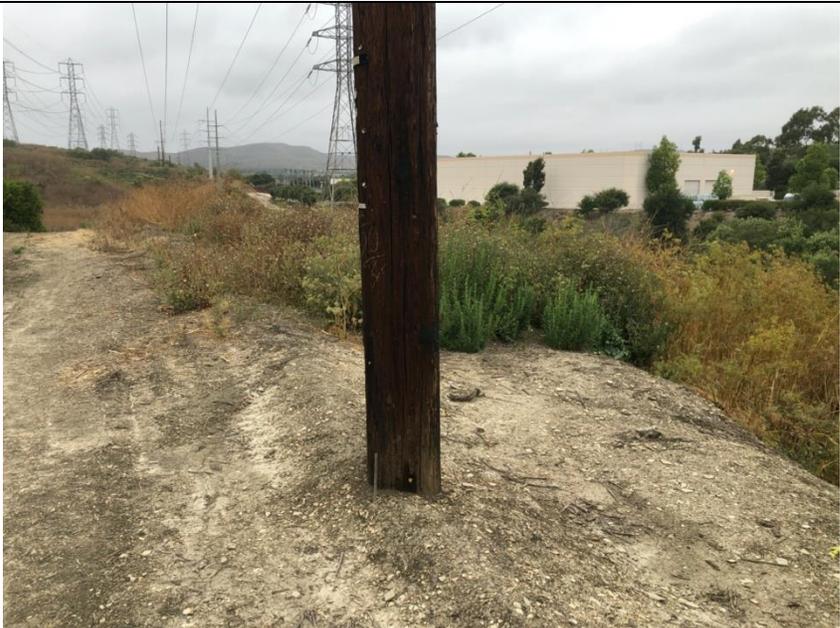
The first stop was at tower location 39 where vegetation clearing was scheduled later in the day. The area within the work limits that had been previously cleared had grown back in with predominately tall, weedy vegetation (Photo 1). A nesting bird survey had been completed recently with no new nests were observed.

Photo 1 – Tower location 39 with tall weedy vegetation. Photo facing west.

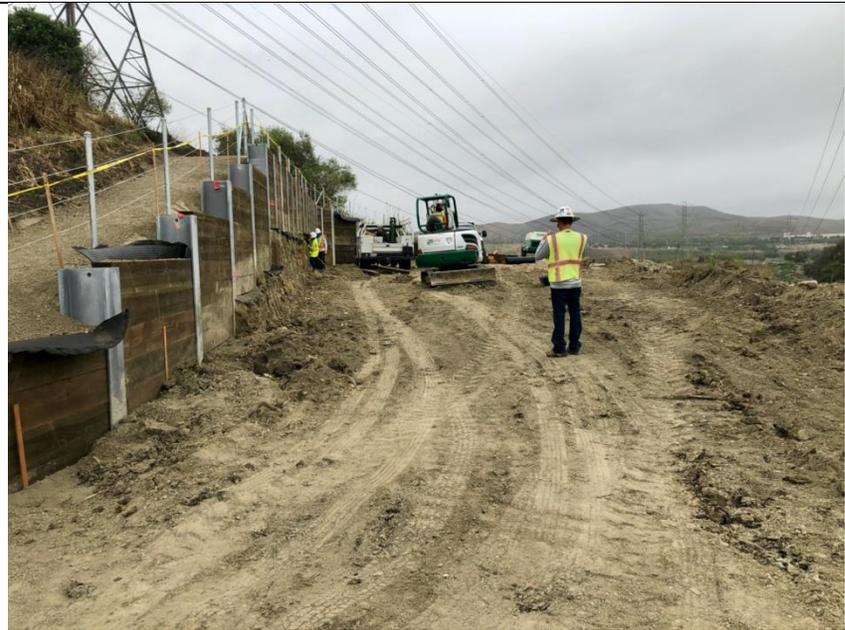
We walked to tower location 36 where crews continued to work on soil removal and wall construction (Photo 2). The railing had been installed along the top of the wall. The juvenile red-tailed hawks (*Buteo jamaicensis*) were present around this area and a pair of California gnatcatchers (*Poliophtila californica*) were observed. The LEI said the gnatcatchers had successfully nested nearby and an avian monitor would observe the pair.

Photo 2 – Pad construction at tower location 36. Photo facing northwest.
07/02/20	SOCRE transmission corridor

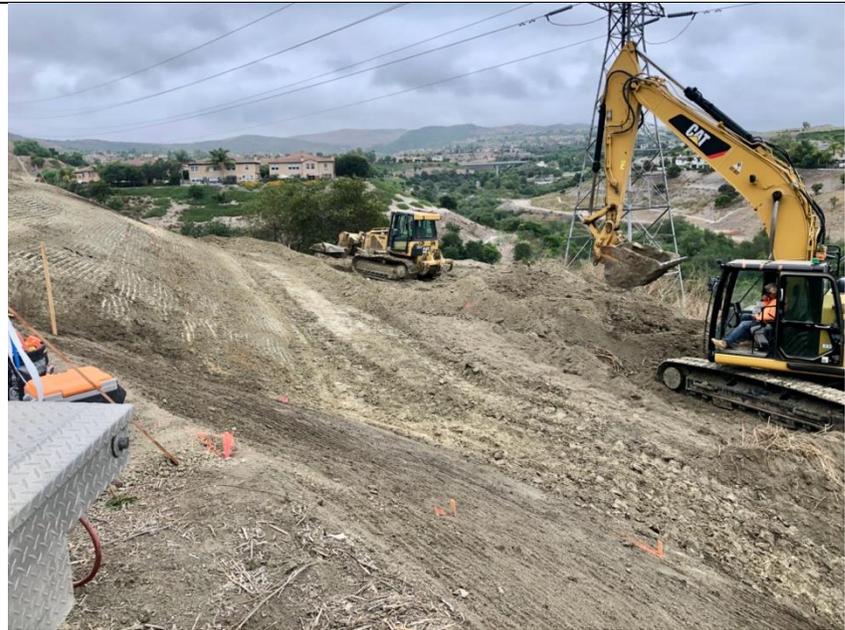
At tower location 32, a crew was digging out the pad below the new brow ditch (Photo 4). According to the LEI the kingbird (*Tyrannus verticalis*) nest had been predated. I questioned how they determined this and the LEI said they found the nest at the bottom of the tower. An Environmental Inspector spot-checked this construction activity.

Photo 4 – Tower pad construction at tower location 32. Photo facing north.
07/02/20	SOCRE transmission corridor

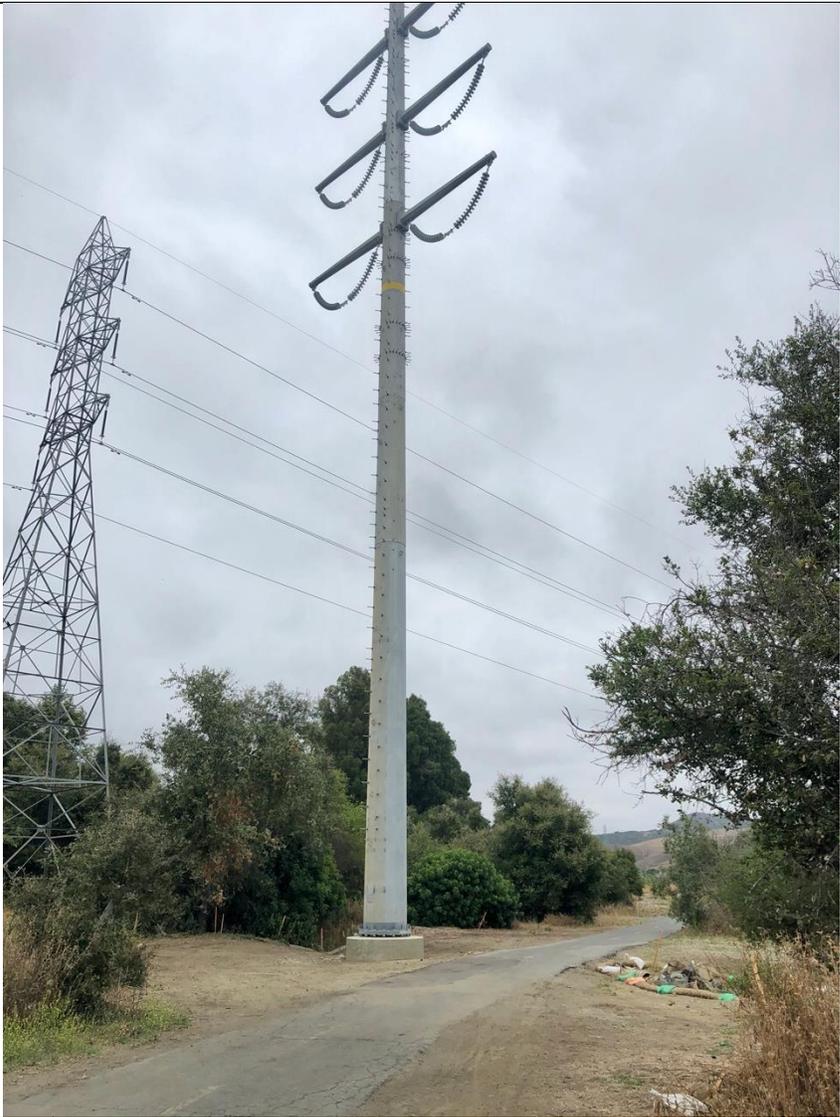
We traveled to tower location 9 where the new tower had been installed. The site was in good condition with no new impacts from erecting the tubular steel pole (TSP) (Photo 8). We also stopped at tower location 10 where most of the TSP had been installed (Photo 9). There had been gravel laid down around the base of the tower to suppress dust and some equipment was staged onsite near the creek corridor (Photo 10). The tower at tower location 11 was being erected and work continued on the pad at tower location 13. The TSP for location 7 was being prepared for installation at tower location 8.

Photo 8 – Newly erected tower at tower location 9. Photo facing southeast.

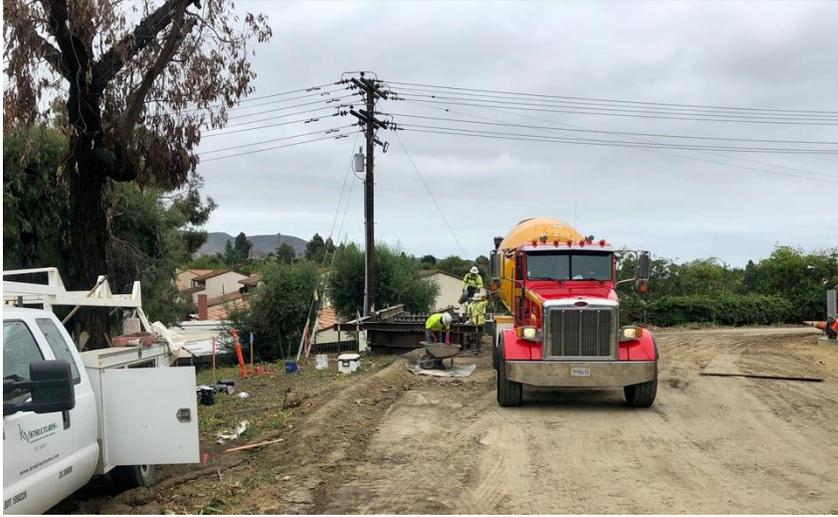
My final stop along the transmission corridor was at tower location 4 where the KV Structures crew was pouring the tower foundation (Photo 11). The concrete washout station had been properly set up nearby. The access road was dusty and we discussed the proper dust control measures to employ. Once again I pointed out the advantages of the "end-of-day" dust control, especially for dusty locations on the following day's work schedule.

Photo 11 – Concrete trucks pouring the foundation for tower location 4. Photo facing south.
07/02/20	West of San Juan Capistrano Substation – jack and bore site

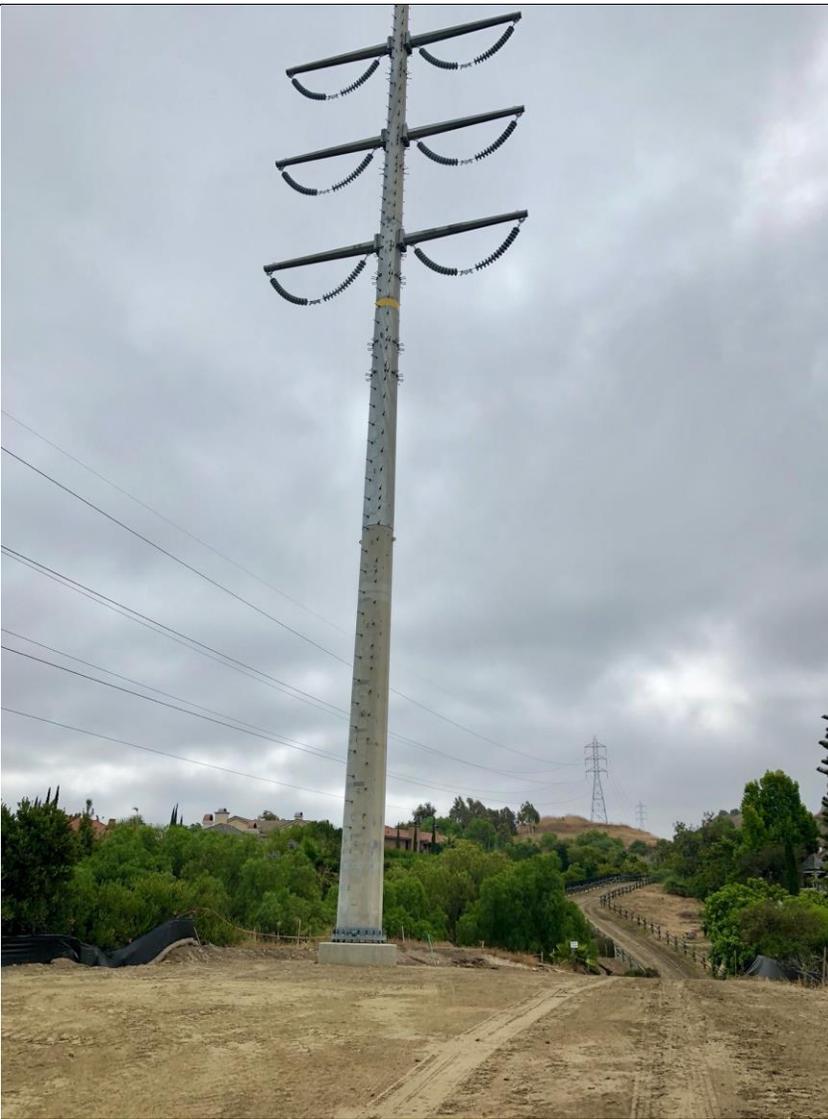
At tower location 11, the TSP was installed (Photo 9). I observed the work area and did not see any issues with dust control.

Photo 9 – Newly erected tower at tower location 11. Photo facing south.

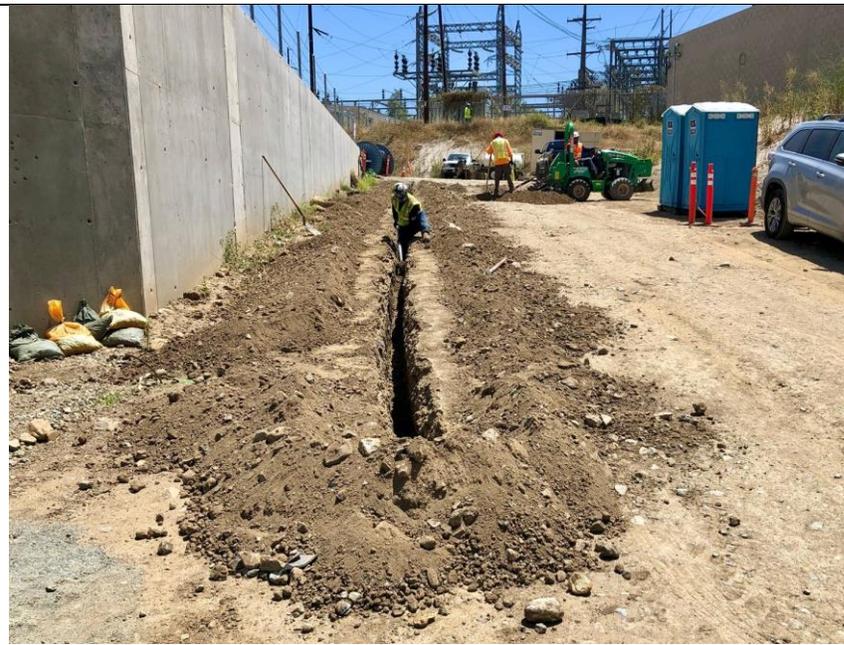
Within the substation, grounding wire installation continued along the southern side of the 138-kilovolt (kV) gas-insulated substation (GIS) building (Photo 14). Some foundation drilling was being completed around the transformers (Photo 15).

Photo 14 – Grounding wire installation. Photo facing east.
07/08/20	San Juan Capistrano Substation

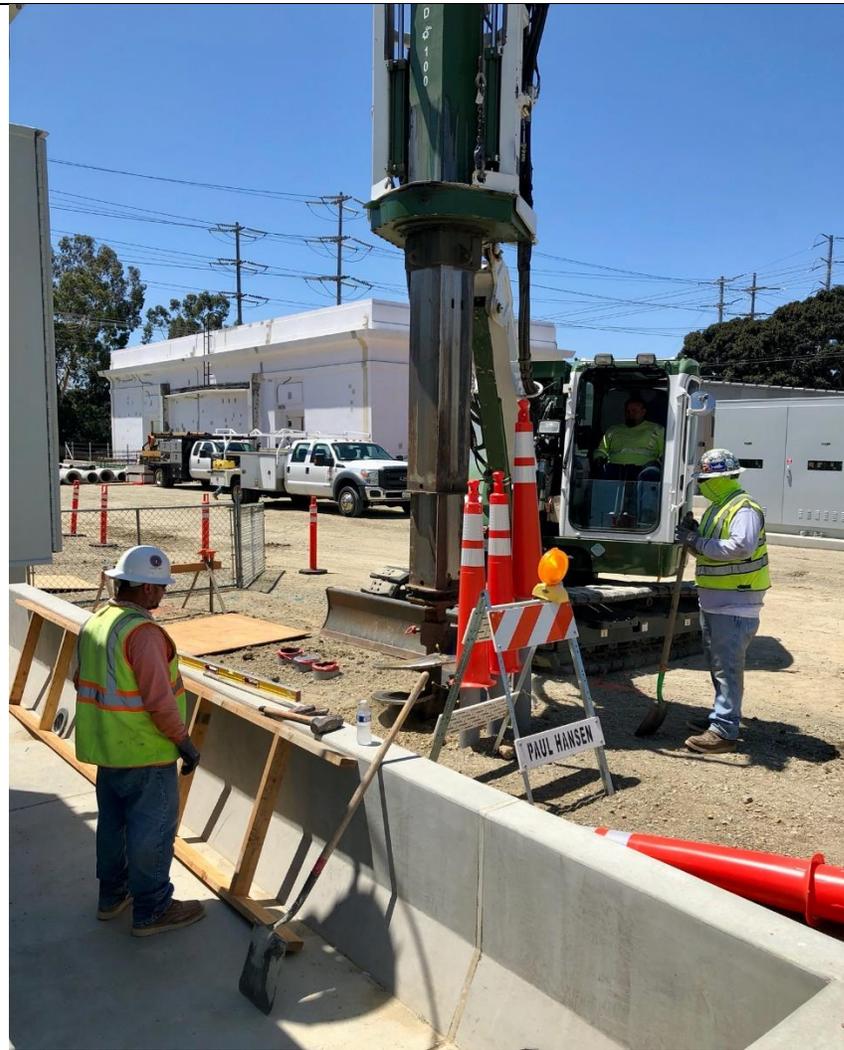
Photo 15 – Foundation drilling near the transformers. Photo facing southwest.

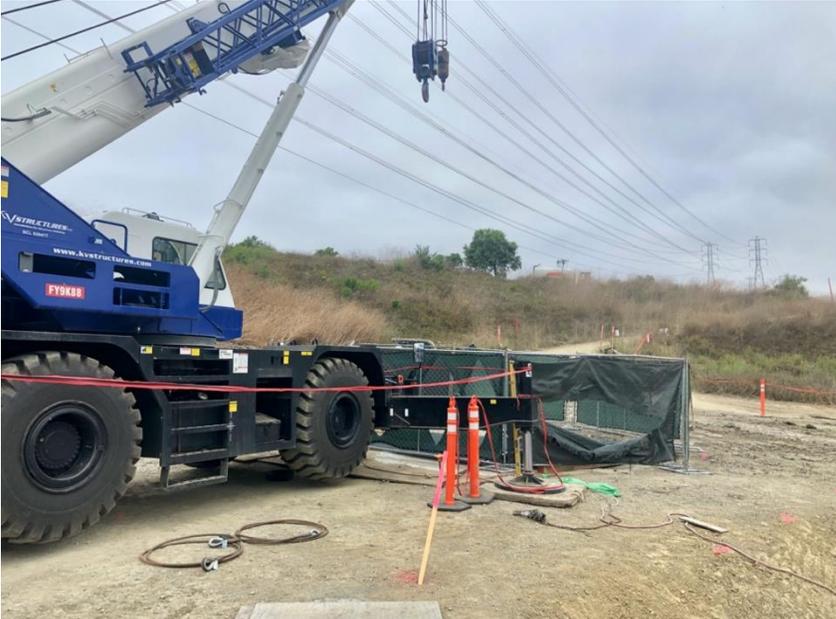
I arrived onsite at the San Juan Capistrano Substation at 0600 and proceeded immediately to tower location 34 for an inspection before construction began for the day. They had begun drilling the foundation hole and had fenced off and covered the hole (Photo 1). I noted several openings in the hole coverings that could allow animals to enter and become trapped (Photo 2). Tracks on the dusty access road showed that many animals inhabit this riparian corridor. I also heard and observed a yellow-breasted chat (*Icteria virens*) around the tower site.

Photo 1 – Tower location 34 where drilling had begun. The area was fenced off and the excavation hole was covered when not being used. Photo facing north.

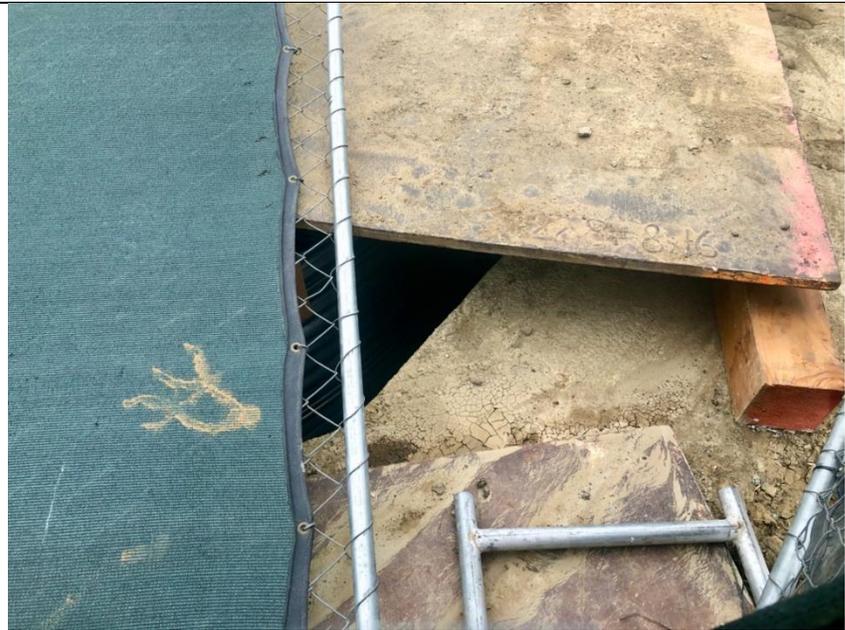
Photo 2 – Openings in the plates covering the tower location 34 foundation hole.
07/16/20	SOCRE transmission corridor

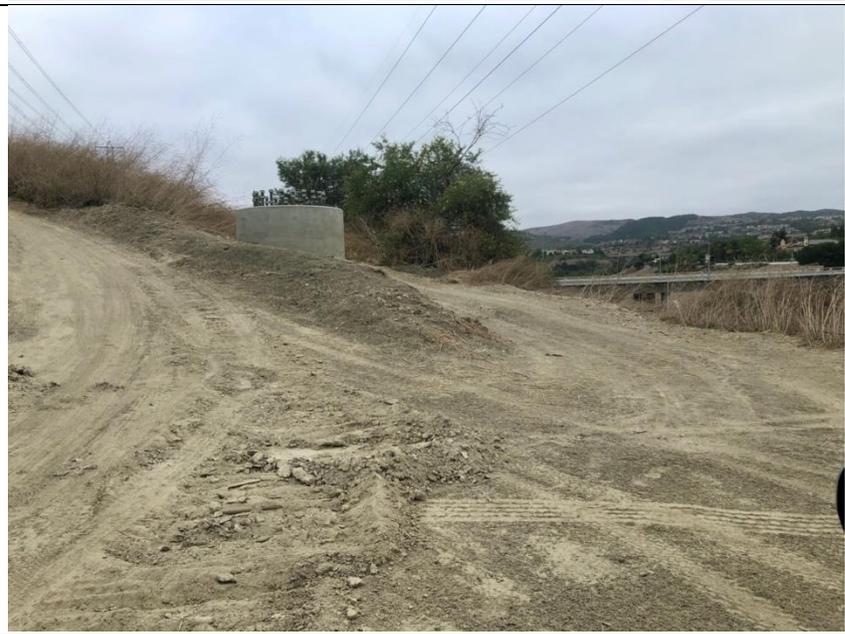
We drove the access road past tower location 33 and observed that the pad had been drilled and poured (Photo 3).

Photo 3 – Tower foundation at tower location 33. Photo facing north.

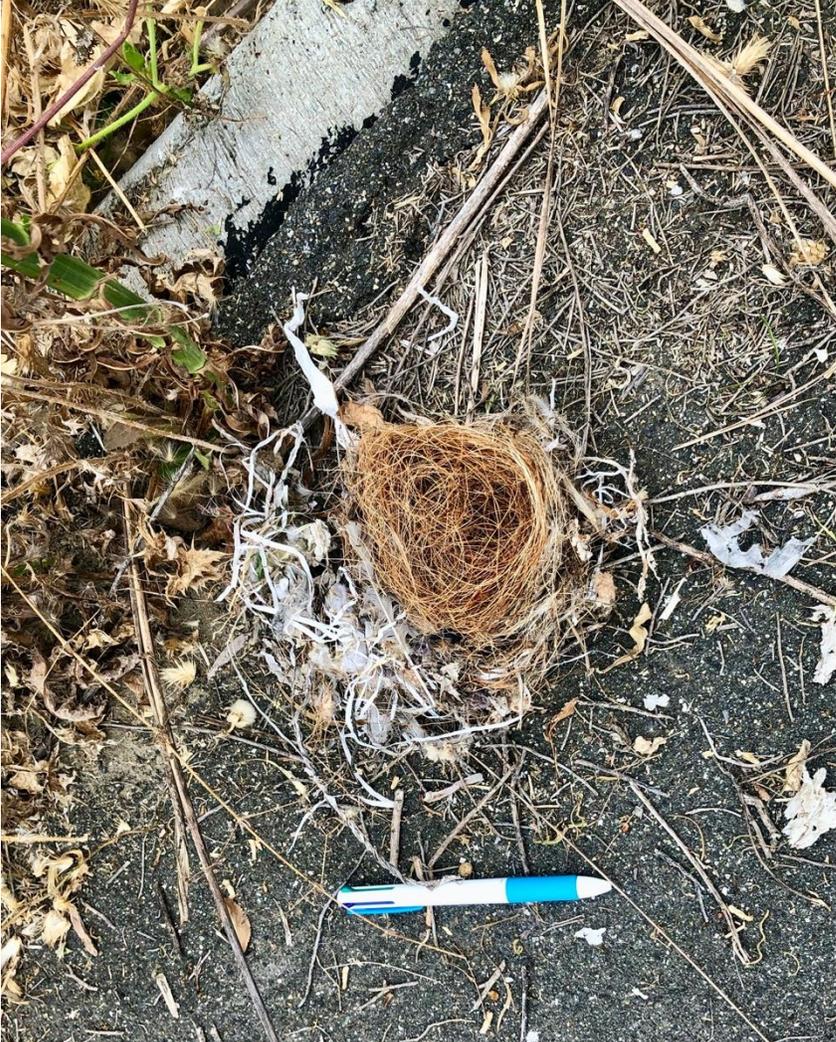
Photo 3 – Predated kingbird nest at the lattice tower near tower location 34.

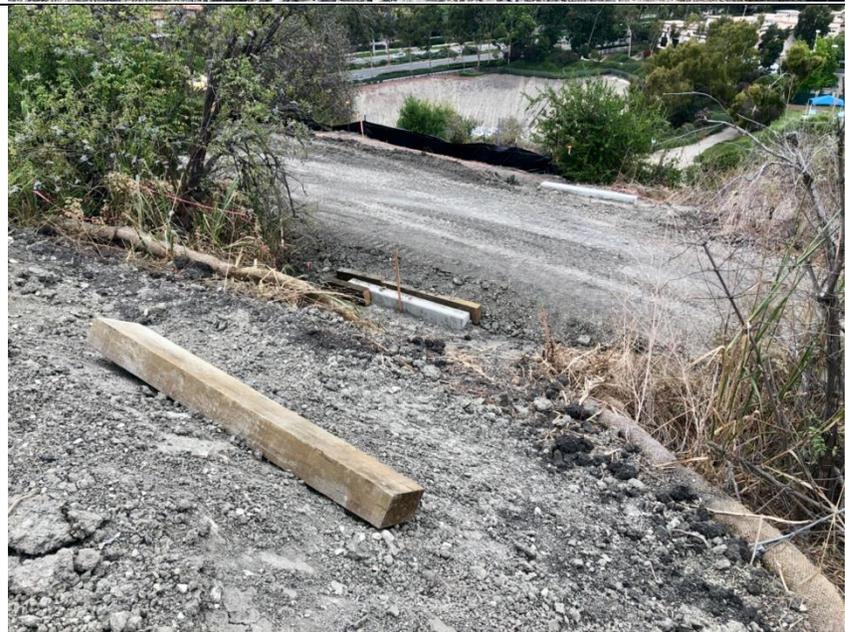
Photo 6 – Drainage piping appeared to be complete at tower location 36 with some restoration remaining. Photo facing northeast.
