October 1, 2020

Re: Monthly Report Summary #34 for the South Orange County Reliability Enhancement (SOCRE) Project

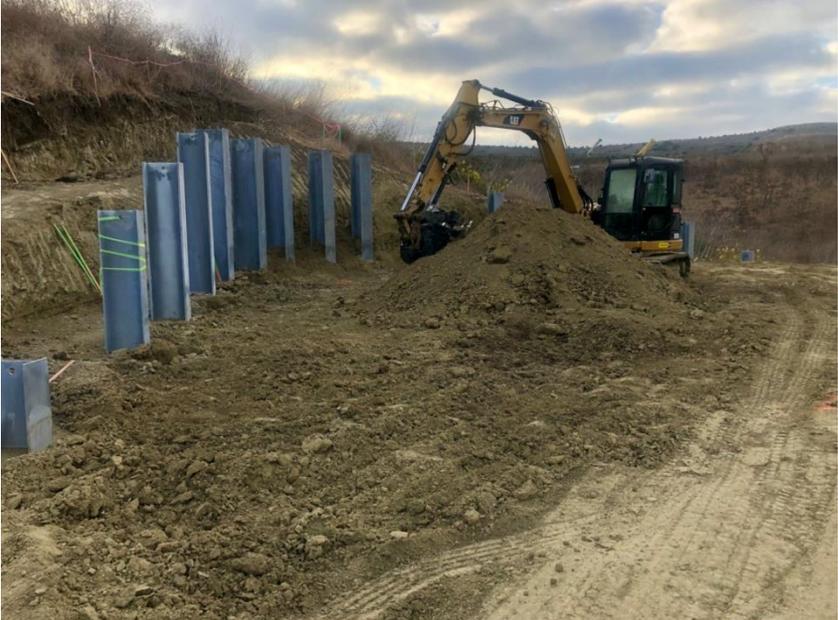
The first stop was at tower location 24, north of the La Pata staging area. Work at the site included installation of the wall, creating the brow ditch behind the wall, and removing soil from the pad (Photo 1). The bird nesting season appeared to be ending as there were no new nesting birds found along the transmission corridor.

Photo 1 – Tower pad construction at tower location 24. Photo facing south.

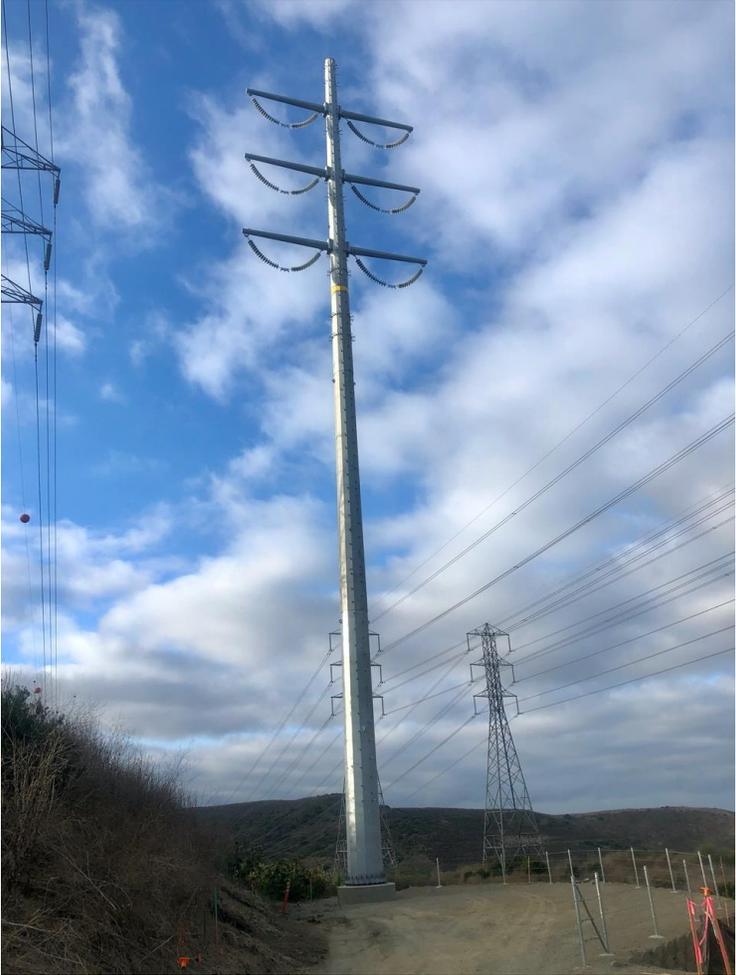
We stopped at tower location 23 where the entire tower structure had been installed (Photo 2). A brow ditch was under construction on the upslope side of the tower pad (Photo 3). The ditch construction will run into native vegetation and the LEI and I discussed the extent of the vegetation removal. The LEI also indicated that the final restoration BMP work will utilize burlap covered wattles that are completely biodegradable and do not trap animals like the plastic-covered wattles.

Photo 2 – Newly erected tower 23. Photo facing south.
08/06/20	SOCRE transmission corridor

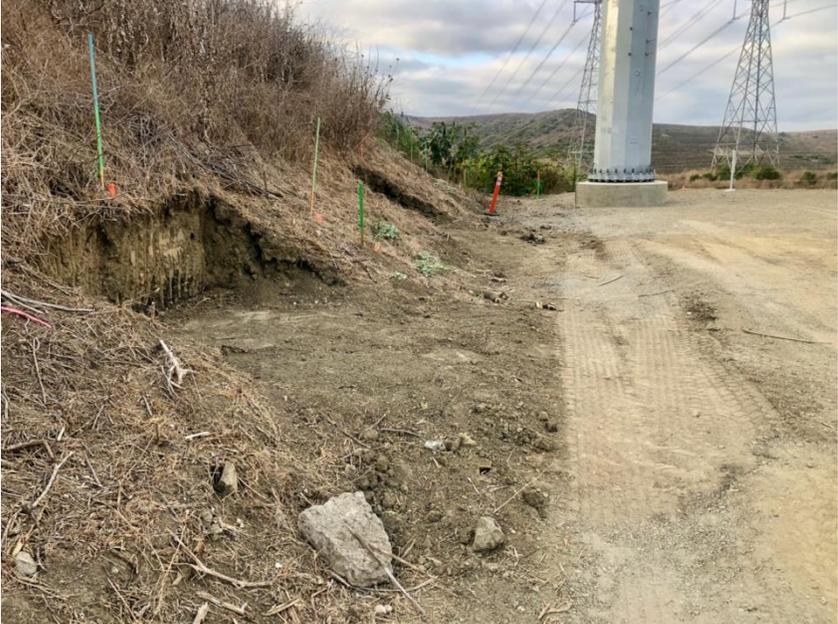
Photo 3 – Brow ditch excavation at tower location 23. Photo facing south.

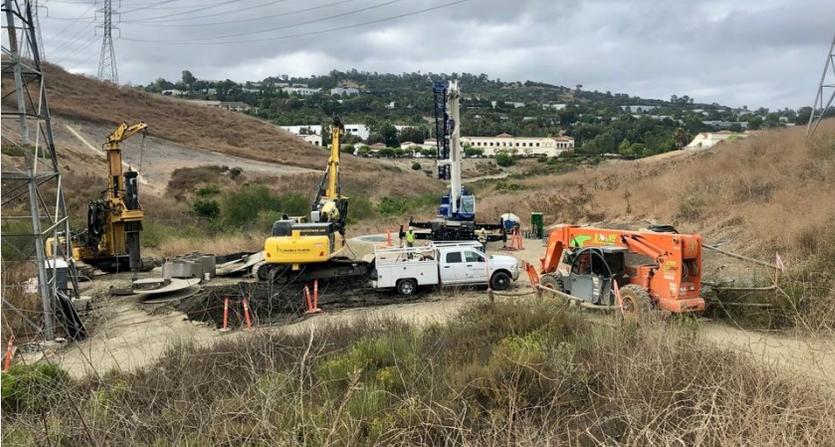
At tower location 34, the drilling crew was working on re-drilling the foundation hole after the partial collapse of the hole (Photo 6). The drilling encountered groundwater, so the tailings were wet and hauled offsite. The avian biologist was onsite and confirmed there were no new nesting birds in the area. The KV Structures foreman observed a rattlesnake in the area and did not interact with it.

Photo 6 – Drilling work at tower location 34. Photo facing south.

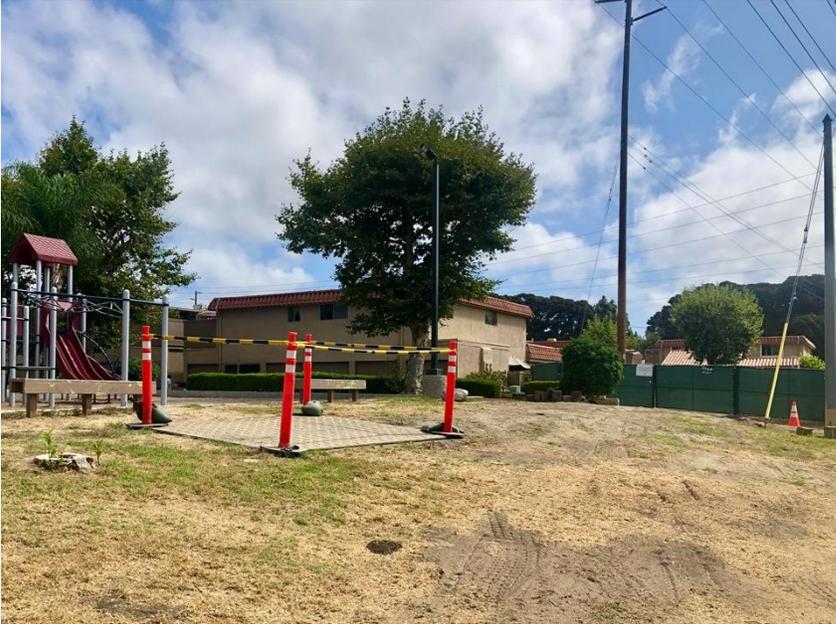
I travelled to the substation and observed the jack and bore exit hole location; no work was being conducted and the site was sealed (Photo 10). The boring work had been completed and the crews were working to connect the conduit installed under the railroad tracks (Photo 11) to the conduit installed under Camino Capistrano (Photo 12). Traffic control continued along the public roadway.

Photo 10 – Exit hole work site sealed off. Photo facing north.
08/06/20	West of San Juan Capistrano Substation – jack and bore site

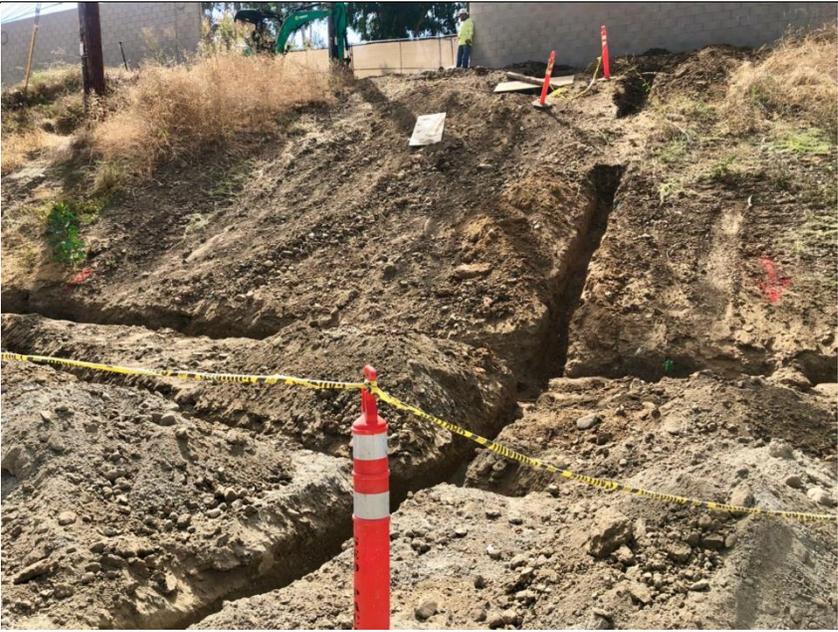
At the substation, I met with the EI and observed crews continuing to work on installing grounding wire within the southern boundary area (Photo 13). Work was ongoing on the electrical equipment near the 138-kilovolt (kV) gas-insulated substation (GIS) building (Photo 14). Wire pulling was being performed between many of the vaults onsite (Photo 15), and wire work continued within the GIS building (Photo 16).

Photo 13 – Grounding wire installation along the southern boundary wall area. Photo facing south.

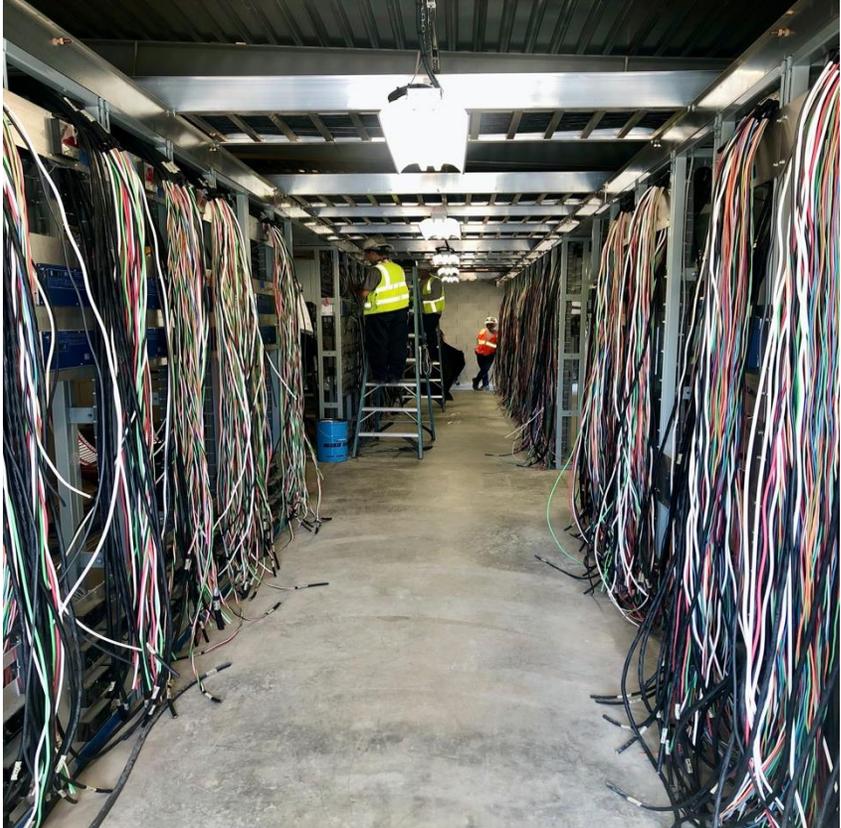
Photo 16 – Wiring work within the 138-kV GIS building.

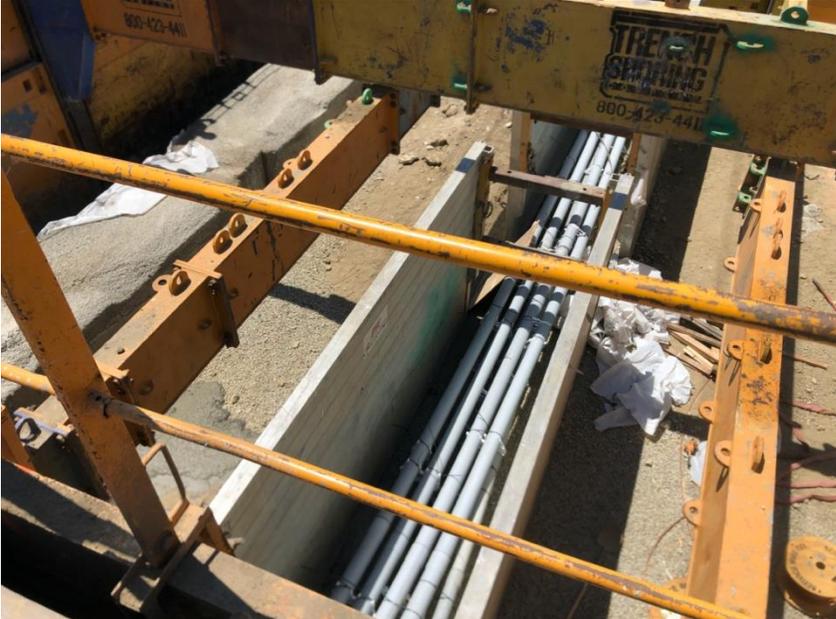
No work was being conducted at the jack and bore exit area west of the railroad tracks. I met with the Environmental Inspector (EI) and we observed that concrete forms were being placed around the conduit in the bore pit, ready for encasement in cement (Photo 1). Crews continued trenching and installing the conduit from the substation to the conduit already laid under the railroad tracks (Photo 2). This work required traffic control as the trenching extended to the edge of Camino Capistrano.

Photo 1 – Conduit in the bore pit, formed for encasement in cement.

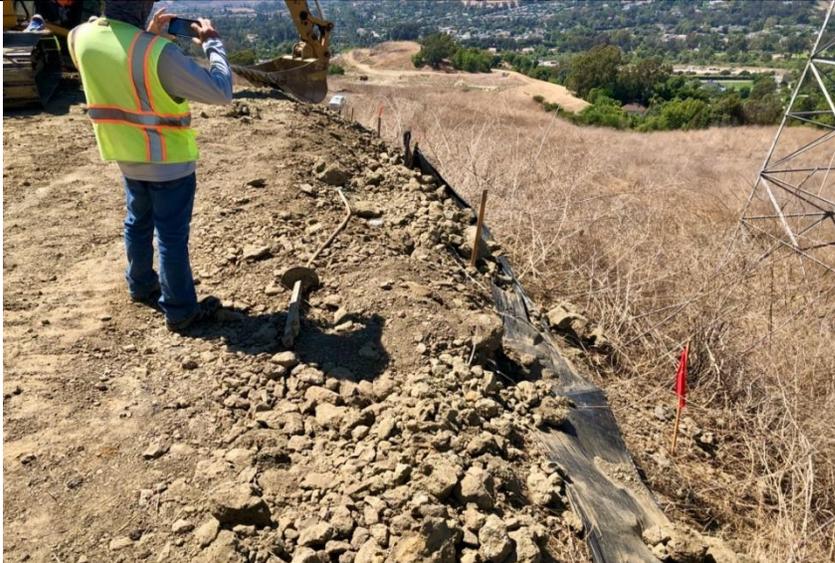
Photo 9 – BMPs at tower location 13 knocked over by soil work. Photo facing northwest.

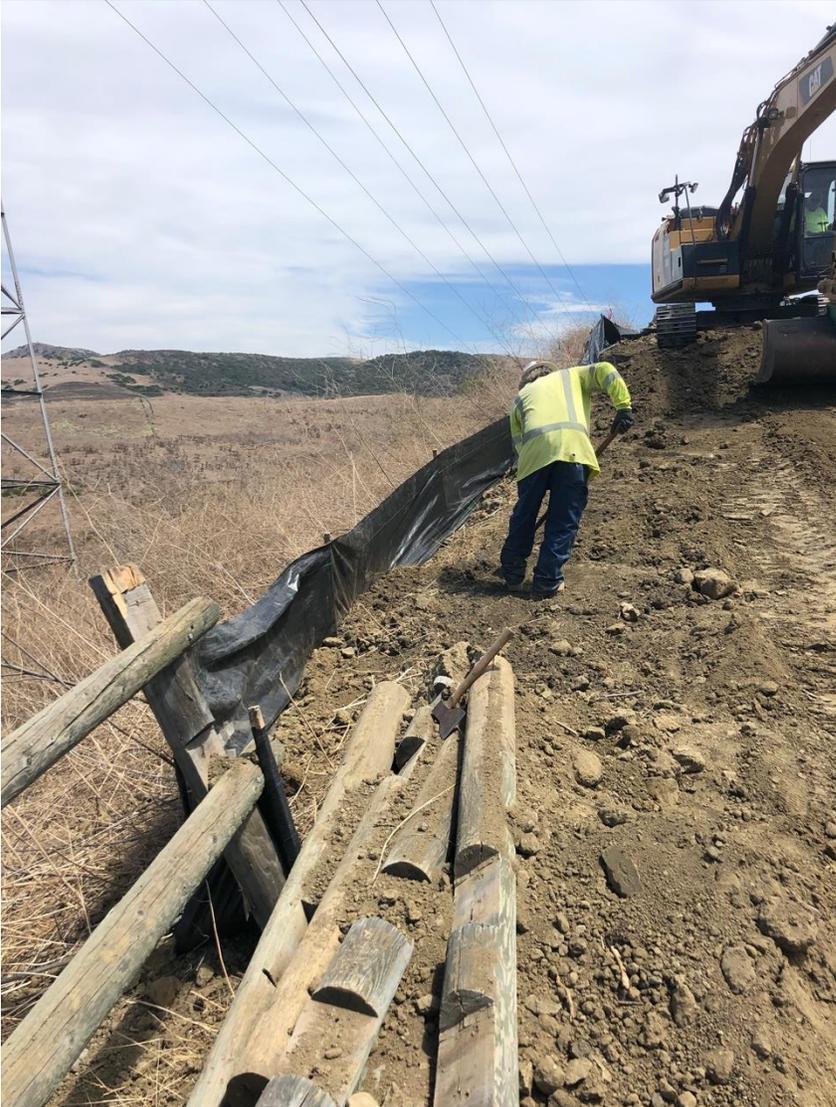
Photo 10 – Replacement of the silt fencing at tower location 13. Photo taken by the EI. Photo facing southeast.

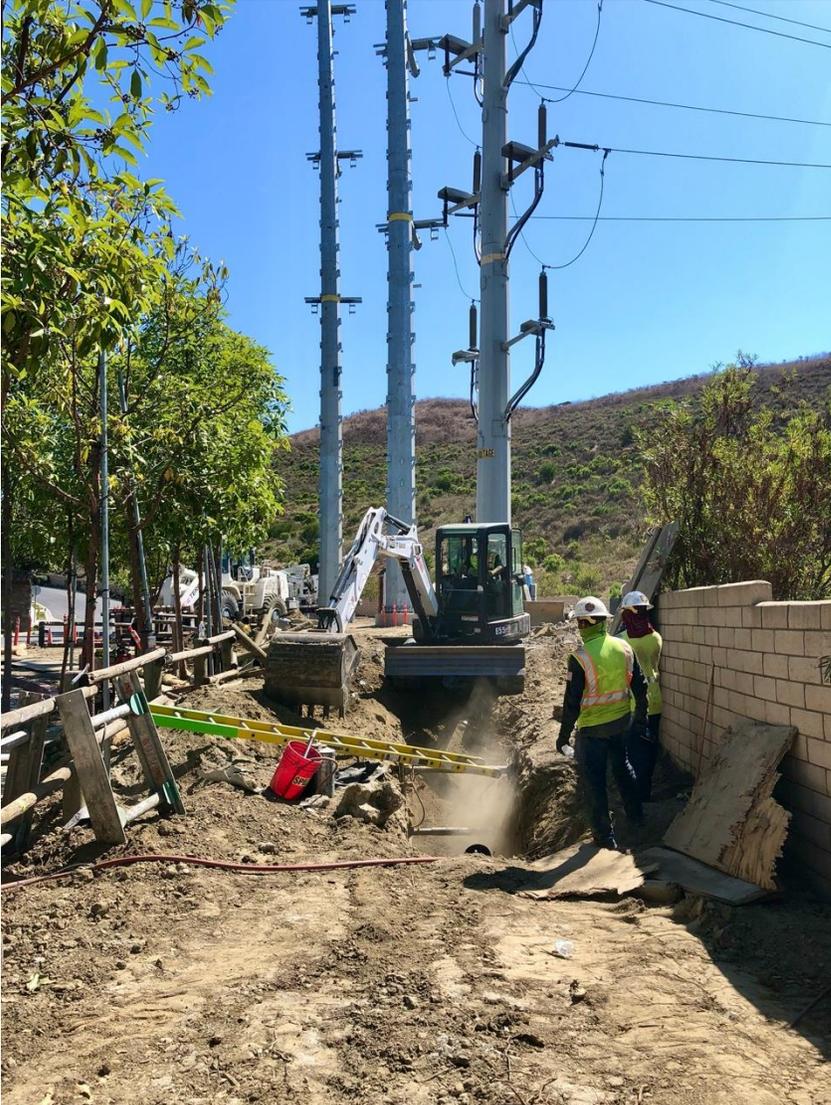
At tower locations 16 and 17, a crew continued to work on the conduit installation from Stallion Ridge Road to the towers (Photo 11). They removed a portion of the recently installed conduit to be replaced with new piping. The work created dust, but no water truck or water buffalo was onsite. Both the EI and I spoke with the construction personnel about having water nearby and conducting dust control.

Photo 11 – Conduit trenching continued near tower locations 16 and 17. Photo facing south.
08/12/20	SOCRE transmission corridor

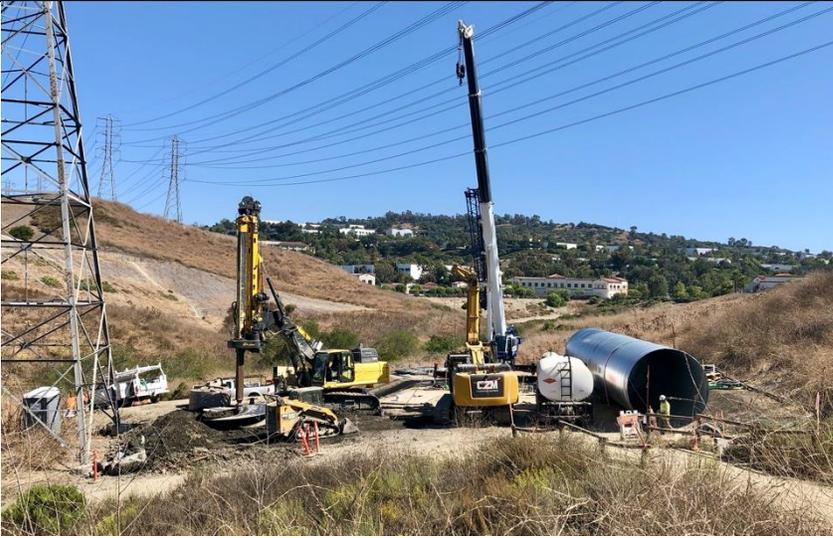
At tower location 34, the drilling crew continued to re-drill the foundation hole, reaching the concrete plug at the base of the hole (Photos 14 and 15). The metal annulus was onsite, and the crew was welding segments together; several crew members were on fire watch. A new EI was overseeing the work at this location. I introduced myself and we discussed nesting bird issues and sealing up the foundation hole at the end of the workday.

Photo 14 – Work at tower location 34. Photo facing south.

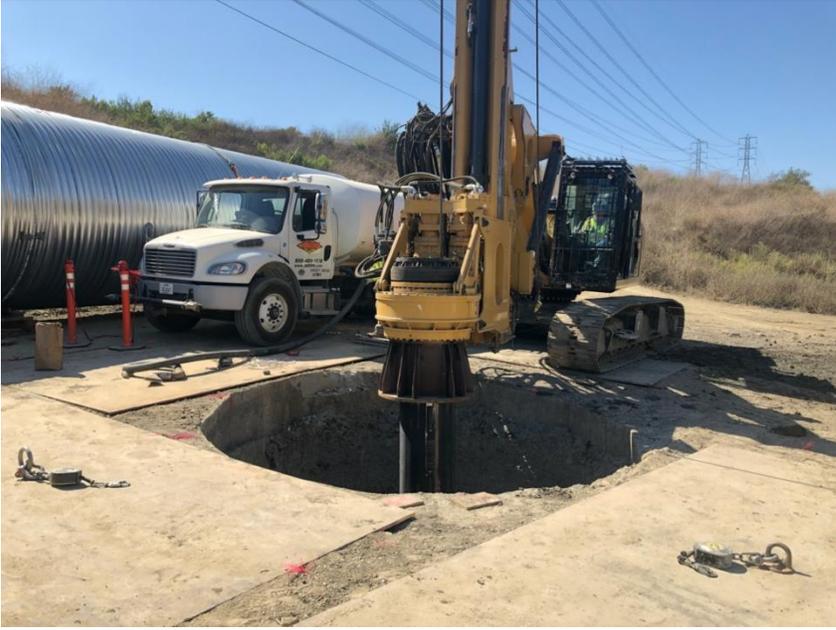
Photo 15 – Drilling operation at tower location 34. Photo facing northwest.
08/12/20	SOCRE transmission corridor

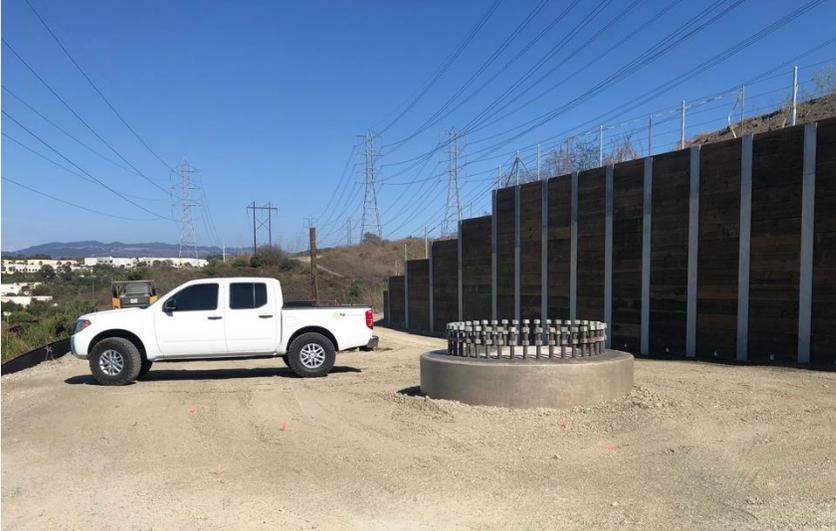
My final stop was at tower location 36 where the tower pad had been completed and the tower foundation had been poured (Photo 16). The EI noticed that a piece of equipment lacked secondary containment; he found an extra drip pan and placed it below the machine. Remaining work was to be performed on the brow ditch and the drainage culverts (Photo 17).

Photo 16 – Completed tower pad and tower foundation at location 36. Photo facing east.

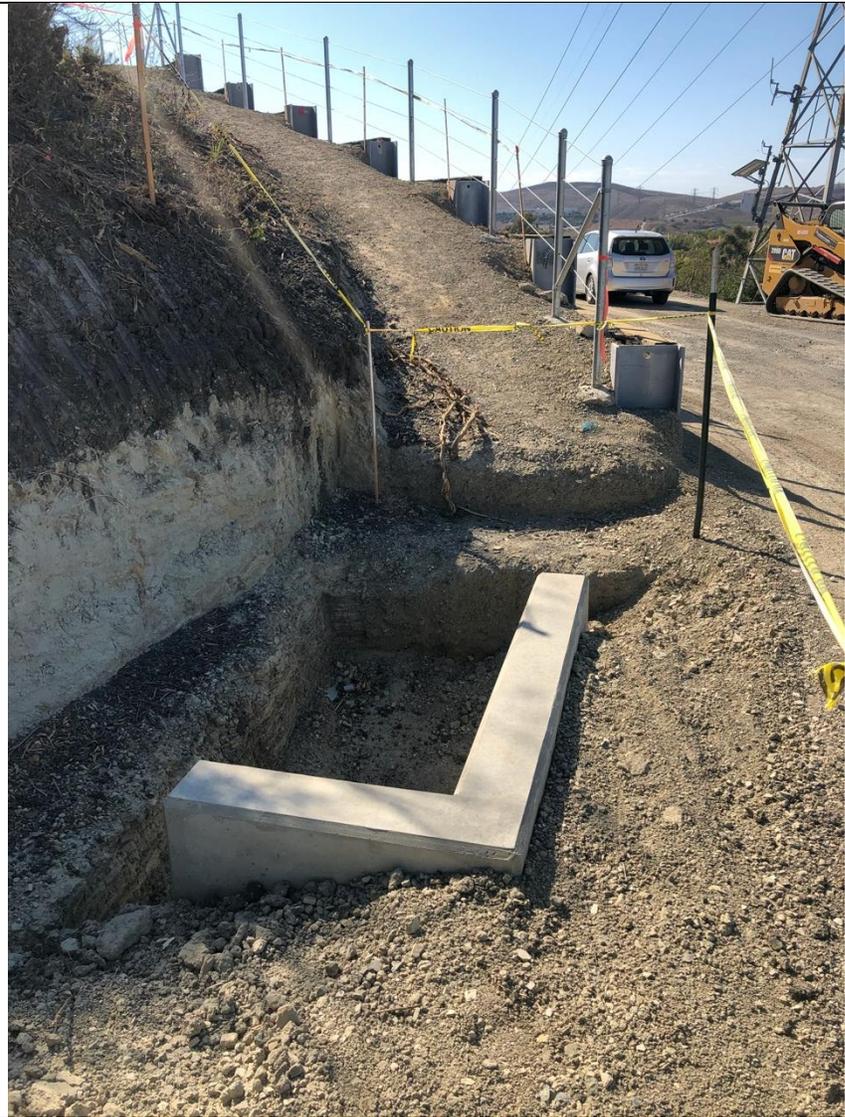
Photo 17 – Site drainage to be completed at tower location 36. Photo facing northwest.

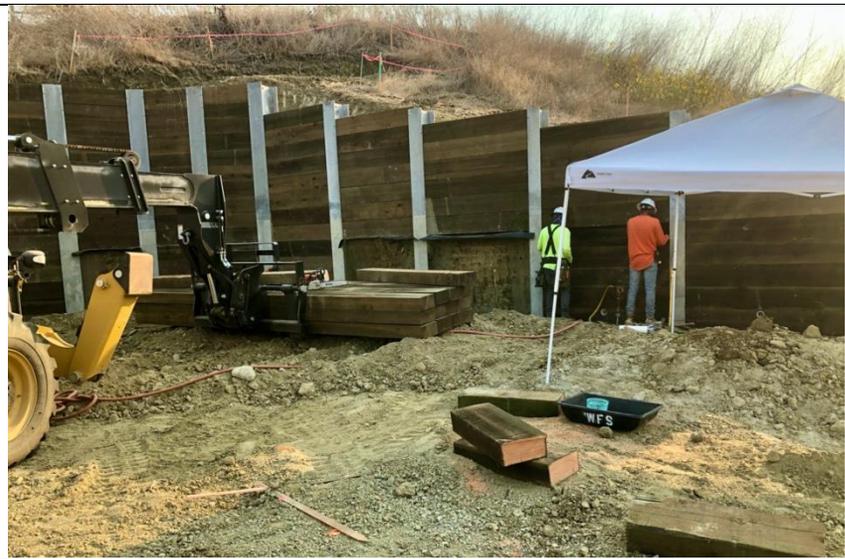
I travelled back to the La Pata staging area to meet with the Environmental Inspector (EI). We drove to tower location 24 where a small crew was working on wall installation (Photo 4). The EI observed that about 6 feet of material had been excavated from the tower pad; the excavated soil was hauled offsite. In the arroyo north of the tower site, I heard a least Bell's vireo (*Vireo bellii pusillus*) calling.

Photo 4 – Retaining wall work at tower location 24. Photo facing east.
08/20/20	SOCRE transmission corridor

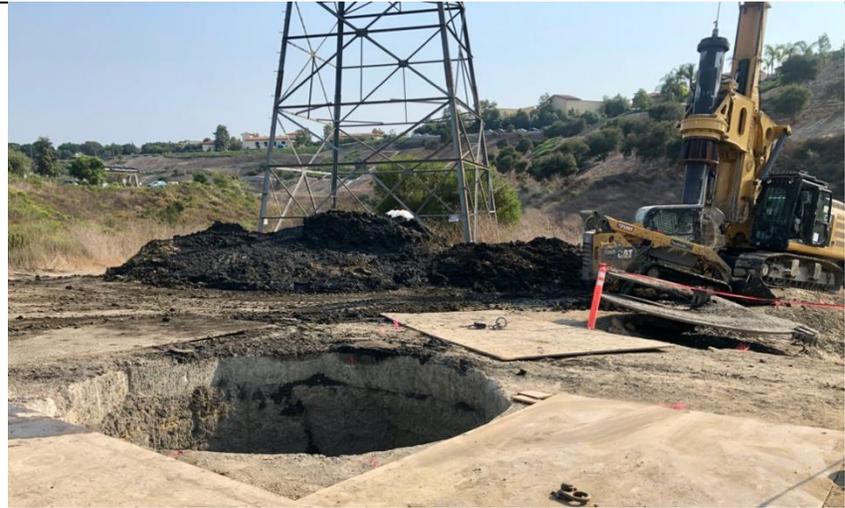
We travelled to tower location 34 where the drilling crew had completed re-drilling the foundation hole (Photo 5) and was preparing to place the corrugated metal casing (Photo 6). The EI observed that the water truck had an oil leak. The KV Structures crew spent time cleaning up the oil within the job site and laying down absorbent material on the pavement (Photo 7).

Photo 5 – Foundation hole at tower location 34 with tailings stockpiled onsite. Photo facing east.
08/20/20	SOCRE transmission corridor

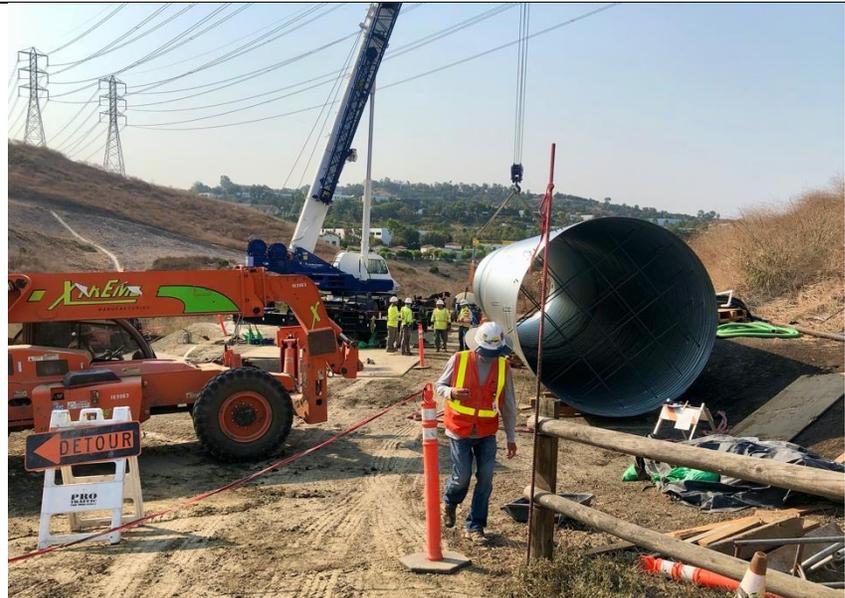
Photo 6 – Foundation work and corrugated metal casing installation at tower location 34. Photo facing south.

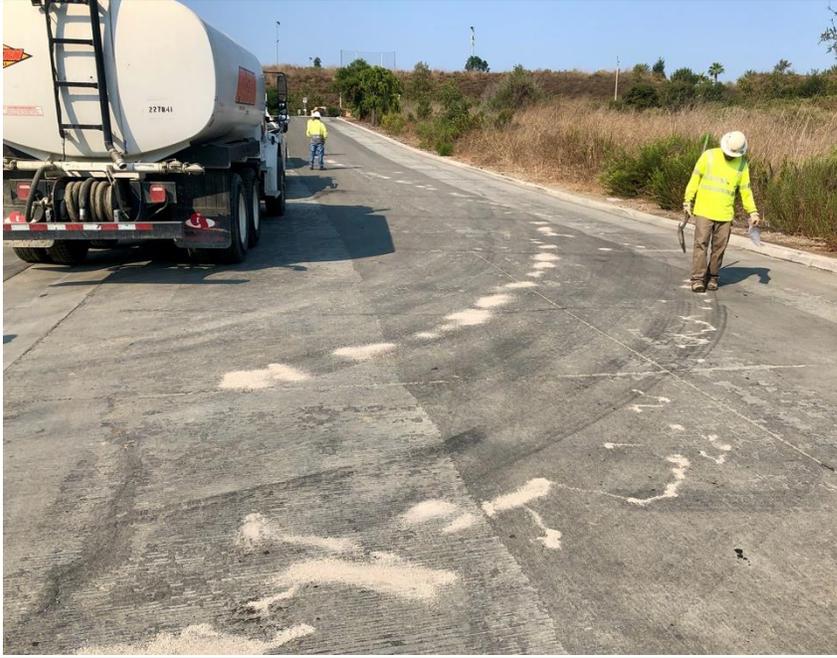
Photo 7 – Cleanup of an oil leak on pavement along the access road near tower location 34. Photo facing west.
08/20/20	SOCRE transmission corridor

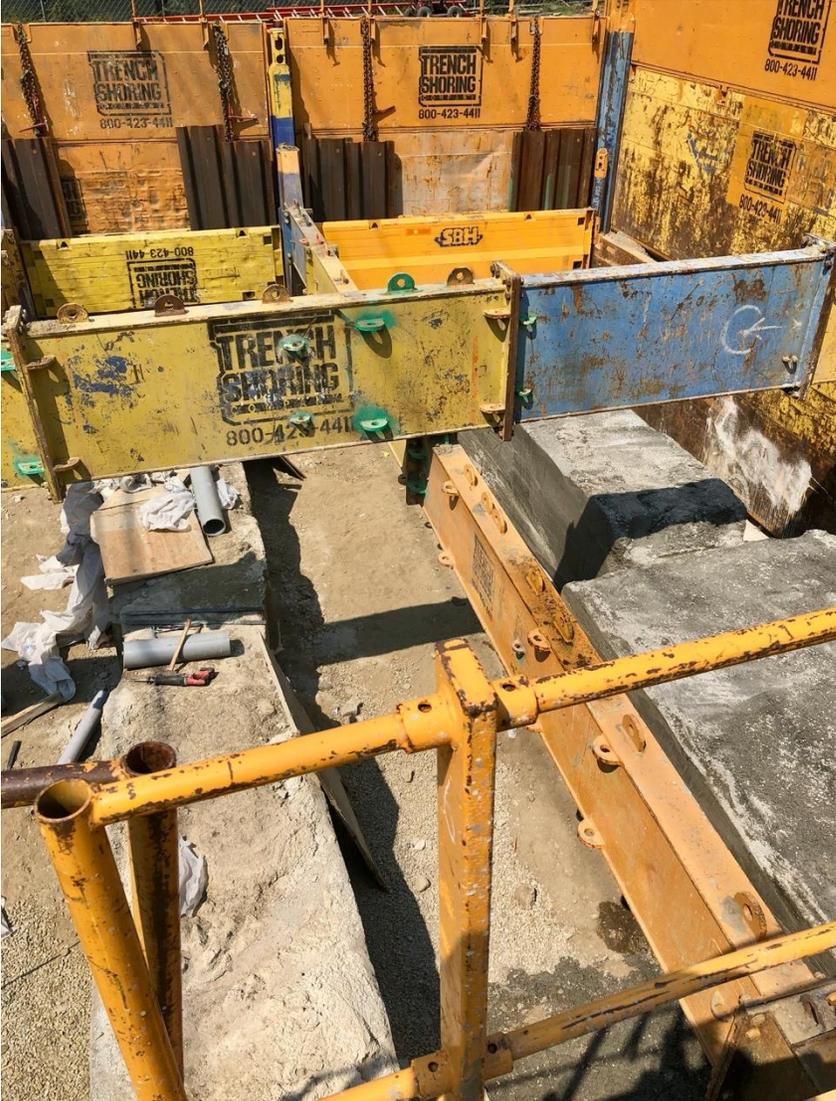
I drove to the San Juan Capistrano substation and met with the EI assigned there. The conduit in the bore hole was connected and encased in cement (Photo 11). The onsite construction inspector explained that the bore hole must remain open for several weeks as they were not able to schedule concrete pouring services since concrete factories were temporarily closed due to extreme heat. The plan was to fill the hole with cement to within 6 feet of the surface and then replace the stockpiled soil (Photo 12). I emphasized that the soil stockpile needs to be regularly watered or covered to prevent dust during the next several weeks.

Photo 11 - Conduit in the bore pit was installed, connected, and encased in cement.
08/20/20	West of San Juan Capistrano Substation – jack and bore site
