November 30, 2020

Re: Monthly Report Summary #36 for the South Orange County Reliability Enhancement (SOCRE) Project

This report provides a summary of the compliance monitoring activities that occurred during the period from **October 1 to 31, 2020**, for the South Orange County Reliability Enhancement (SOCRE) Project in Orange County, California. Compliance monitoring was performed four times between October 1 and 31, 2020, to ensure all project-related activities conducted by San Diego Gas and Electric (SDG&E) and its contractors were in compliance with the Final Environmental Impact Report (Final EIR) for the SOCRE Project, as adopted by the California Public Utilities Commission (CPUC) on December 15, 2016.

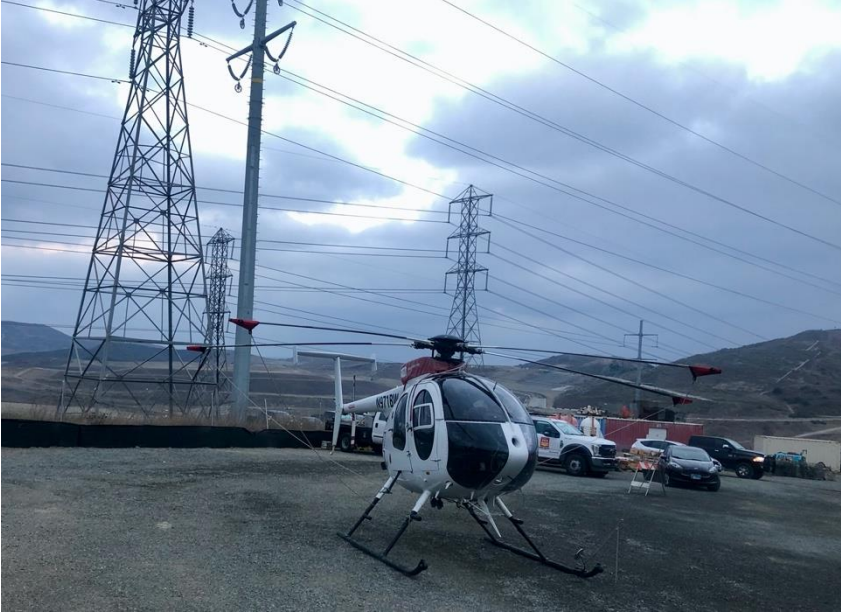
Photo 1 – A helicopter parked at the La Pata staging area. Photo facing west.
10/08/20	SOCRE transmission corridor

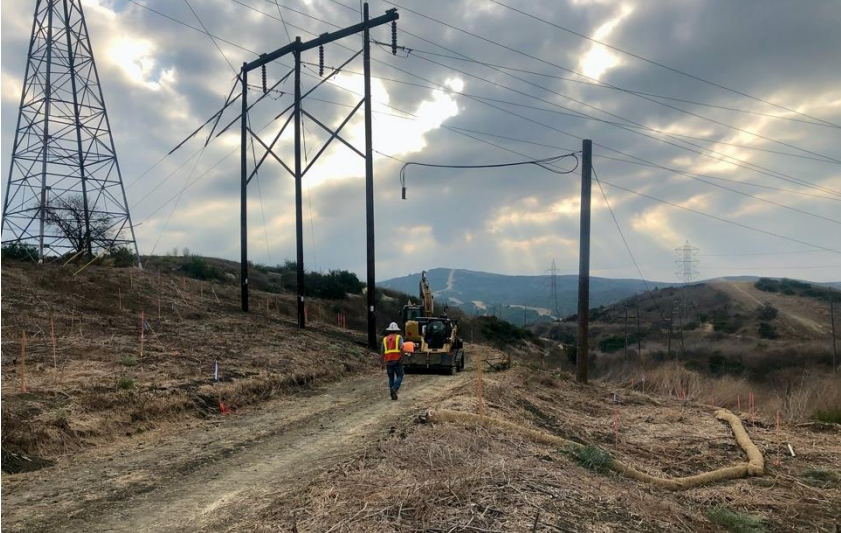
Photo 2 – Vegetation clearing at tower location 42. Photo facing southeast.
10/08/20	SOCRE transmission corridor

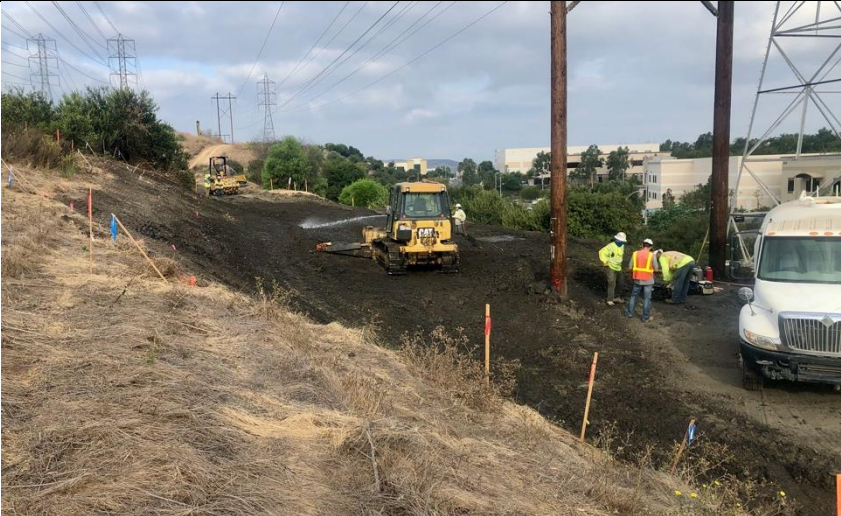
At tower location 41, the archaeology and cultural monitors were present along with a paleontology monitor due to sensitive resources present nearby. (Photo 3). A water truck was performing dust control on the access roads. During grading work, a large adult California toad (*Anaxyrus boreas halophilus*) was unearthed, captured by the paleontology monitor, and released offsite. The LEI and I walked to tower location 40 where a drill rig was parked onsite and a survey crew was observing the grading work to ensure the drilling location was accurately identified (Photo 4). The drill rig was leaking fluid and adequate secondary containment was in place.

Photo 3 – Cultural resource, Native American, and paleontology monitors present at tower location 41 during grading work due to sensitive resources present nearby. Photo facing west.

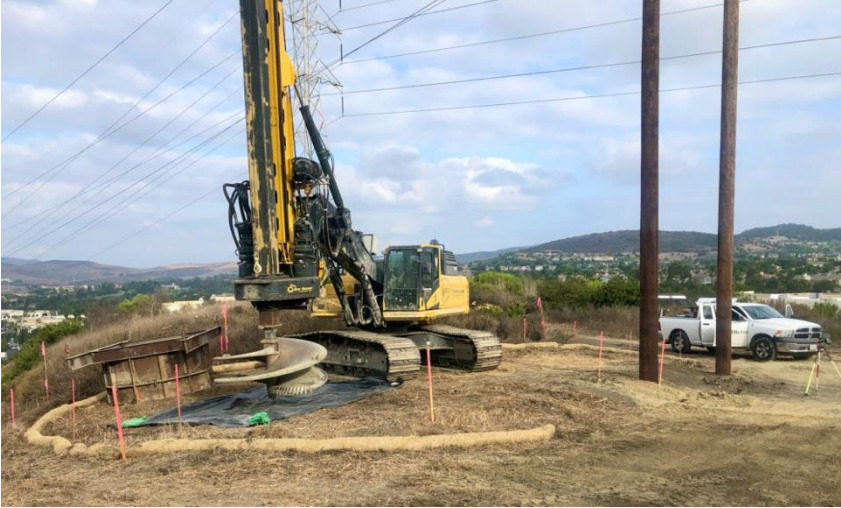
Photo 4 – Drilling work at tower location 40. Photo facing north.
10/08/20	SOCRE transmission corridor

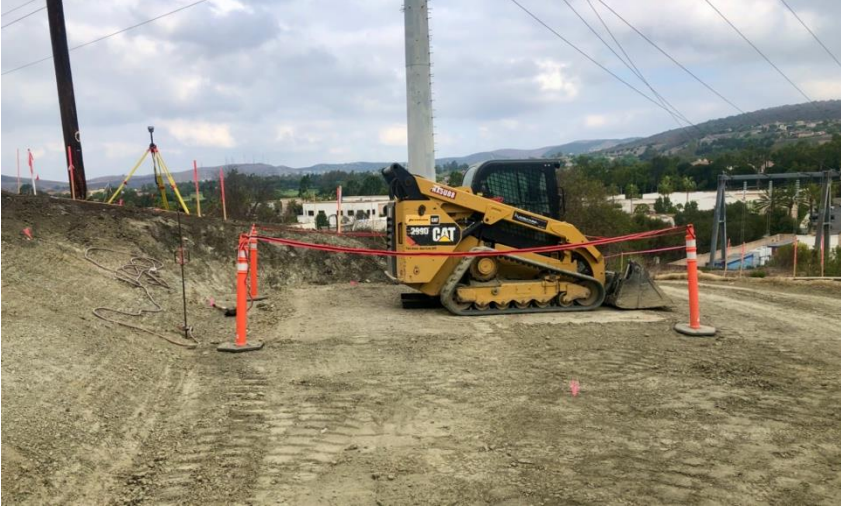
I drove to the access road at tower location 38 and walked to the site with the LEI. The KV Structures crew had recently drilled the tower foundation hole and was waiting to install the rebar cage. The foundation hole was covered with metal plates and soil and equipment was parked on top of it (Photo 5).

Photo 5 – The tower foundation was drilled at location 38 and the hole was covered with metal plates. Photo facing north.
10/08/20	SOCRE transmission corridor

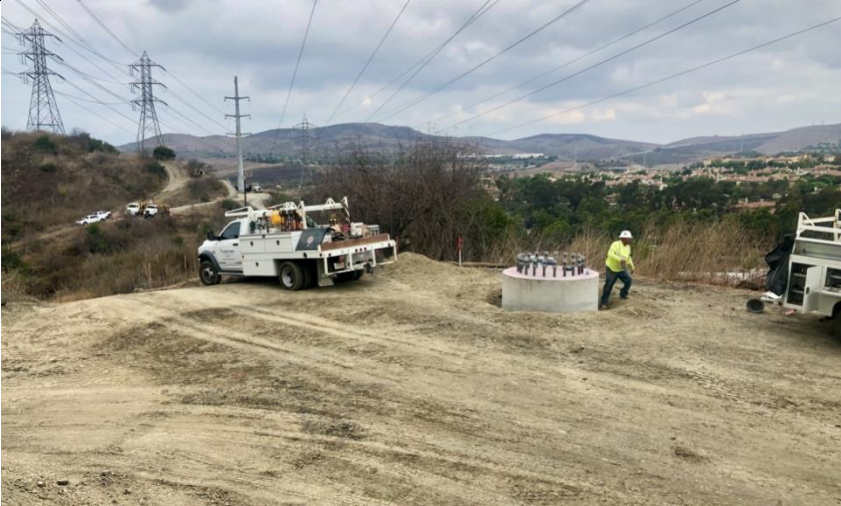
The avian biologist joined us and we walked back to tower location 37 where the tower foundation was poured (Photo 6). We walked to tower location 36 where the pulling equipment was set up and pulling was underway with rope and wire from tower location 30 (Photo 7). I observed tower location 30 with my binoculars where I saw three wire pulling trucks parked within the approved workspace; however, there were three to four additional work trucks parked on the slope outside of the workspace. I pointed this out to the LEI and he was able to have the vehicles moved shortly after.

Photo 6 – The tower foundation was poured at tower location 37. Photo facing northwest.

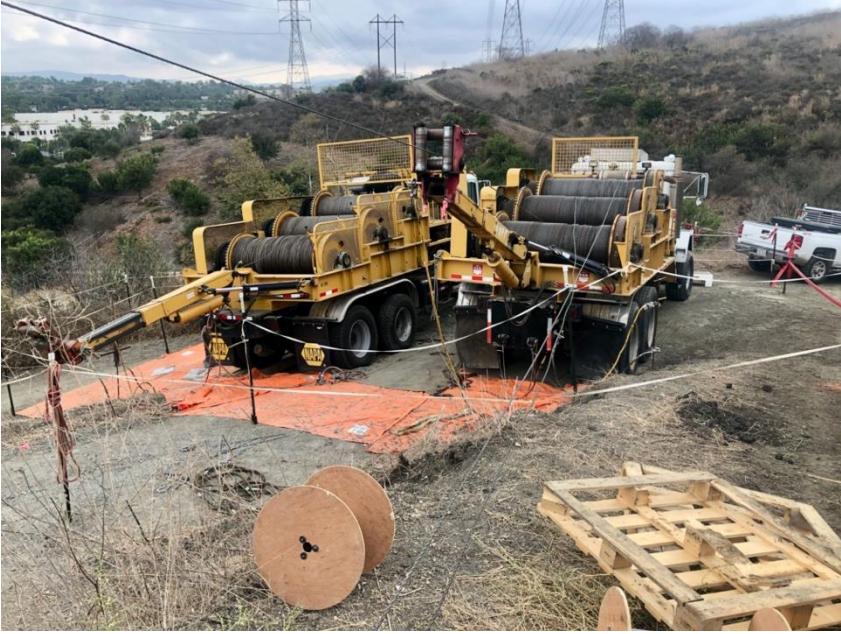
Photo 7 – Wire pulling equipment set up at tower location 36. Photo facing east.
10/08/20	SOCRE transmission corridor

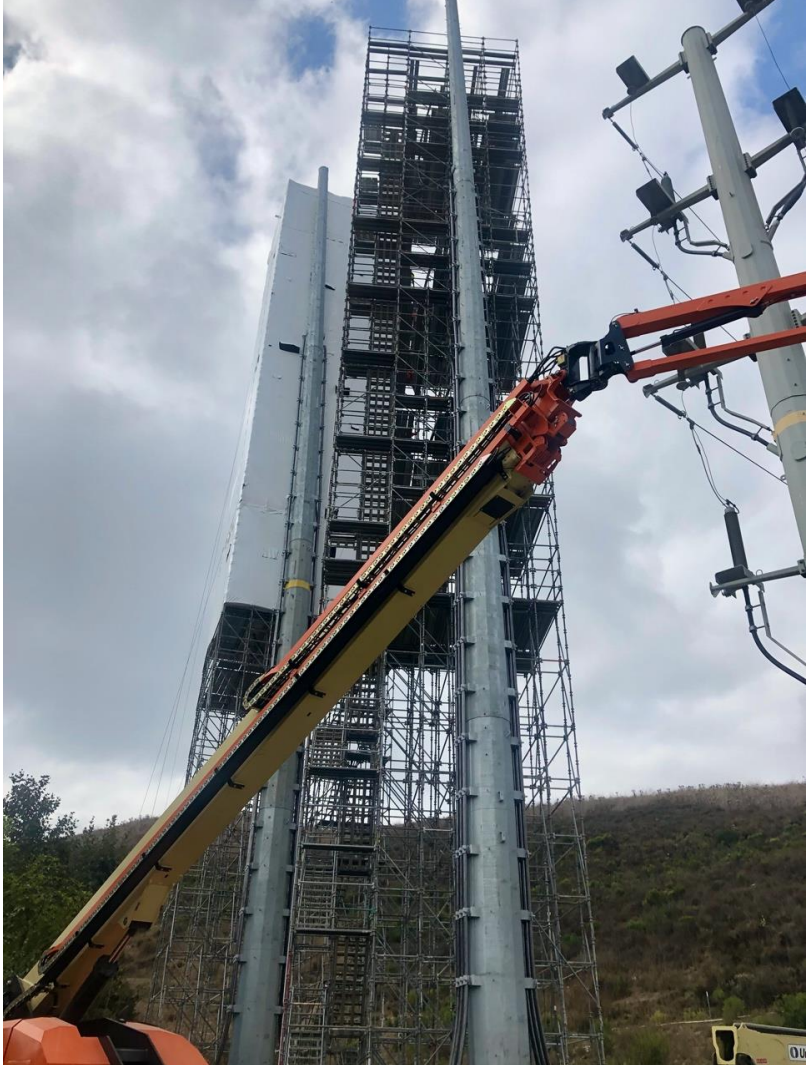
Photo 8 – Scaffolding at tower locations 16 and 17. Photo facing southwest.

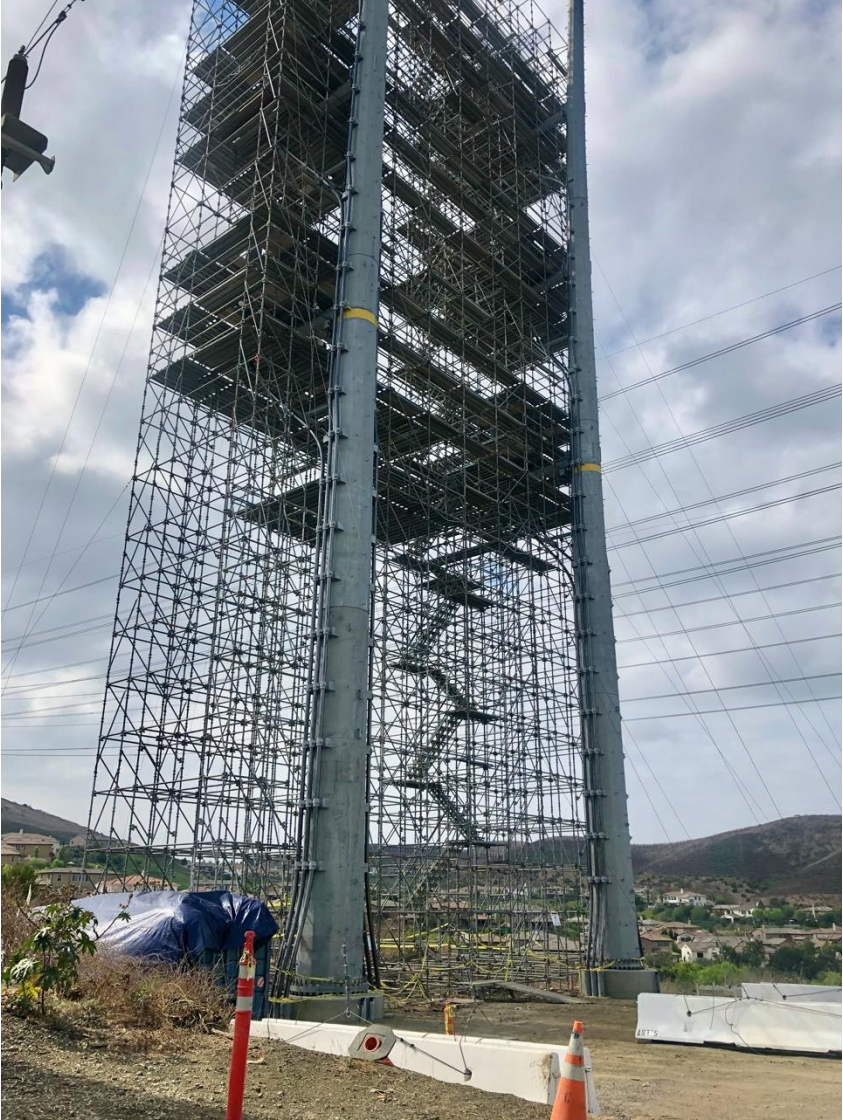
Photo 9 – Scaffolding around towers 18 and 19. Photo facing southwest.
10/08/20	West of San Juan Capistrano Substation – jack and bore site

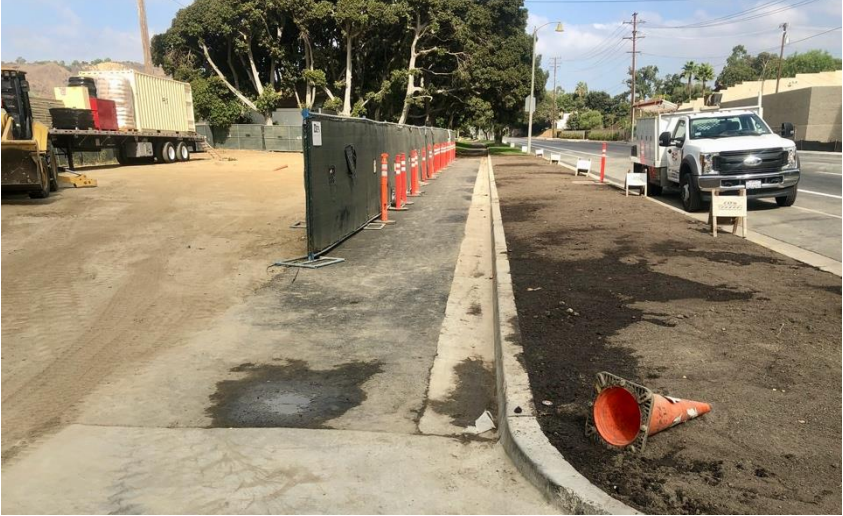
Photo 10 – Restoration work along the bore site. Photo facing north.

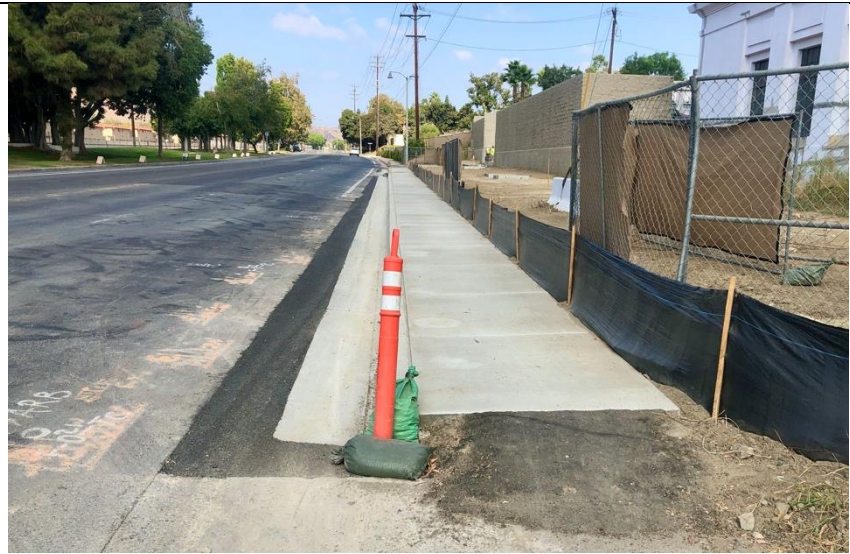
Photo 11 – Cleanup along Camino Capistrano. Photo facing north.
10/08/20	San Juan Capistrano Substation

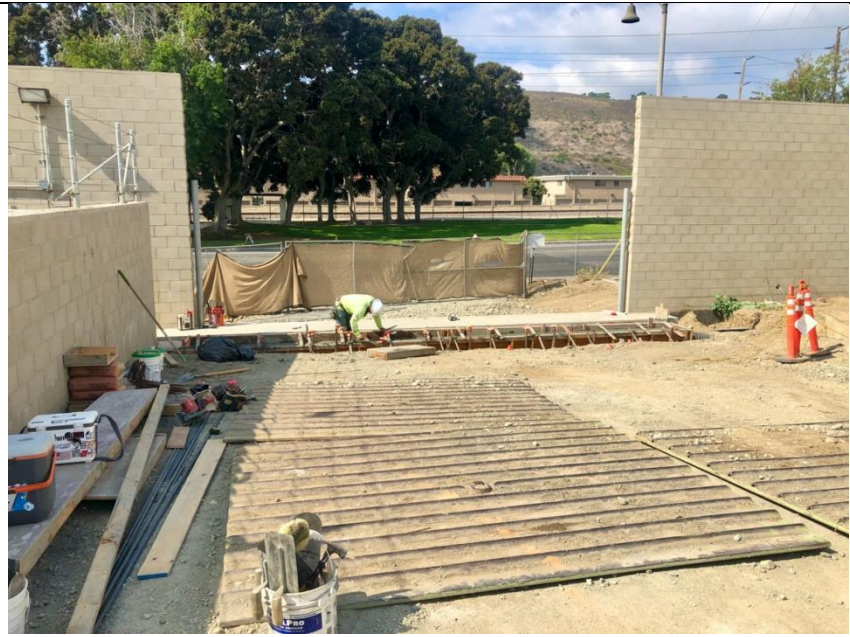
Inside the substation crews continued to work on the foundation for the automatic gate at the northern entrance (Photo 12). Work was also being conducted around the transformers (Photo 13) and the soil was sprayed with a mulch to stabilize the area (Photo 14).

Photo 12 – Work performed at the northern entrance to the substation. Photo facing west.

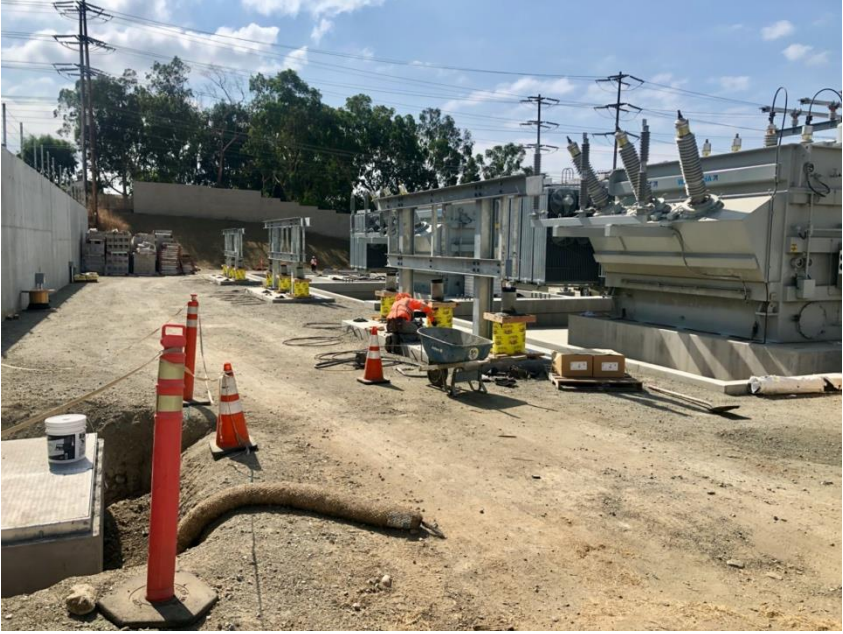
Photo 13 – Work around the transformers. Photo facing south.
10/08/20	San Juan Capistrano Substation

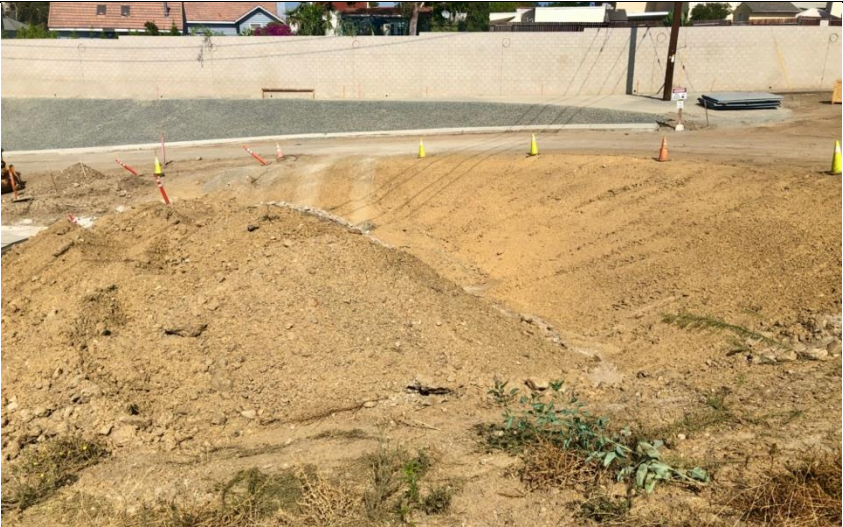
Photo 14 – Mulch sprayed on areas of exposed soil within the project site. Photo facing north.

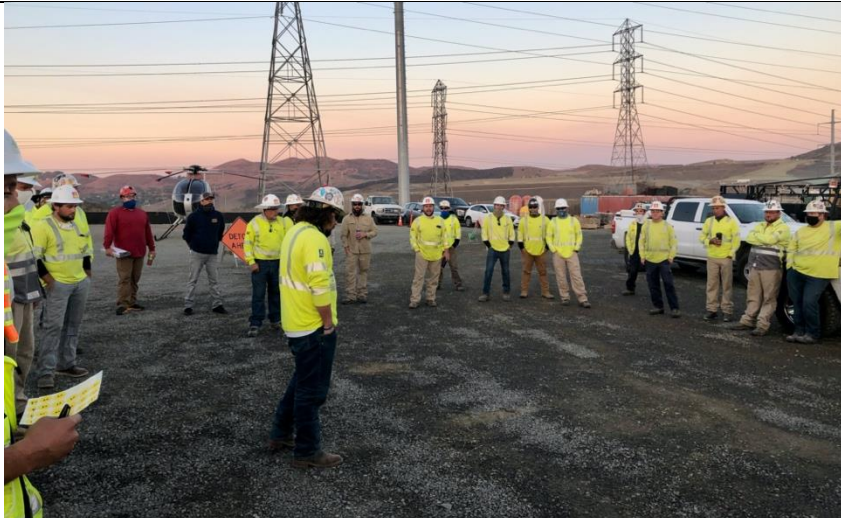
Photo 1 – Morning tailboard at the La Pata staging area to discuss helicopter activities. Photo facing west.

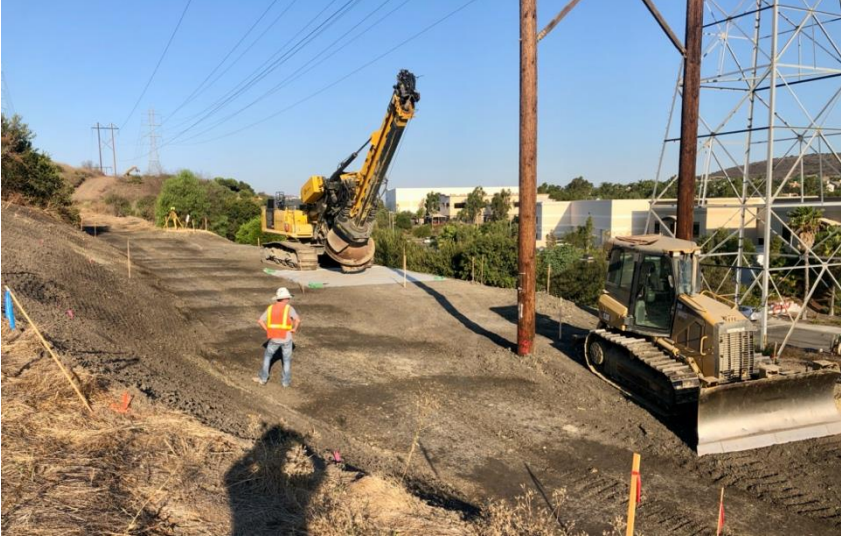
The grading work at tower location 41 was completed and the drill rig was parked on the new pad (Photo 3). The drill rig had extensive secondary containment due to previous leaks, but no leaks were observed.

Photo 3 – Grading completed for the pad at tower location 41. Photo facing west.

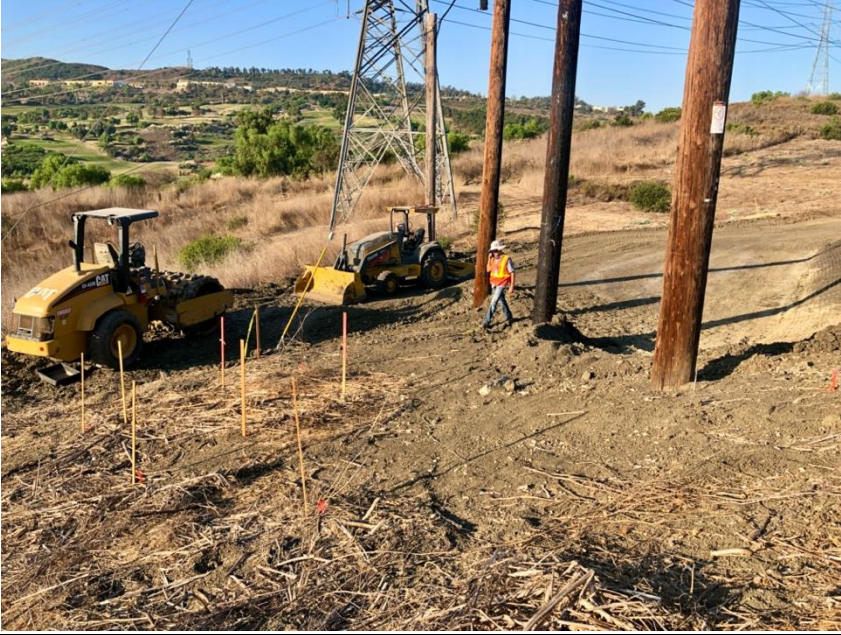
The drill rig was to be moved to tower location 42 to drill the foundation hole. Some tower pad grading was completed with the remaining soil work to be completed with the excess soil generated from the foundation hole (Photo 4). According to the EI, once the foundation hole was drilled at location 42, work would then continue at tower location 41.

Photo 4 – Drilling work began at tower location 42 with excess soil used to level the area for the tower pad. Photo facing west.
10/15/20	SOCRE transmission corridor

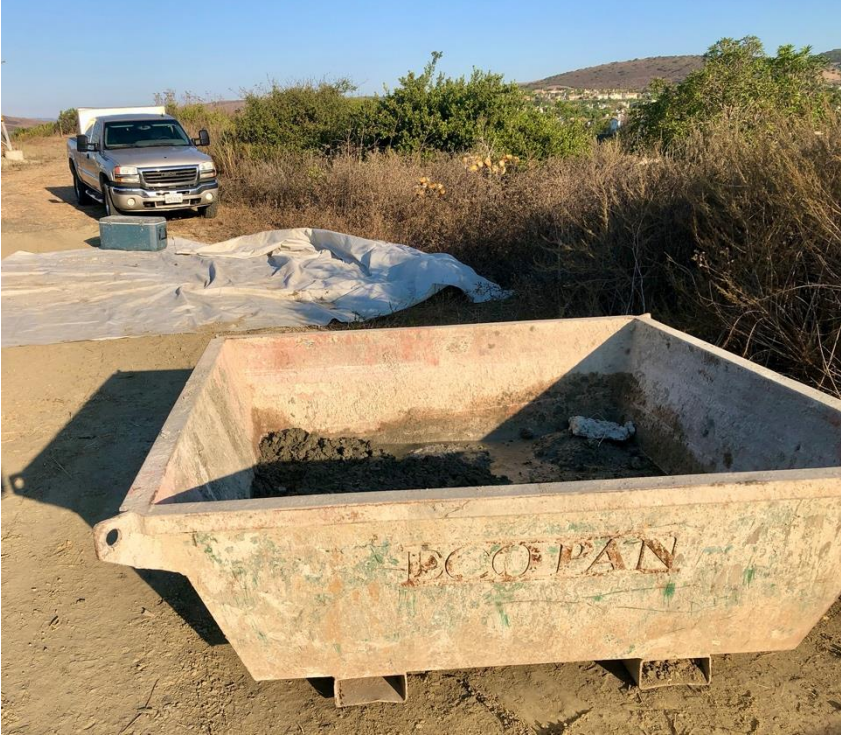
At tower location 40, the foundation had been poured the previous day and the concrete trucks were being washed (Photo 5). A small crew was onsite removing the forms from around the foundation (Photo 6).

Photo 5 – Concrete washout bins at tower location 40. Photo facing northwest.

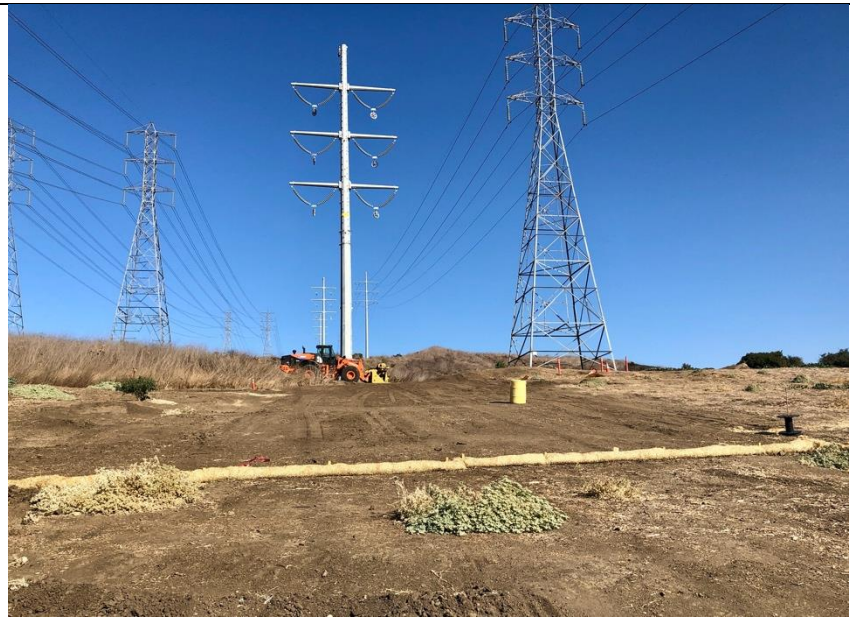
Photo 8 – Wire pulling site near tower location 30. Photo facing north.
10/15/20	SOCRE transmission corridor

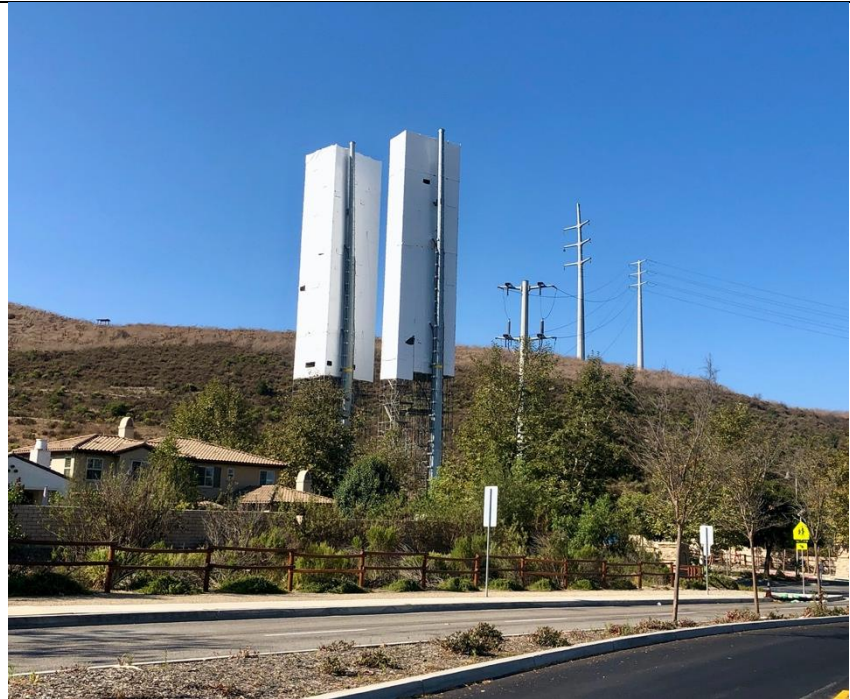
Photo 9 – Wrapped scaffolding at tower locations 16 and 17. Photo facing west.

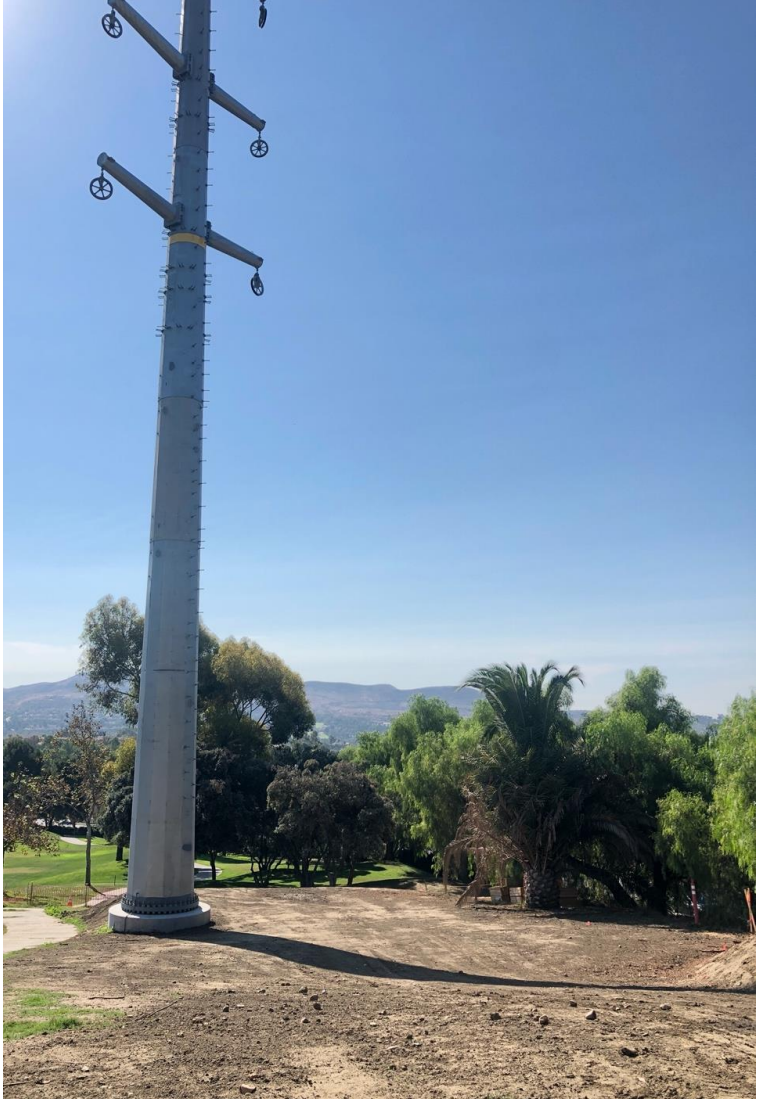
Photo 11 – Tubular steel pole at tower location 5 where helicopter stringing activity was scheduled to occur. Photo facing south.
10/15/20	West of San Juan Capistrano Substation – jack and bore site

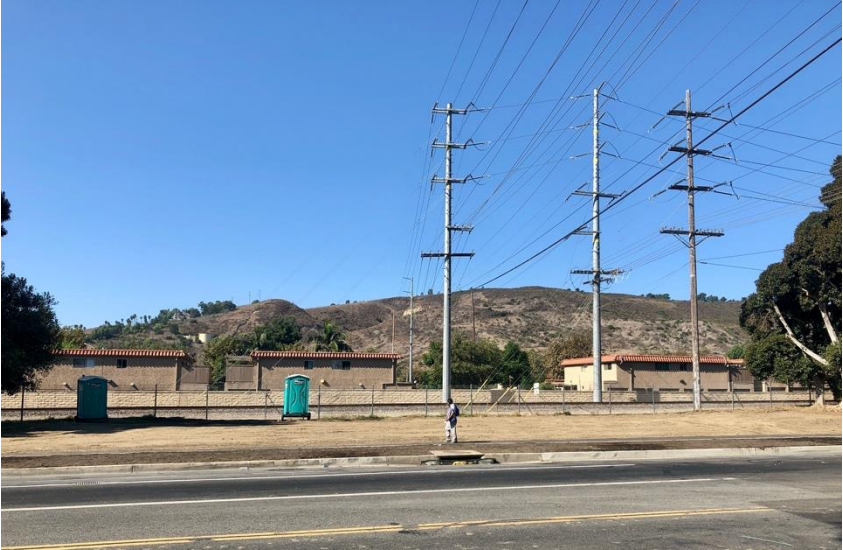
Photo 12 – Mostly restored bore site. Photo facing west.

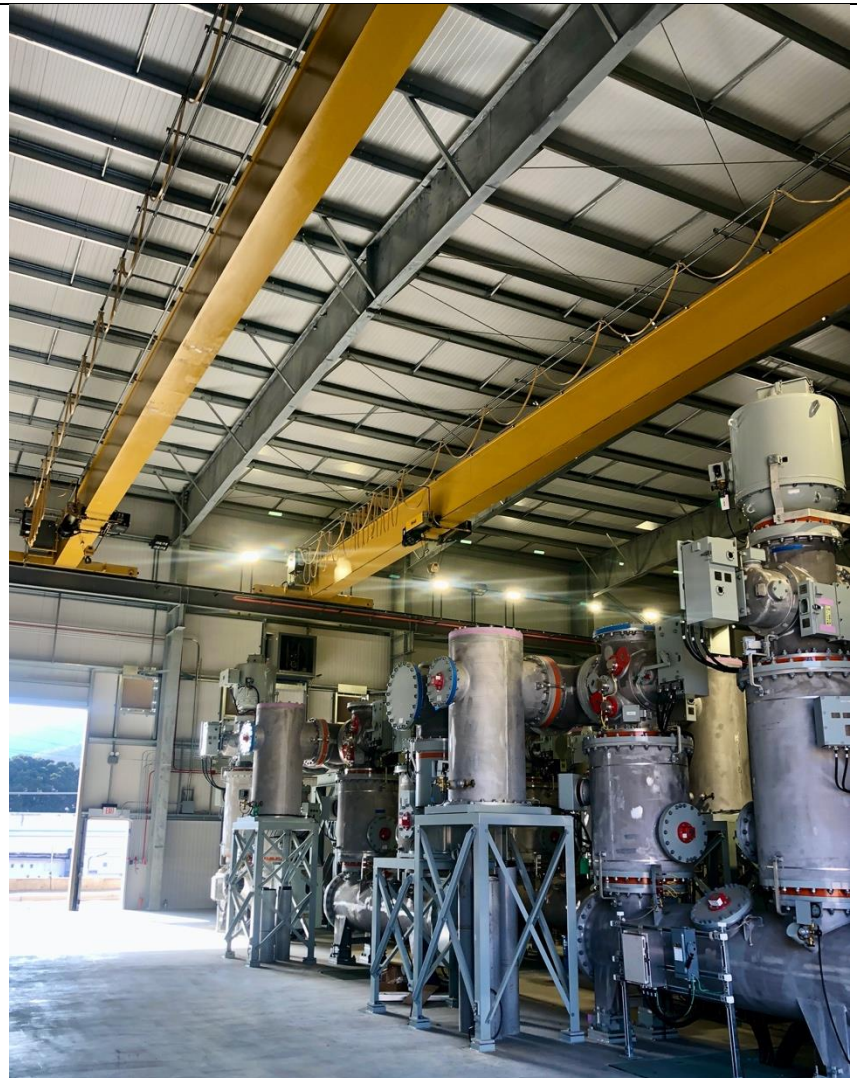
Photo 3 – Roof cranes installed in the 138-kV GIS building.
10/21/20	San Juan Capistrano Substation

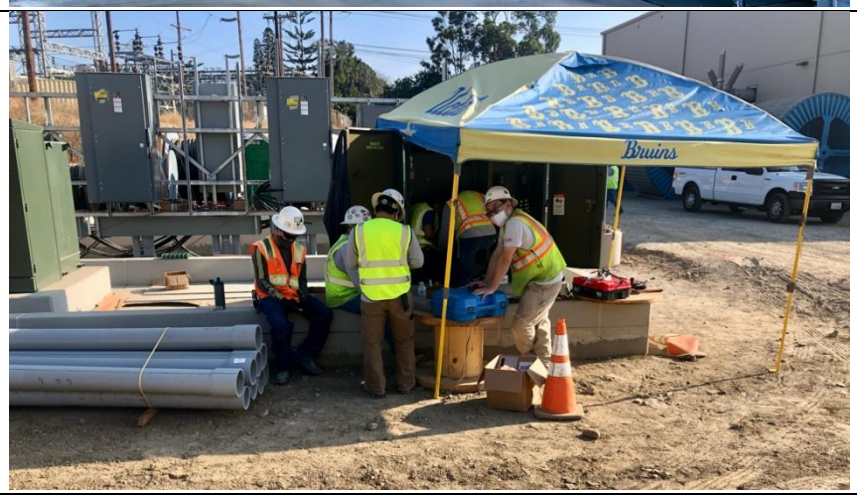
Photo 4 – Crews working on the wiring outside of the GIS building. Photo facing south.

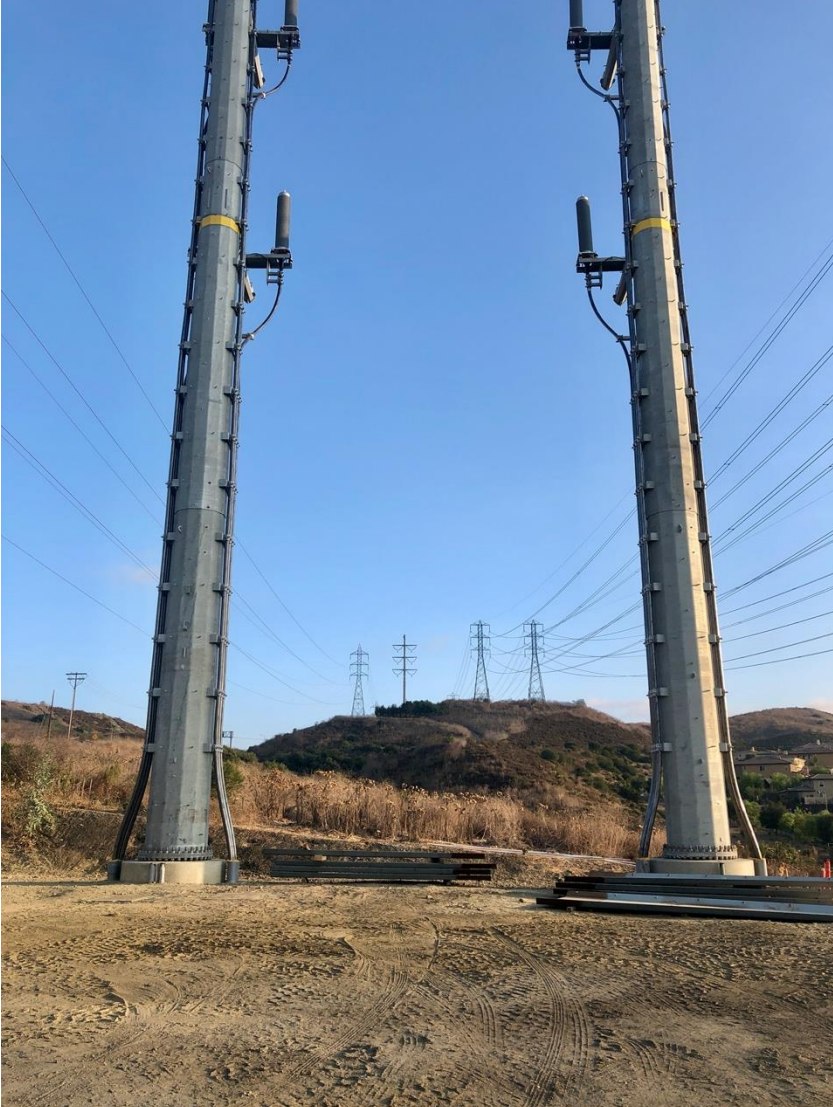
Photo 12 – Towers 18 and 19 with scaffolding removed. Photo facing south.
10/21/20	SOCRE transmission corridor

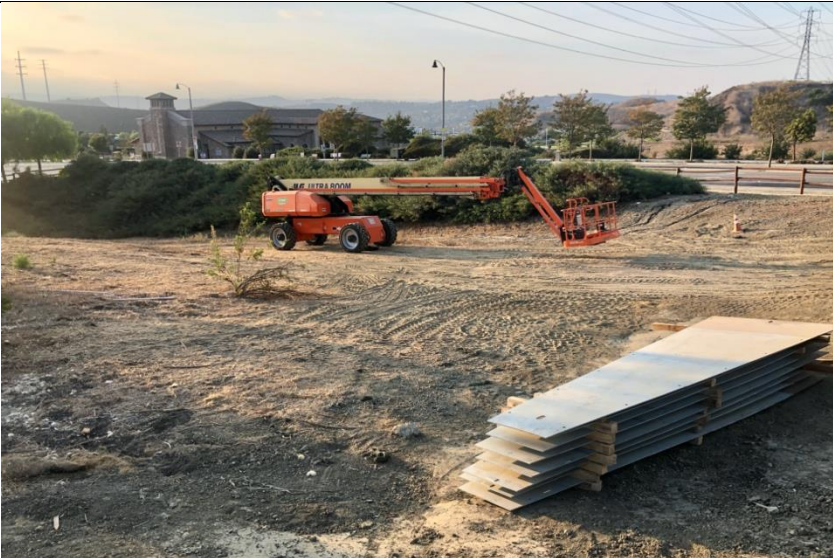
Photo 13 – Workspace near towers 18 and 19 required dust control. Photo facing northwest.

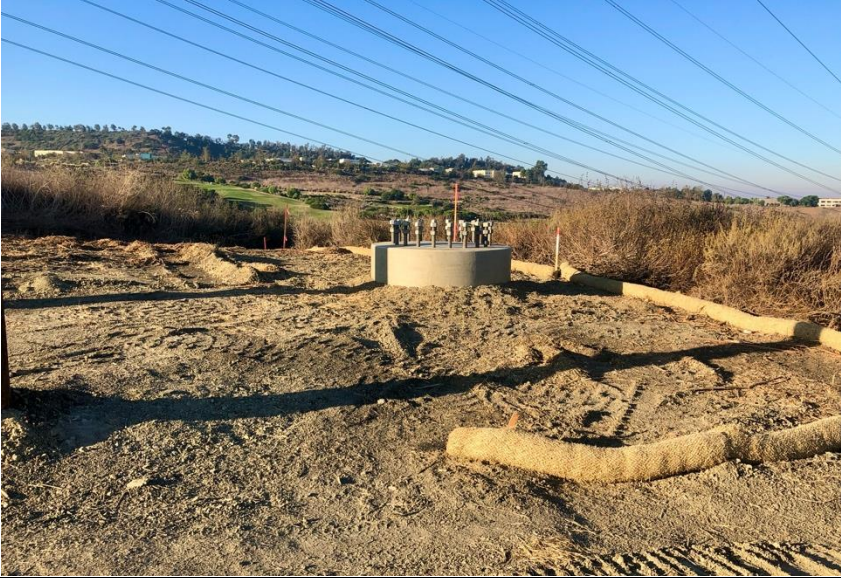
Photo 5 – Foundation at tower location 40. Photo facing west.
10/29/20	SOCRE transmission corridor

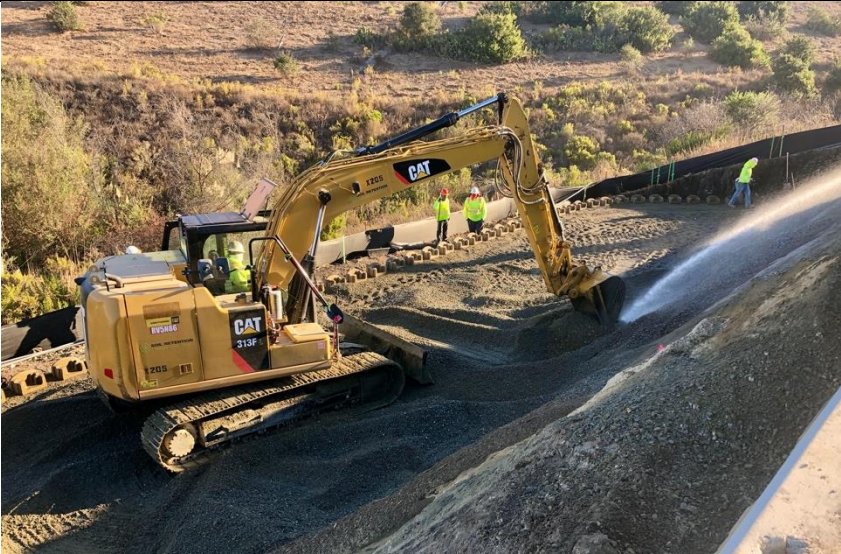
Photo 6 – Wall construction and backfilling around tower pad at tower location 39. Photo facing east.
10/29/20	SOCRE transmission corridor

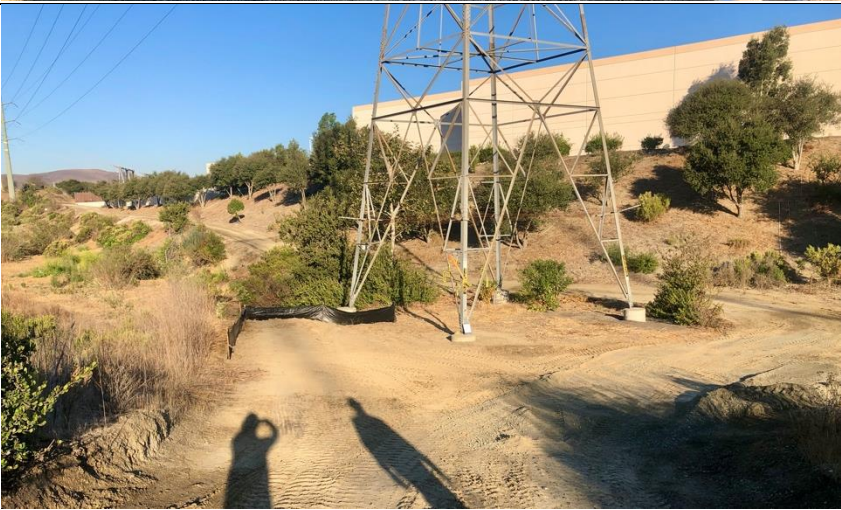
Photo 7 – Additional workspace near tower location 39 used as a turnaround and delineated with silt fencing. Photo facing northwest.

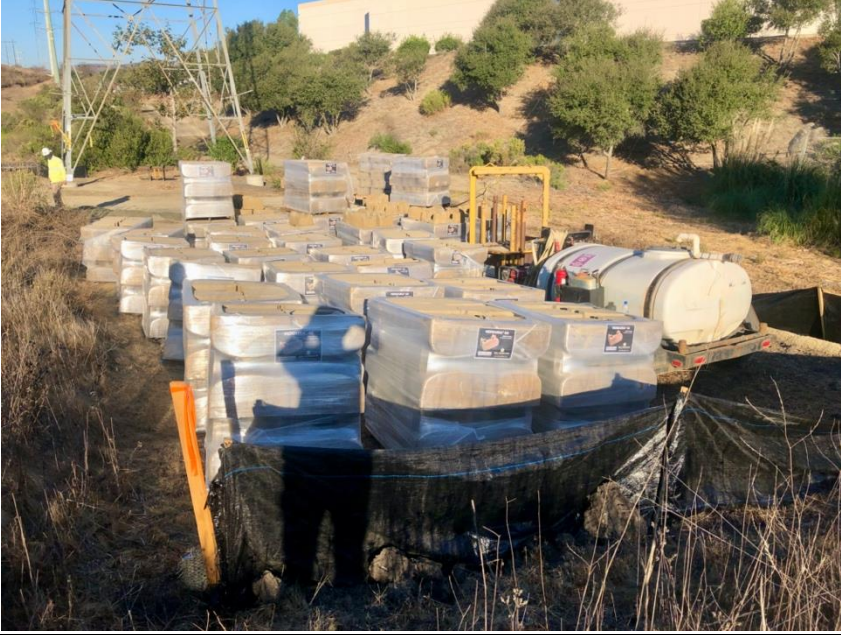
Photo 8 – Additional workspace near tower location 39 used to stage the wall blocks and other construction materials. Photo facing northwest.
10/29/20	SOCRE transmission corridor

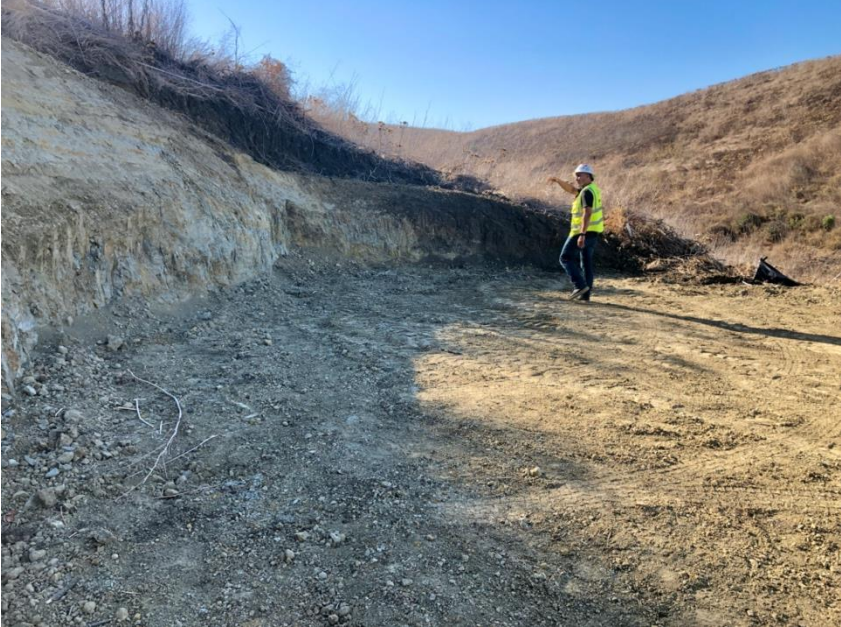
Photo 9 – Grading completed along the south side of the pad at tower location 14 where the boundary of the workspace was not clearly delineated. Photo facing southwest.

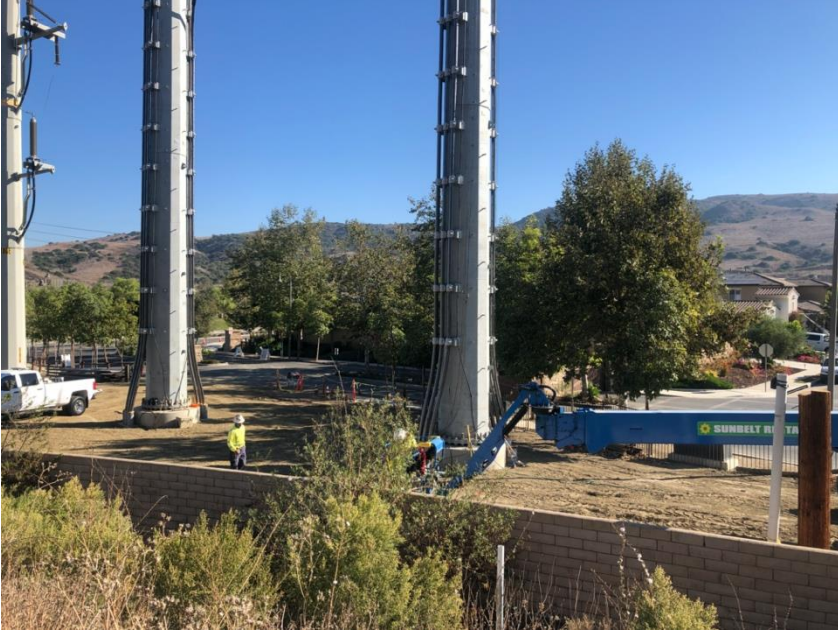
Photo 10 – Work at tower locations 16 and 17. Photo facing east.
10/29/20	SOCRE transmission corridor

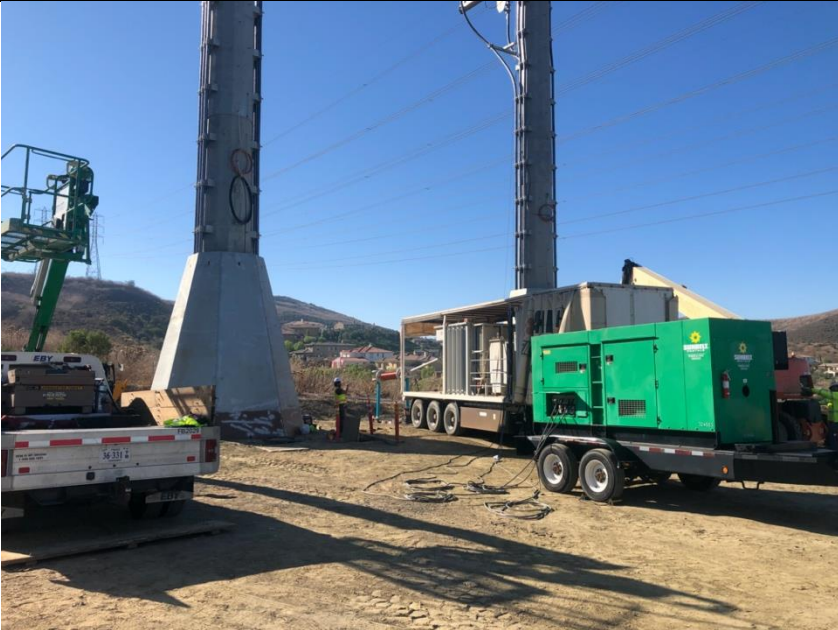
Photo 11 – Work continued at tower locations 18 and 19. Photo facing southwest.

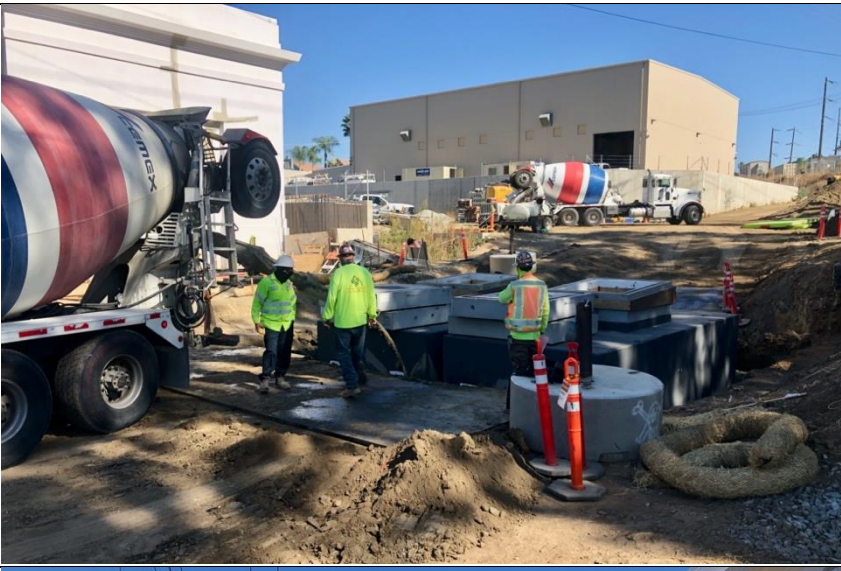
Photo 14 – Concrete trucks poured slurry around the newly installed vault within the substation. Photo facing east.
10/29/20	San Juan Capistrano Substation

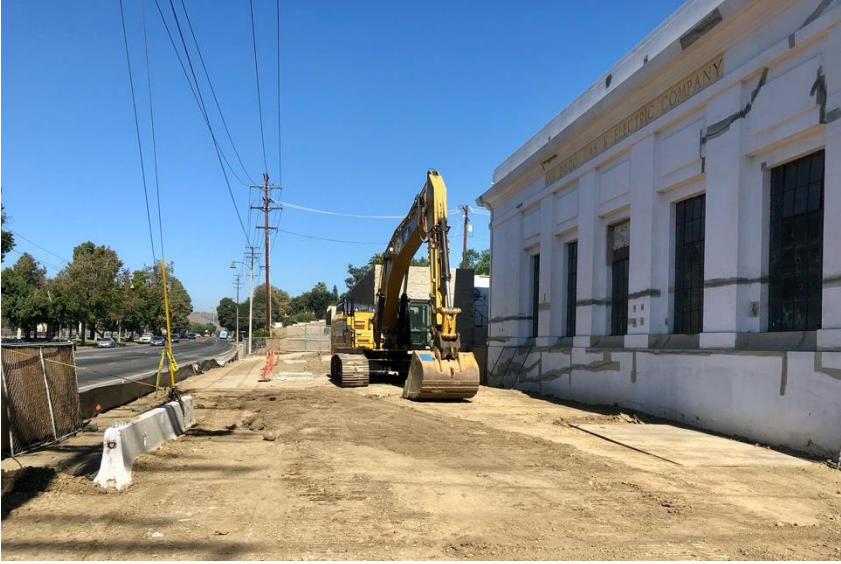
Photo 15 – Equipment parked between the existing utility building and Camino Capistrano. Photo facing north.
