**Re: Monthly Report Summary #39 for the South Orange County Reliability Enhancement (SOCRE) Project**

## South Orange County Reliability Enhancement Project CPUC Site Inspection Form

<b>Project:</b>	South Orange County Reliability Enhancement (SOCRE) Project	<b>Date:</b>	January 7, 2021
<b>Project Proponent:</b>	San Diego Gas & Electric (SDG&E)	<b>Report #:</b>	VS109
<b>Lead Agency:</b>	California Public Utilities Commission (CPUC)	<b>Monitor(s):</b>	CPUC/WSP (formerly Ecology and Environment, Inc.) Compliance Monitor
<b>CPUC PM:</b>	Andrew Barnsdale, Energy Division	<b>AM/PM Weather:</b>	Partly cloudy, cool, and calm
<b>CPUC CM (WSP):</b>	Joe Donaldson	<b>Start/End time:</b>	0630 to 1100
<b>Project NTP(s):</b>	Notice to Proceed (NTP)-3, NTP-5, and NTP-6

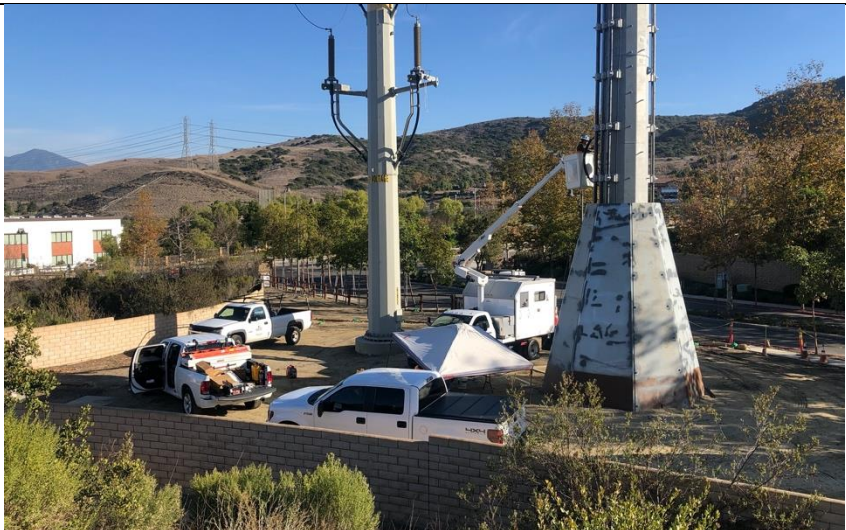
A crew was working on the towers at locations 16 and 17 (Photo 4).

Photo 4 – A crew working on tower locations 16 and 17. Photo facing east.
01/07/21	SOCRE transmission corridor

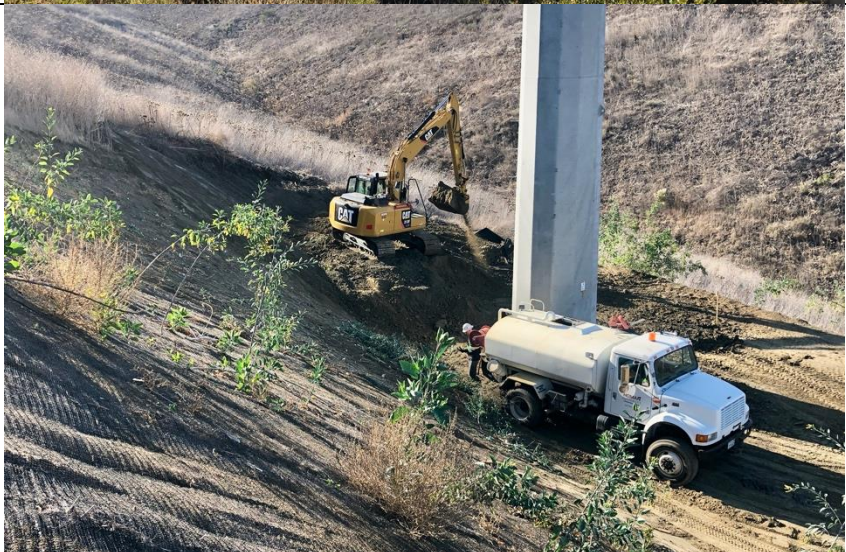
We drove to tower location 14 where a crew was rebuilding the cut bank at the south end of the tower pad (Photo 5). The soil was being recompacted into its original location and would be covered with a coconut fiber matting. A brow ditch needed be to excavated at this location.

Photo 5 – Restoration of the cut bank at tower location 14. Photo facing southwest.
01/07/21	SOCRE transmission corridor

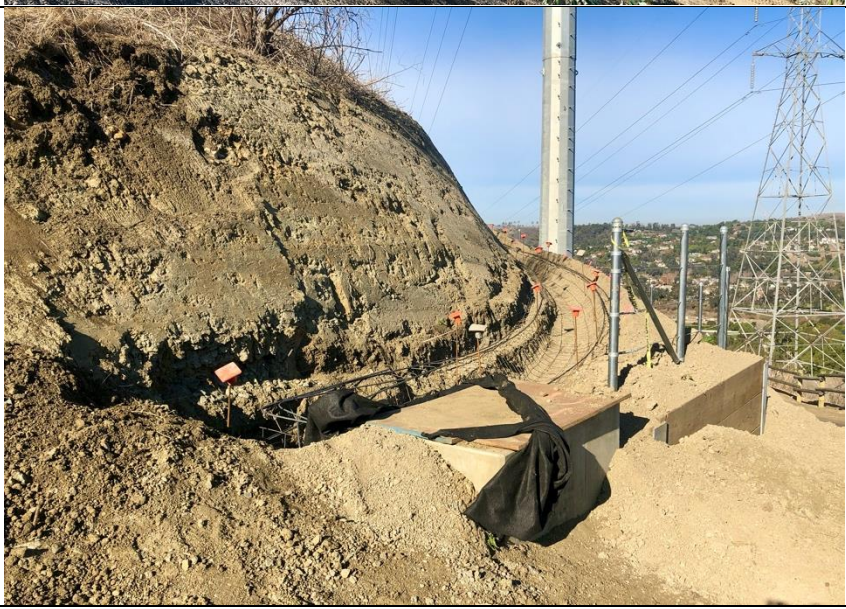
At tower location 13, brow ditch construction was underway (Photo 6). The ditch had been dug and lined with wire and would be ready for cement slurry to be poured. The existing fence had been reinstalled along the roadway. The EI indicated that they installed climbing structures in the open holes and checked them in the morning; no animals were found in the holes.

Photo 6 – Brow ditch construction at tower location 13. Photo facing northwest.

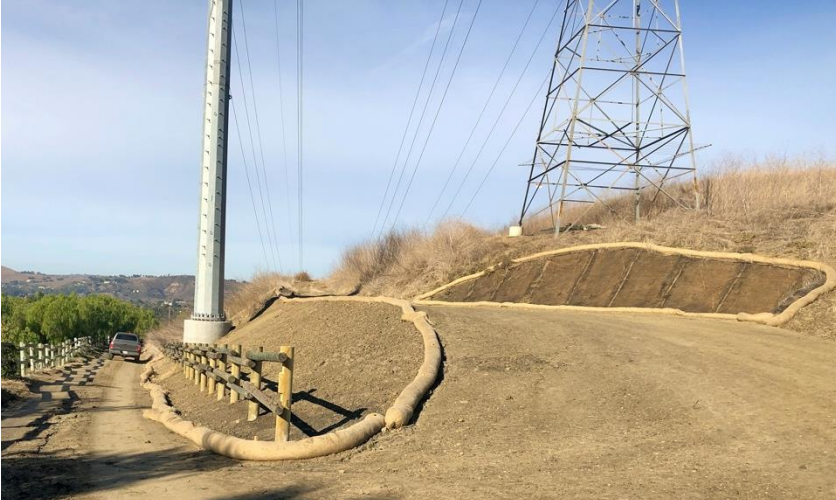
As we drove by tower location 12, it was noted that BMPs were in place and no erosion damage was observed following the Christmas weekend rain event (Photo 7).

Photo 7 – BMPs in place at tower location 12. Photo facing north.
01/07/21	SOCRE transmission corridor

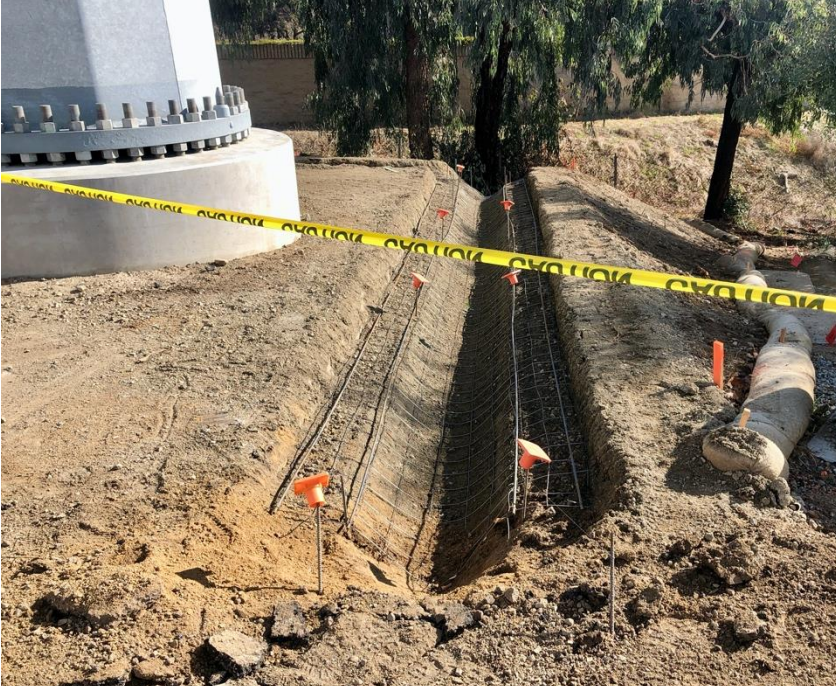
At tower location 4, a crew continued to work on the brow ditch around the tower foundation, preparing to pour slurry (Photo 8). The graded area appeared well stabilized with BMPs and no issues with irrigation leaks were observed (Photo 9).

Photo 8 – Brow ditch construction around the foundation at tower location 4. Photo facing east.
01/07/21	SOCRE transmission corridor

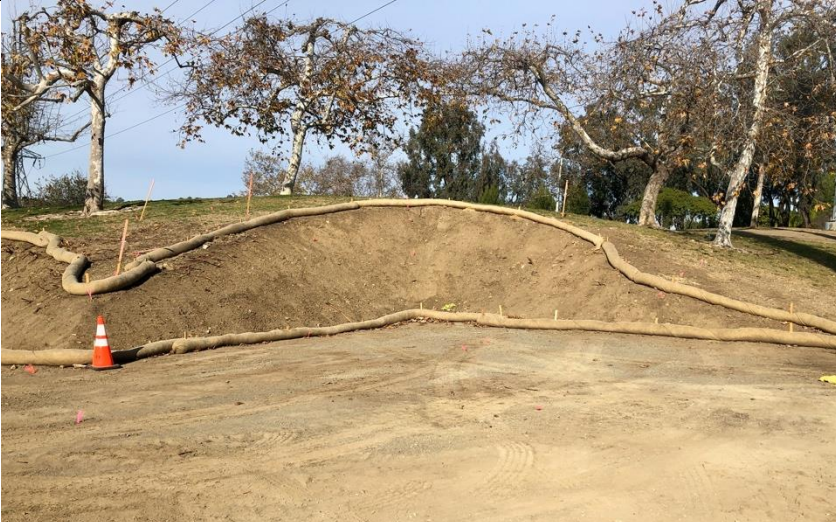
Photo 9 – Stabilization of the graded area near tower location 4. Photo facing northwest.

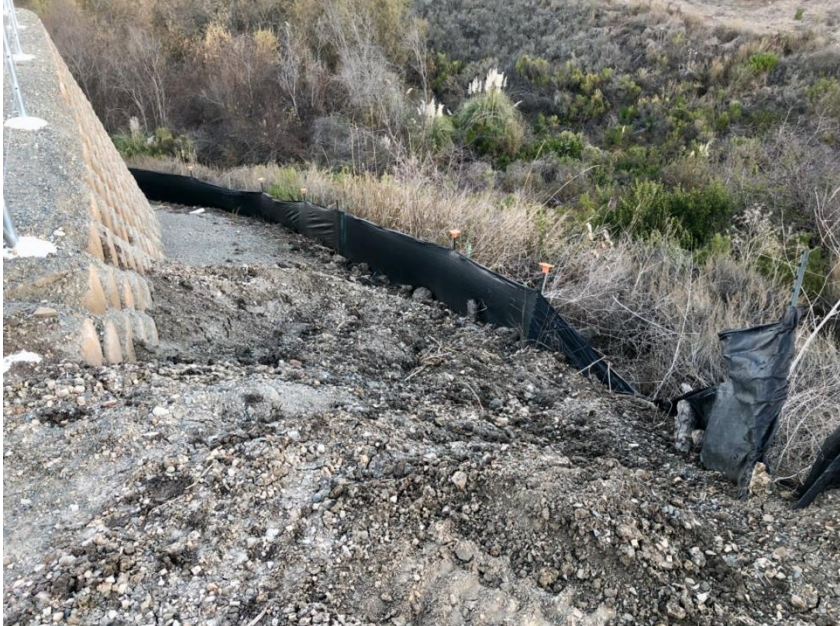
The EI and I headed south to tower location 39. The additional workspace below the tower site remained fenced and grassy vegetation was growing after the last rain (Photo 1). Work continued on the brow ditch around the tower pad and the foundation was prepared to be poured. Excess soil appeared to require additional restoration at the eastern end of the wall (Photo 2).

Photo 2 – Final restoration needed below the wall at tower location 39. Photo facing north.
01/13/21	SOCRE transmission corridor

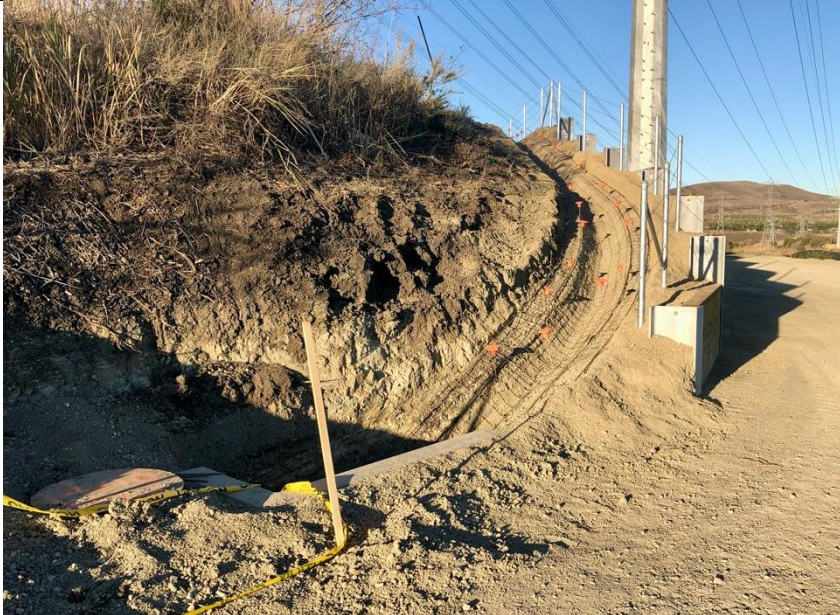
At tower location 36, the brow ditch work was ongoing with most of the forms and the metal ditch lining in place and ready to be poured (Photos 3 and 4).

Photo 3 – Brow ditch work at tower location 36. Photo facing west.

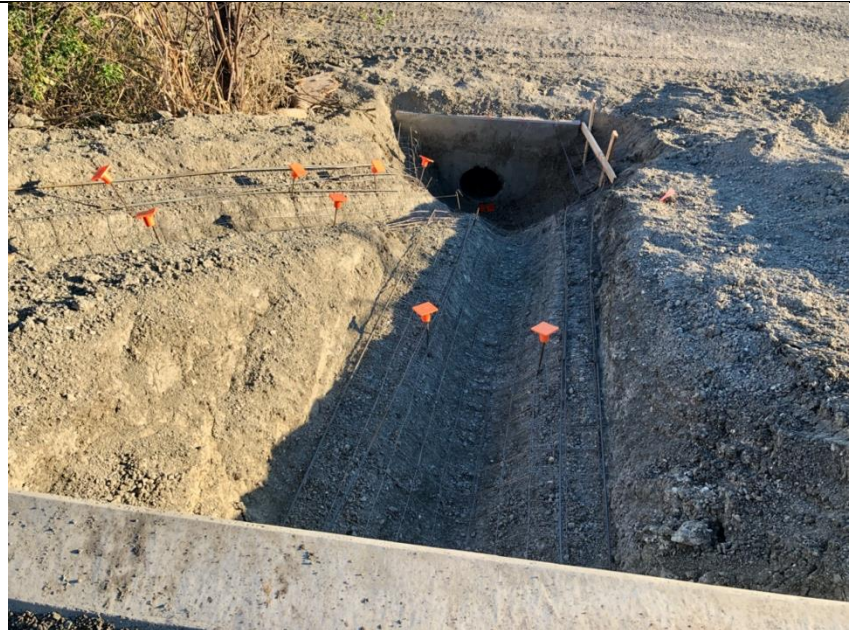
Photo 4 – Brow ditch work at tower location 36.
01/13/21	SOCRE transmission corridor

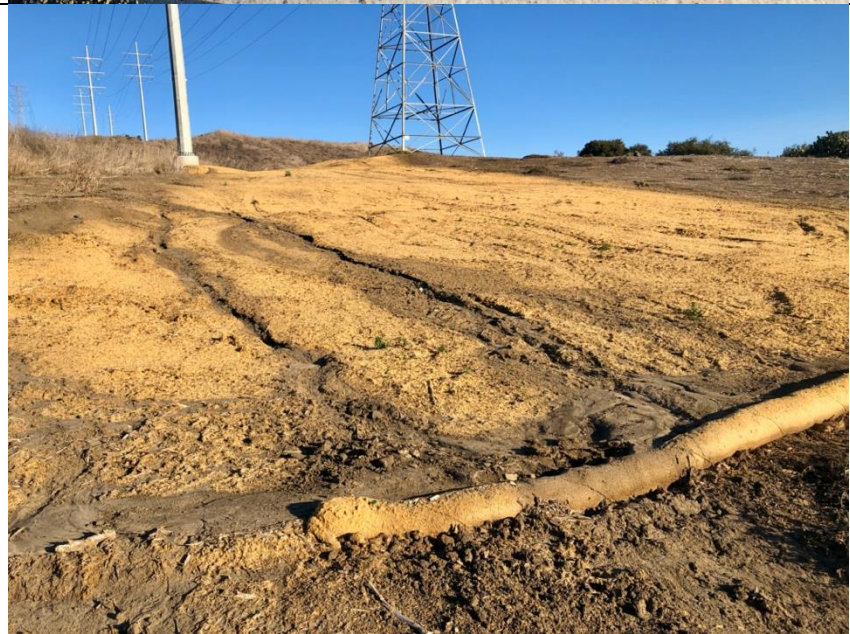
We stopped at the pull site below tower location 30 that had been hydroseeded and BMPs were added (Photo 5). Rainwater runoff coming from the access road came through the disturbed area causing minor erosion. We discussed how to divert the runoff before it crossed the newly hydroseeded pull site. A pair of red-tailed hawks (*Buteo jamaicensis*) were observed in the lattice steel tower next to tower location 30.

Photo 5 – Hydroseeding and BMPs in below tower location 30. Photo facing north.

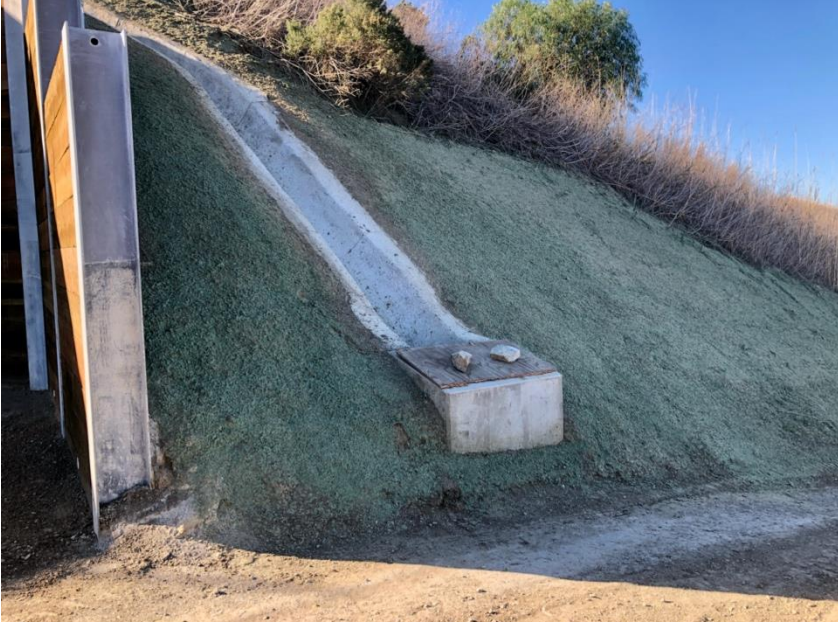
At tower location 13, the brow ditches were poured and the hydroseeding had been completed (Photo 6).

Photo 6 – Brow ditch and hydroseeded slope at tower location 13. Photo facing west.
01/21/21	SOCRE transmission corridor

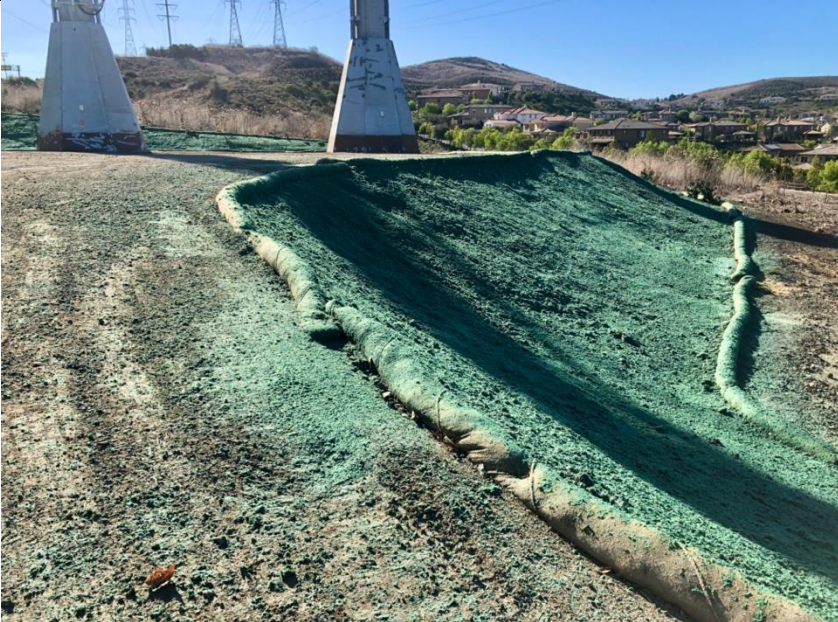
Photo 7 – BMPs and newly hydroseeded area at tower locations 18 and 19. Photo facing south.

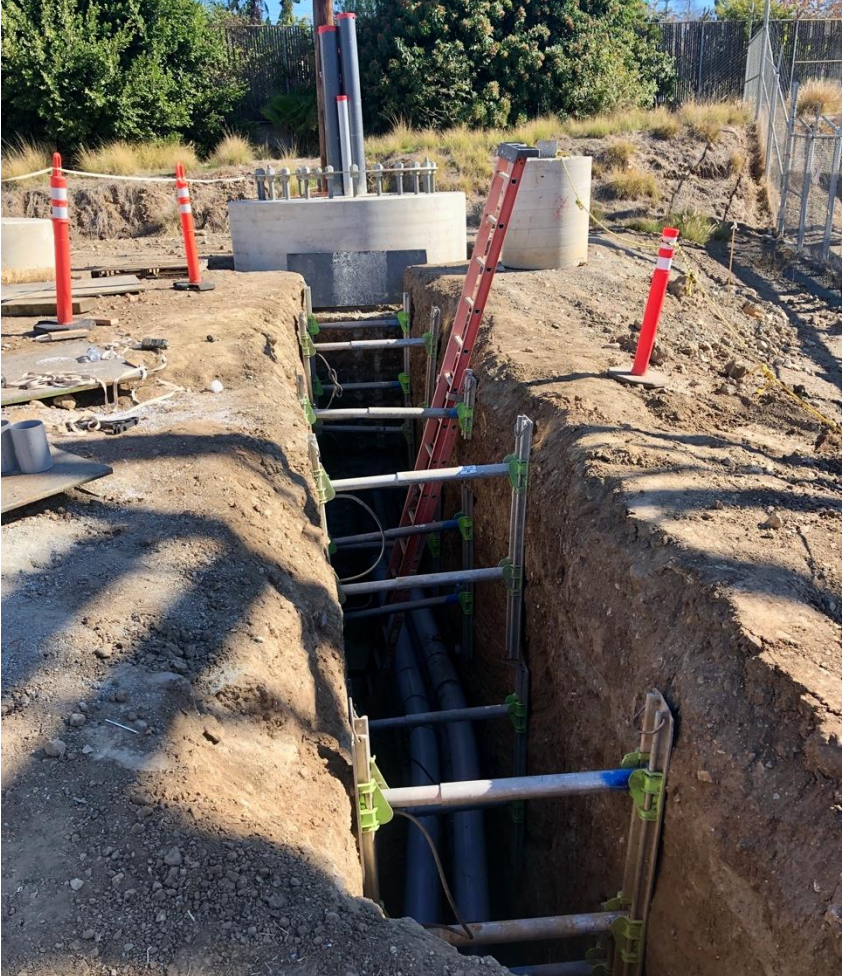
Conduit installation continued at the two new TSP foundations near the 12-kV substation facility (Photo 11). These trenches would also remain open for a time. I asked the EI to be sure that they were covered and sealed during the upcoming rain events.

Photo 11 - Conduit trench at the TSPs near the 12-kV substation facility. Photo facing east.
