**Re: Monthly Report Summary #44 for the South Orange County Reliability Enhancement (SOCRE) Project**

## South Orange County Reliability Enhancement Project CPUC Site Inspection Form

<b>Project:</b>	South Orange County Reliability Enhancement (SOCRE) Project	<b>Date:</b>	June 8, 2021
<b>Project Proponent:</b>	San Diego Gas & Electric (SDG&E)	<b>Report #:</b>	VS121
<b>Lead Agency:</b>	California Public Utilities Commission (CPUC)	<b>Monitor(s):</b>	CPUC/WSP USA Inc. Compliance Monitor
<b>CPUC PM:</b>	Andrew Barnsdale, Energy Division	<b>AM/PM Weather:</b>	Scattered clouds, mild, and calm
<b>CPUC CM (WSP):</b>	Joe Donaldson	<b>Start/End time:</b>	1430 to 1600
<b>Project NTP(s):</b>	Notice to Proceed (NTP)-3, NTP-4, and NTP-5

<b>Project:</b>	South Orange County Reliability Enhancement (SOCRE) Project	<b>Date:</b>	June 22, 2021
<b>Project Proponent:</b>	San Diego Gas & Electric (SDG&E)	<b>Report #:</b>	VS122
<b>Lead Agency:</b>	California Public Utilities Commission (CPUC)	<b>Monitor(s):</b>	CPUC/WSP Compliance Monitor
<b>CPUC PM:</b>	Andrew Barnsdale, Energy Division	<b>AM/PM Weather:</b>	Partly cloudy, cool, and calm
<b>CPUC CM (WSP):</b>	Joe Donaldson	<b>Start/End time:</b>	0630

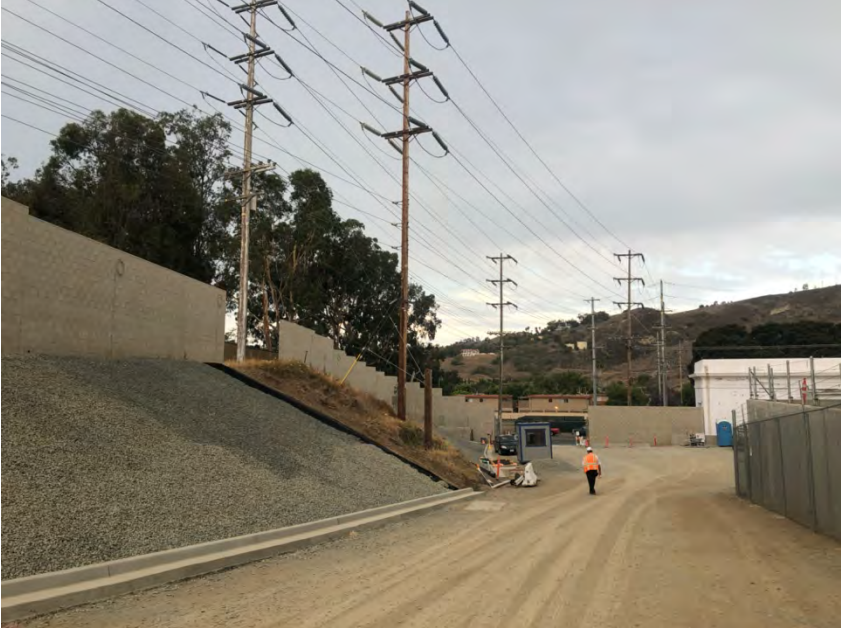
Work was completed along the southern access road. Work included slope armoring and curb and gutter installation (Photo 2).

Photo 2 – Curb work and slope protection was nearly completed along the southern access road. Photo facing west.
06/22/21	San Juan Capistrano Substation

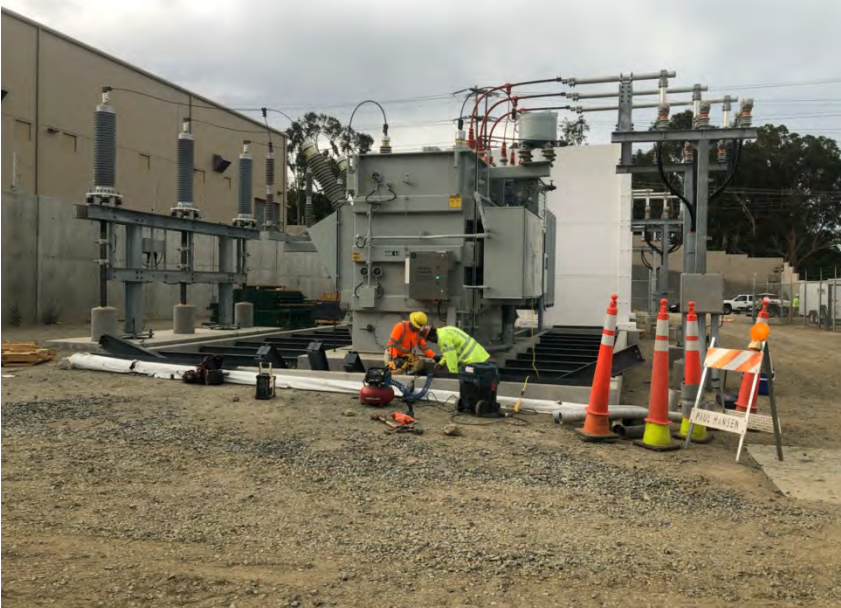
A small crew was working around the transformers (Photo 3). Entry into the area required fire-resistant clothing.

Photo 3 – A crew worked on the transformer foundations. Photo facing south.
