Re: Monthly Report Summary #49 for the South Orange County Reliability Enhancement (SOCRE) Project

South Orange County Reliability Enhancement Project CPUC Site Inspection Form

Project:	South Orange County Reliability Enhancement (SOCRE) Project	Date:	November 2, 2021
Project Proponent:	San Diego Gas & Electric (SDG&E)	Report #:	VS132
Lead Agency:	California Public Utilities Commission (CPUC)	Monitor(s):	CPUC/WSP USA Inc. Compliance Monitor
CPUC PM:	Andrew Barnsdale, Energy Division	AM/PM Weather:	Sunny and mild with a slight breeze
CPUC CM (WSP USA Inc.):	Joe Donaldson	Start/End time:	1345 to 1500
Project NTP(s):	Notice to Proceed (NTP)-3, NTP-4, and NTP-6

Project:	South Orange County Reliability Enhancement (SOCRE) Project	Date:	November 17, 2021
Project Proponent:	San Diego Gas & Electric (SDG&E)	Report #:	VS133
Lead Agency:	California Public Utilities Commission (CPUC)	Monitor(s):	CPUC/WSP USA Inc. Compliance Monitor
CPUC PM:	Andrew Barnsdale, Energy Division	AM/PM Weather:	Sunny and calm with mild temps
CPUC CM (WSP USA Inc):	Joe Donaldson	Start/End time:	1400 to 1500
Project NTP(s):	Notice to Proceed (NTP)-3, NTP-4, and NTP-6

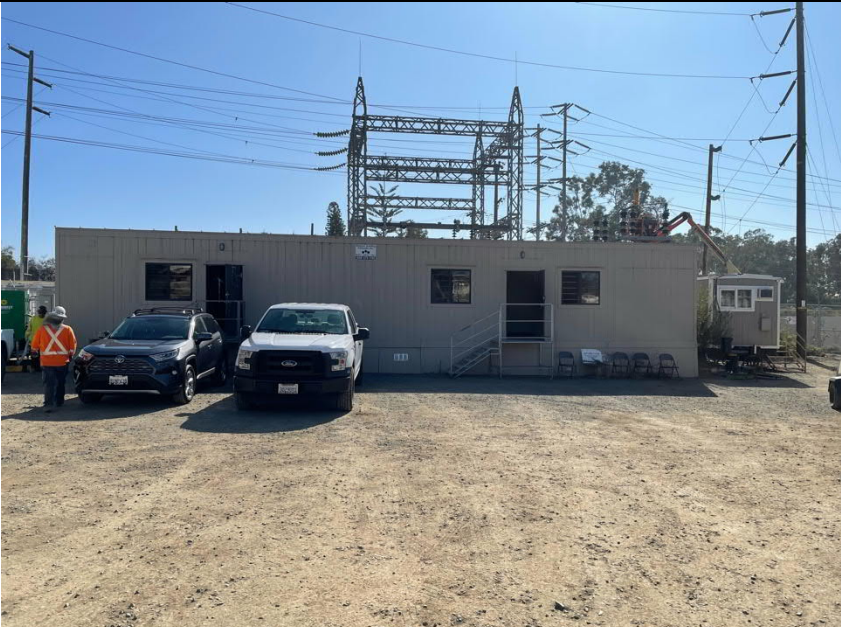
Work was focused on the removal of the former 138-kV substation. Crews were emptying and moving construction trailers to accommodate the new 138-kV substation facility (Photo 1). The trailers were being relocated to an area just east of the former utility structure.

Photo 1 – The construction trailers are being moved to a new location. Photo facing south.

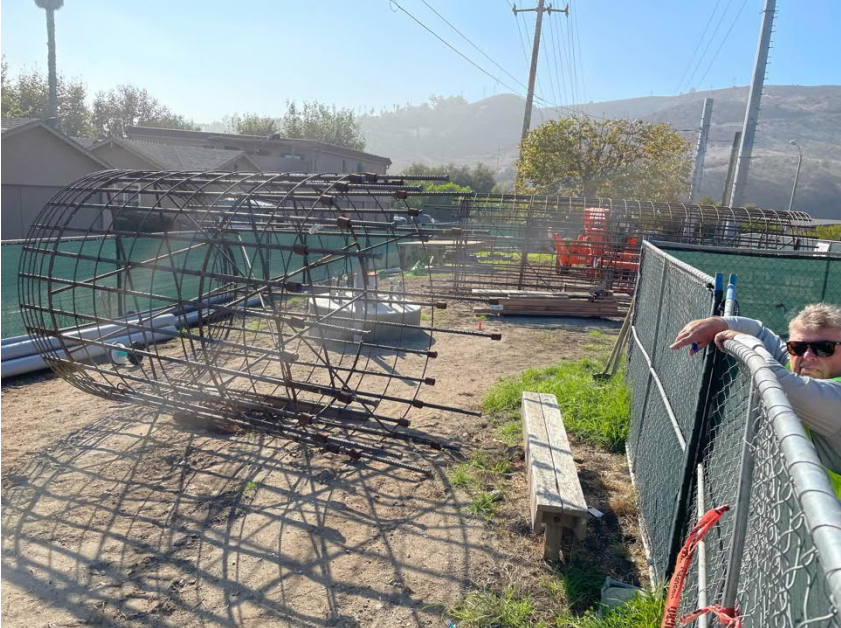
We drove to the work areas west of the railroad tracks; no work was taking place and the areas had been fenced off. Crews delivered rebar cages for the additional tubular steel poles and staged them in one of the laydown yards (Photos 8 and 9).

Photo 8 – Rebar cages delivered to one of the laydown areas west of the railroad tracks. Photo facing west.
11/03/21	Area west of Camino Capistrano and railroad

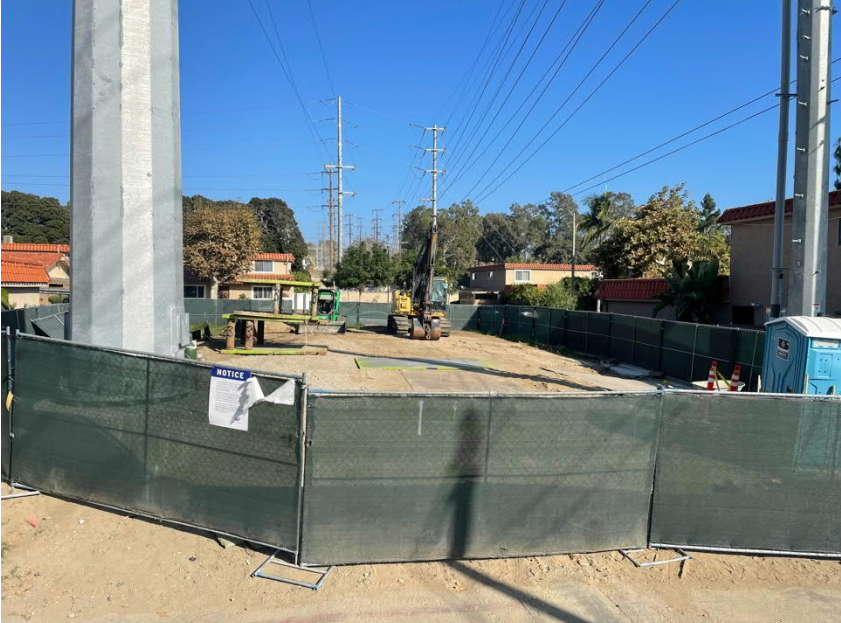
Photo 9 - Fenced construction area west of the railroad tracks. Photo facing east.

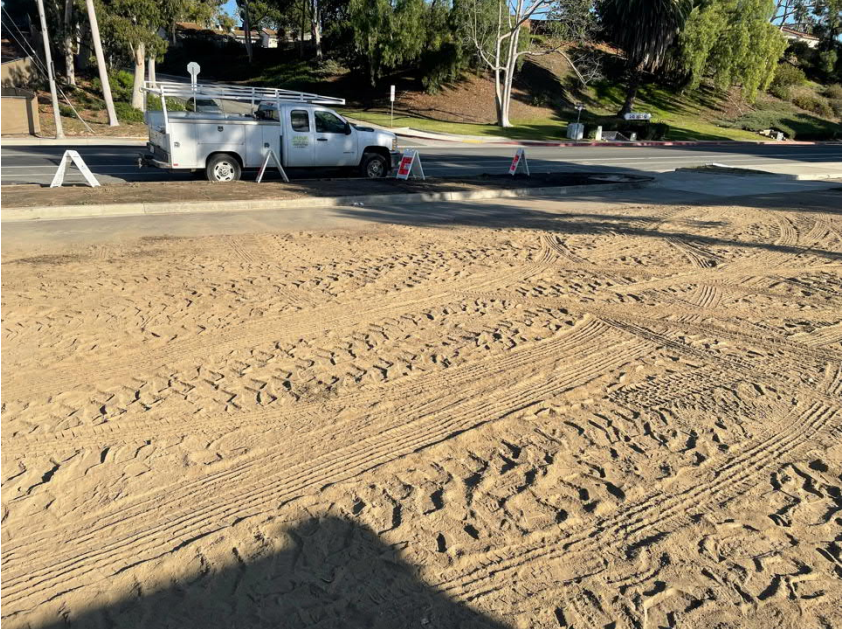
A crew was working in the bore pit area along the railroad tracks just west of Camino Capistrano. They had drilled a foundation hole for a tubular steel pole (TSP), set the rebar cage, and poured the concrete foundation. The hole was covered with steel plates (Photo 4). They intend to pour the bolt cage within the next few days (Photo 5). The access road and surrounding area for the bore pit were very dusty (Photo 6). I discussed the dust control needs for this area with the EI.

Photo 6 – Access road to the TSP foundation work area west of the railroad. Photo facing southeast.
