**Re: Monthly Report Summary #51 for the South Orange County Reliability Enhancement (SOCRE) Project**

## South Orange County Reliability Enhancement Project CPUC Site Inspection Form

| <b>Project Proponent:</b> | San Diego Gas & Electric (SDG&E) | <b>Report #:</b> | VS136 |

| <b>Project Proponent:</b> | San Diego Gas & Electric (SDG&E) | <b>Report #:</b> | VS137 |

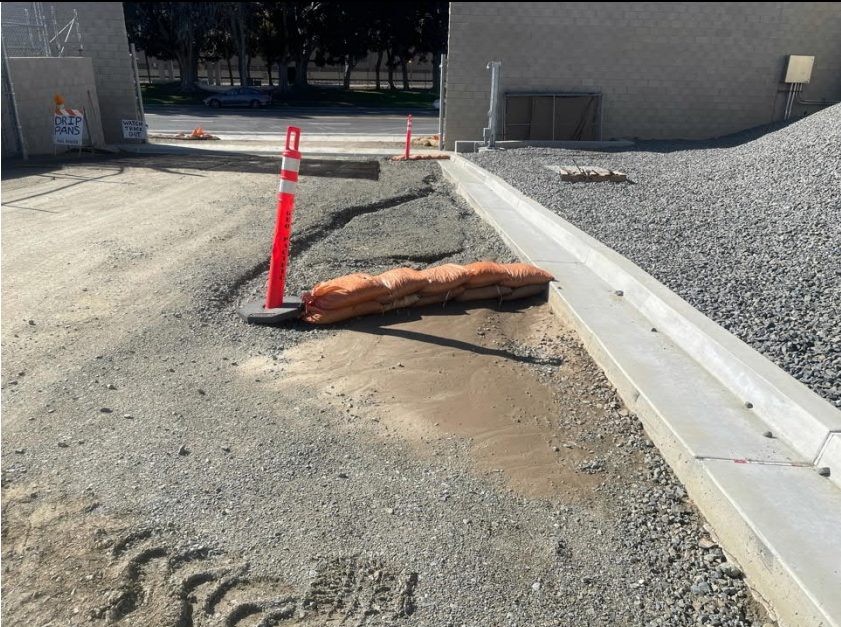
I met with the Environmental Inspector (EI) and we walked through the substation together. It appeared that the rain did not cause any erosion issues, and the BMPs appeared to reduce any problems from the rainwater runoff (Photo 1). Some muddy areas remained within the construction area, but the crews were careful about track out onto public roadways (Photo 2). Rumble plates remain in place at both entry/exit points for the substation.

| <b>REPRESENTATIVE SITE PHOTOGRAPHS</b> | | | |
|--|---|--|--|
| 1/05/22 | San Juan Capistrano Substation | | Photo 1 – BMPs along the access roads helped reduce problems with rainwater runoff. Photo facing west. |

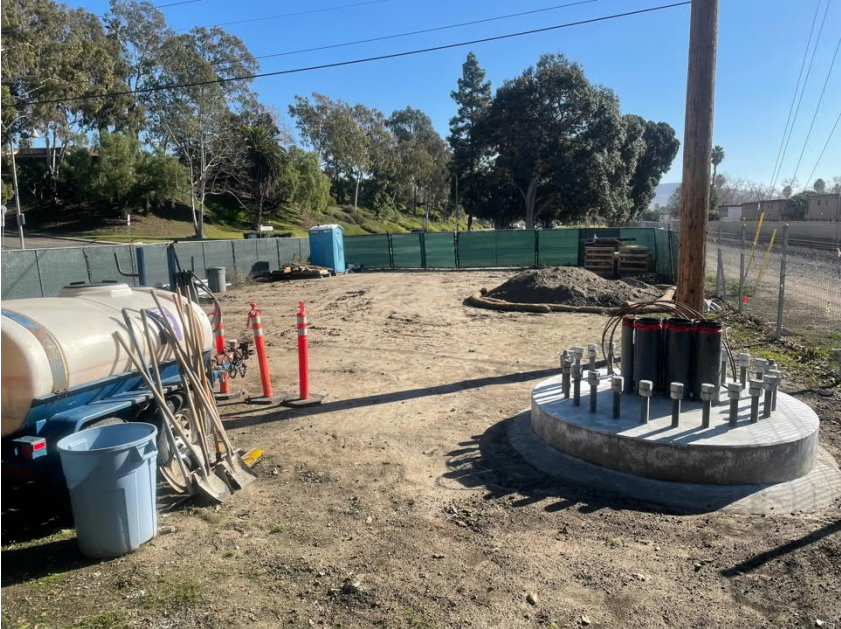
I observed the fenced bore pit area located west of the substation between Camino Capistrano and the railroad tracks. I did not notice any issues with rainwater runoff (Photo 6).

| REPRESENTATIVE SITE PHOTOGRAPHS | | | |
|---|---|--|---|
| 1/05/22 | Area west of the substation between Camino Capistrano and the railroad tracks | | Photo 6 – No rainwater runoff issues were observed in the fenced bore pit area. Photo facing south. |

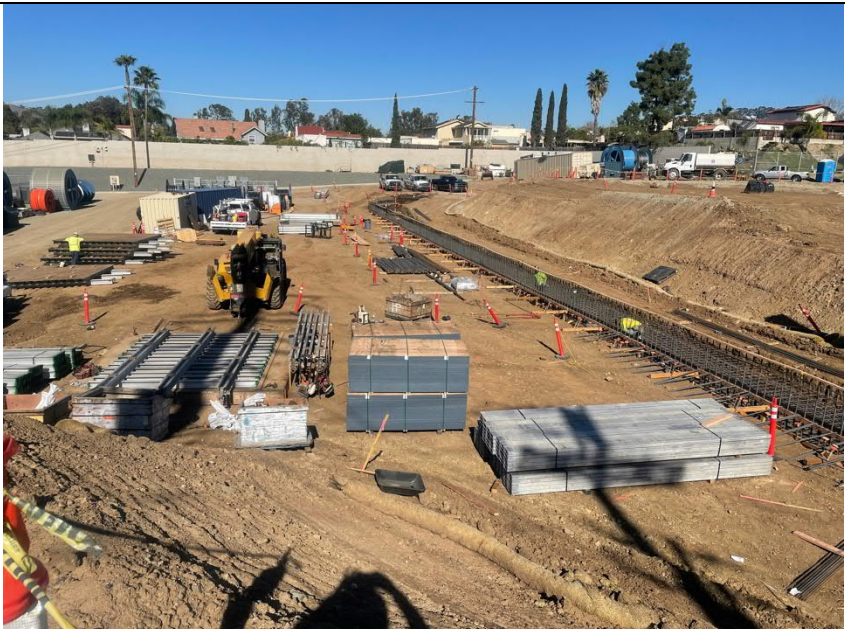
Work has been progressing on the new 230-kV substation facility within the San Juan Capistrano Substation, with the crews beginning to work on building the retaining wall (Photo 1).

| REPRESENTATIVE SITE PHOTOGRAPHS | | | |
|---|---|--|--|
| 1/20/22 | San Juan Capistrano Substation | | Photo 1 – Construction of the retaining wall at the new 230-kV substation. Photo facing north. |

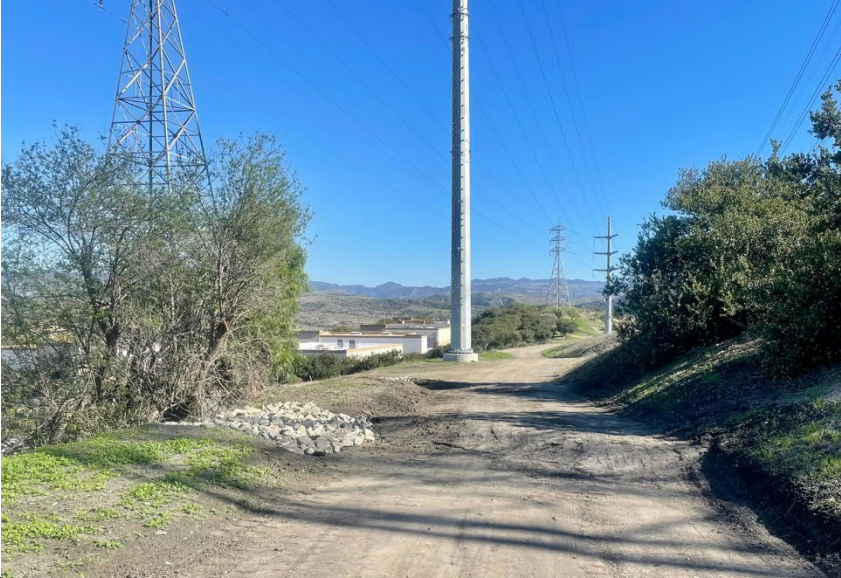
The LEI and I traveled along portions of the transmission corridor to inspect some of the areas prone to erosion. Our first stop was at the tubular steel pole (TSP) at Location 41 where some work was performed on the access road. At this location, work crews had added a water bar and a rock energy dissipater (Photo 4). Some additional BMPs were installed below the TSP at Location 41 to prevent sediment from flowing onto public roads (Photo 5).

| REPRESENTATIVE SITE PHOTOGRAPHS | | | |
|---|---|---|--|
| 1/20/22 | SOCRE Project transmission line route | | Photo 4 – Erosion control work completed along the access road near the TSP at Location 41. Photo facing east. |

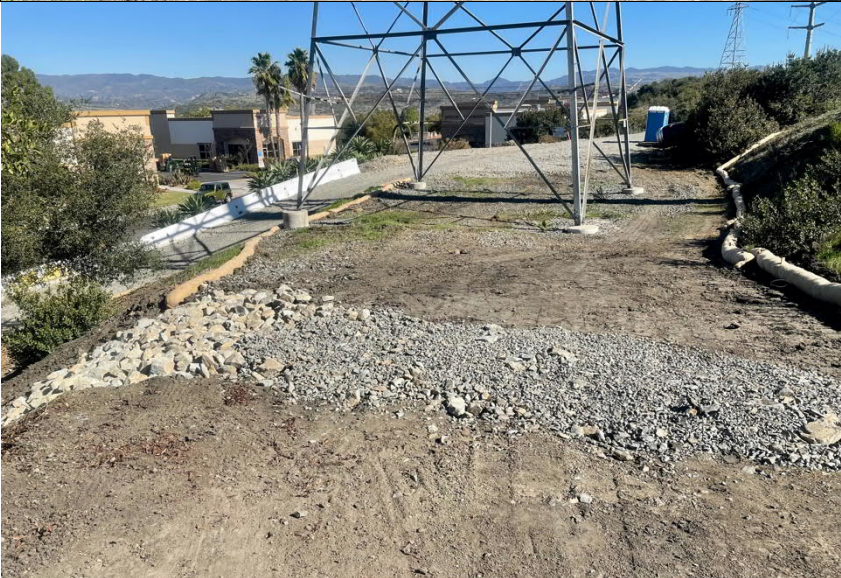
| REPRESENTATIVE SITE PHOTOGRAPHS | | | |
|---|---|---|--|
| 1/20/22 | SOCRE Project transmission line route | | Photo 5 – Erosion control work completed below the TSP at Location 41. Photo facing east. |

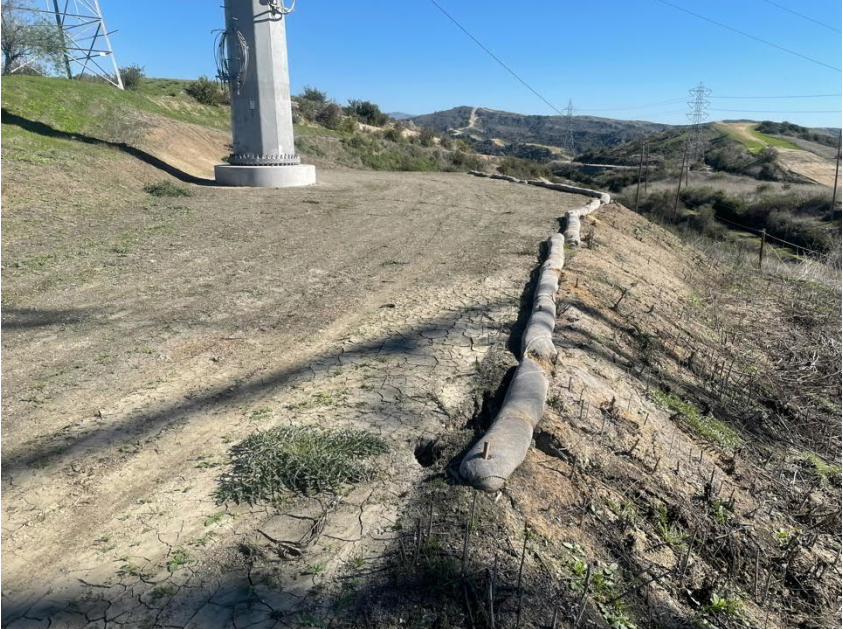
We also examined the BMPs at Location 42 (Photo 6). The tower pad at this location appeared stable, although there was some erosion evident beneath a few of the straw wattles.

| REPRESENTATIVE SITE PHOTOGRAPHS | | | |
|---|---|--|---|
| 1/20/22 | SOCRE Project transmission line route | | Photo 6 – The TSP tower pad at Location 42 appears stable with some erosion beneath straw wattles. Photo facing east. |
