Re: Monthly Report Summary #52 for the South Orange County Reliability Enhancement (SOCRE) Project

CPUC Site Inspection Report for
February 7, 2022

South Orange County Reliability Enhancement Project CPUC Site Inspection Form

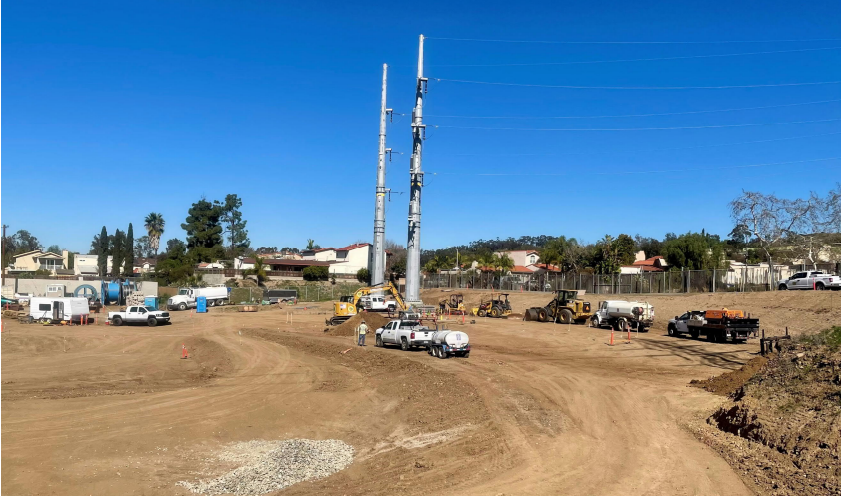
Some earthwork (excavation) was being performed within the footprint of the new 230-kV substation facility. A paleontological monitor arrived onsite to monitor this work (Photo 2). Currently, no other earthwork is planned for this area until the retaining wall is completed.

Photo 2 – Earthwork at the new 230-kV substation facility is temporarily on hold. Photo facing northeast.
2/07/22	San Juan Capistrano Substation

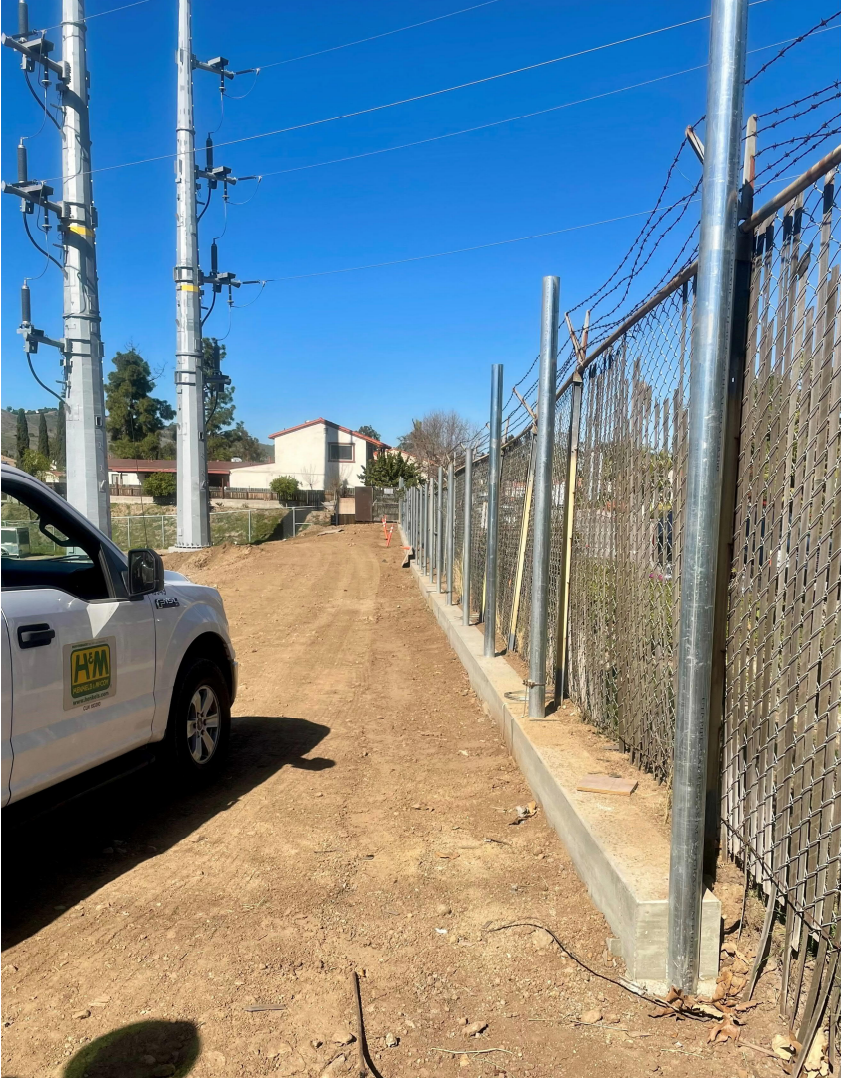
A fencing crew continued to install the new fence along the eastern edge of the project site (Photo 3).

Photo 3 – New fence installation along the eastern edge of the substation site. Photo facing north.
