**Re: Monthly Report Summary #54 for the South Orange County Reliability Enhancement (SOCRE) Project**

## South Orange County Reliability Enhancement Project CPUC Site Inspection Form

<b>Project:</b>	South Orange County Reliability Enhancement (SOCRE) Project	<b>Date:</b>	April 13, 2022
<b>Project Proponent:</b>	San Diego Gas & Electric (SDG&E)	<b>Report #:</b>	VS141
<b>Lead Agency:</b>	California Public Utilities Commission (CPUC)	<b>Monitor(s):</b>	CPUC/WSP Compliance Monitor
<b>CPUC PM:</b>	Andrew Barnsdale, Energy Division	<b>AM/PM Weather:</b>	Sunny and warm w/ a slight breeze
<b>CPUC CM (WSP):</b>	Joe Donaldson	<b>Start/End time:</b>	1045 – 1200 hrs
<b>Project NTP(s):</b>	Notice to Proceed (NTP)-1, NTP-2, NTP-2 Addendum 1, NTP-3, NTP-4, and NTP-5

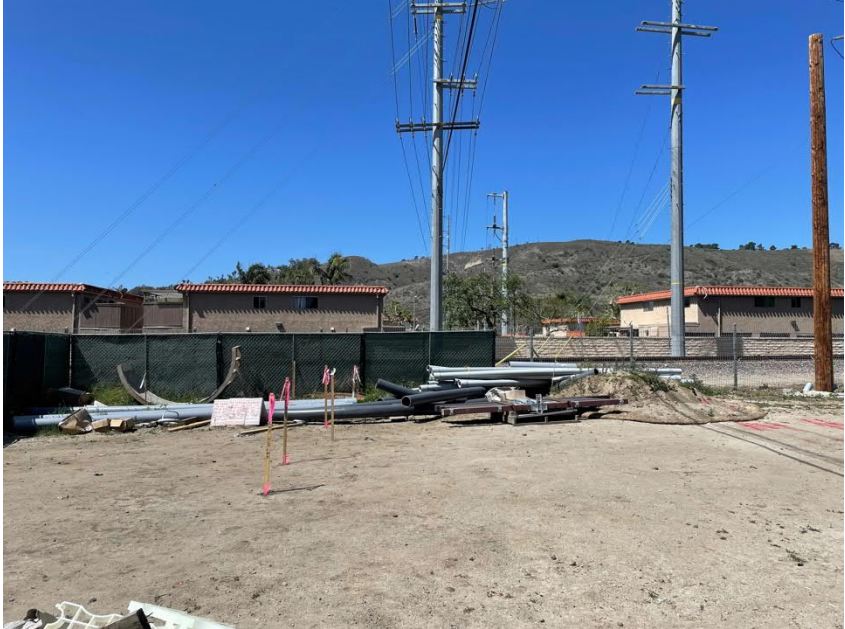
The last tubular steel pole (TSP) foundation was to be drilled and poured within the next few days. The location had been staked out in the bore pit location on the east side of the railroad tracks (Photo 4). The area was fenced and well maintained.

Photo 4 – The last TSP location within the bore pit site. TSP foundation to be drilled soon. Photo facing west.
