**Re: Monthly Report Summary #56 for the South Orange County Reliability Enhancement (SOCRE) Project**

## South Orange County Reliability Enhancement Project CPUC Site Inspection Form

<b>Project:</b>	South Orange County Reliability Enhancement (SOCRE) Project	<b>Date:</b>	June 20, 2022
<b>Project Proponent:</b>	San Diego Gas & Electric (SDG&E)	<b>Report #:</b>	VS145
<b>Lead Agency:</b>	California Public Utilities Commission (CPUC)	<b>Monitor(s):</b>	CPUC/WSP Compliance Monitor
<b>CPUC PM:</b>	Louis Torres, Energy Division	<b>AM/PM Weather:</b>	Sunny, mild temps and a slight breeze
<b>CPUC CM (WSP):</b>	Fernando Guzman	<b>Start/End time:</b>	1100 – 1200 hrs
<b>Project NTP(s):</b>	Notice to Proceed (NTP)-1, NTP-2, NTP-2 Addendum 1, NTP-3, NTP-4, and NTP-5

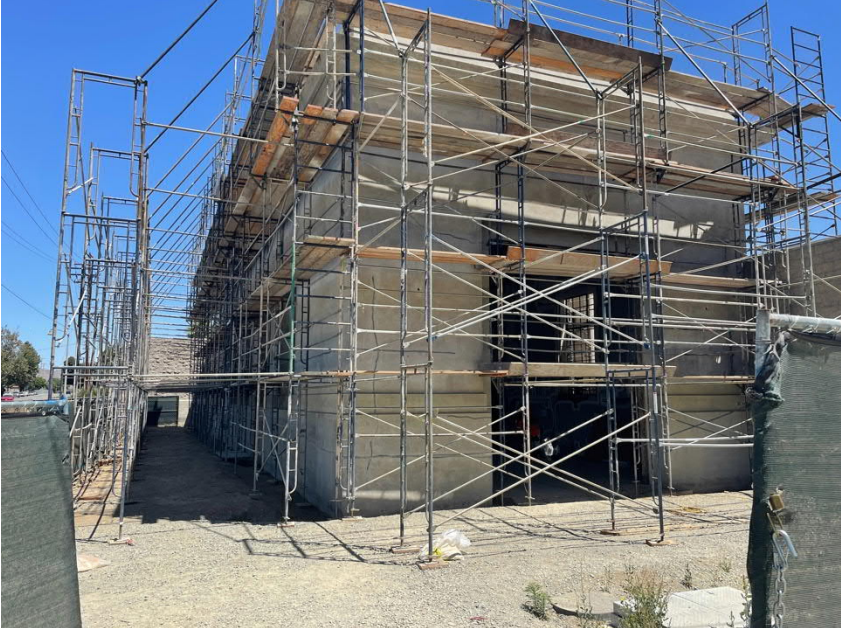
Abatement crews continued to work on the former utility structure, with scaffolding in place (Photo 4). According to the EI they had removed all the hazardous materials and were preparing to paint the building. I did not observe any air monitoring equipment, possibly because they had completed removal of the hazardous materials.

<p>Photo 4 – Cleanup work on the former utility structure is complete, with painting to commence. Photo facing north.</p>

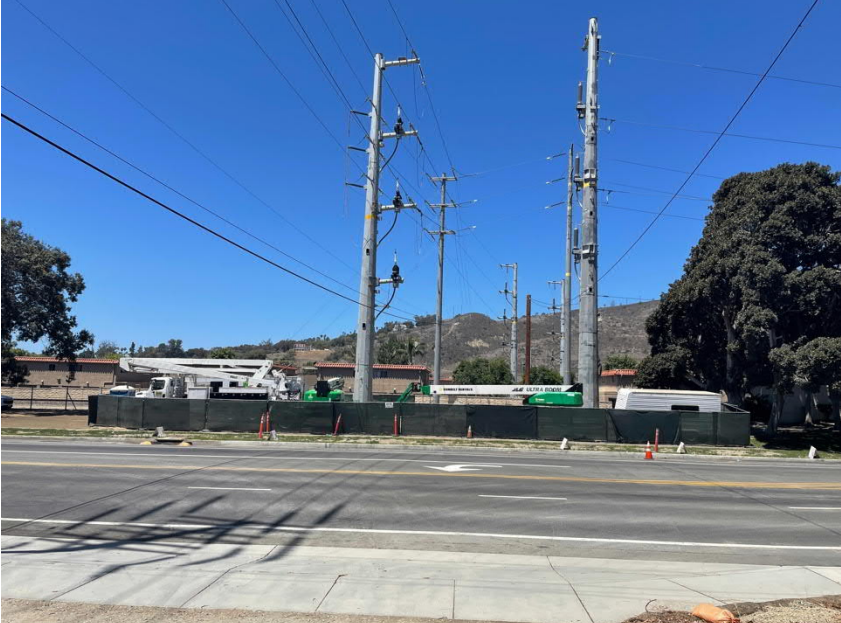
Crews continued to work on the equipment and on wiring up in the tubular steel poles west of the substation (Photo 5). A stockpile of excavated slurry remained within the fenced construction area (Photo 6). They expected to be done with this work area soon and will be cleaning it up.

<p>Photo 5 – Work continues on the tubular steel poles west of Camino Capistrano. Photo facing west.</p>

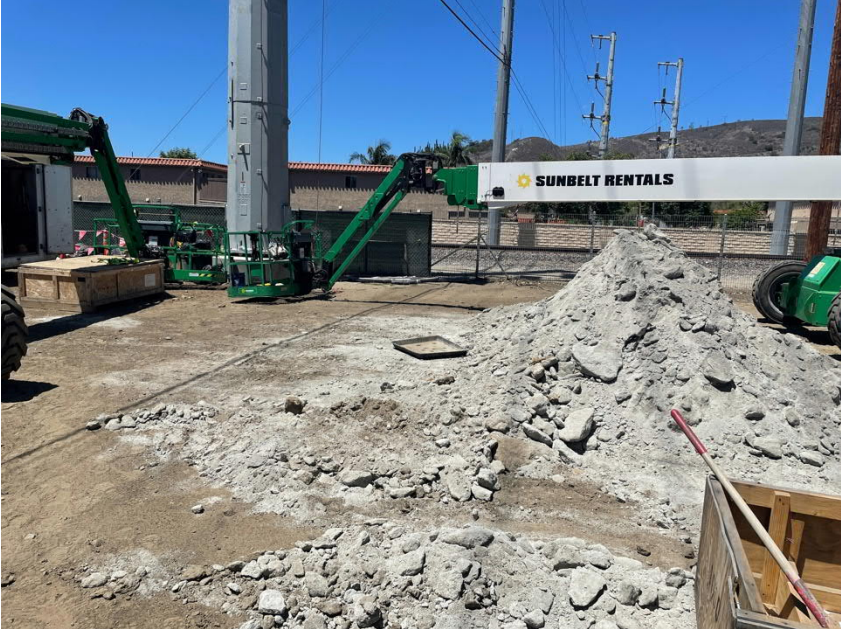
Photo 6 – Excavated slurry stockpiled with the fenced construction zone. Photo facing west.
