Re: Monthly Report Summary #58 for the South Orange County Reliability Enhancement (SOCRE) Project

South Orange County Reliability Enhancement Project CPUC Site Inspection Form

Project:	South Orange County Reliability Enhancement (SOCRE) Project	Date:	August 10, 2022
Project Proponent:	San Diego Gas & Electric (SDG&E)	Report #:	VS148
Lead Agency:	California Public Utilities Commission (CPUC)	Monitor(s):	CPUC/WSP Compliance Monitor
CPUC PM:	Louis Torres, Energy Division	AM/PM Weather:	Clear, warm, and breezy
CPUC CM (WSP):	Fernando Guzman	Start/End time:	1130 – 1230 hrs
Project NTP(s):	Notice to Proceed (NTP)-1, NTP-2, NTP-2 Addendum 1, NTP-3, NTP-4, and NTP-5

Project:	South Orange County Reliability Enhancement (SOCRE) Project	Date:	August 30, 2022
Project Proponent:	San Diego Gas & Electric (SDG&E)	Report #:	VS149
Lead Agency:	California Public Utilities Commission (CPUC)	Monitor(s):	CPUC/WSP Compliance Monitor
CPUC PM:	Louis Torres, Energy Division	AM/PM Weather:	Clear, warm, and a slight breeze
CPUC CM (WSP):	Fernando Guzman	Start/End time:	1130 – 1230 hrs
Project NTP(s):	Notice to Proceed (NTP)-1, NTP-2, NTP-2 Addendum 1, NTP-3, NTP-4, and NTP-5

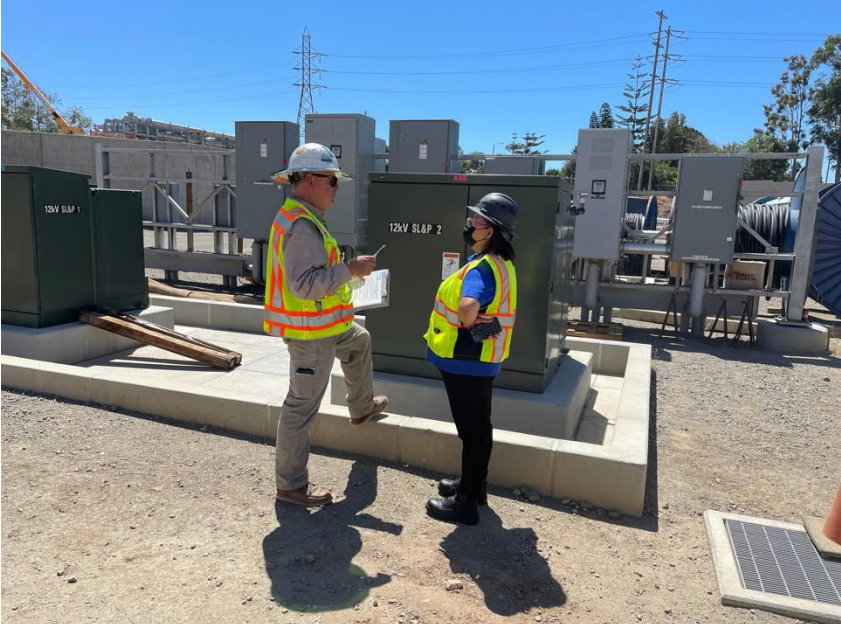
I met with the onsite Environmental Inspector (EI) at 1130 hours. The EI needed to train a new crew member (Photo 1), so I toured the substation site on my own. I met with the EI toward the end of my site visit to discuss the construction progress and any compliance issues.

Photo 1 – The onsite EI providing environmental training to a new crew member. Photo facing south.

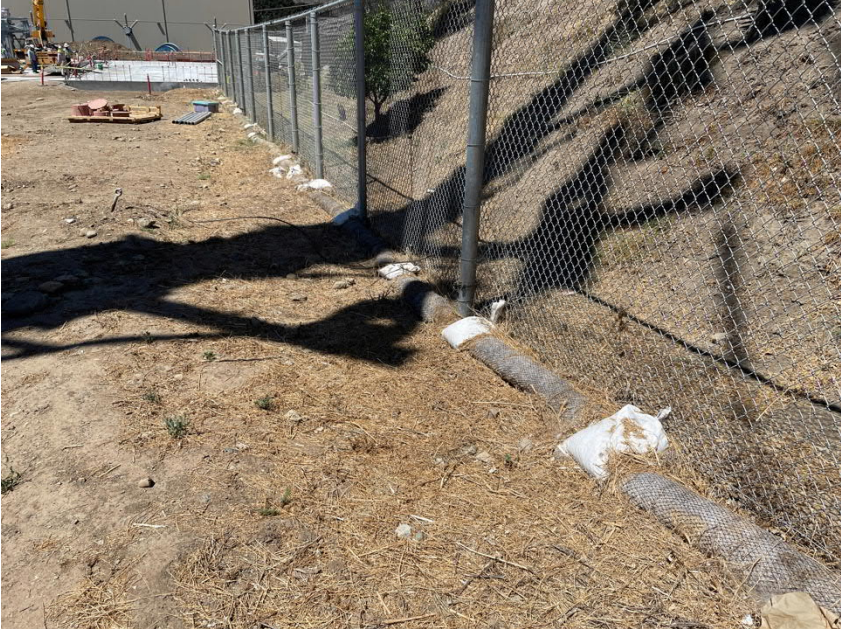
A large amount of the old, plastic-wrapped straw wattle remains on site and should be removed and replaced prior to the next rainy season (Photo 8). I spoke to the EI about using burlap-wrapped straw wattle, as the plastic wrapping can entrap small animals, in particular some species of lizards and snakes.

Photo 8 – Old plastic-wrapped straw wattles. Photo facing west.

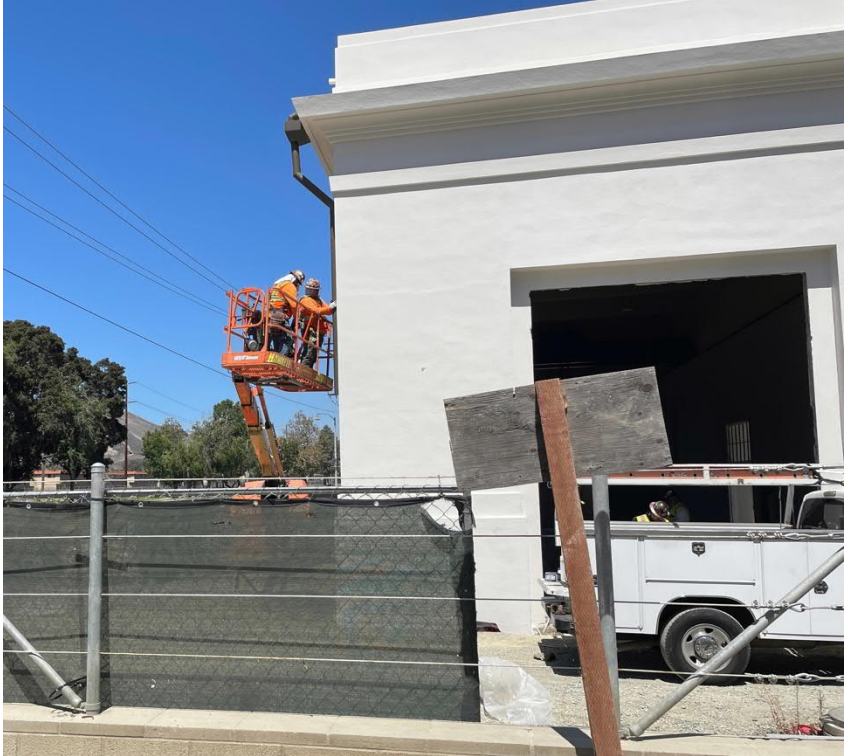
A crew was working on the former utility structure, installing gutters and downspouts (Photo 4).

Photo 4 – Crew working on the former utility structure.
