Re: Monthly Report Summary #62 for the South Orange County Reliability Enhancement (SOCRE) Project

South Orange County Reliability Enhancement Project CPUC Site Inspection Form

Project:	South Orange County Reliability Enhancement (SOCRE) Project	Date:	December 1, 2022
Project Proponent:	San Diego Gas & Electric (SDG&E)	Report #:	VS154
Lead Agency:	California Public Utilities Commission (CPUC)	Monitor(s):	CPUC/WSP Compliance Monitor
CPUC PM:	Louis Torres, Energy Division	AM/PM Weather:	Cloudy & cool with a slight breeze
CPUC CM (WSP):	Fernando Guzman	Start/End time:	1100 – 1330 hrs
Project NTP(s):	Notice to Proceed (NTP)-3, NTP-4, and NTP-7

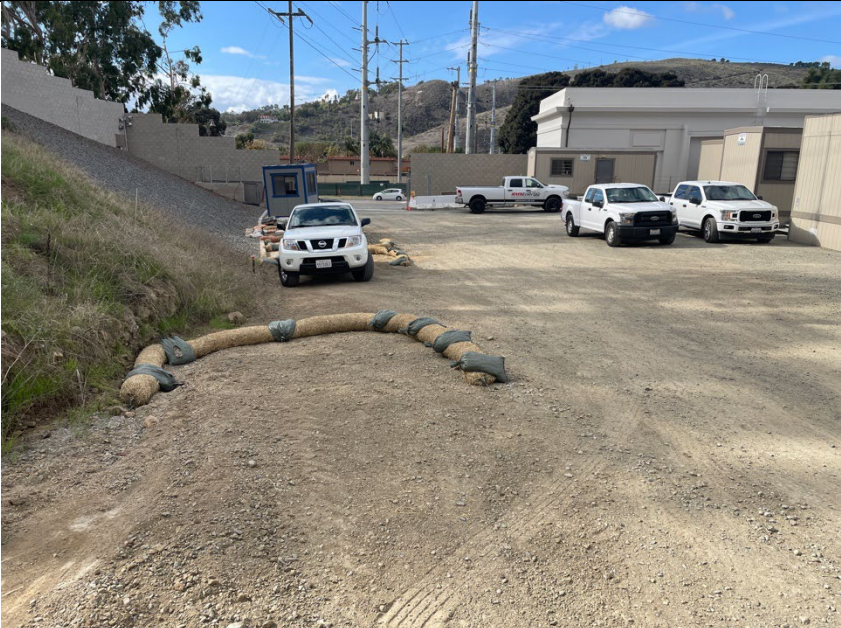
Best management practices (BMPs) were in place along the access roads (Photo 1) and around some of the soil stockpiles (Photo 2) due to a forecasted chance of rain. Areas of ponded water were still present within the project site (Photo 3). Some of the exposed dirt slopes had been hydromulched.

Photo 1 – BMPs in place along the access road. Photo facing west.

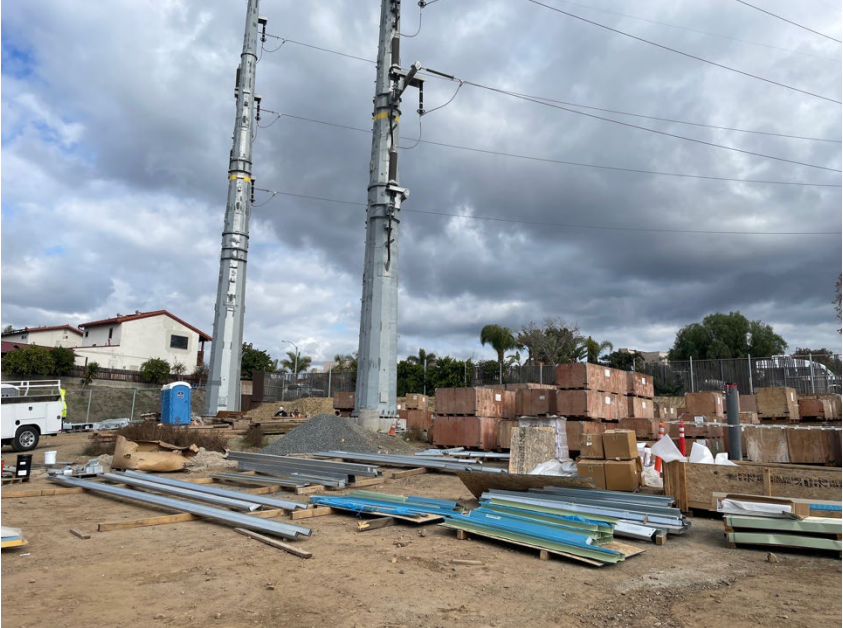
Large quantities of construction materials were being delivered to the project site as one of the two La Pata staging areas was being shut down (Photo 6).

Photo 6 – Construction materials being staged at the project site. Photo facing northeast.
12/01/22	SOCRE Project

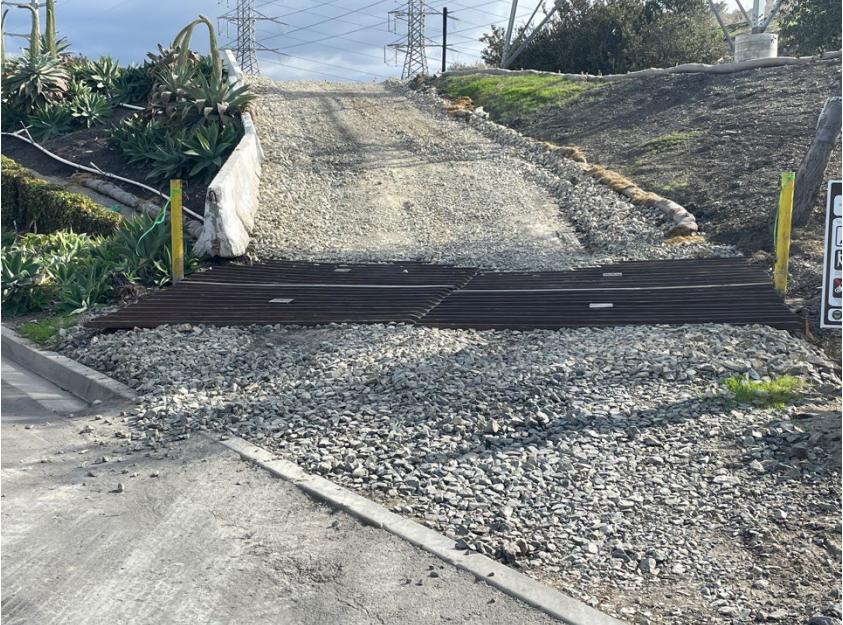
Work on Phase II of the transmission line installation near the Talega substation was increasing. Improvements had been made to the entry/exit BMPs at one of the access roads, with additional gravel added (Photo 7).

Photo 7 – Upgraded exit/entry BMPs near TSP 41. Photo facing south.

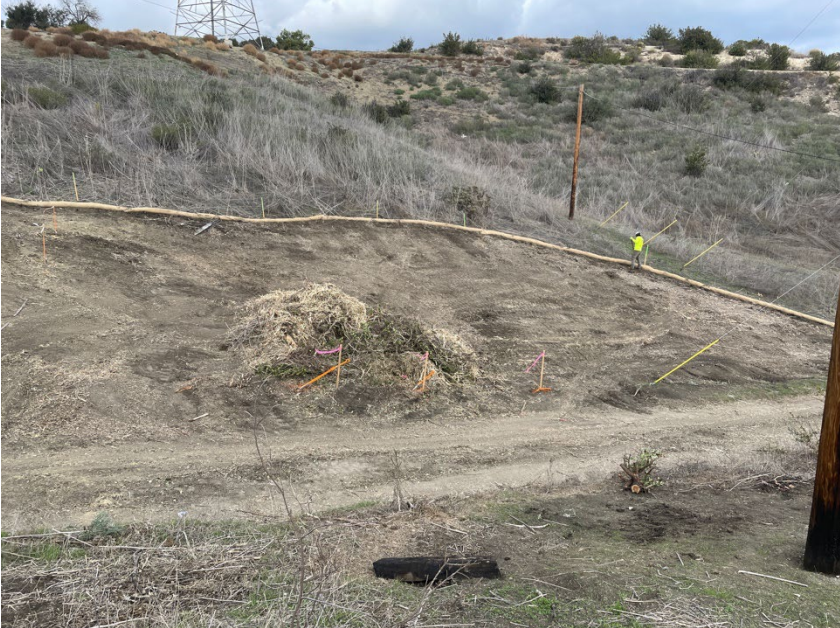
Crews were clearing vegetation and installing BMPs along the access roads and at the new tower locations (Photos 8, 9, and 10). The majority of the work was focused on tubular steel pole 43 and 44 and the six smaller towers/poles to be erected in the area. A biological monitor was present on site, along with archeological monitors and cultural monitors. According to the monitors nothing of significance had been found, although the archeological monitor had found some small stone flakes and the biological monitor had caught and removed an adult gopher snake from the work area.

Photo 10 – Vegetation clearing and BMP installation at TSP 43 location. Photo facing north.
12/01/22	SOCRE Project

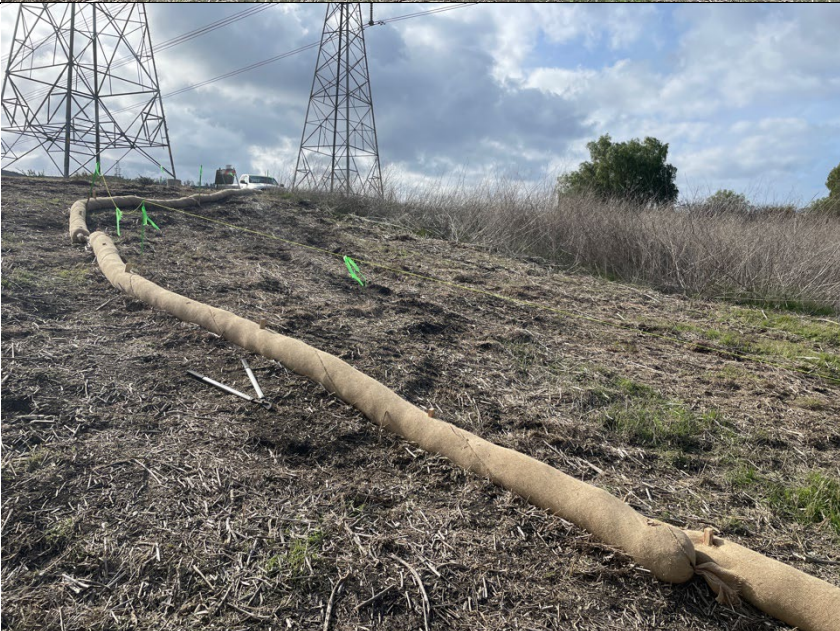
A small portion of weedy habitat was mowed outside of the approved work areas (Photo 11). This work had been reported and the area reflagged. The EI informed me that some thought was being given to improving the delineation of the work zones.

Photo 11 – Small area of vegetation clearing done outside of the approved work zones. Photo facing west.
