Re: Monthly Report Summary #63 for the South Orange County Reliability Enhancement (SOCRE) Project

South Orange County Reliability Enhancement Project CPUC Site Inspection Form

Project:	South Orange County Reliability Enhancement (SOCRE) Project	Date:	January 12, 2023
Project Proponent:	San Diego Gas & Electric (SDG&E)	Report #:	VS155
Lead Agency:	California Public Utilities Commission (CPUC)	Monitor(s):	CPUC/WSP Compliance Monitor
CPUC PM:	Louis Torres, Energy Division	AM/PM Weather:	Mostly cloudy, cool and calm
CPUC CM (WSP):	Fernando Guzman	Start/End time:	1200 – 1400 hrs
Project NTP(s):	Notice to Proceed (NTP)-1, NTP-2, NTP-2 Addendum 1, NTP-3, NTP-4, and NTP-5

Project:	South Orange County Reliability Enhancement (SOCRE) Project	Date:	January 24, 2023
Project Proponent:	San Diego Gas & Electric (SDG&E)	Report #:	VS156
Lead Agency:	California Public Utilities Commission (CPUC)	Monitor(s):	CPUC/WSP Compliance Monitor
CPUC PM:	Louis Torres, Energy Division	AM/PM Weather:	Clear & sunny, mild temps and a slight breeze
CPUC CM (WSP):	Fernando Guzman	Start/End time:	1230 – 1530 hrs
Project NTP(s):	Notice to Proceed (NTP)-1, NTP-2, NTP-2 Addendum 1, NTP-3, NTP-4, and NTP-5

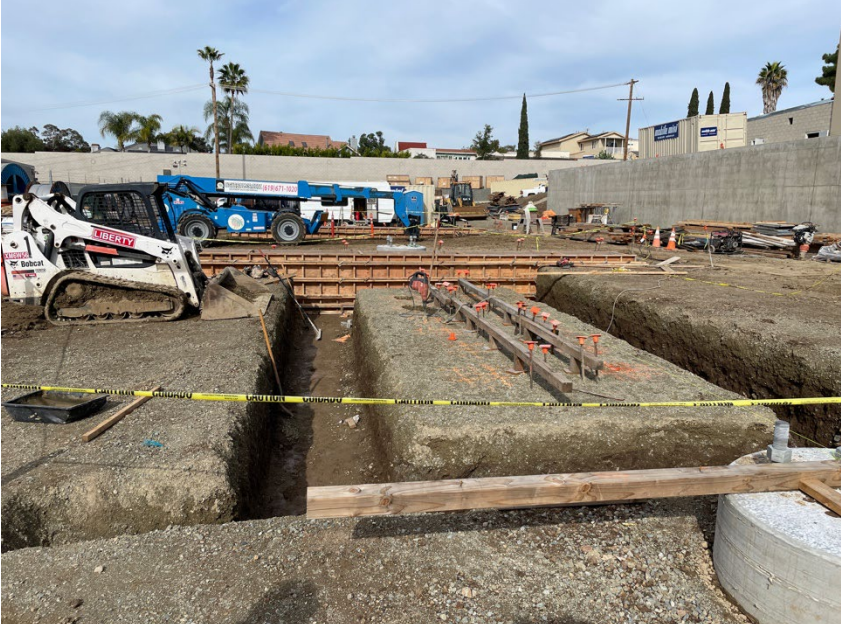
The location had received considerable rainfall in the weeks before my visit, which had limited work activities to areas inside the new substation and the control room until recently. A small window of dry weather allowed some crews to begin work again on the transformer foundations (Photo 1) and on the exterior of the substation (Photo 5).

Photo 1 – Work on the transformer foundations. Photo facing north.

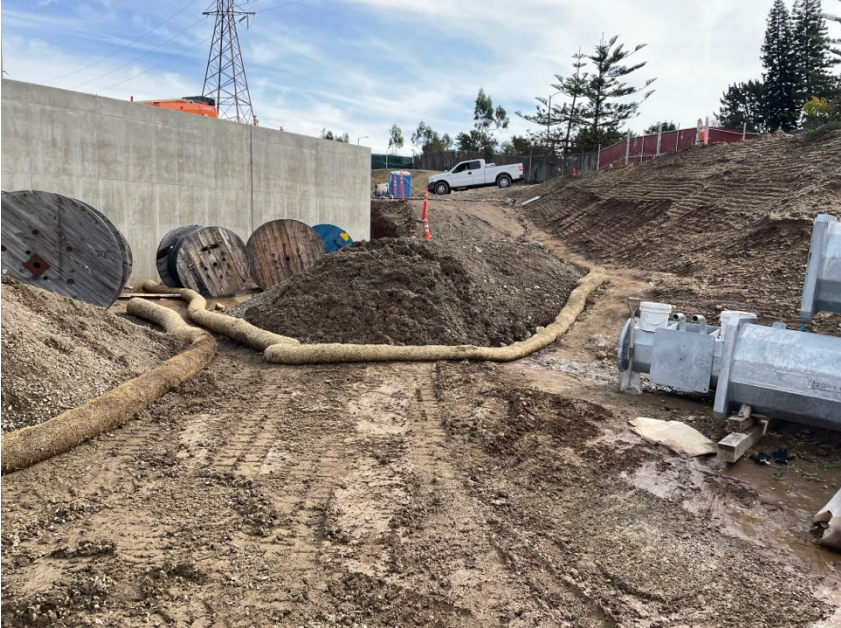
The site was still quite wet and muddy with best management practices (BMPs) still in place (Photos 2, 3, 4). Another set of storms was predicted, and the EI informed me that will be doing some additional grading and BMP installation to keep mud and stormwater runoff on site. I observed some very muddy tires (Photo 6) and the EI informed me that in addition to rumble plates workers will try to knock the mud out of the treads with hammers. Street sweepers were also operating along the public roadways outside of the project site.

Photo 2 – BMPs around soil stockpiles. Photo facing southeast.
1/12/23	SOCRE Project

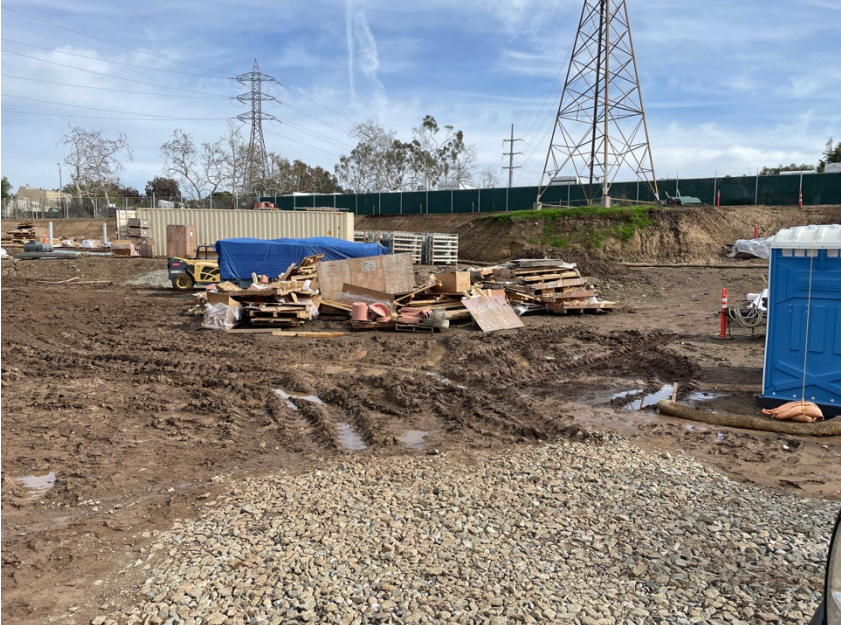
Photo 3 – Muddy conditions onsite. Photo facing east.

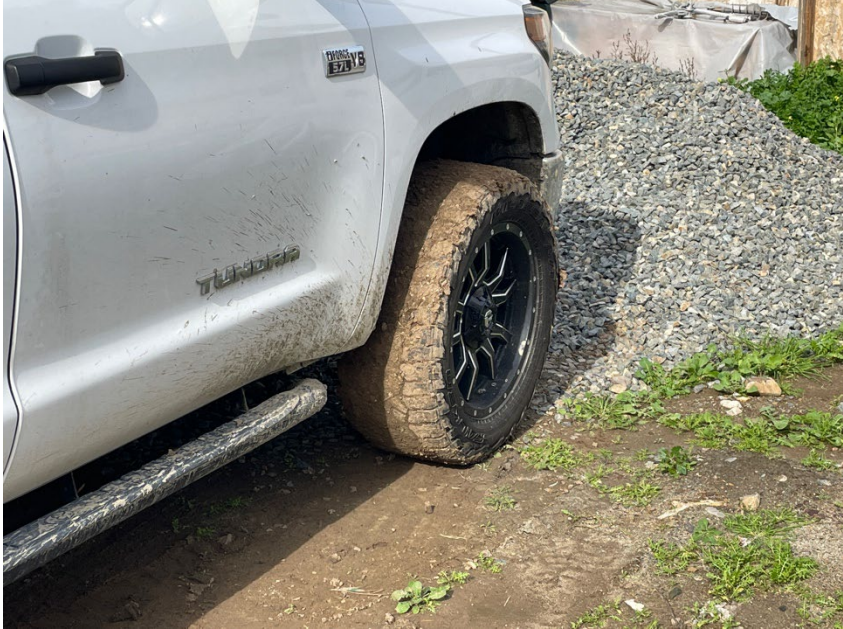
Photo 6 – Muddy tires noted on work vehicles within the substation.
1/12/23	SOCRE Project

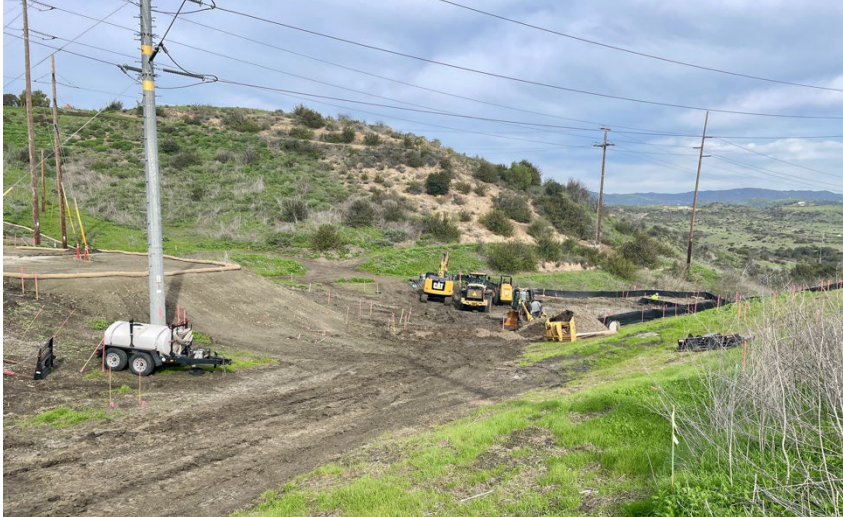
I departed the substation and drove to the Phase 2 transmission line installation near the Talega substation. Conditions had been too wet and muddy for crews to be working in this area, but a BMP crew was adding to the erosion control measures (Photos 7, 8, 9). Another small crew was installing sign posts with a power auger (Photo 10).

Photo 7 – BMP work within the cleared work areas for the Phase 2 tubular steel pole installation. Photo facing north.

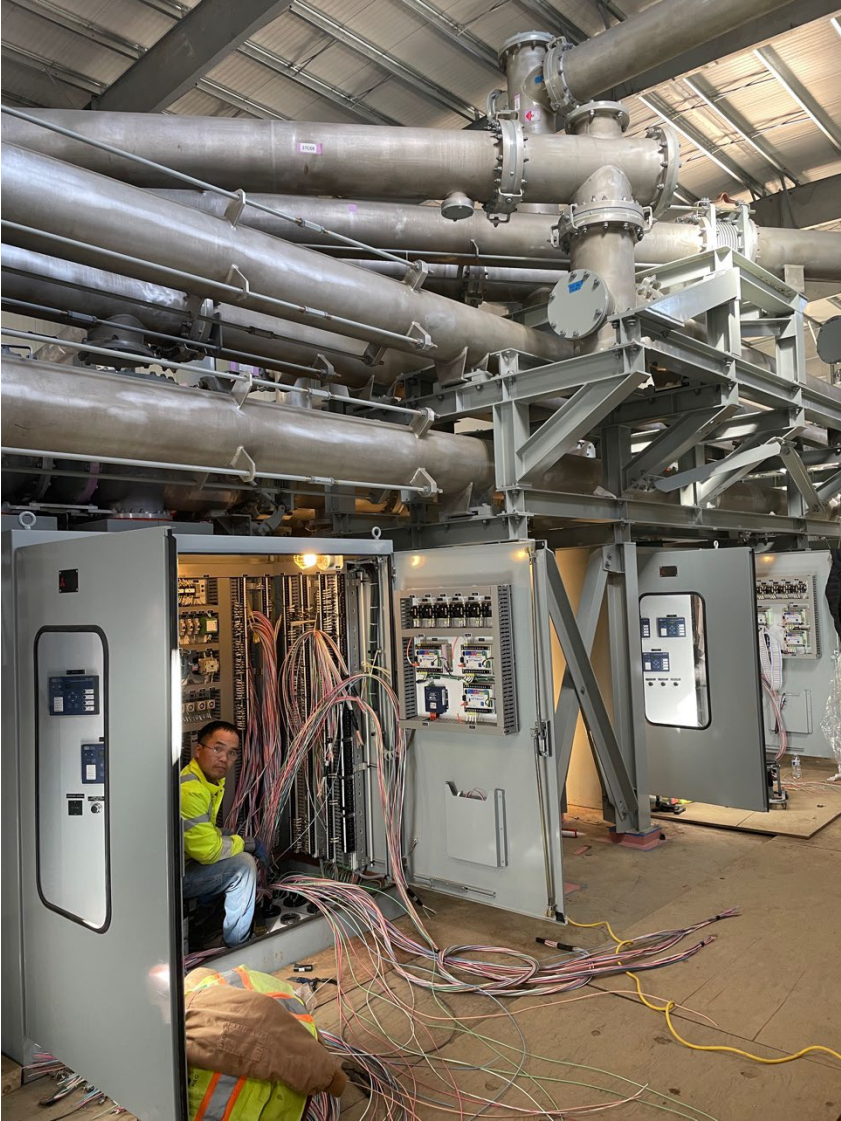
Wiring work continued within the new substation and in the adjacent control room (Photos 4 & 5). The EI informed me that there were six or seven different contractors on site with upwards of 50 total crew members. All crew members had all been given the environmental training.

Photo 4 – Wiring work inside the new substation.

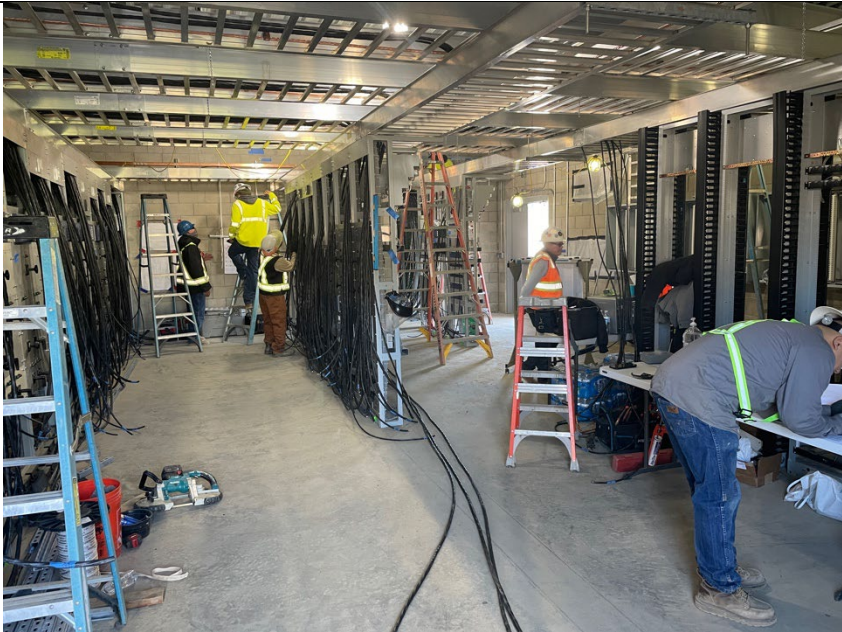
Photo 5 – Wiring work inside of the control room.
1/24/23	SOCRE Project

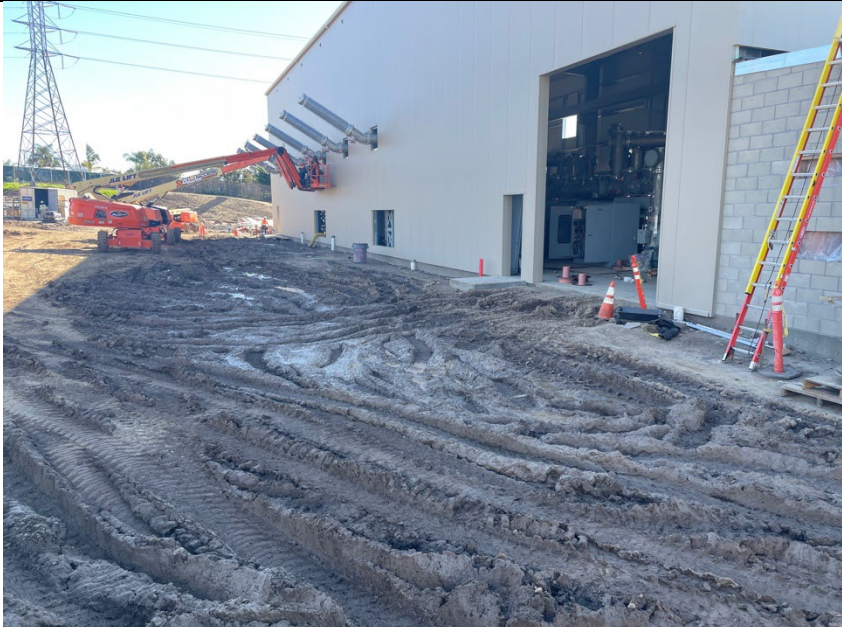
Work continued on the exterior of the new substation; however, this area on the north side of the substation was extremely muddy (Photo 6). BMPs remained around the soil stockpiles (Photo 7).

Photo 6 – work along the north side of the substation – note the very muddy conditions. Photo facing south.

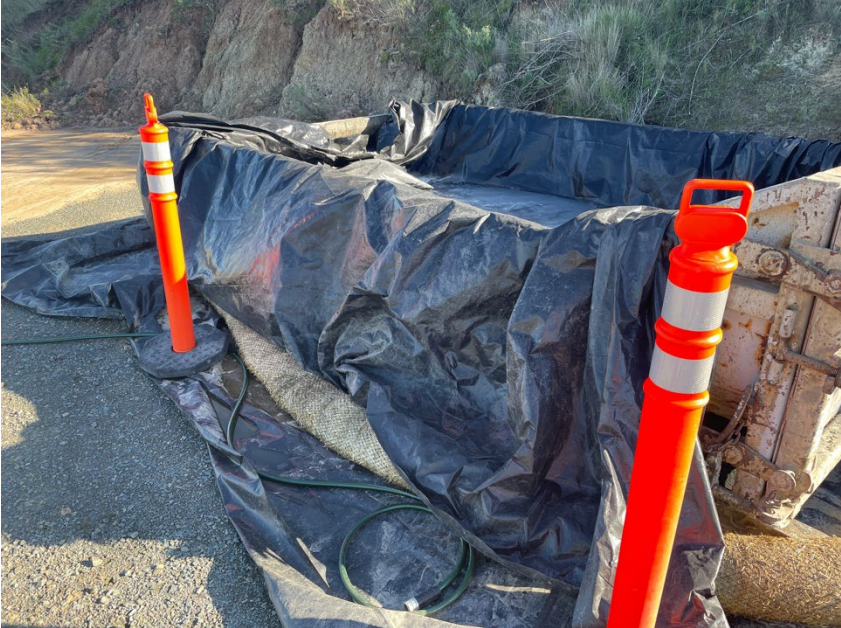
The LEI and I walked to the TSP 18A location where a crew was installing steel beams for a retaining wall (Photo 14). The crew had gone for the day and several problems were noted in and around the work area: the concrete washout bin looked to be collecting rainwater and it appeared that it was being drained off with a nearby hose (Photo 15); and none of the drilled holes had been adequately covered and sealed (Photo 16). This was both a safety issue and a violation of the environmental conditions of the project. The LEI called for one of the crews to address the problems. After I left the site I received a photo from the LEI showing that the holes around the beams had been sealed (Photo 17).

Photo 15 – Concrete washout bin for the TSP 18A work.
1/24/23	SOCRE Project – Phase 2

Check on erosion control measures, concrete washout bins and covering holes.

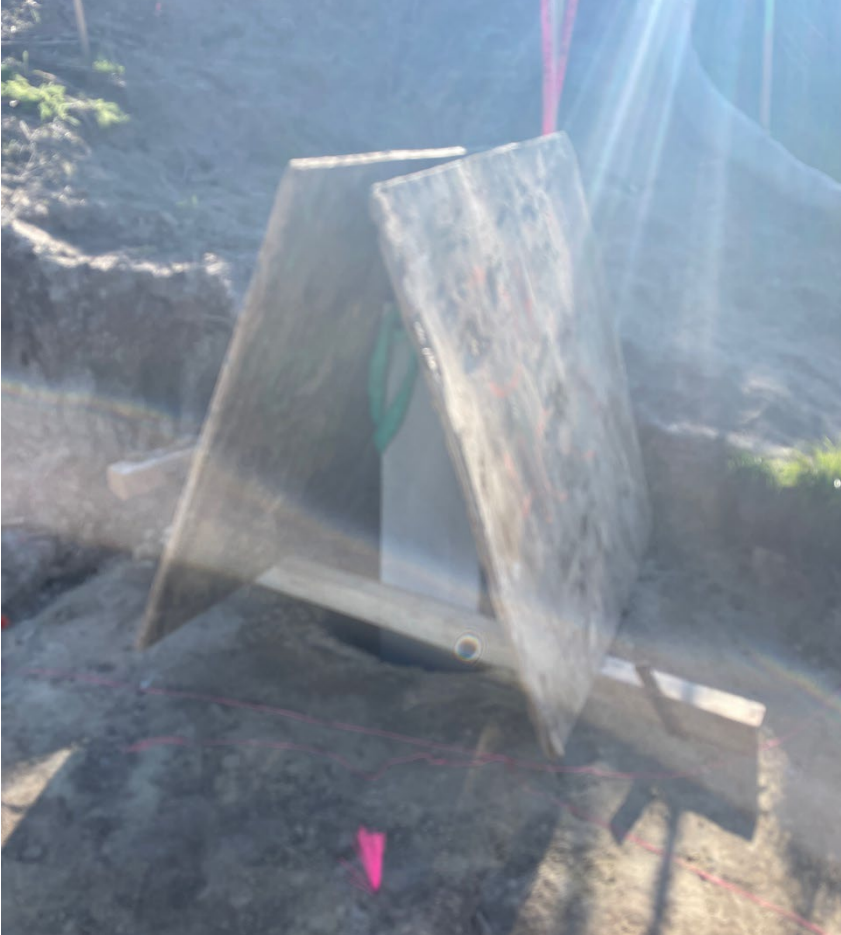
Photo 16 – Installed H beam at the TSP 18A without adequate coverage of the drilled hole.

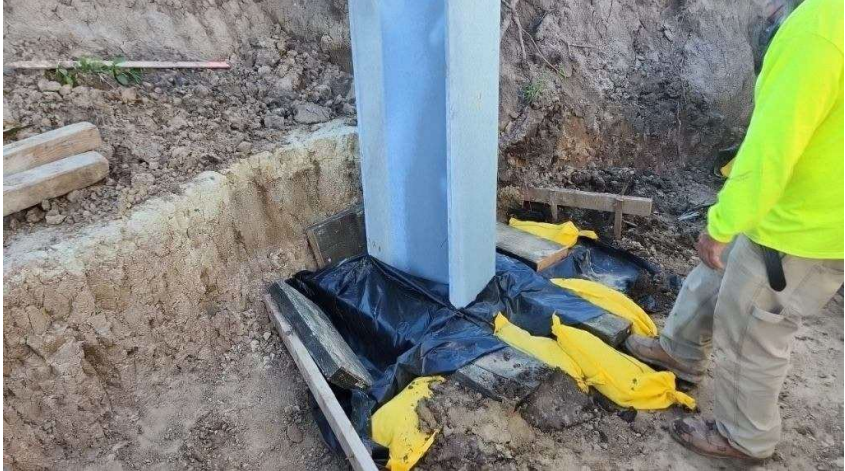
Photo 17 – Crews covering the holes at TSP 18A.
