Re: Monthly Report Summary #64 for the South Orange County Reliability Enhancement (SOCRE) Project

South Orange County Reliability Enhancement Project CPUC Site Inspection Form

Project:	South Orange County Reliability Enhancement (SOCRE) Project	Date:	February 28, 2023
Project Proponent:	San Diego Gas & Electric (SDG&E)	Report #:	VS158
Lead Agency:	California Public Utilities Commission (CPUC)	Monitor(s):	CPUC/WSP Compliance Monitor
CPUC PM:	Louis Torres, Energy Division	AM/PM Weather:	Partly cloudy, cool and breezy
CPUC CM (WSP):	Fernando Guzman	Start/End time:	1345 – 1500 hrs
Project NTP(s):	Notice to Proceed (NTP)-1, NTP-2, NTP-2 Addendum 1, NTP-3, NTP-4, NTP-5, NTP-6, NTP-6 Addendum 1, and NTP-7

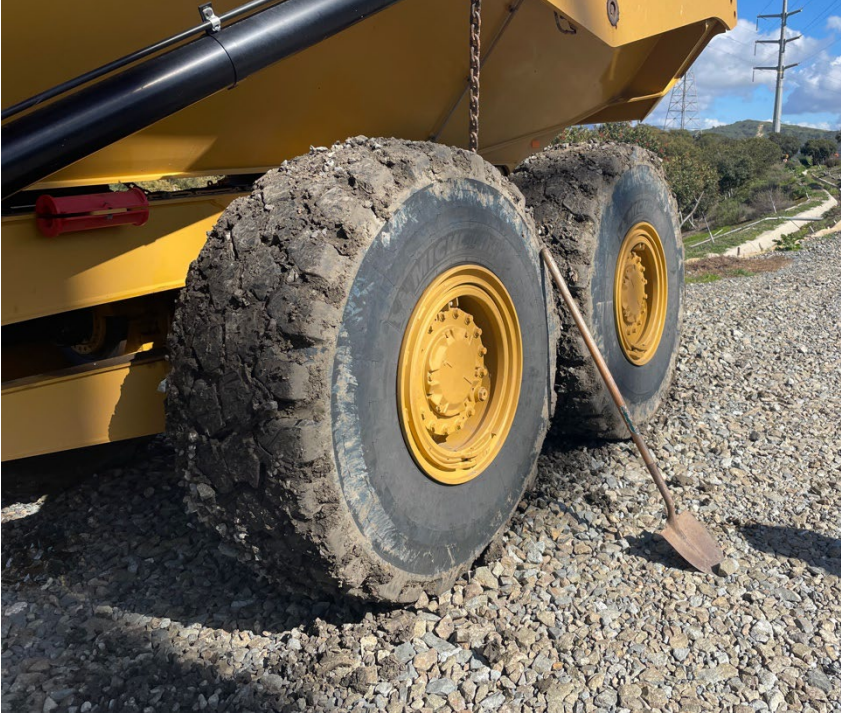
No work was underway at the Phase II area, although crews had delivered additional equipment and materials to the site. Rumble plates and gravel were in place at the access road entrances (Photo 6), but the wet clay soil was difficult to remove from the vehicle and equipment tires (Photo 7). Some additional gravel on the access road would help with the track out issue.

REPRESENTATIVE SITE PHOTOGRAPHS			
Date	Location	Photo	Description
2/28/23	SOCRE Project – Phase 2

Photo 7 – Sticky clay soils are difficult to remove from the tire treads. Photo facing east.
2/28/23	SOCRE Project – Phase 2

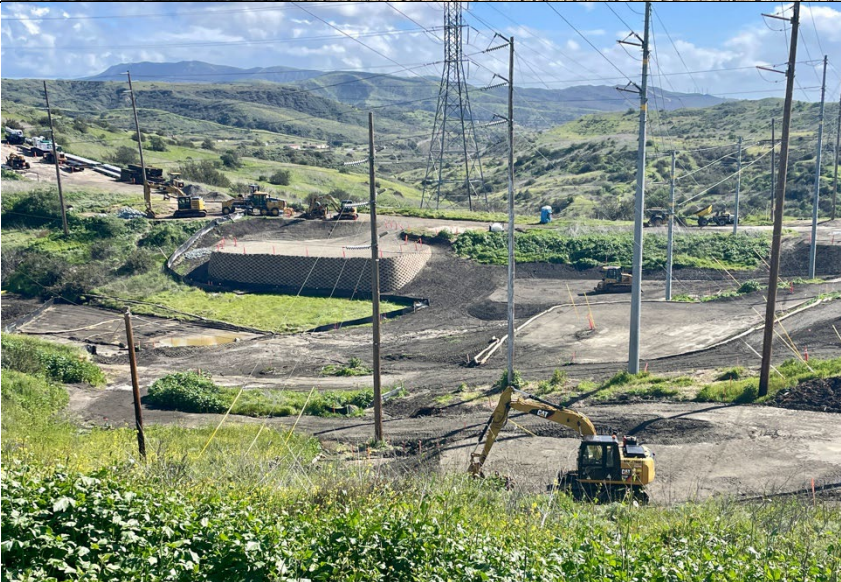
Some upgrades to the BMPs had been recently completed (Photos 8, 9, and 10). The BMPs seemed to be keeping sediment from leaving the project areas. However, there were numerous locations where additional straw wattles would help slow the rainwater runoff and prevent rilling (Photo 11).

Photo 8 – Overview of the main Phase II work area. Photo facing south.

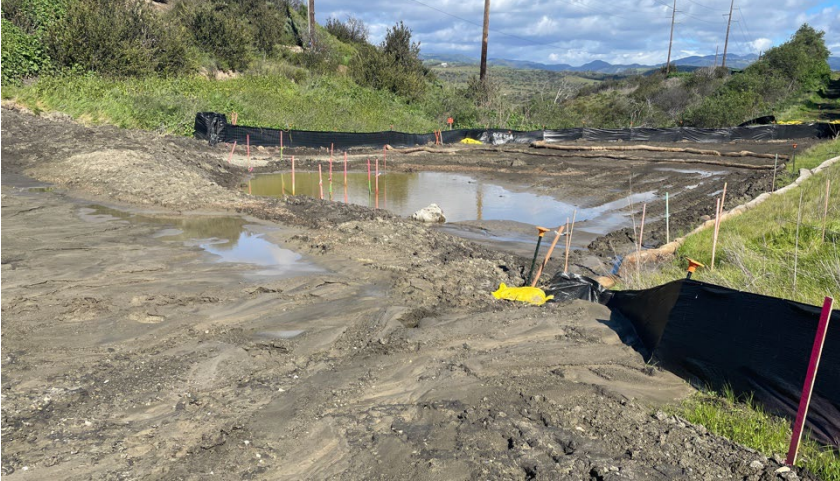
Photo 9 – BMPs within the drainage. Photo facing east.
2/28/23	SOCRE Project – Phase 2

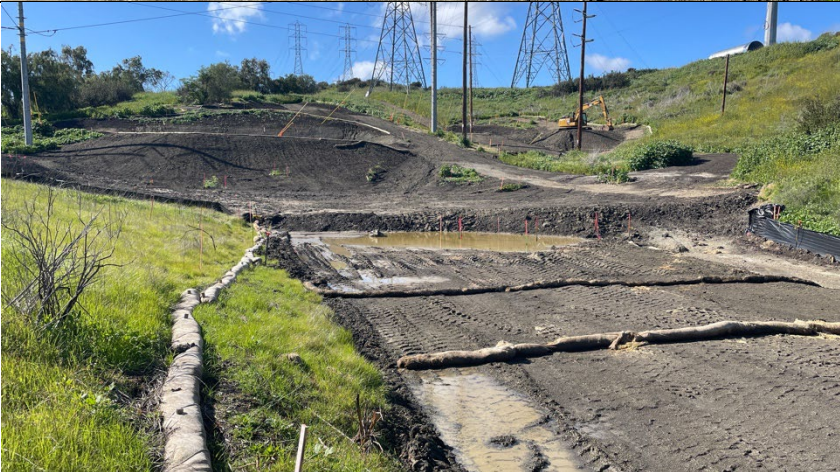
Photo 10 – BMPs within the drainage. Photo facing west.
2/28/23	SOCRE Project – Phase 2

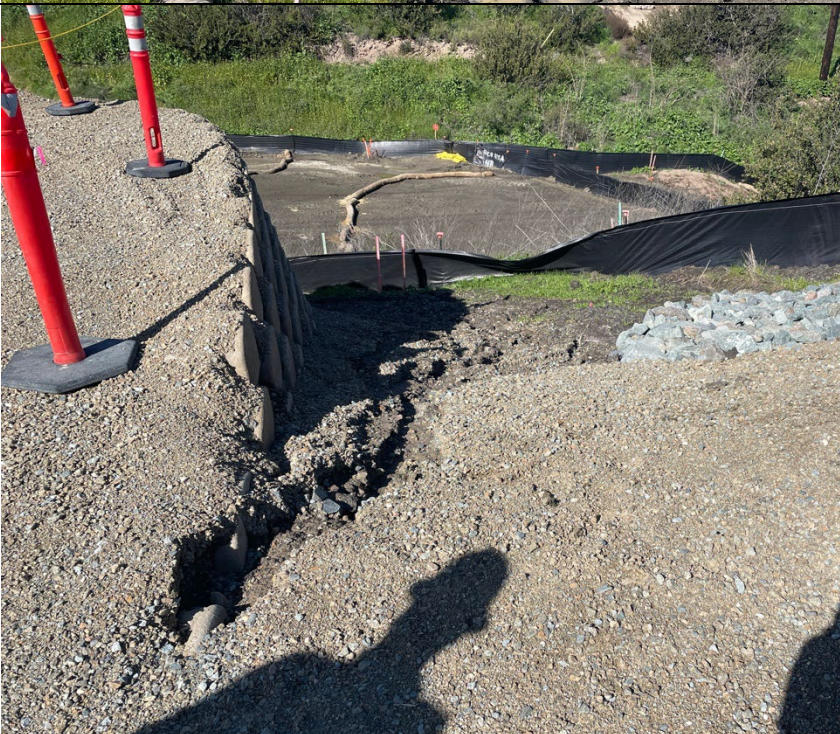
Photo 11 – Rilling off of one of the tower pads – some extra wattles would be helpful here. Photo facing north.

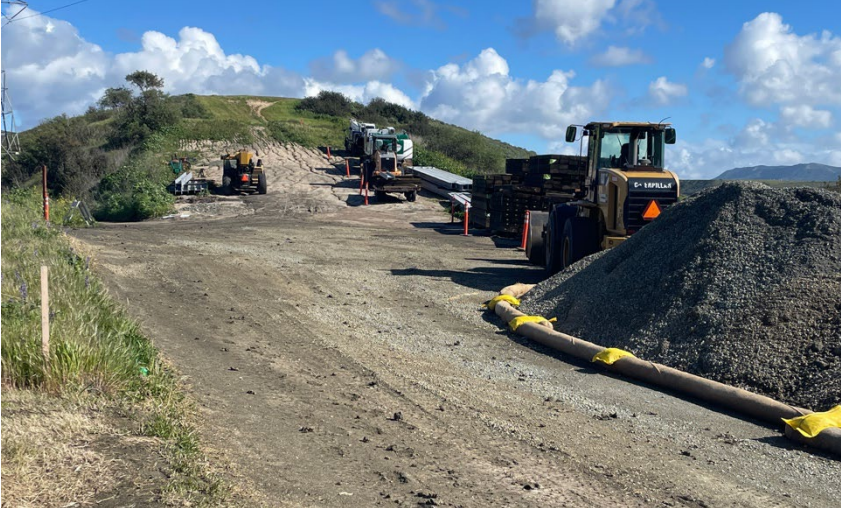
Large quantities of equipment and materials were being staged along the access roads and within the cleared fire breaks (Photo 12).

Photo 12 – Staging materials and equipment along a cleared fire break. Photo facing east.
2/28/23	SOCRE Project – Phase 2

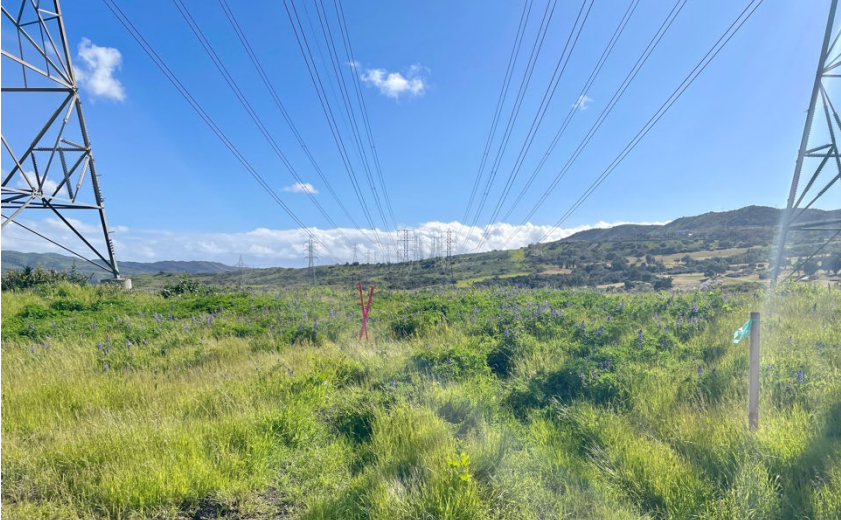
I briefly examined the area proposed for a staging area (Photo 13). It was a fairly level area between two lattice work towers that was vegetated with annual grasses and lupine.

Photo 13 – Proposed staging area near the Phase II work area. Photo facing south.
