Re: Monthly Report Summary #65 for the South Orange County Reliability Enhancement (SOCRE) Project

CPUC Site Inspection Reports

South Orange County Reliability Enhancement Project CPUC Site Inspection Form

Project:	South Orange County Reliability Enhancement (SOCRE) Project	Date:	March 22, 2023
Project Proponent:	San Diego Gas & Electric (SDG&E)	Report #:	VS159
Lead Agency:	California Public Utilities Commission (CPUC)	Monitor(s):	CPUC/WSP Compliance Monitor
CPUC PM:	Louis Torres, Energy Division	AM/PM Weather:	Overcast, cool and breezy following recent rains
CPUC CM (WSP):	Fernando Guzman	Start/End time:	1300 – 1600 hrs
Project NTP(s):	Notice to Proceed (NTP)-1, NTP-2, NTP-2 Addendum 1, NTP-3, NTP-4, and NTP-5

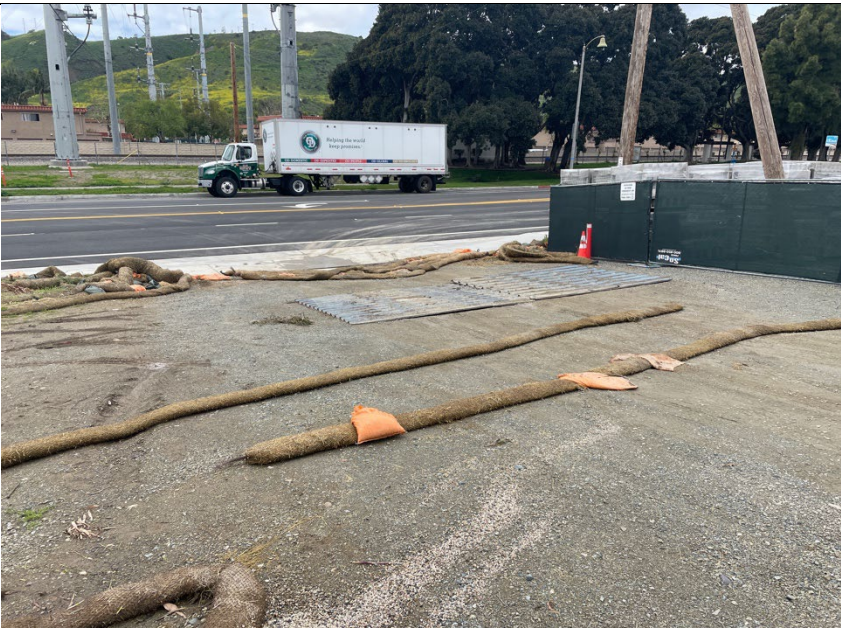
The exit/entry best management practices (BMPs) appeared to be in good condition (Photo 1), and street sweepers were operating in the public roadway.

Photo 1 – Exit/Entry BMPs remain in place and are functioning. Photo facing west.

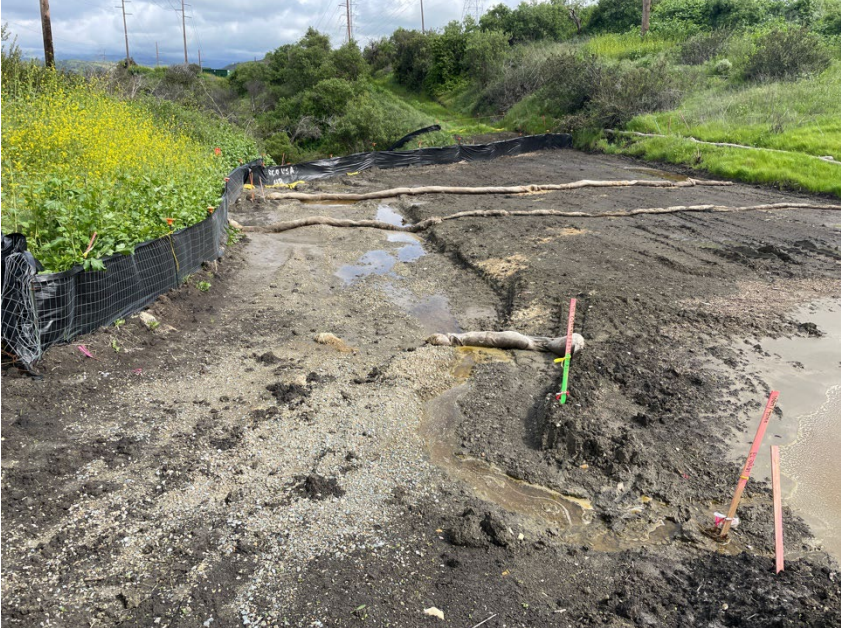
Crews were waiting for the Phase II area to dry out before beginning work again (Photo 5). Some BMP upgrades had been completed, but the large amount of rain had overwhelmed most of the BMPs (Photos 6 & 7). A new straw wattle placed along the edge of a tower pad helped stop a rill from enlarging (Photo 8). I discussed some additional BMPs with the EI; however, the muddy site conditions made accessing and working in the area difficult.

Photo 6 – BMPs within the drainage. Photo facing east.
3/23/23	SOCRE Project – Phase 2

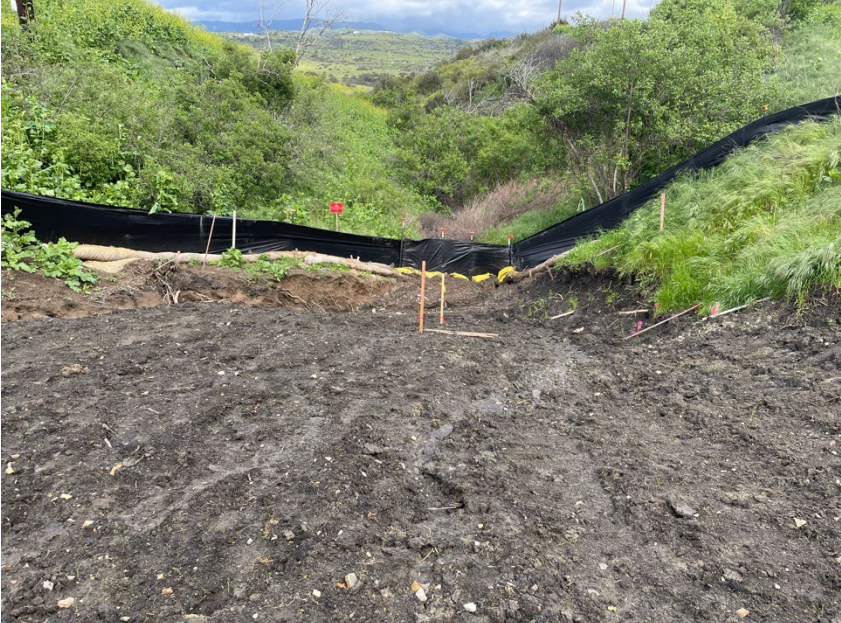
Photo 7 – BMPs within the drainage. Photo facing east.

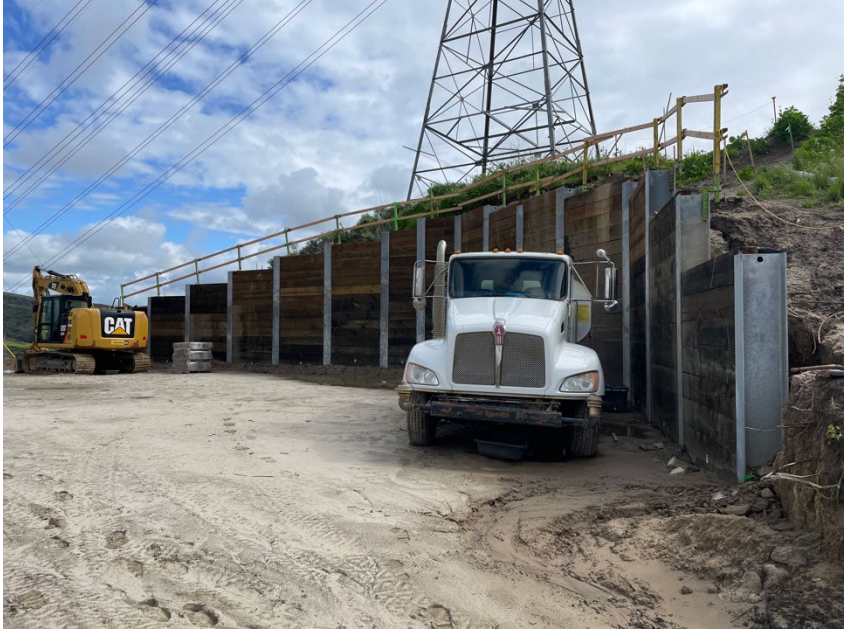
Equipment remained parked at the 18A tower site; all equipment had drip pans underneath (Photo 10).

Photo 10 – Parked equipment at the 18A TSP site. Photo facing south.
