Re: Monthly Report Summary #67 for the South Orange County Reliability Enhancement (SOCRE) Project

CPUC Site Inspection Reports

South Orange County Reliability Enhancement Project CPUC Site Inspection Form

Project:	South Orange County Reliability Enhancement (SOCRE) Project	Date:	May 3, 2023
Project Proponent:	San Diego Gas & Electric (SDG&E)	Report #:	VS162
Lead Agency:	California Public Utilities Commission (CPUC)	Monitor(s):	CPUC/WSP Compliance Monitor
CPUC PM:	Andrew Chan, Energy Division	AM/PM Weather:	Partly cloudy, mild temps and a slight breeze
CPUC CM (WSP):	Fernando Guzman	Start/End time:	1200 – 1500 hrs
Project NTP(s):	Notice to Proceed (NTP)-1, NTP-2, NTP-2 Addendum 1, NTP-3, NTP-4, and NTP-5

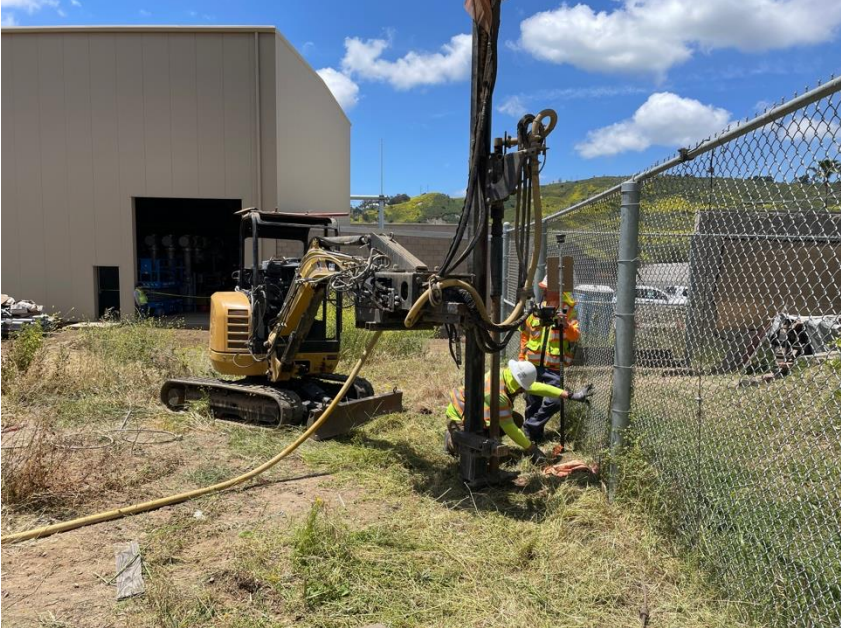
Installation of the infrastructure continued east of the substation (Photo 5). Grounding rod installation was being performed along the northeastern fence line (Photo 6), and cable was being laid out in preparation for being pulled through conduit (Photo 7).

Photo 6 – Work along the northern boundary fence. Photo facing west.
5/03/23	SOCRE Project

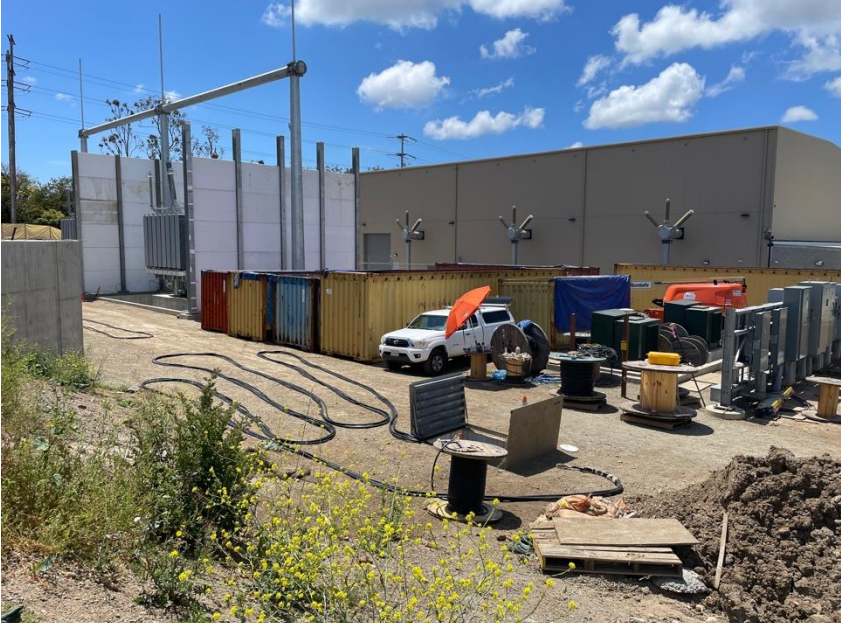
Photo 7 – Cable laid out in preparation for pulling through conduit. Photo facing southwest.

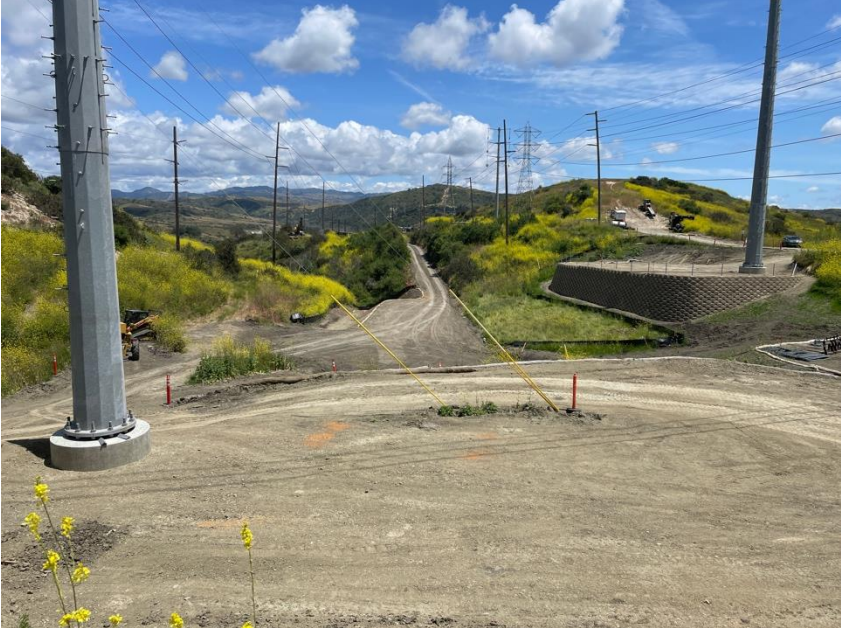
Much of the Phase II site had been cleaned up, with old BMPs removed and some restoration completed (Photo 8). The Lead Environmental Inspector (LEI) and I walked the site and discussed the possible rain event and BMP needs.

Photo 8 – Overview of some of the Phase II work area. Photo facing east.
5/03/23	SOCRE Project – Phase 2	 	Photo 9 – The foundation hole for TSP 50 is now ready to be poured. Photo facing east.

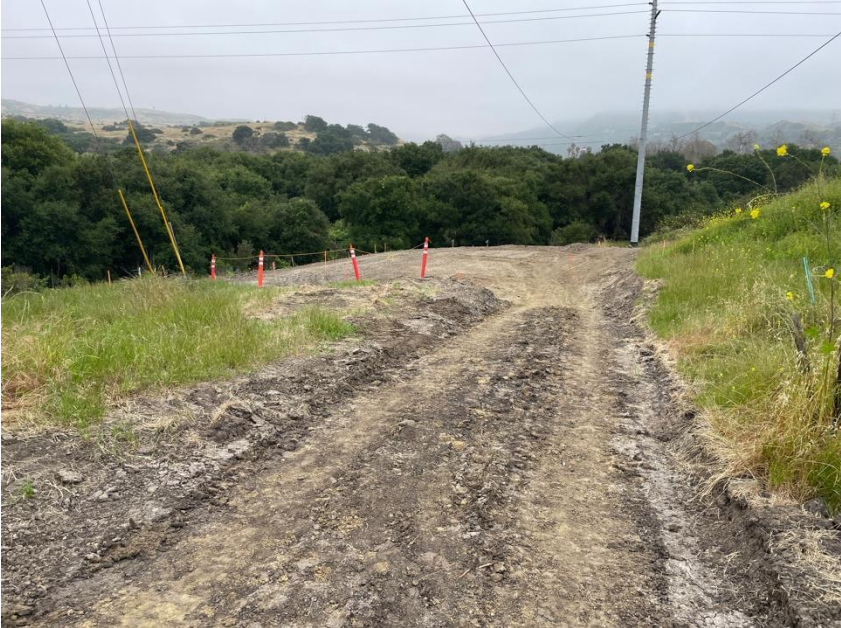
I proceeded to the TSP 47 site at the Phase II portion of the project (Photo 7). No work had occurred there since my last site visit. AT&T crews were working near the Talega substation, and I was informed by the Lead Environmental Inspector (LEI) that they were moving communication cables (Photo 8).

Photo 7 – The TSP 47 site. No work is underway. Photo facing east.
5/18/23	SOCRE Project – Phase 2

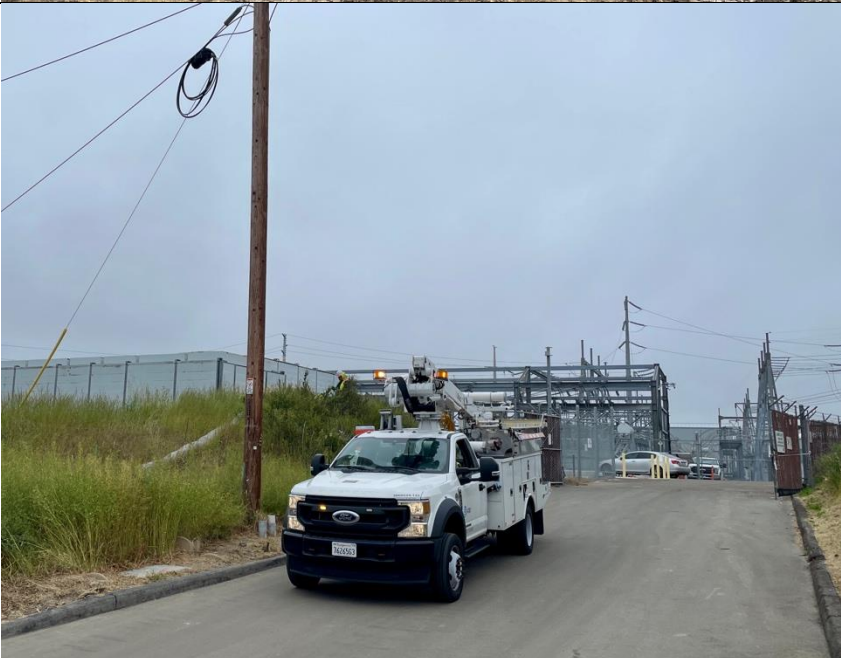
Photo 8 – AT&T crews are on site. Photo facing south.

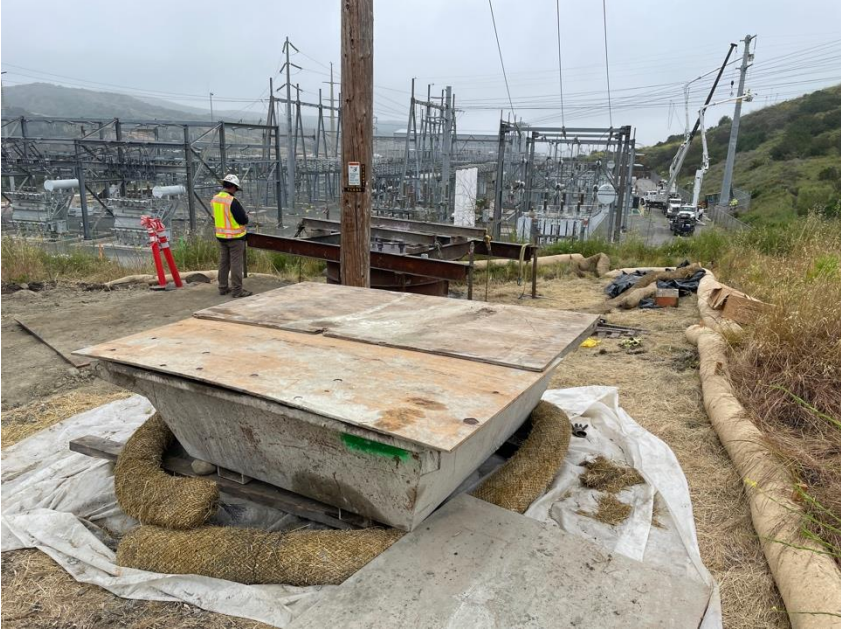
The foundation for TSP 7B had been poured the day before my site visit (Photo 11). The concrete washout bin remained on site and was well contained.

<p>Photo 11 – The foundation for TSP 7B was poured the previous day. Note the concrete washout bin is well contained. Photo facing south.</p>
5/18/23	SOCRE Project – Phase 2

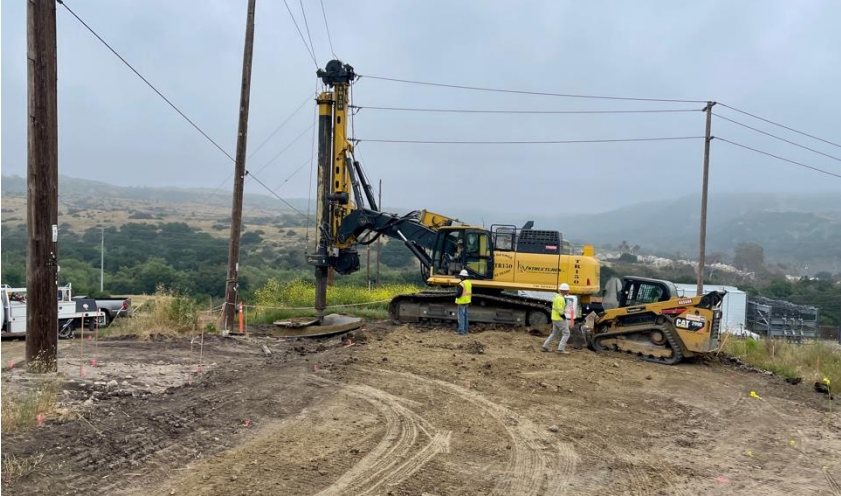
The drilling crew was working on the foundation hole for TSP 46 (Photo 12). The work was being monitored by a biologist and a paleontologist. The paleontological monitor was also checking the drilling for the 60-foot tie-back rods that were being installed through the retaining wall at TSP 45 (Photo 13).

<p>Photo 12 – The foundation hole is being drilled for TSP 46. A paleontological monitor was onsite. Photo facing northeast.</p>
