**Re: Monthly Report Summary #68 for the South Orange County Reliability Enhancement (SOCRE) Project**

CPUC Site Inspection Reports

## South Orange County Reliability Enhancement Project CPUC Site Inspection Form

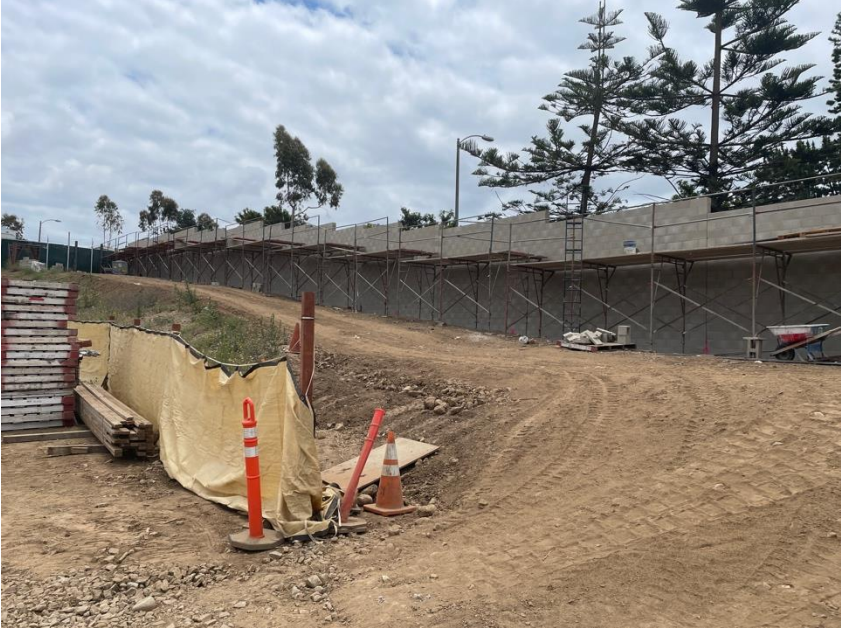
The sound walls were nearly complete along the southern boundary (Photo 2), and along the northern boundary (Photo 5). The mortar mixing station remained onsite and appeared to be well contained (Photo 6). Fencing along the eastern boundary had been erected (Photo 4).

| REPRESENTATIVE SITE PHOTOGRAPHS | | | |
|---|---|---|--|
| 6/07/23 | SOCRE Project | | Photo 2 – Work on the southern sound wall. Photo facing south. |

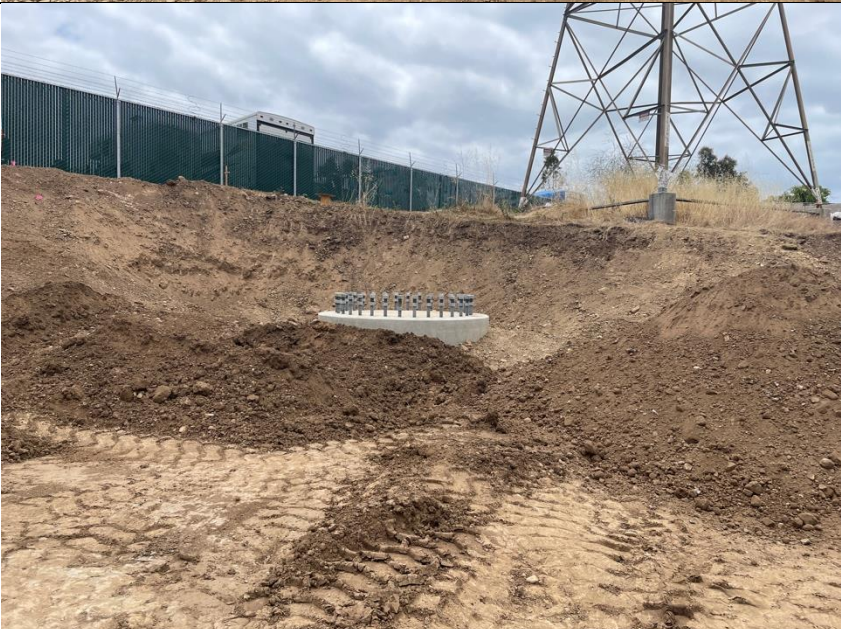
The EI said that they expect two large tubular steel poles (TSPs) to be erected soon. Grading around the foundations was underway (Photo 3).

| REPRESENTATIVE SITE PHOTOGRAPHS | | | |
|---|---|---|--|
| 6/07/23 | SOCRE Project | | Photo 3 – Grading around the completed TSP foundation. Photo facing southeast. |

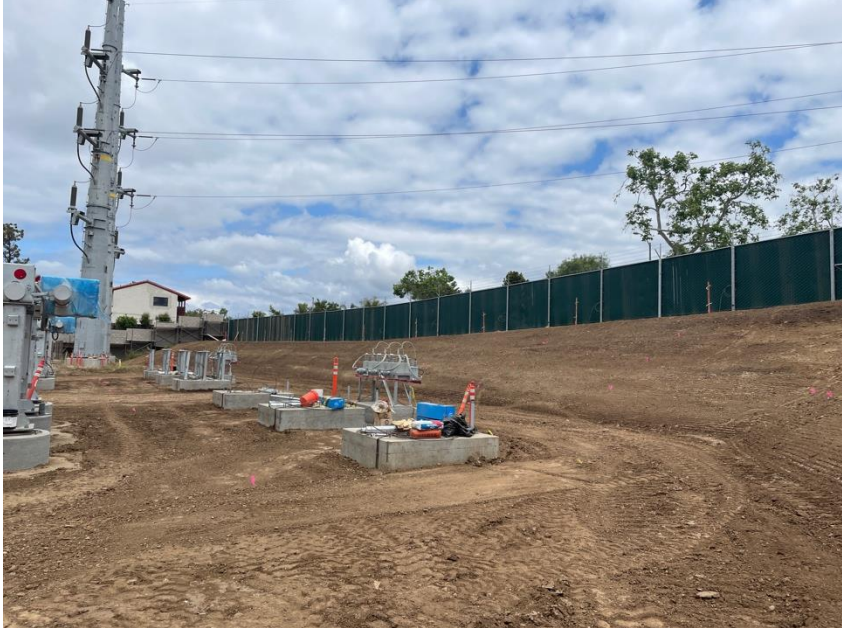
| REPRESENTATIVE SITE PHOTOGRAPHS | | | |
|---|---|---|--|
| 6/07/23 | SOCRE Project | | Photo 4 – Final grade and the newly installed boundary fence along the eastern border. Photo facing northeast. |

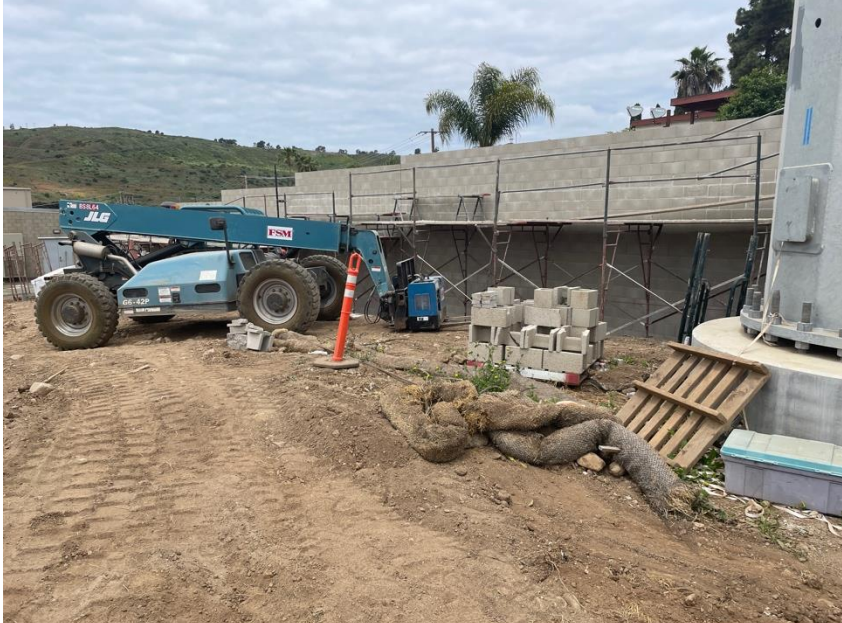
| REPRESENTATIVE SITE PHOTOGRAPHS | | | |
|---|---|---|--|
| 6/07/23 | SOCRE Project | | Photo 5 –Work on the northern boundary fence/sound wall. Photo facing northwest. |

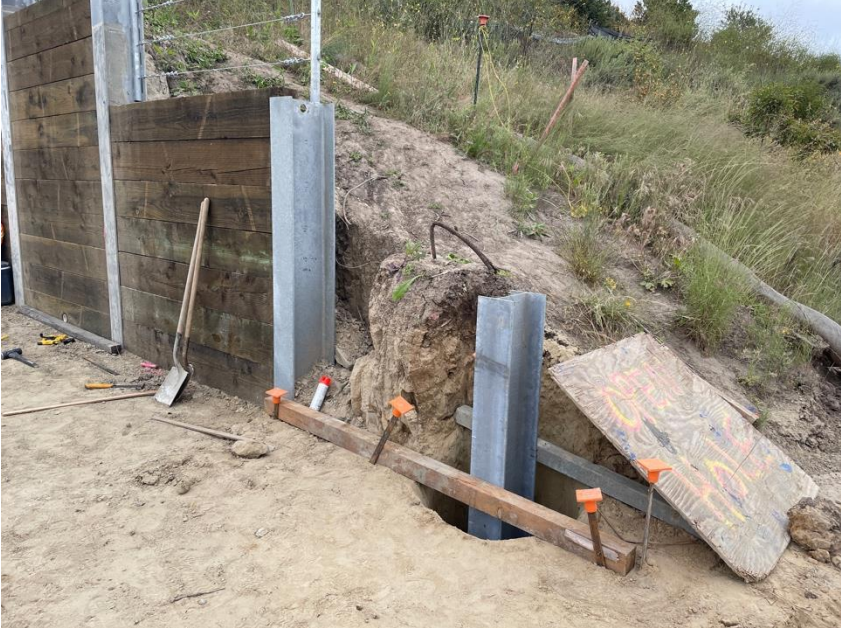
At the TSP 18 tower pad an additional retaining beam had been placed with the other beams (Photo 10). A concrete truck was observed travelling to TSP 18 to pour the beam hole. Additional earthwork was scheduled for this area.

| REPRESENTATIVE SITE PHOTOGRAPHS | | | |
|---|---|---|--|
| 6/07/23 | SOCRE Project – Phase 2 | | Photo 10 – An additional beam added to the wall at TSP 18. Photo facing southwest. |

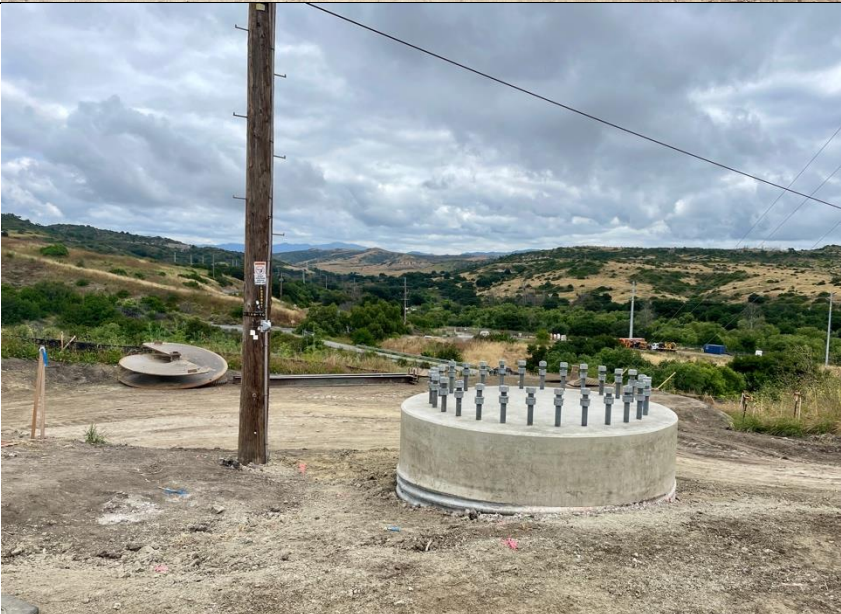
The foundation at TSP 46 had been poured (Photo 11).

| REPRESENTATIVE SITE PHOTOGRAPHS | | | |
|---|---|---|--|
| 6/07/23 | SOCRE Project – Phase 2 | | Photo 11 – The foundation for TSP 46 was completed. Photo facing north. |

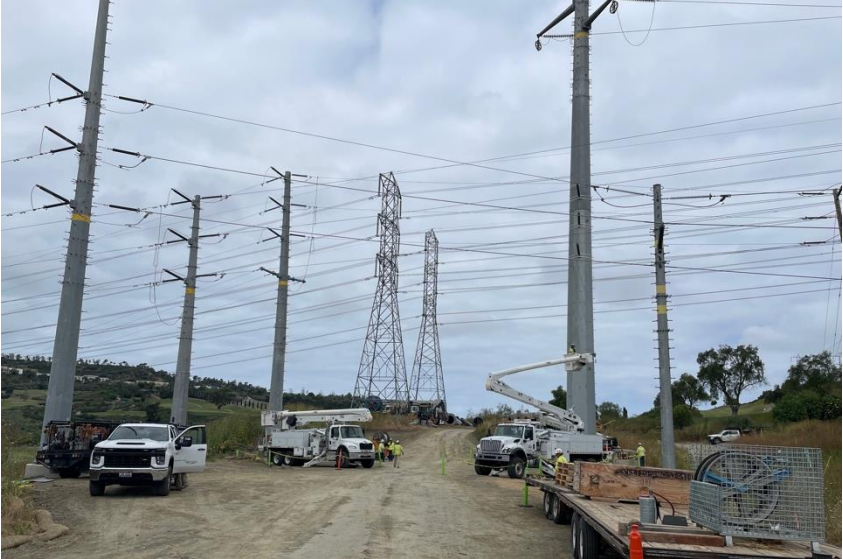
Wire stringing crews were working in the western portion of the work area, including up in TSP 43 (Photos 15 and 16). There were numerous vehicles and equipment onsite, and they were using the newly approved staging area.

| REPRESENTATIVE SITE PHOTOGRAPHS | | | |
|---|---|---|---|
| 6/07/23 | SOCRE Project – Phase 2 | | Photo 15 – Wire stringing crews. Photo facing west. |

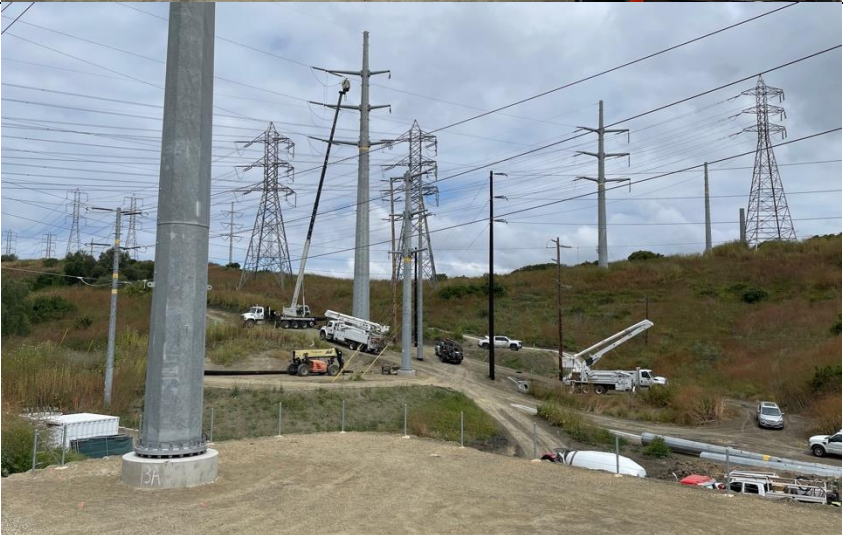
| REPRESENTATIVE SITE PHOTOGRAPHS | | | |
|---|---|---|---|
| 6/07/23 | SOCRE Project – Phase 2 | | Photo 16 –Wire stringing activity. Photo facing west. |

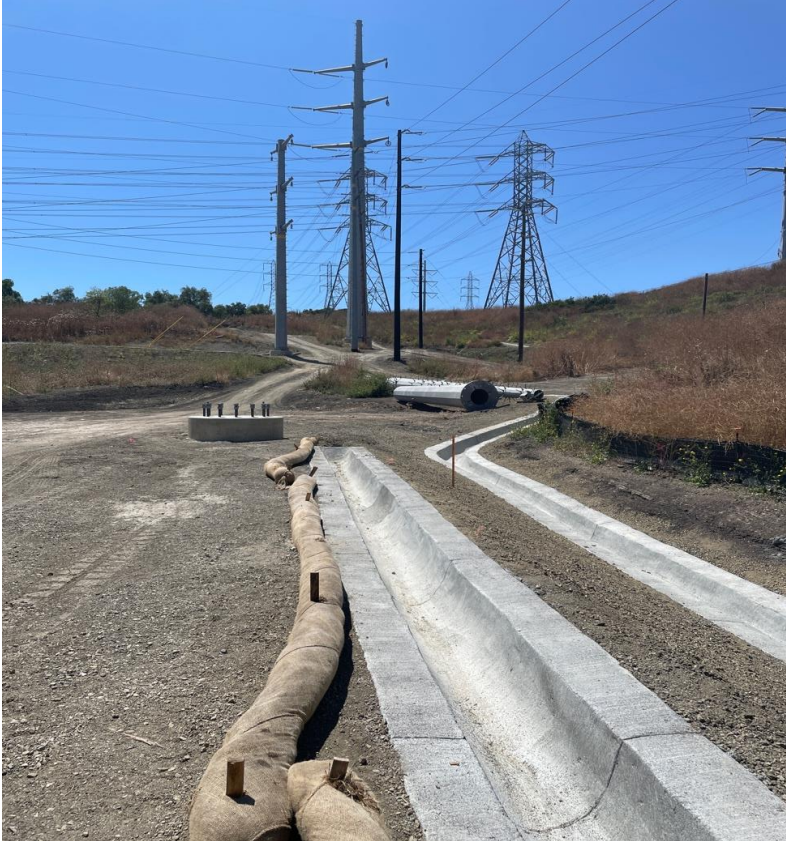
| REPRESENTATIVE SITE PHOTOGRAPHS | | | |
|---|---|--|--|
| 6/28/23 | SOCRE Project – Phase 2 | | Photo 14 – Drainage ditches and TSPs to be installed. Photo facing west. |

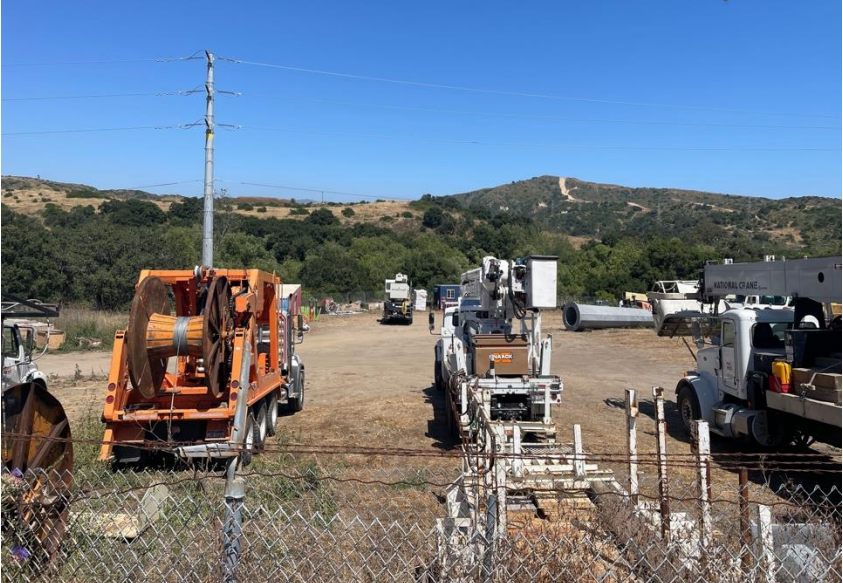
| REPRESENTATIVE SITE PHOTOGRAPHS | | | |
|---|---|--|--|
| 6/28/23 | SOCRE Project – Phase 2 | | Photo 15 – Staging area north of the Talega substation. Photo facing east. |
