Re: Monthly Report Summary #69 for the South Orange County Reliability Enhancement (SOCRE) Project

South Orange County Reliability Enhancement Project CPUC Site Inspection Form

Project:	South Orange County Reliability Enhancement (SOCRE) Project	Date:	July 20, 2023
Project Proponent:	San Diego Gas & Electric (SDG&E)	Report #:	VS166
Lead Agency:	California Public Utilities Commission (CPUC)	Monitor(s):	CPUC/WSP Compliance Monitor
CPUC PM:	Andrew Chan, Energy Division	AM/PM Weather:	Sunny, warm, and breezy
CPUC CM (WSP):	Fernando Guzman	Start/End time:	1000 to 1300
Project NTP(s):	Notice to Proceed (NTP)-1, NTP-2, NTP-2 Addendum 1, NTP-3, NTP-4, NTP-5, NTP-6, and NTP-7

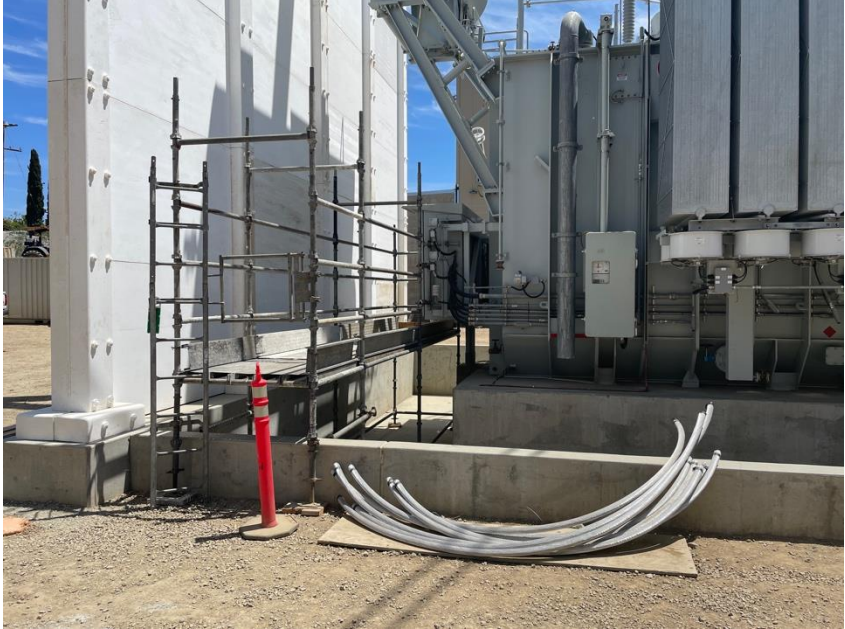
Construction activity continued around the transformers (Photo 4).

Photo 4 – Work around the transformers. Photo facing east.
7/20/23	SOCRE Project - Phase 2

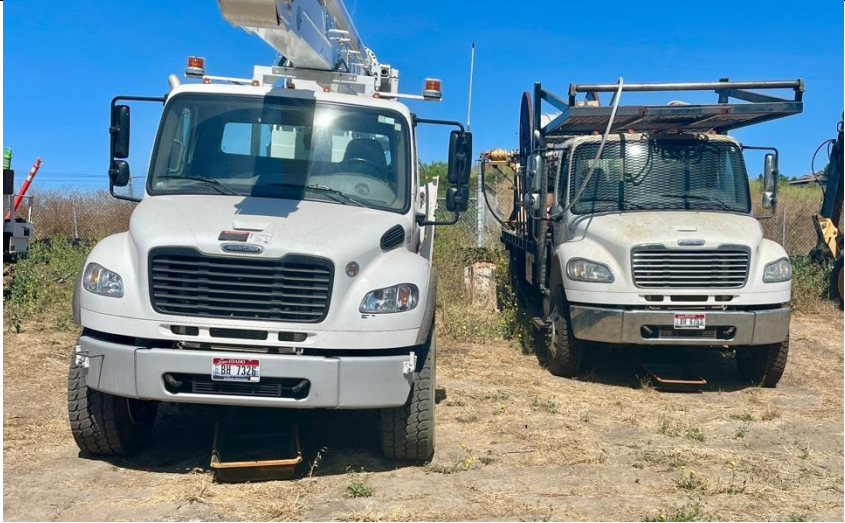
I walked through the staging area at the end of the road, inspecting the silt fencing and drip pans (Photo 5). The area was well maintained; however, the site was dusty with several inches of dust present within the staging area access road (Photo 6).

Photo 5 – Secondary containment present under equipment parked in the staging area north of Talega substation. Photo facing west.

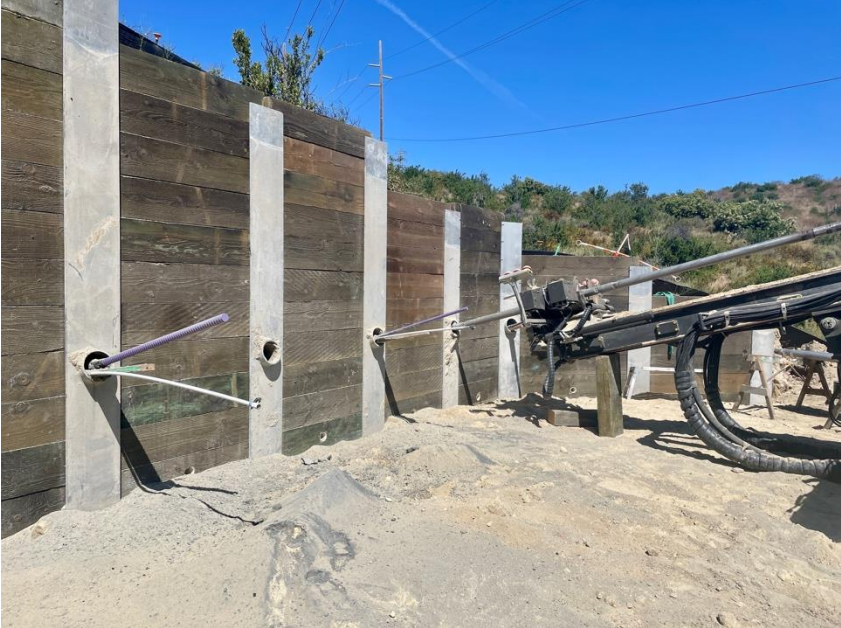
At the TSP 45 tower pad a crew was working on tie-backs that stabilized the retaining wall (Photos 9 and 10). The area around the cement mixing equipment remained well contained.

Photo 10 – Tie-back work at Location 45. Photo facing west.
7/20/23	SOCRE Project – Phase 2	 	Photo 11 – Water truck watering the access road. Photo facing northeast.

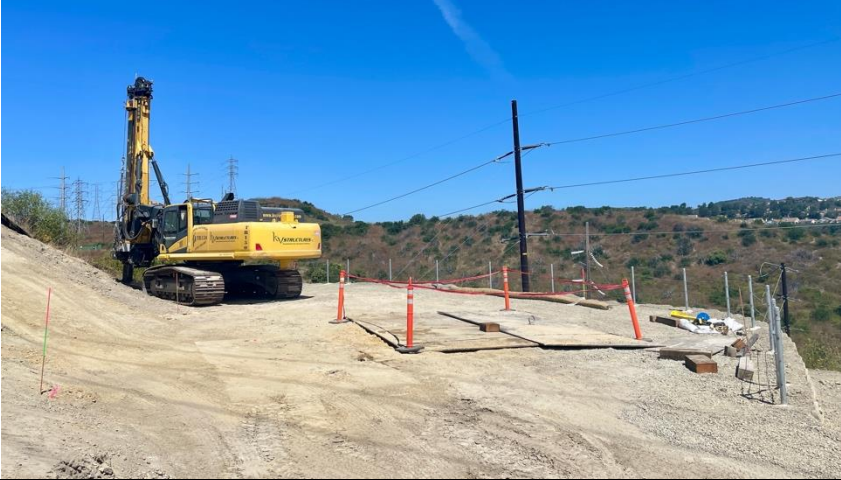
The foundation hole at Location 6B was drilled and partially poured. The hole had been covered (Photo 12).

Photo 12 – New foundation hole drilled at Location 6B. Photo facing west.
7/20/23	SOCRE Project – Phase 2

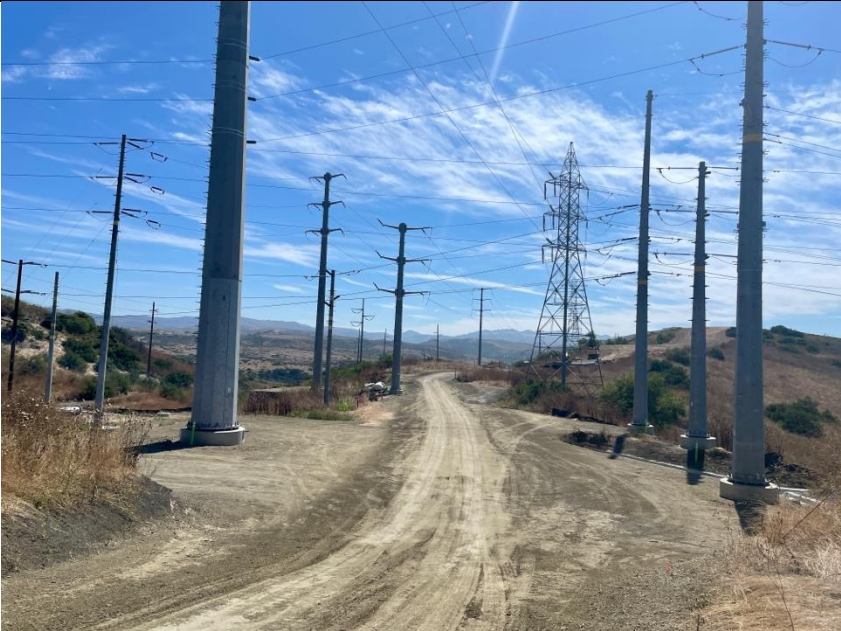
No work was being completed at the west end of Phase II and the equipment had been relocated (Photo 13). The additional staging area was cleared of equipment with only a TSP segment remaining (Photo 14).

Photo 13 – New TSPs at the western portion of Phase II work. Photo facing west.

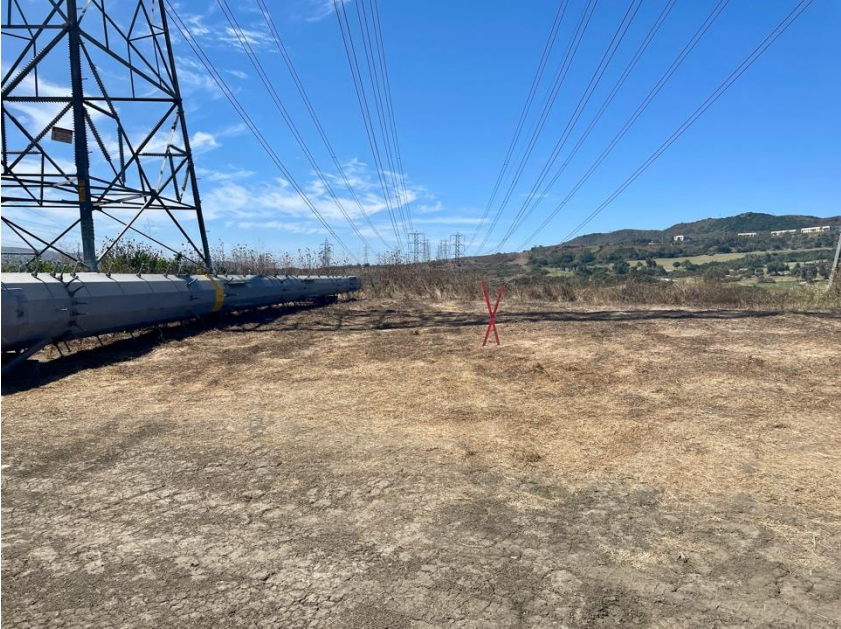
Photo 14 – Staging area was mostly cleared out. Photo facing south.
7/20/23	SOCRE Project – Phase 2

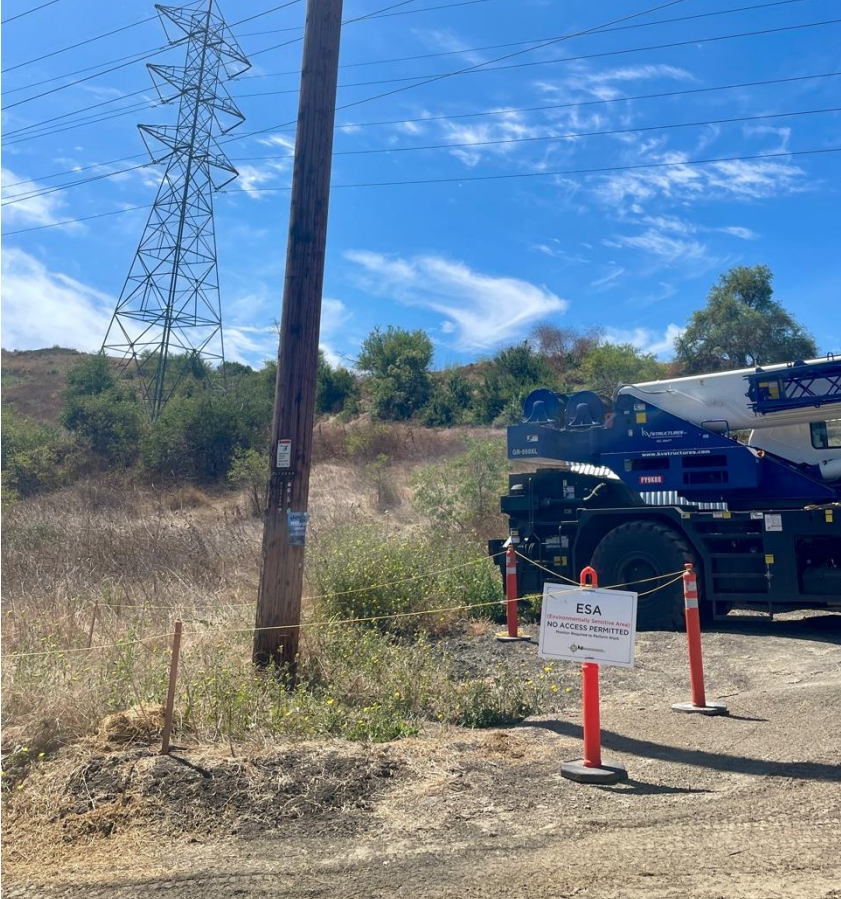
One active House Finch (*Haemorhous mexicanus*) nest was inspected with a buffer in place around the pole. Any work around this pole was monitored by a project biologist (Photo 15).

Photo 15 – Nesting bird buffer. Photo facing south.
