Re: Monthly Report Summary #71 for the South Orange County Reliability Enhancement (SOCRE) Project

CPUC Site Inspection Reports

South Orange County Reliability Enhancement Project CPUC Site Inspection Form

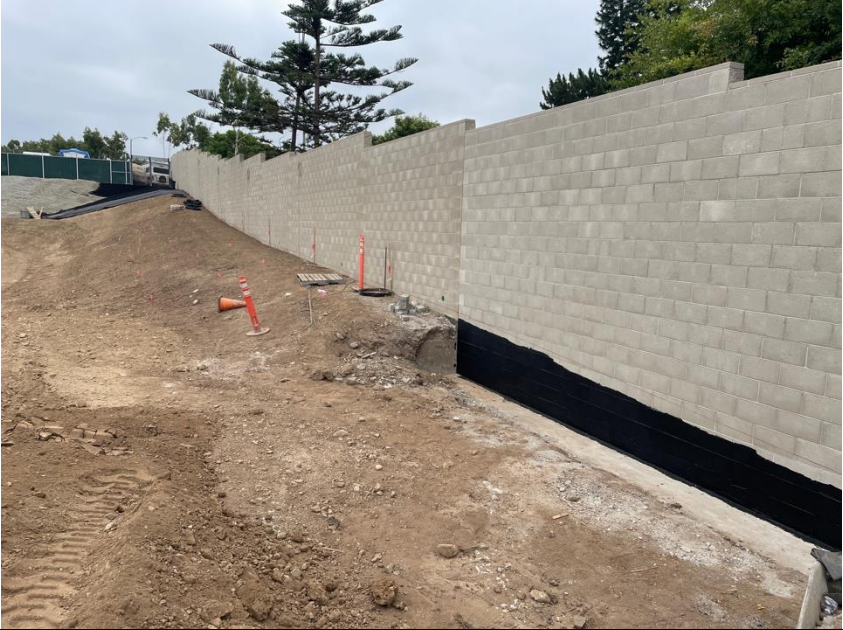
The remaining portions of the sound wall barrier were completed along the southern portion of the site (Photos 1 and 2).

Photo 2 – The sound barrier wall was completed along the southern side of the project site. Photo facing southeast.
9/28/23	SOCRE Project

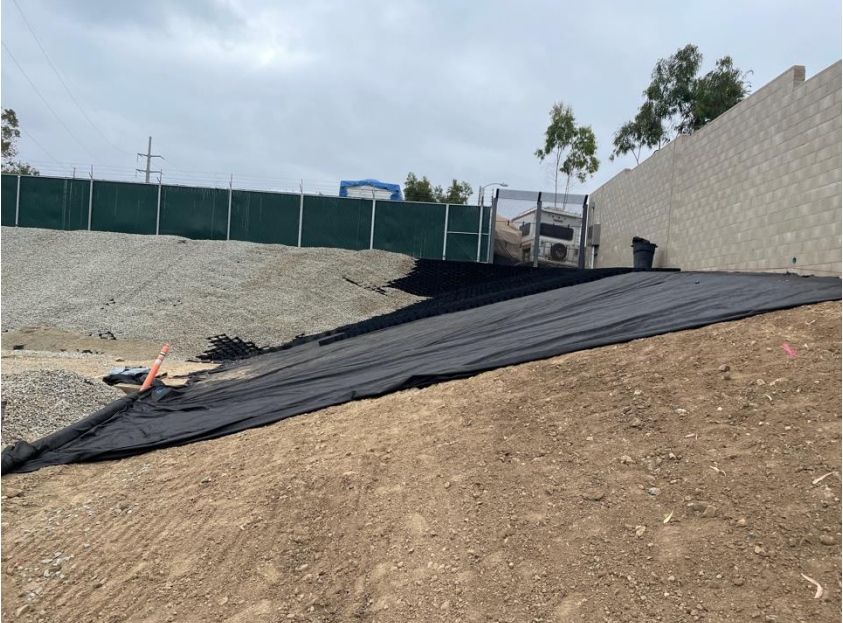
Work continued on slope stabilization with the installation of filter fabric, geoweb, and gravel (Photo 3).

Photo 3 – Filter fabric, GeoWeb and gravel were being installed on the sloping portions of the site. Photo facing east.
