Re: Monthly Report Summary #72 for the South Orange County Reliability Enhancement (SOCRE) Project

CPUC Site Inspection Reports

South Orange County Reliability Enhancement Project CPUC Site Inspection Form

Project:	South Orange County Reliability Enhancement (SOCRE) Project	Date:	October 19, 2023
Project Proponent:	San Diego Gas & Electric (SDG&E)	Report #:	VS170
Lead Agency:	California Public Utilities Commission (CPUC)	Monitor(s):	CPUC/WSP Compliance Monitor
CPUC PM:	Andrew Chan, Energy Division	AM/PM Weather:	Sunny, warm, and calm
CPUC CM (WSP):	Fernando Guzman	Start/End time:	1130 to 1315
Project NTP(s):	Notice to Proceed (NTP)-1, NTP-2, NTP-2 Addendum 1, NTP-3, NTP-4, NTP-5, NTP-6, and NTP-7

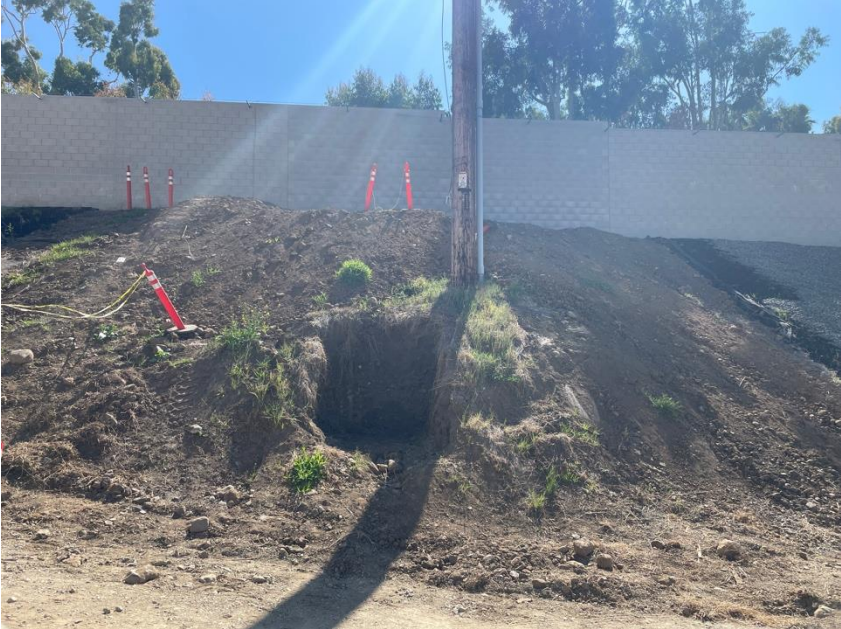
A small portion of the southern earthen wall on site remained incomplete, awaiting installation of the final tubular steel pole (TSP) (Photo 1).

Photo 1 – A portion of the southern earthen wall awaiting stabilization. Photo facing south.

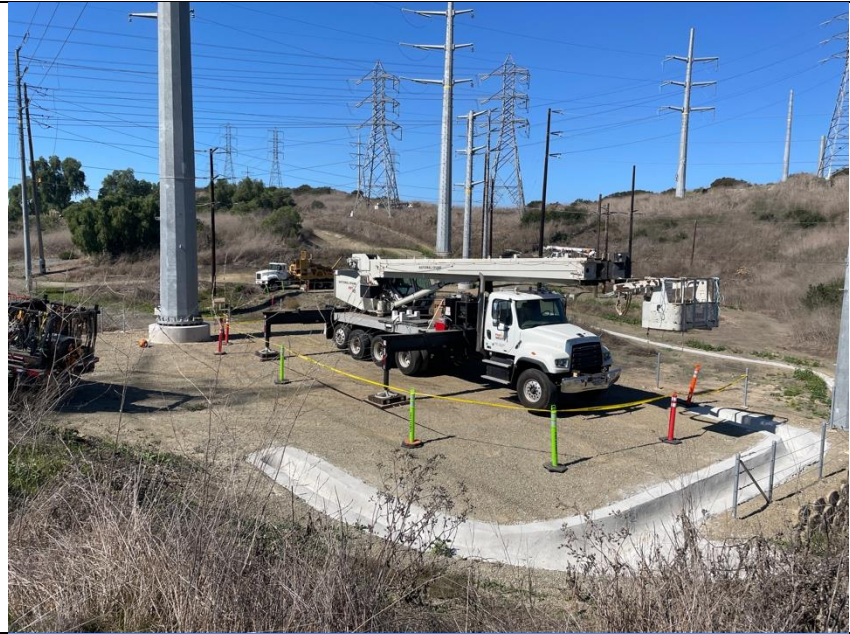
Photo 6 – Equipment at the Phase II work area preparing to pull wire. Photo facing northwest.
10/19/23	SOCRE Project – Phase II

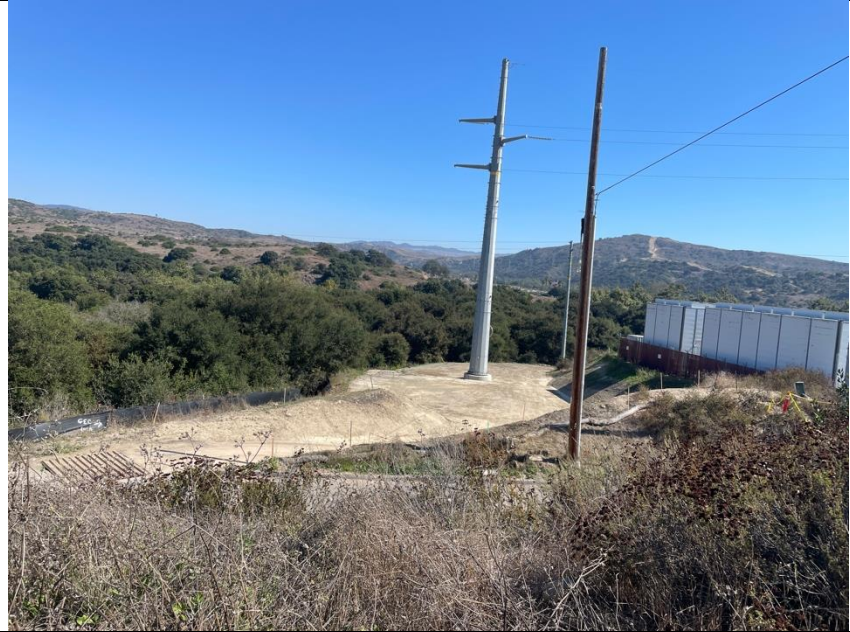
I drove to the Phase II work area as crews were preparing to pull wire. I met with the Lead Environmental Inspector (LEI) and we drove around the site. Many pieces of equipment were present onsite (Photos 5 and 6). The LEI stated that a biologist sweeps the project area prior to work beginning in the morning. No animals have been observed. I observed the TSP 47 pad site and access road (Photo 7).

Photo 7 – TSP 47. Photo facing east.
