Re: Monthly Report Summary #73 for the South Orange County Reliability Enhancement (SOCRE) Project

CPUC Site Inspection Reports

South Orange County Reliability Enhancement Project CPUC Site Inspection Form

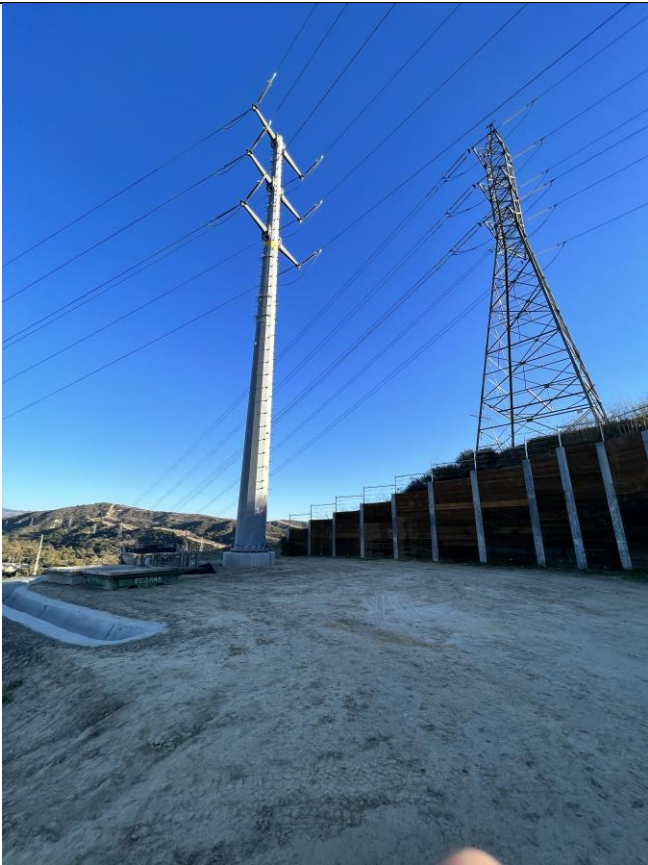
We drove throughout the Phase II work areas and stopped to inspect the v-ditch and retaining wall built near tubular steel pole (TSP) 45 (Photo 1).

Photo 1 – Slope and drainage protection near TSP 45. Photo facing northwest.
11/28/23	SOCRE Project – Phase II

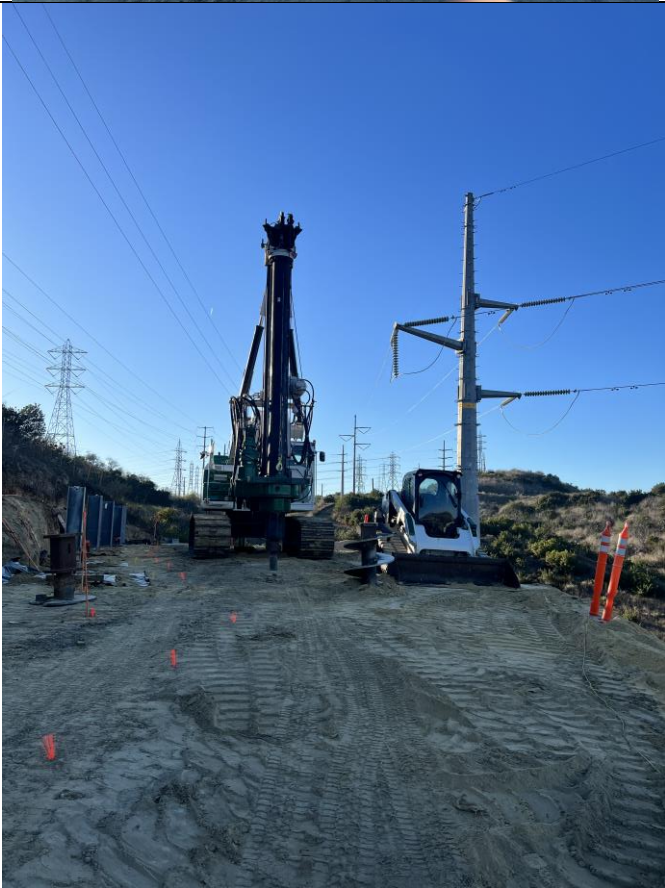
The construction crews had completed work for the day and the equipment used for the tower pad installation was inactive and staged within the work area boundaries. The staged equipment had drip pans underneath as a secondary containment measure for potential leaks (Photos 2 and 3).

Photo 2 – Tower pad installation work was underway, as well as slope stabilization. Photo facing northwest.

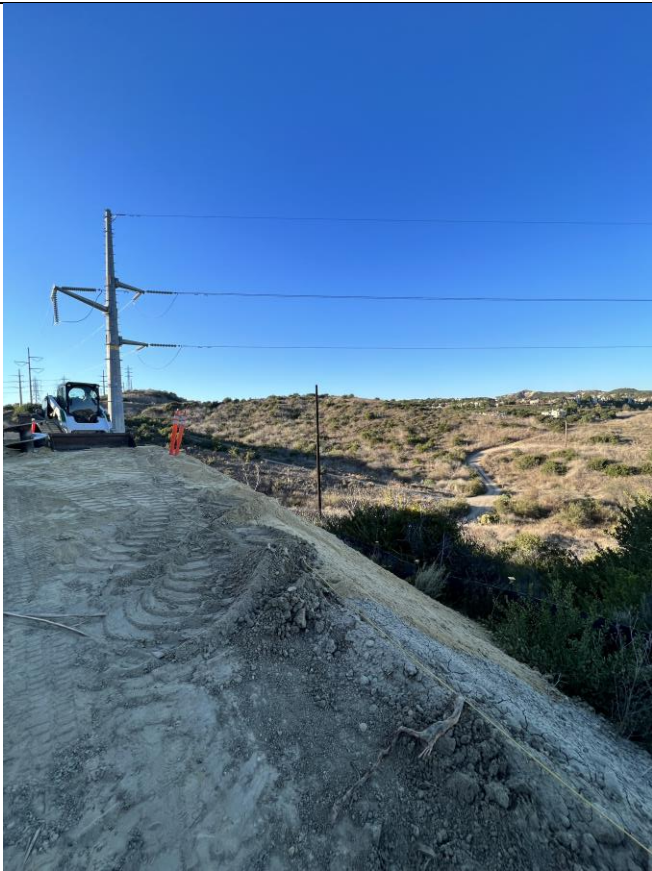
The tower pad foundation holes in the work area were well-covered (Photo 4). The LEI informed me that construction crews would install a retaining wall behind the tower. Additional wire-pulling activities were scheduled for the following week across Minor Project Refinement 20 (MPR-20)-related work areas (Photo 5).

Photo 5 – View of the scheduled wire-pulling work and MPR-20 locations. Photo facing north.
11/28/23	SOCRE Project – Phase II

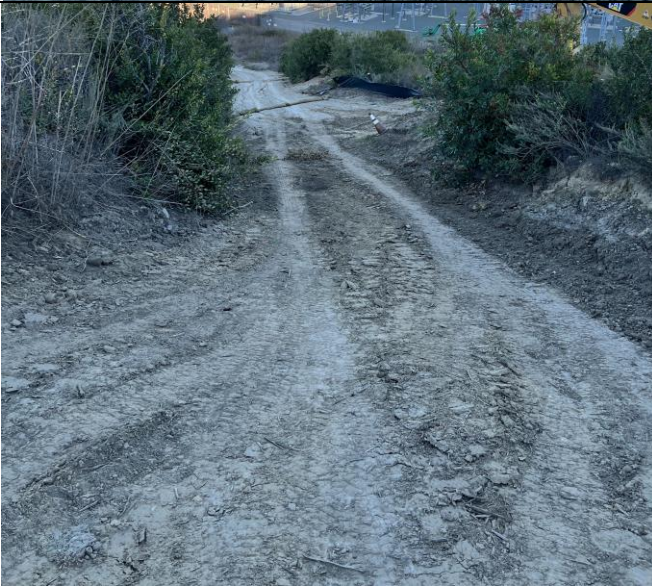
The access roads to this site are steep and had some erosion control measures installed (Photo 6). Rain was anticipated later in the week, and the LEI assured me that a pre-storm inspection and Rain Event Action Plan would be prepared in advance by the Qualified Stormwater Pollution Prevention Plan Practitioner per the Stormwater Pollution Prevention Plan.

Photo 6 – Steep access road with erosion control measures installed.

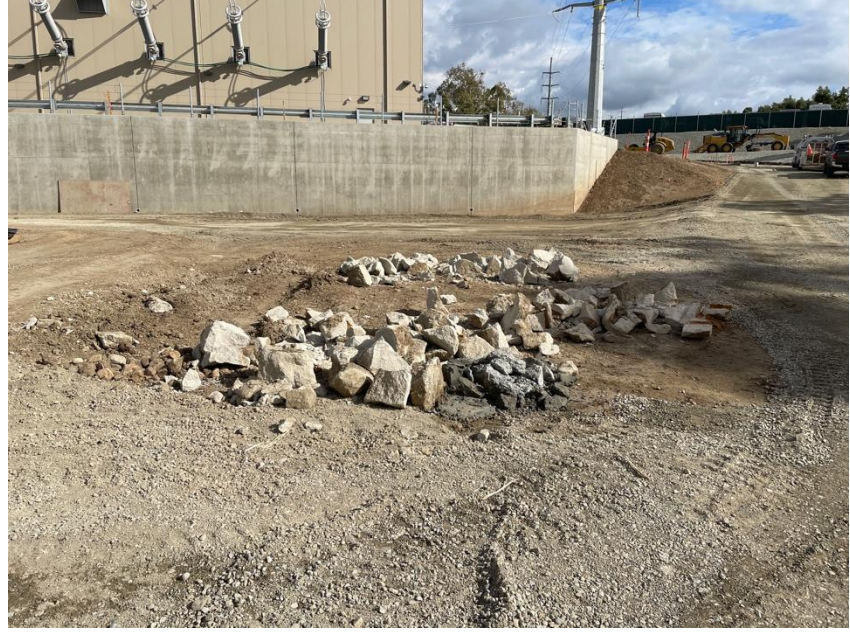
Construction debris remained on site awaiting clean up and removal (Photo 3).

A photograph showing a large pile of light-colored rocks and debris on a dirt and gravel surface. In the background, there is a concrete wall and a building with electrical equipment. The sky is blue with some clouds.	Photo 3 – Debris awaiting offsite removal. Photo facing east.
11/29/23	SOCRE Project

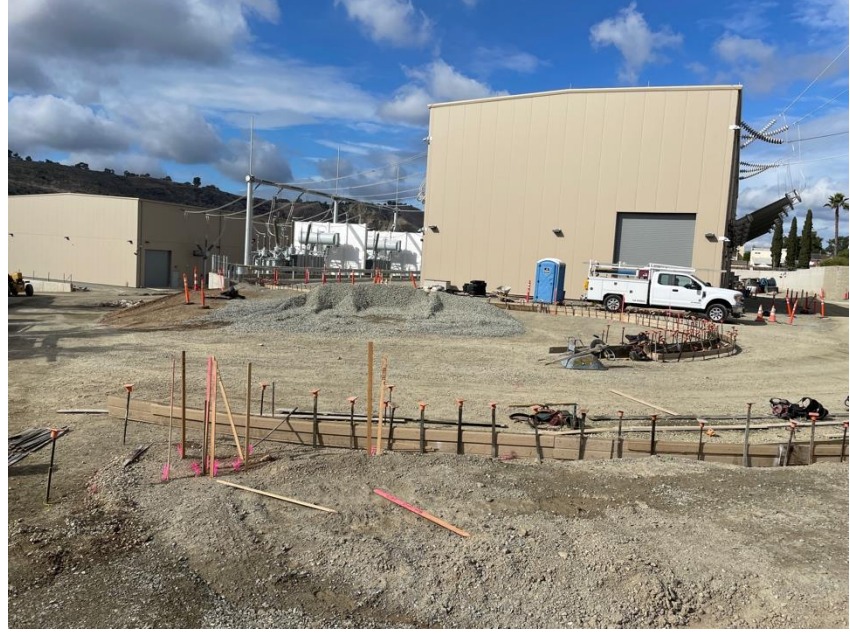
Installation of road base and extensive curb and gutter work continued in preparation for paving the substation area (Photo 4).

A photograph showing a construction site with a large concrete curb and gutter installation. A white pickup truck is parked nearby. In the background, there is a large beige building and a blue sky with clouds.	Photo 4 – Road base work along with curb and gutter installation. Photo facing north.

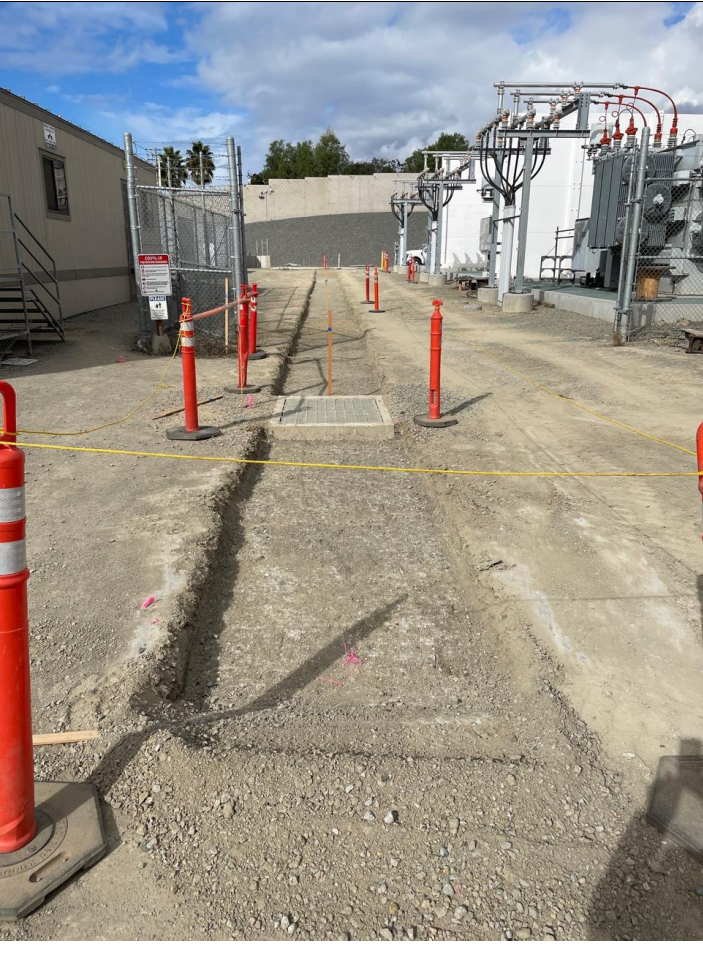
Final grading continued for site drainage at several locations within the new substation (Photo 5).

Photo 5 – Drainage grading underway within the new substation. Photo facing north.
11/29/23	SOCRE Project – Phase II

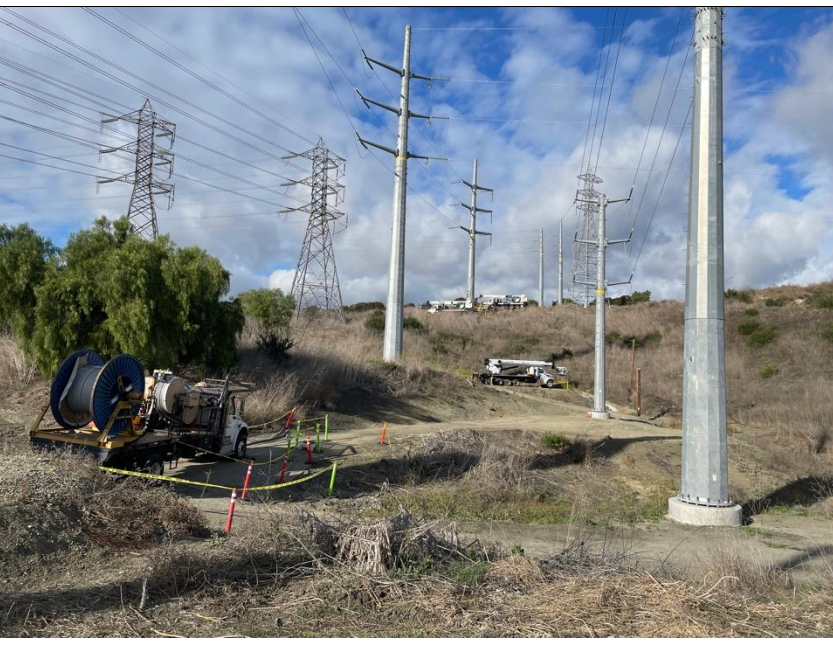
At the Phase II work area crews had equipment on site in preparation for pulling wire (Photo 6). I toured the site with the project biologist and confirmed that work areas were cleared every morning prior to work beginning. The biologist informed me that one rattlesnake (*Crotalus spp.*) had been identified near equipment but had left the area on its own.

Photo 6 – Crews setting up to pull wire. Photo facing north.
