Re: Monthly Report Summary #9 for the South Orange County Reliability Enhancement (SOCRE) Project

South Orange County Reliability Enhancement Project CPUC Site Inspection Form

Project:	South Orange County Reliability Enhancement Project	Date:	July 19, 2018
Project Proponent:	San Diego Gas & Electric	Report #:	VS001
Lead Agency:	California Public Utilities Commission	Monitor(s):	Vince Semonsen
CPUC PM:	Andrew Barnsdale, Energy Division	AM/PM Weather:	Overcast, cool, and calm
CPUC CM (E & E):	Joe Donaldson	Start/End Time:	0700 to 0915
Project NTP(s):	NTP-1, NTP-2, NTP-2 Addendum 1, and NTP-3

Project:	South Orange County Reliability Enhancement Project	Date:	July 24, 2018
Project Proponent:	San Diego Gas & Electric	Report #:	VS002
Lead Agency:	California Public Utilities Commission	Monitor(s):	Vince Semonsen
CPUC PM:	Andrew Barnsdale, Energy Division	AM/PM Weather:	Clear, sunny, and warm, with calm winds
CPUC CM (E & E):	Joe Donaldson	Start/End time:	0730 to 0930
Project NTP(s):	NTP-1, NTP-2, NTP-2 Addendum 1, and NTP-3

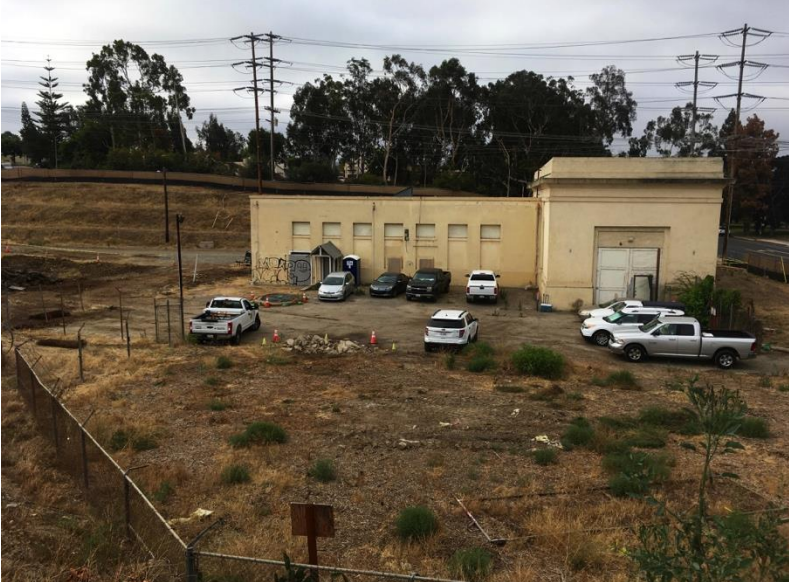
I arrived onsite at the San Juan Capistrano Substation for the 0700 tailboard meeting. A temporary parking area was available on the north side of the Capistrano Substation (Photo 1). During the tailboard meeting, I introduced myself as the California Public Utilities Commission (CPUC) onsite monitor and talked about my general inspection schedule and monitoring philosophy.

Photo 1 – Overview of the parking area and the Capistrano Substation. Photo facing south.
7/19/18	San Juan Capistrano Substation

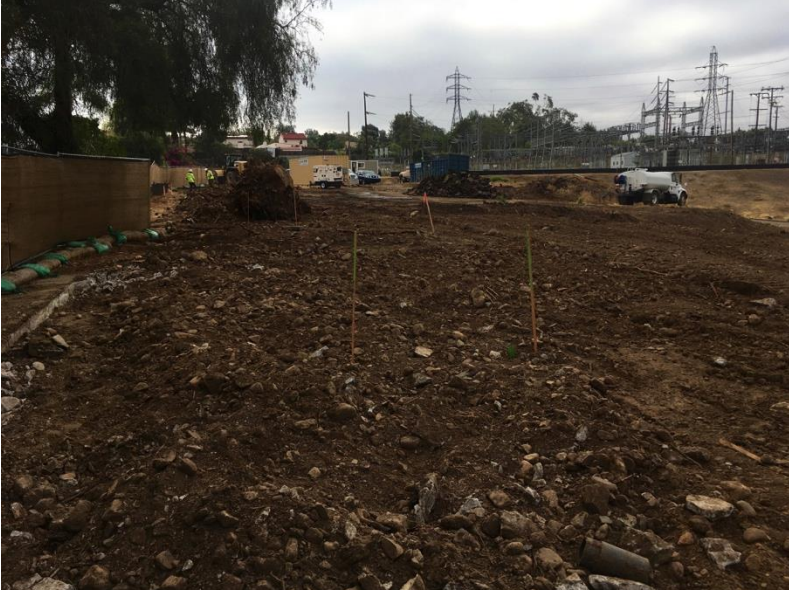
Earlier in the week, crews had started clearing and grubbing of the San Juan Capistrano Substation site and would be continuing this type of activity over the coming weeks (Photo 2). I spoke with the Lead Environmental Inspector Louie Nunez (KP Environmental) and we discussed the project and the upcoming construction schedule. Louie Nunez stated that nesting bird surveys had been conducted before the start of construction activities and no nests were found (MM BR-3, MM BR-6, MM BR-7, MM BR-8).

Photo 2 – Area of clearing and grubbing along the northern border. Photo facing east.
7/19/18	San Juan Capistrano Substation

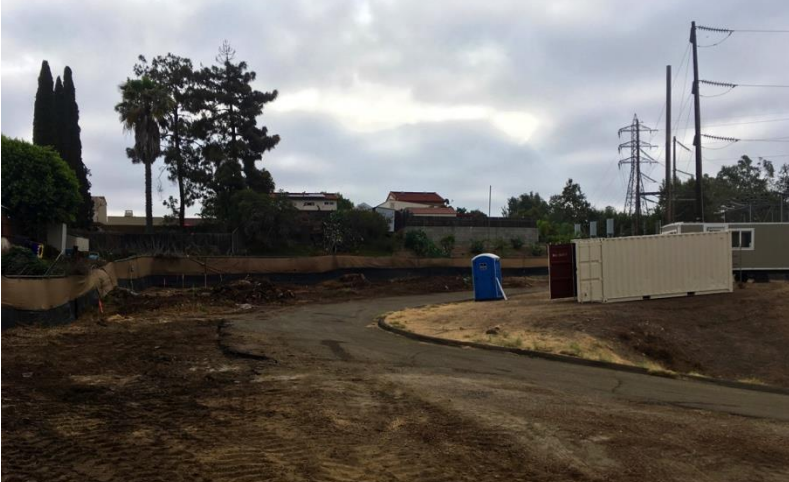
Temporary fencing and screening had been installed around most of the San Juan Capistrano Substation site (APM AEA-3) (Photo 3). The site was clear of any construction garbage and debris (APM AES-1).

Photo 3 – Northeast corner of the project site; note the fencing and screening. Photo facing east.

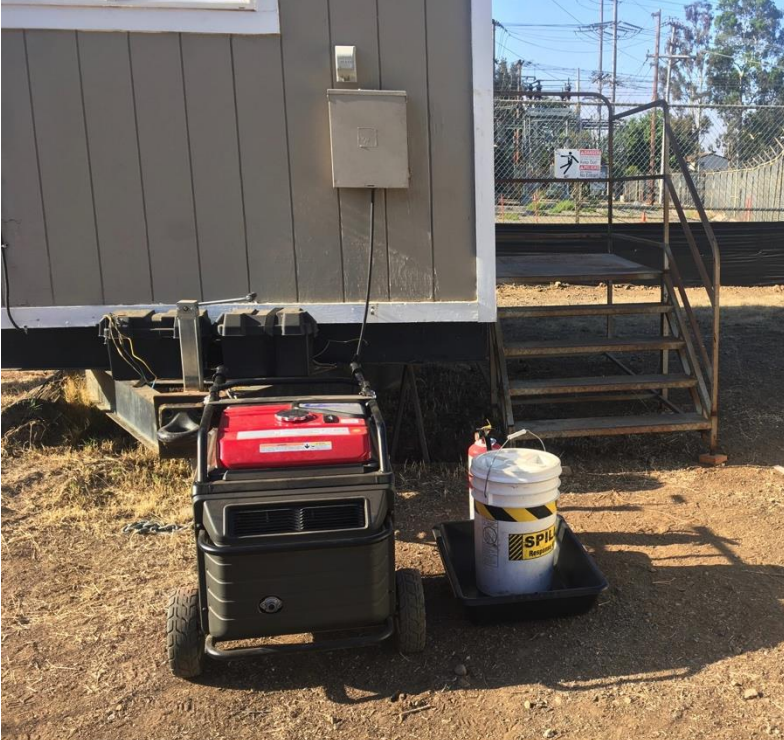
A drip pan, spill kit, and fire extinguisher had been placed next to the small generator I had noted during my previous site visit (Photo 4). The drip pan will be used during refueling of the generator (MM HAZ-1). Other drip pans were being placed under equipment that was parked overnight.

Photo 4 – Generator with drip pan and spill kit.
7/24/18	San Juan Capistrano Substation

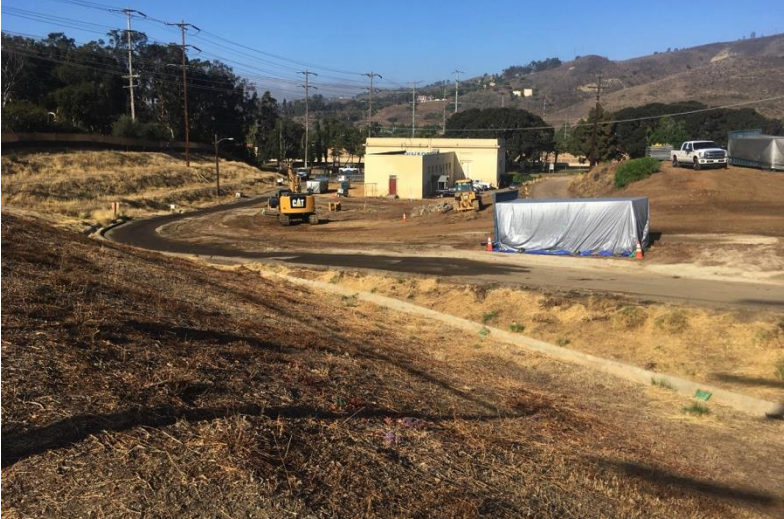
There were several dumpsters onsite and they were tightly covered with tarps. The site remained clear of any construction garbage and debris (APM AES-1) (Photo 5).

Photo 5 – Asphalt road to be removed; tarped dumpsters in the foreground and background. Photo facing west.
