# TL 6975 San Marcos to Escondido Project

## Quarterly Compliance Report

### Quarter 1 2022

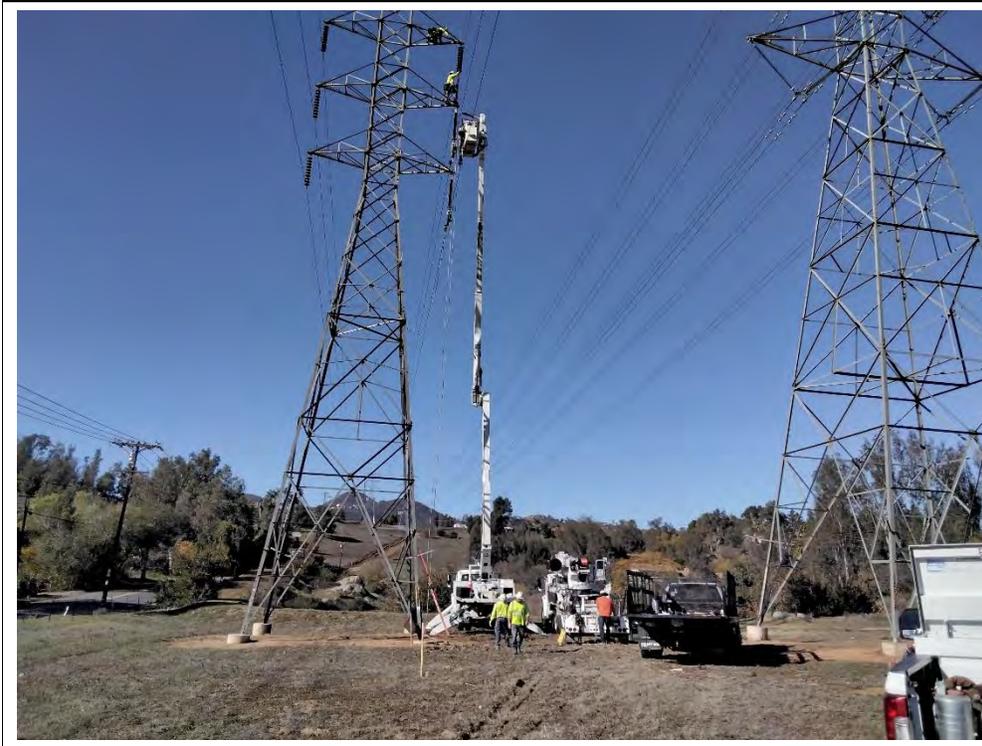
**Photograph 1:**  
January 05, 2022.  
Crews unclipping  
wire and  
installing  
travelers at  
location 107.  
Facing: West

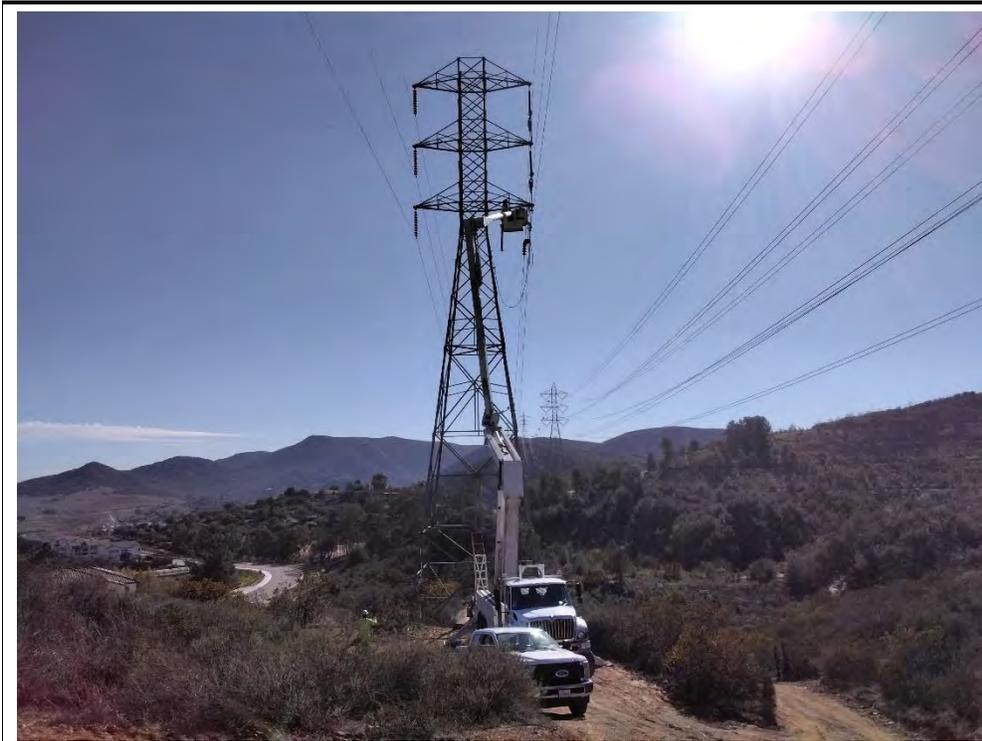
**Photograph 2:**  
January 06, 2022.  
Crews unclipping  
wire and  
installing  
travelers at  
location 101.  
Facing: South

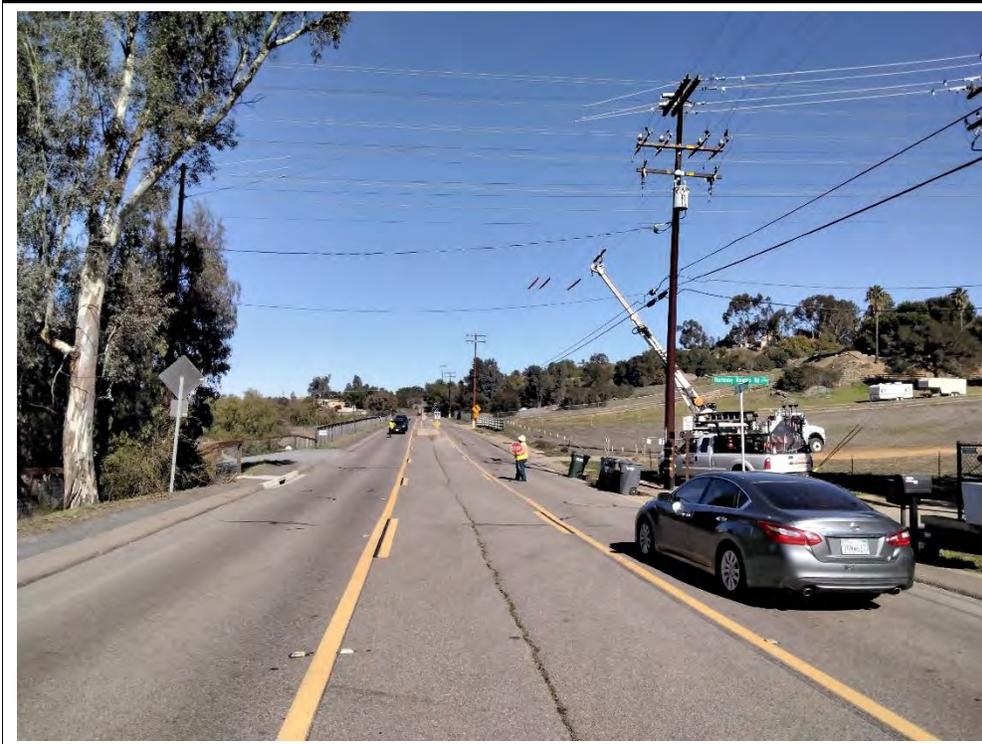
**Photograph 3:**  
January 11, 2022.  
Traffic control  
crews managing  
traffic during  
wire pulls along  
Country Club  
Road, between  
locations 106 and  
105. Facing:  
North.

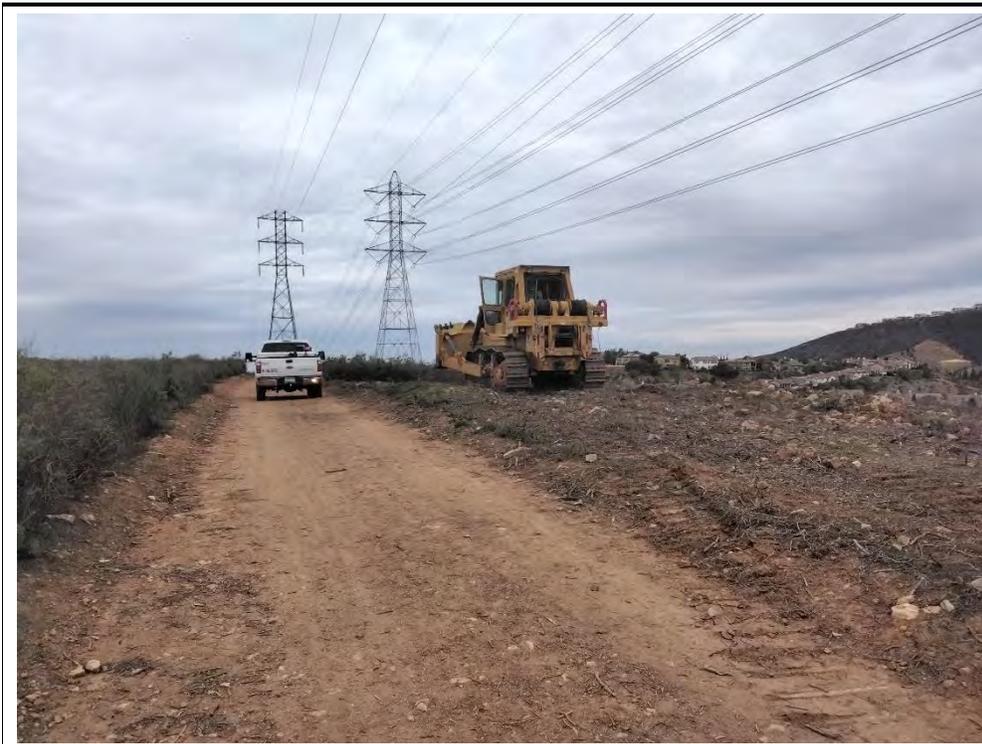
**Photograph 4:**  
January 13, 2022.  
Crews delivering  
“pull Cat” to  
location 85/86  
(snub site).  
Facing: West

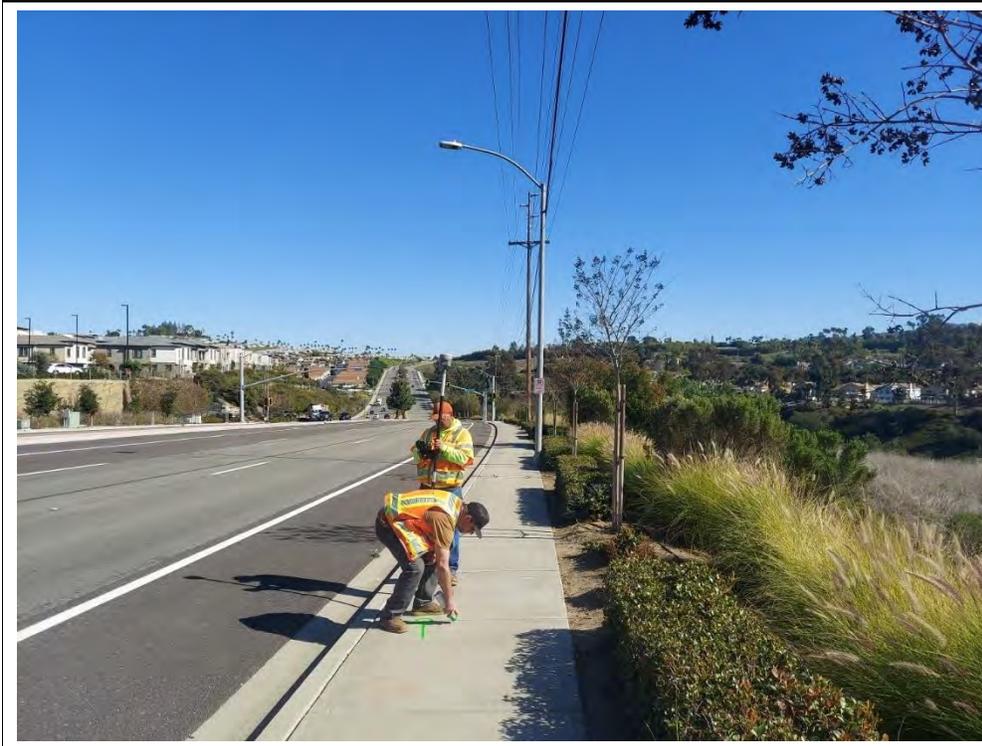
**Photograph 5:**

February 03,  
2022. Staking  
crew marking  
work limits at  
Location 38.  
Facing: West.

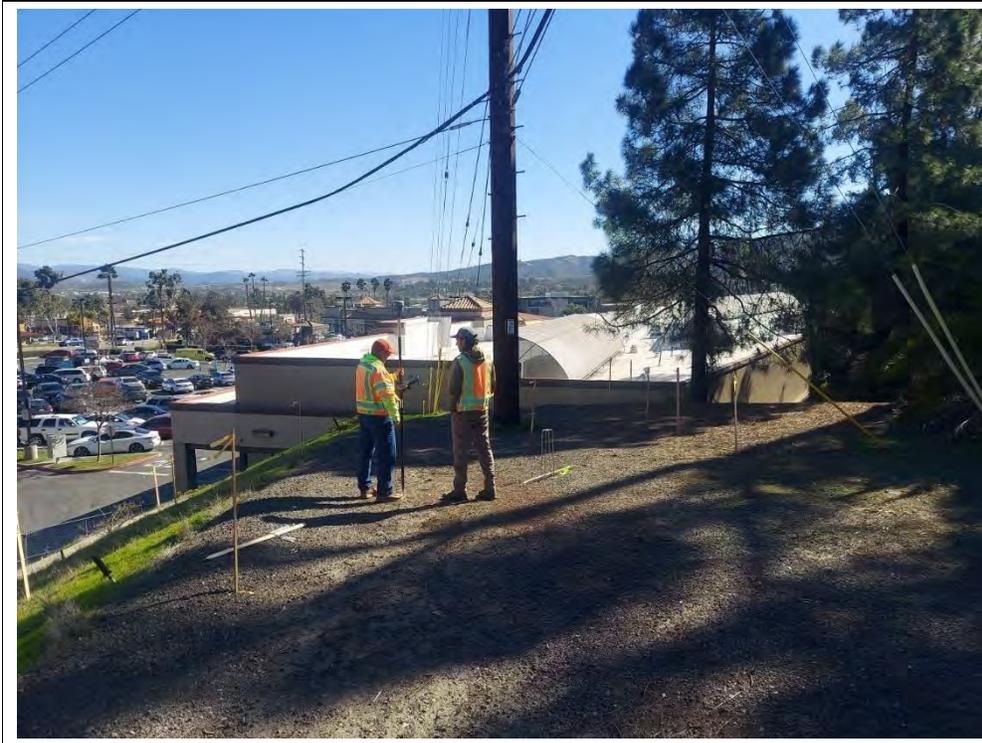
**Photograph 6:**

February 04,  
2022. Staking  
crew marking out  
work limits at  
Location 25.  
Facing: East.

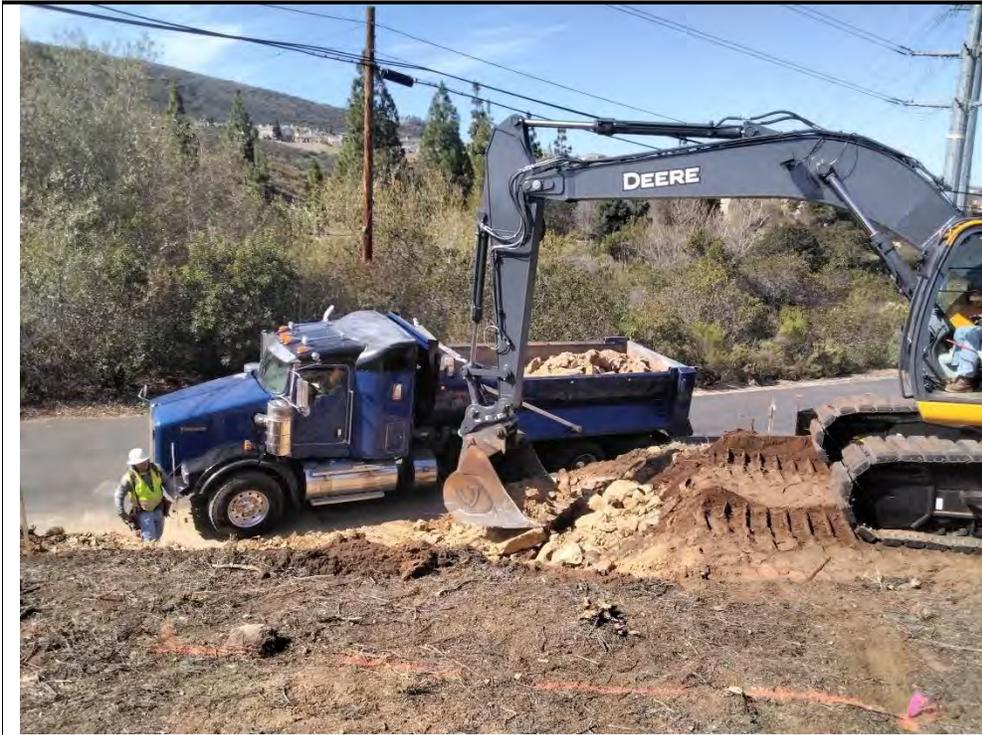
**Photograph 13:**

February 25,  
2022. Excavator  
grading entrance  
to location 70.  
Facing: West

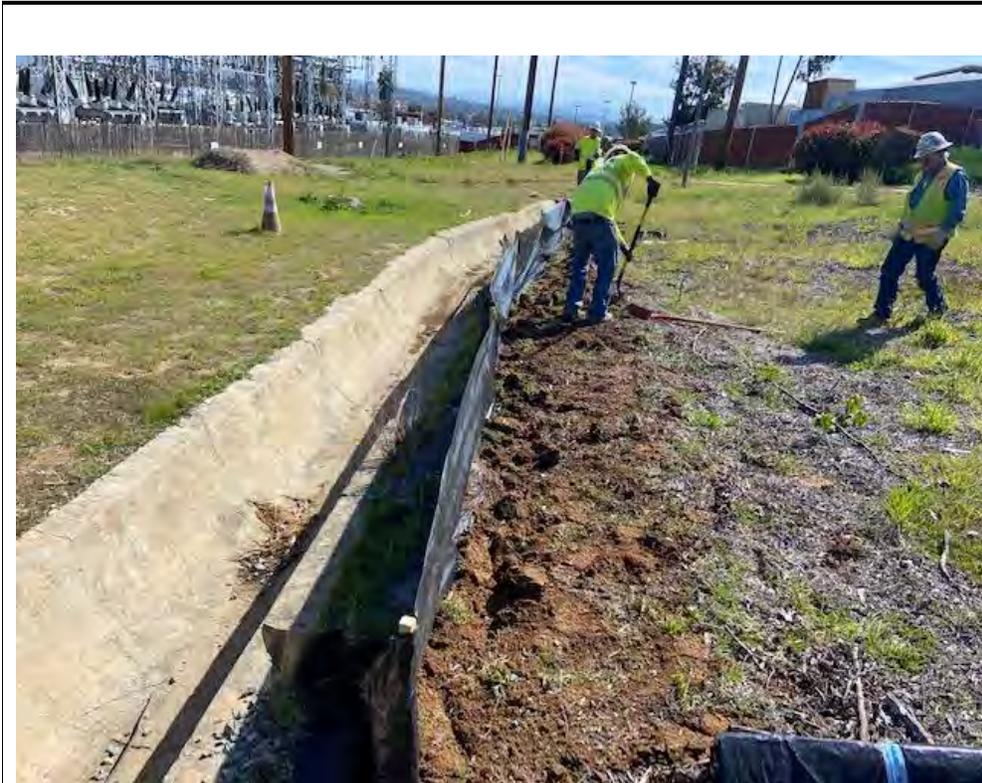
**Photograph 14:**

February 25,  
2022. Crew  
installing BMP's  
around location  
125. Facing: East

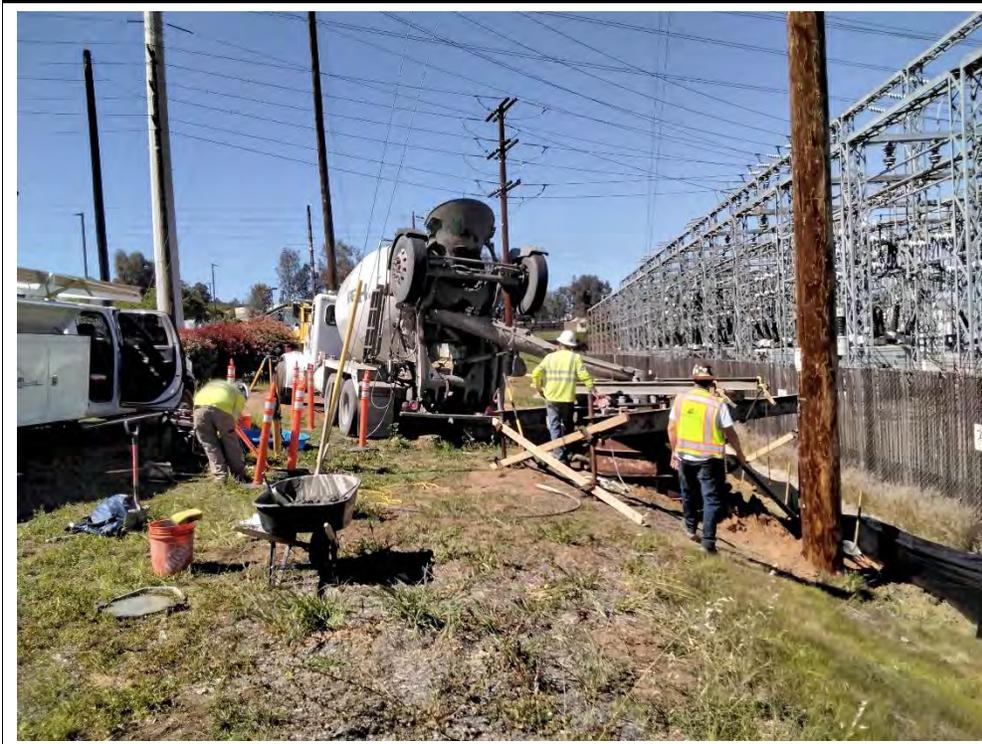
**Photograph 7:**  
March 01, 2022.  
Crews pouring  
concrete  
foundation at  
location 125.  
Facing: West.

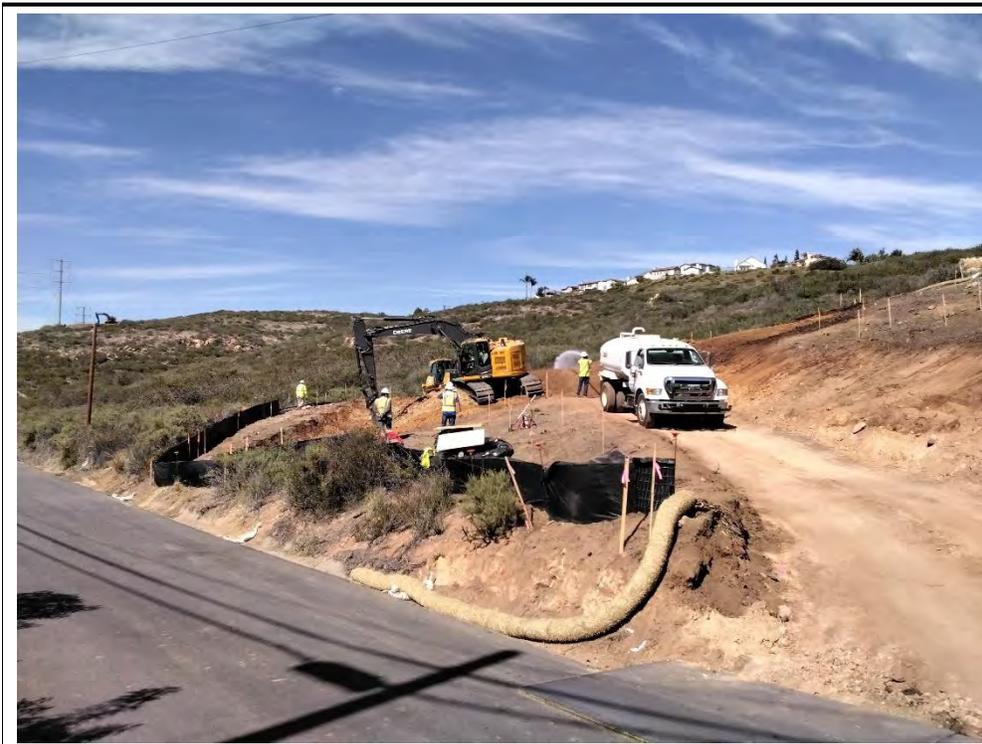
**Photograph 8:**  
March 03, 2022.  
Grading  
operations at  
location 70.  
Facing:  
Northeast.

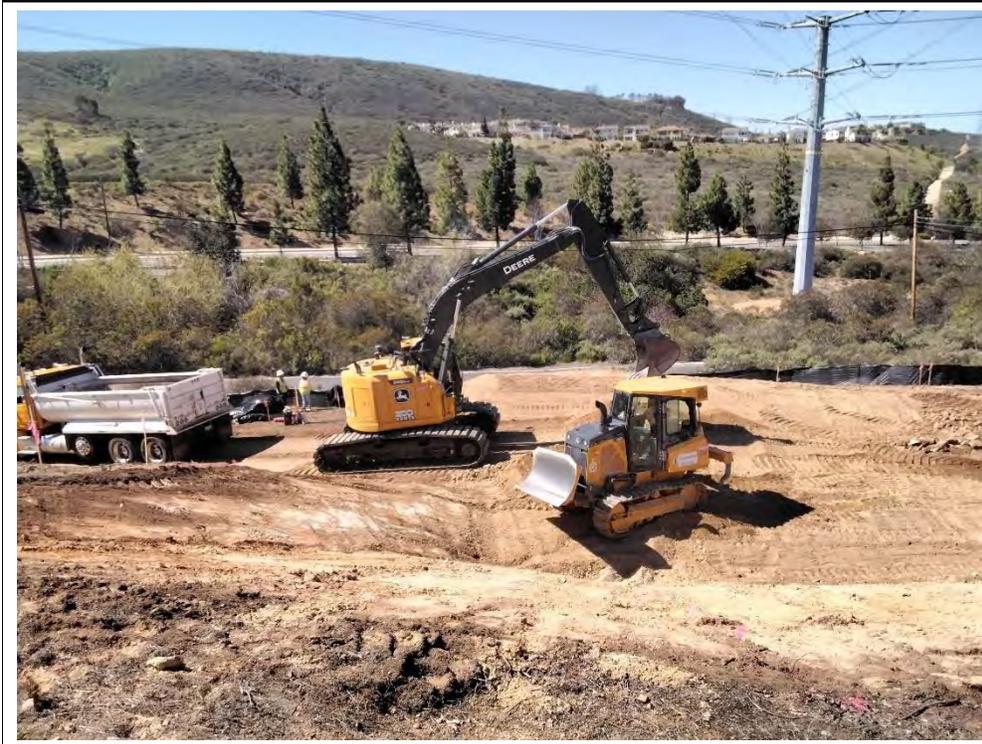
**Photograph 9:**  
March 09, 2022.  
Grading  
operations at  
location 70.  
Facing: West.

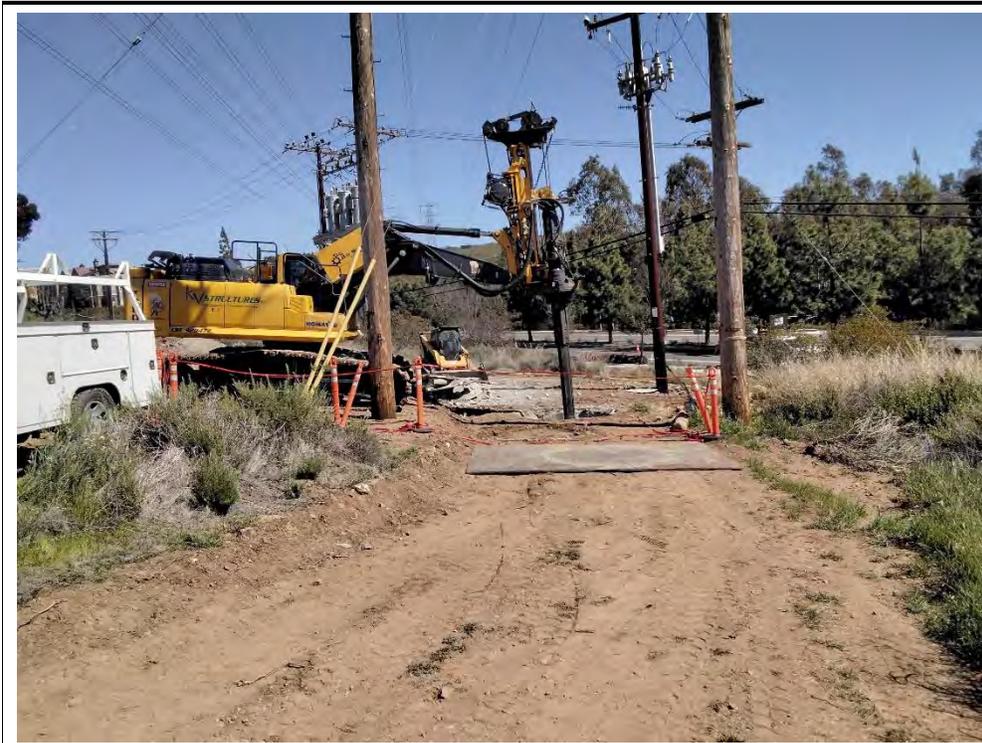
**Photograph 10:**  
March 11, 2022.  
Crews drilling  
foundation at  
location 74.  
Facing: East.

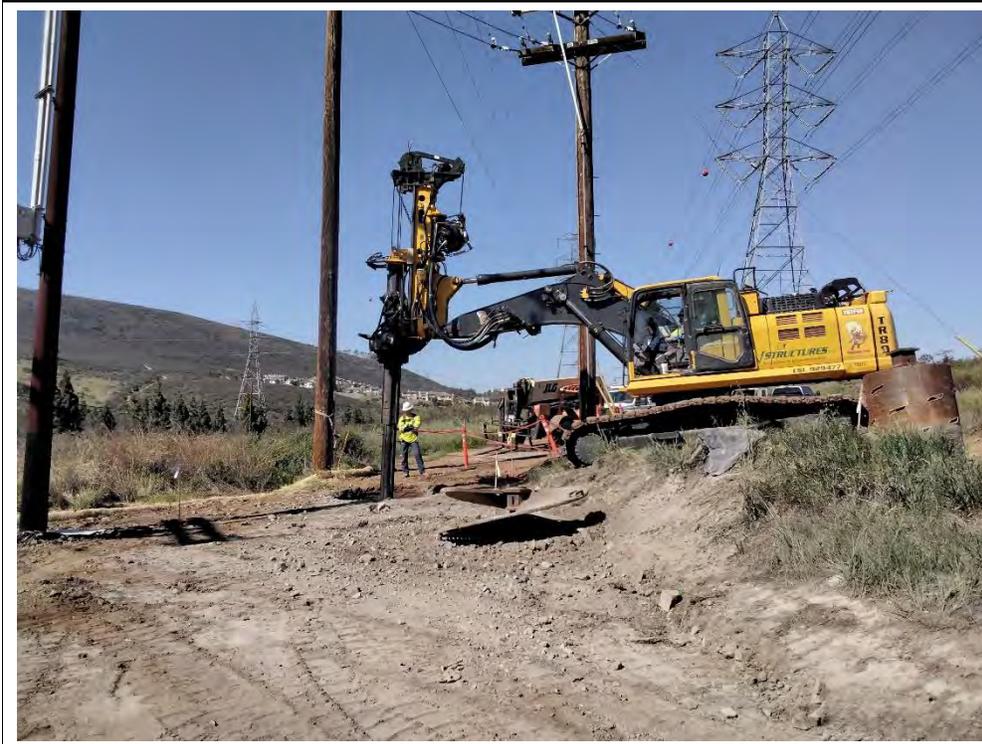
**Photograph 11:**

March 14, 2022.  
Crews drilling  
foundation at  
location 74.  
Facing: West.

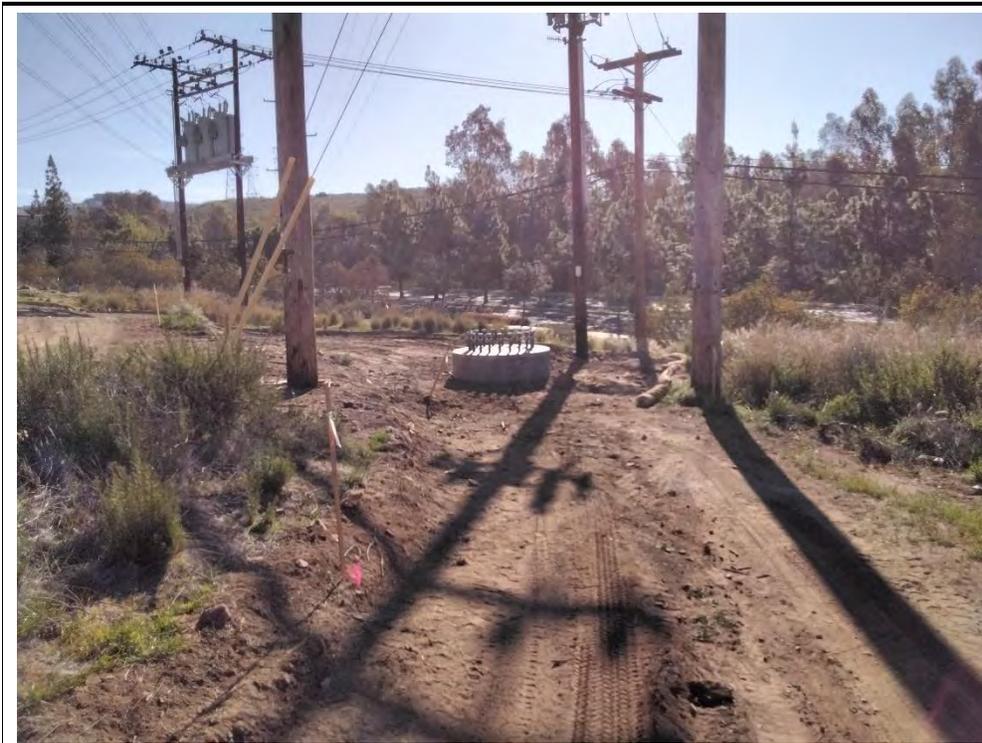
**Photograph 12:**

March 17, 2022.  
Finished concrete  
foundation at  
location 74.  
Facing:  
Southwest

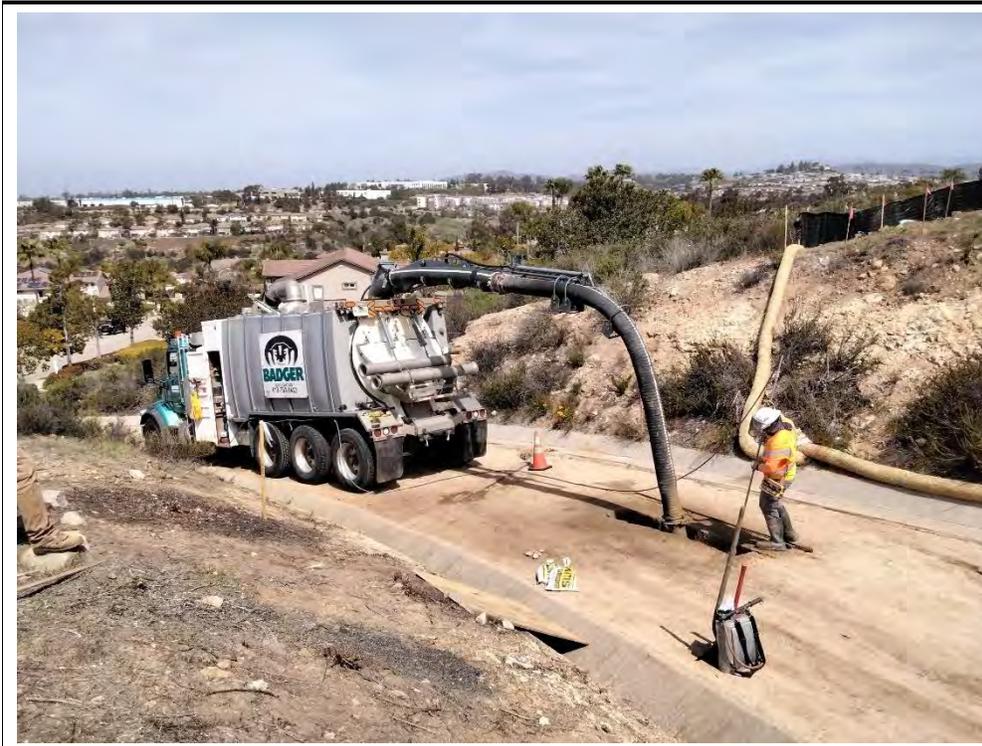
**Photograph 15:**  
March 21, 2022.  
Crews pot holing  
for utilities at  
location 56.  
Facing:  
Northeast.

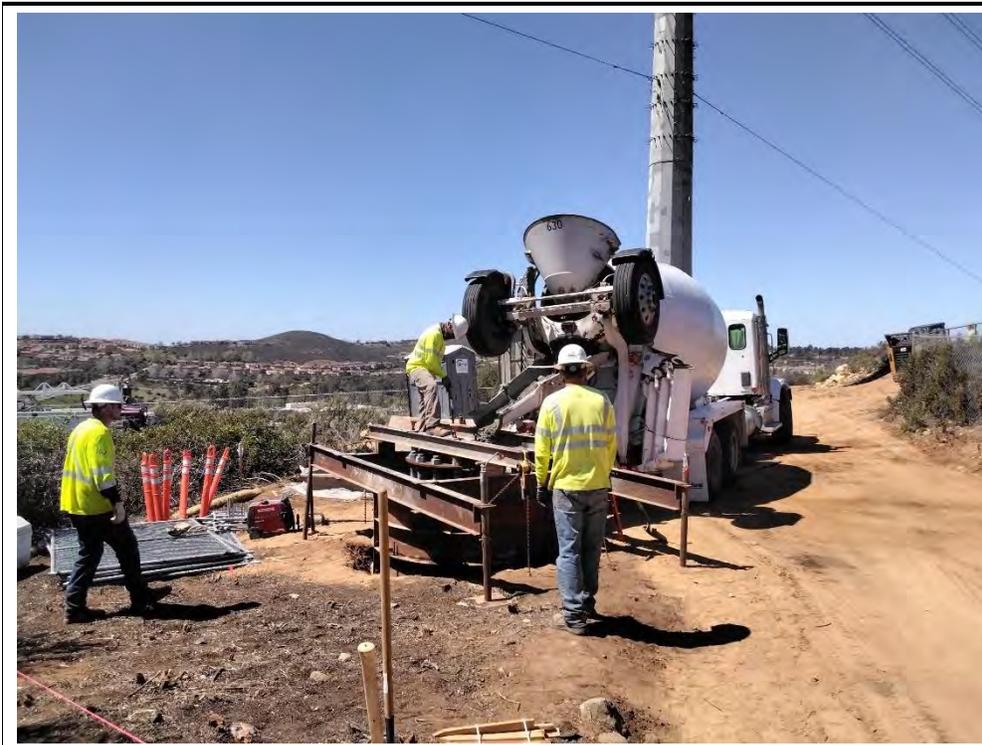
**Photograph 16:**  
March 23, 2022.  
Crews pouring  
concrete  
foundation at  
location 65.  
Facing: West.
