memorandum

subject MPWSP – Ryan Ranch – Bishop Interconnection Project Weekly Report (03/16/2020 –

03/20/2020)

RE: MPWSP Construction Biological Monitoring Report

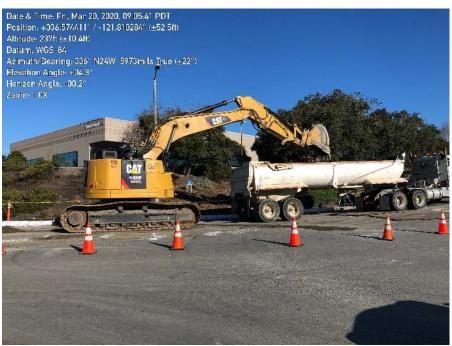
Photo 1. MPE excavation of pipeline trench on Lower Ragsdale Drive.

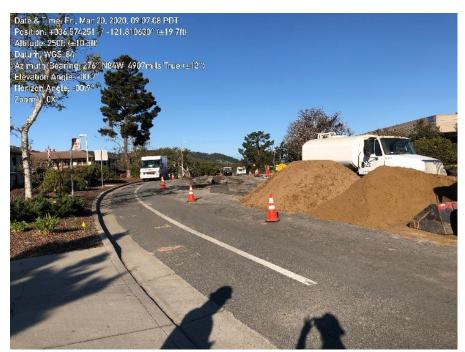
Photo 2. Fill material temporarily stockpiled on Lower Ragsdale Drive

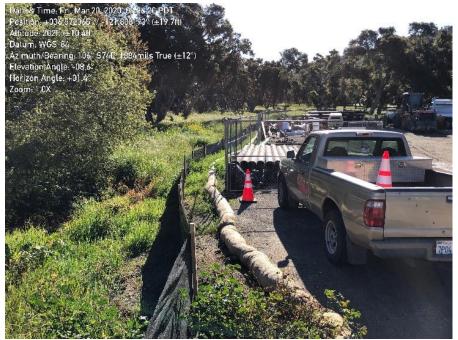
Photo 3. Silt fence surrounding staging area

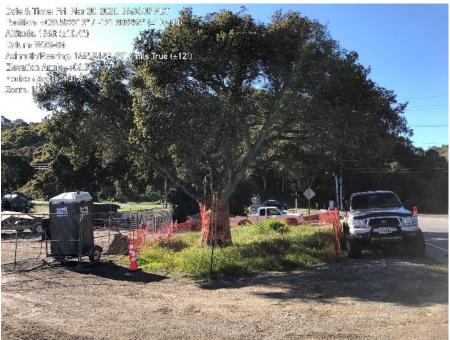
Photo 4. Tree protection at staging area

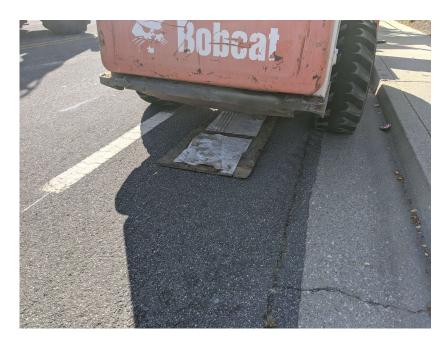
Photo 1. Hazardous spill protection under equipment on alignment. (3-13-2020)

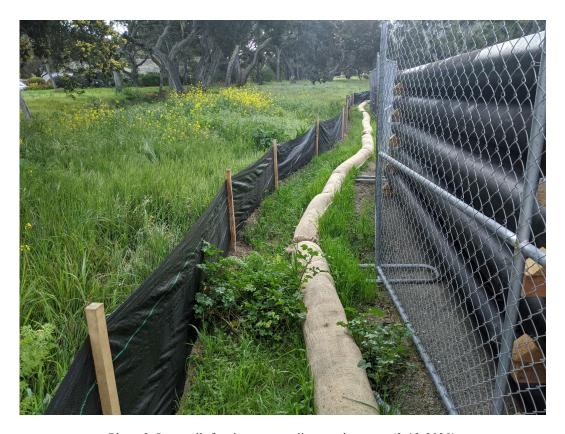
Photo 2. Intact silt fencing surrounding staging area. (3-13-2020)

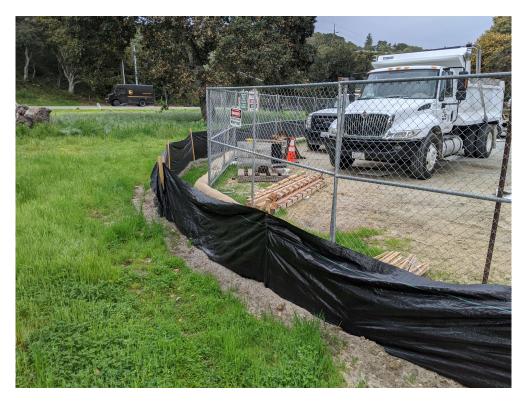
Photo 3. Secondary view of intact silt fencing surrounding staging area. (3-13-2020)

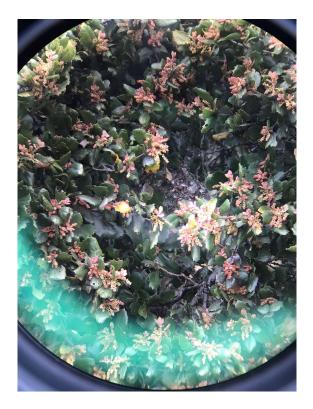
Photo 5. Scoped view of bushtit nest at Station 38+49 northeast of Wilson Road. (03-18-2020)
