# memorandum

subject MPWSP – Ryan Ranch – Bishop Interconnection Project Weekly Report (05/04/2020 – 05/08/2020)

# Ryan Ranch-Bishop Interconnection Improvements Narrative Report

## Monterey Peninsula Water Supply Project (MPWSP)

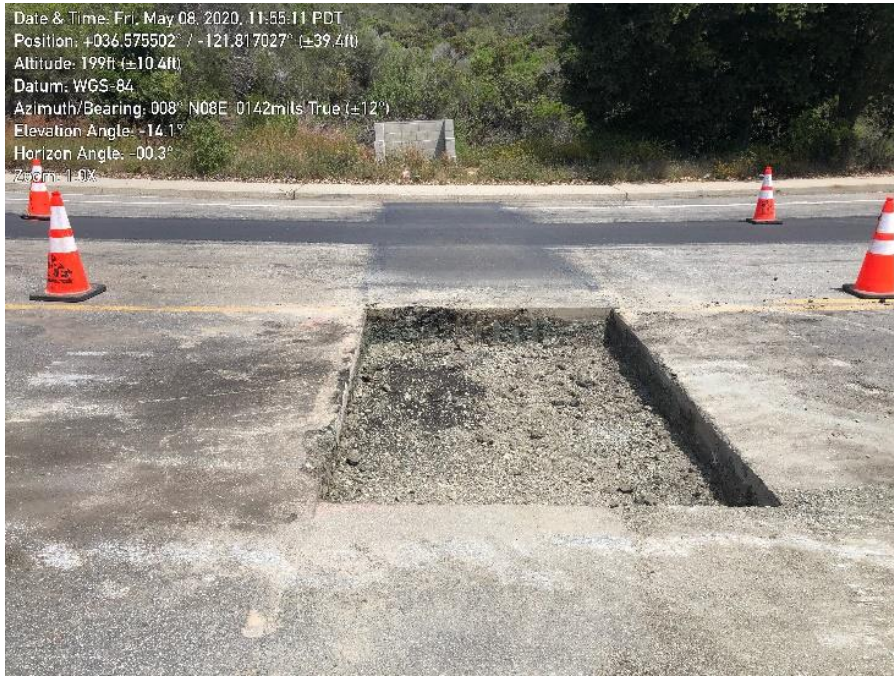
Photo 1. MPE paving repairs on Lower Ragsdale Drive.

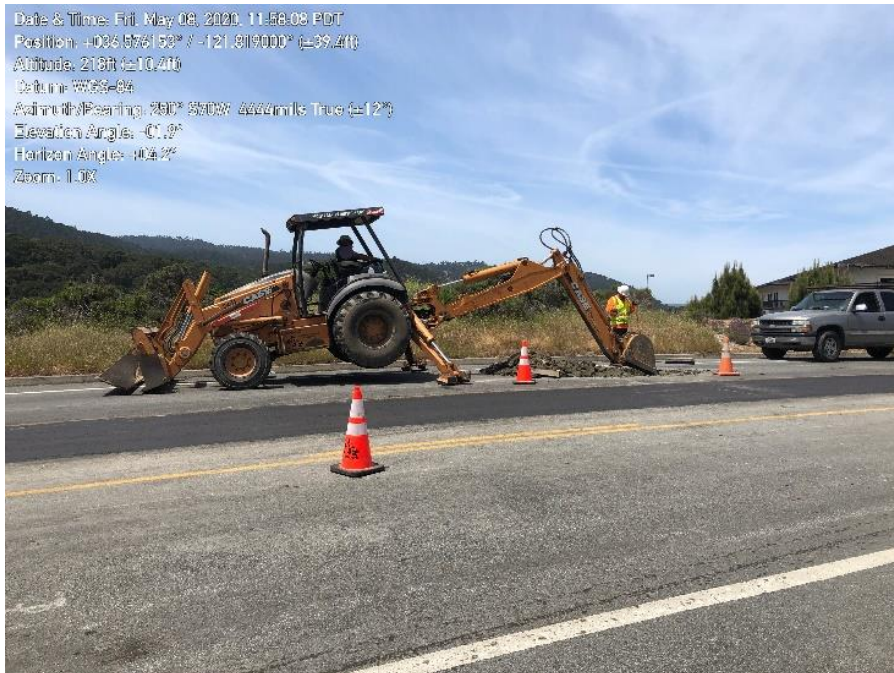
Photo 2. MPE paving repairs on Lower Ragsdale Drive.

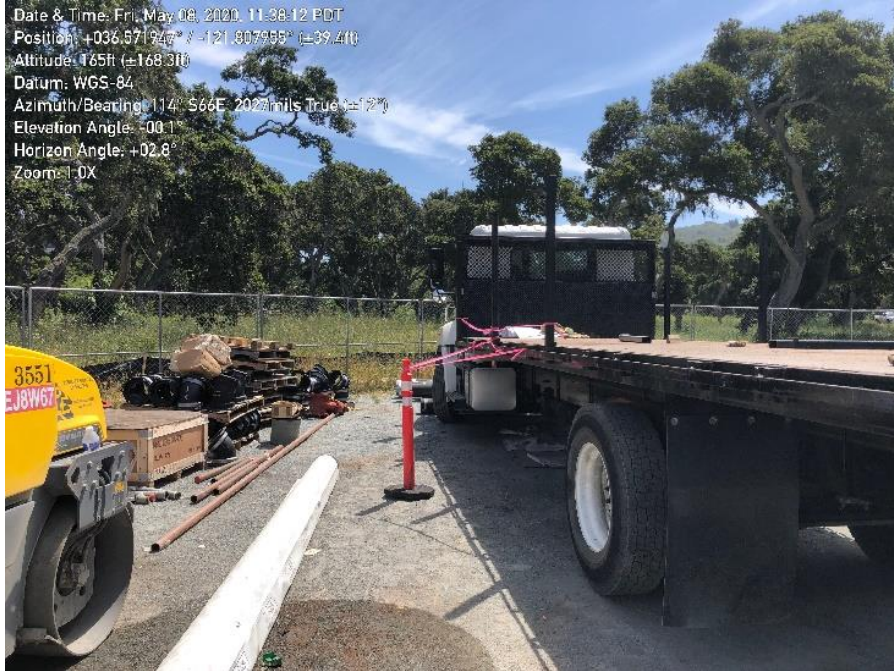
Photo 3. Black phoebe nest under flatbed truck.

- Identified black phoebe (*Sayornis nigricans*) nest under flatbed truck parked inside the staging area, MPE has been informed and has confirmed the truck has been deactivated and will remain protected until the young have fledged and are no longer reliant upon the nest for survival. Protective flagging has been established surrounding the nest to alert all construction workers of nest presence.

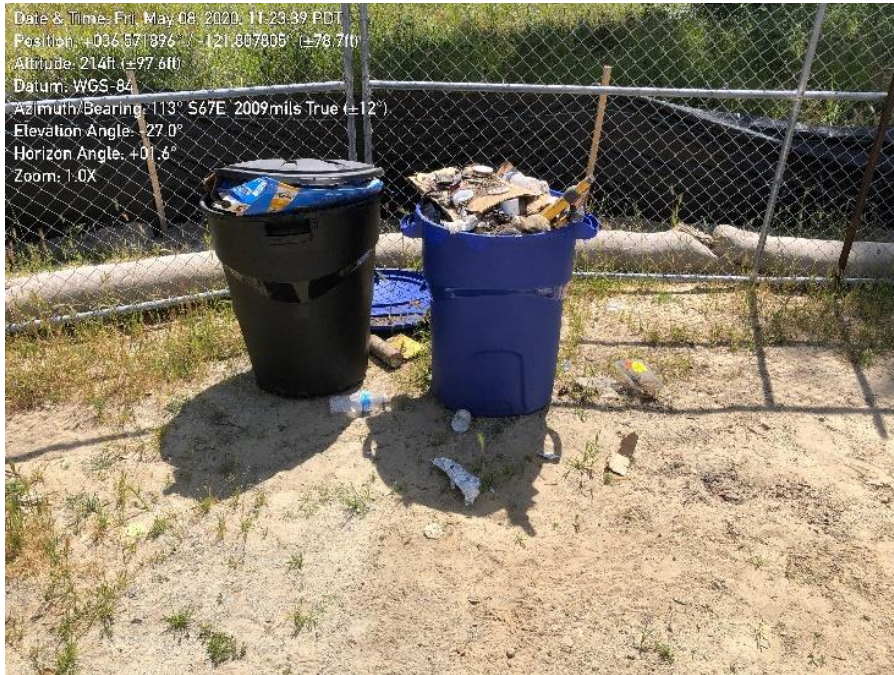
- Trash was bagged but not properly contained within the staging area located off York Road per Mitigation Measure 4.6-1c (18). Trash cans were observed full and without lids, and trash was observed on the ground within the staging area. ESA monitors reported this to CalAm monitors.

Photo 4. Trash improperly stored within staging area.

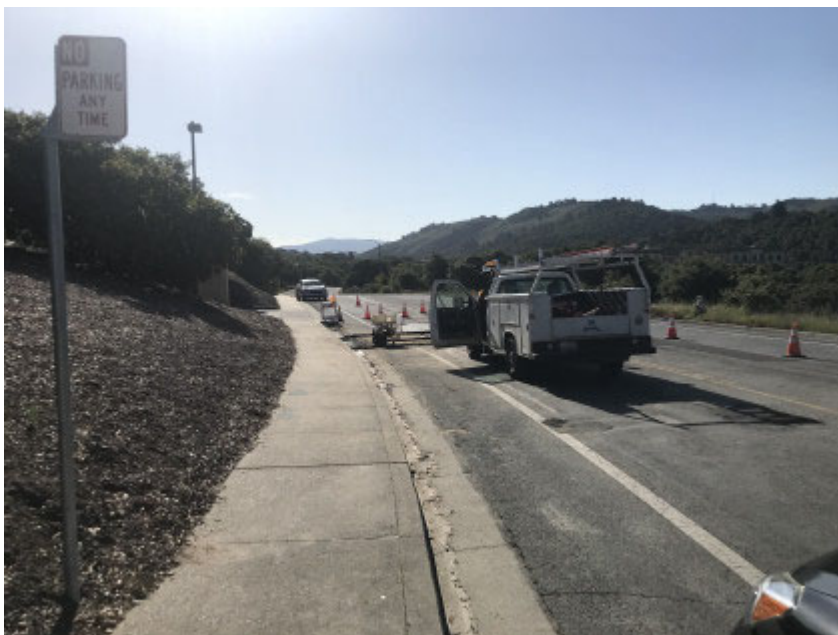
05/01/2020 - MPE repairing alignment leak along Lower Ragsdale Drive.

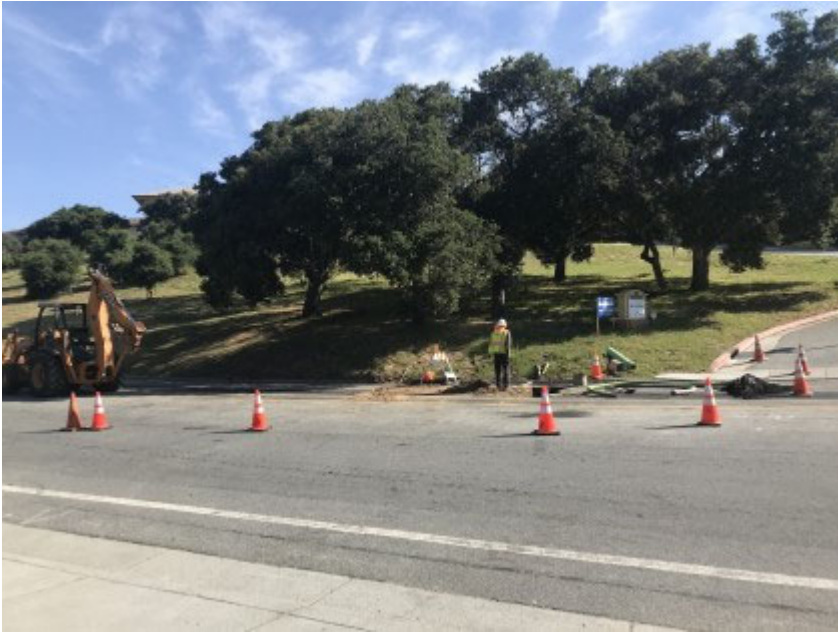
05/01/2020 - MPE repairing alignment leak along Wilson Road.

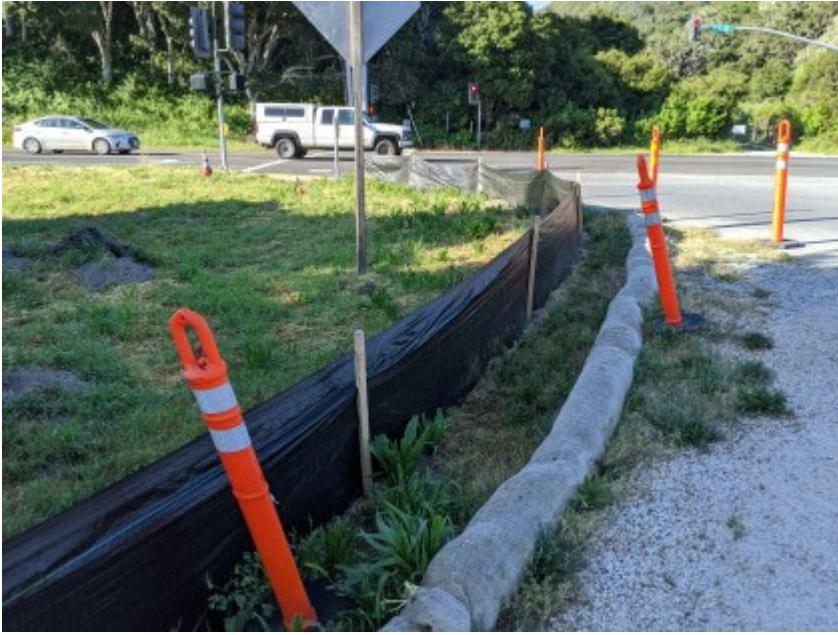
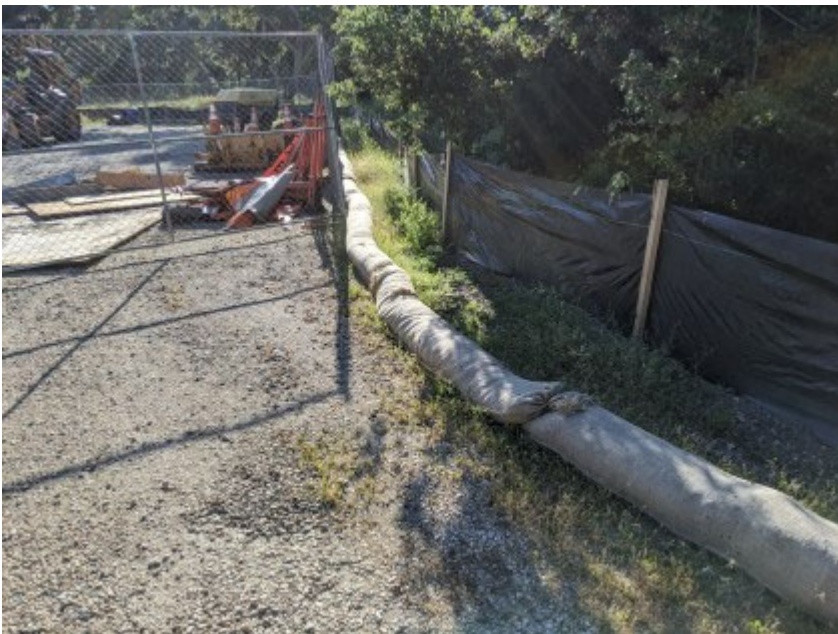
05/04/2020 - Intact silt fencing surrounding staging area.

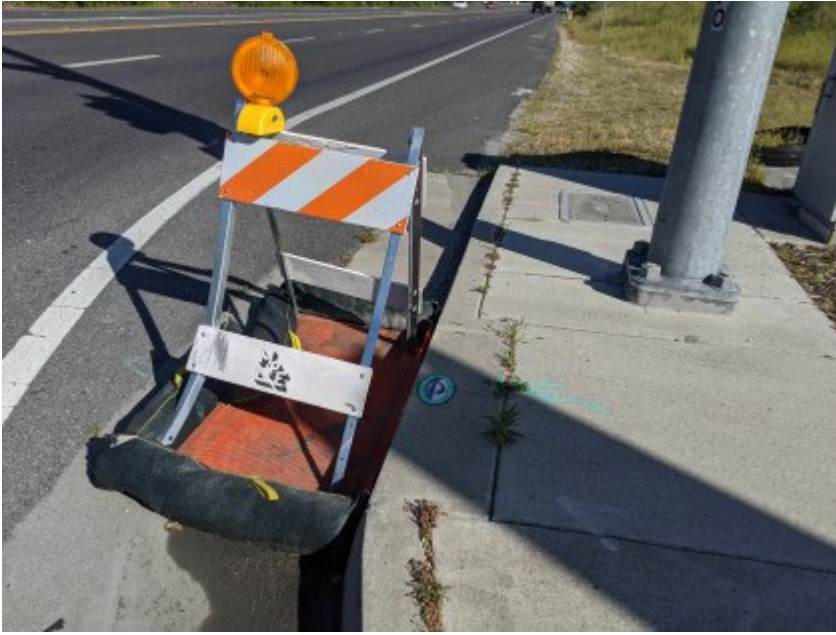
05/04/2020 - Intact stormwater BMPs in use adjacent to construction along Ragsdale Drive.

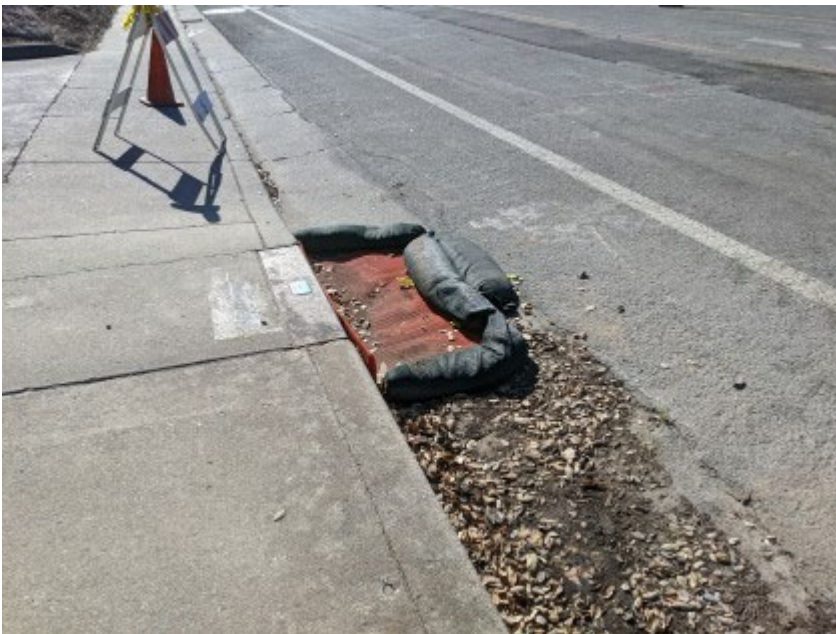
05/04/2020 - Intact stormwater BMPs in use adjacent to construction along Lower Ragsdale Drive.

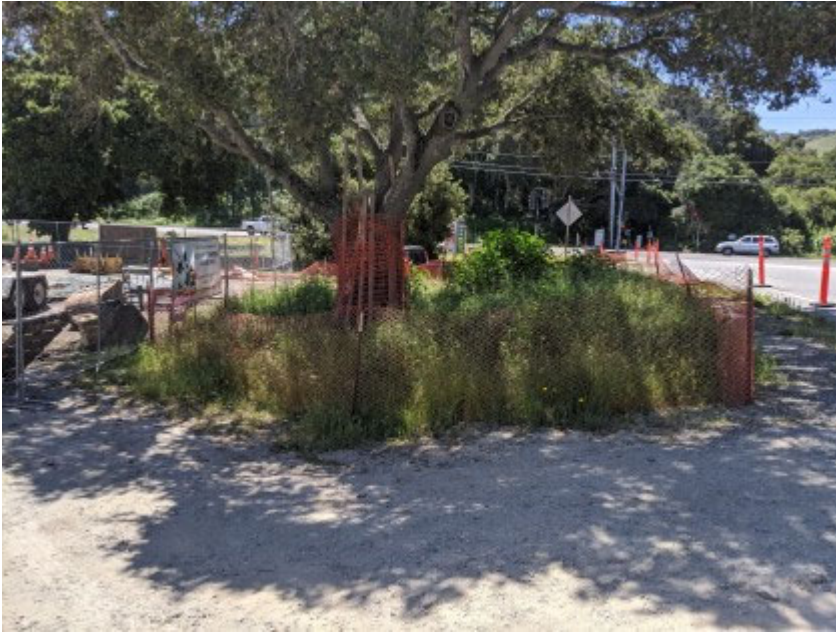
05/04/2020 - Intact ESA fencing surrounding protected oak tree adjacent to staging area.

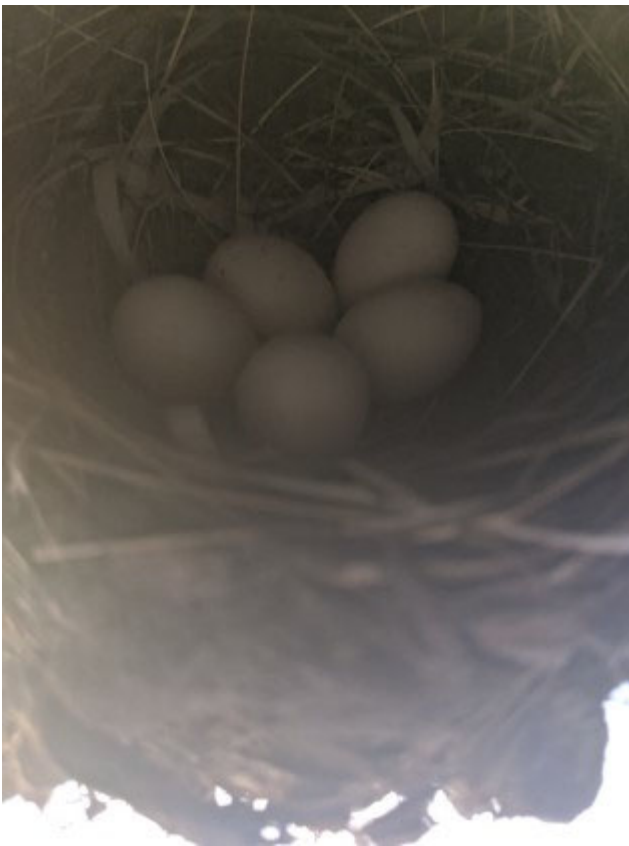
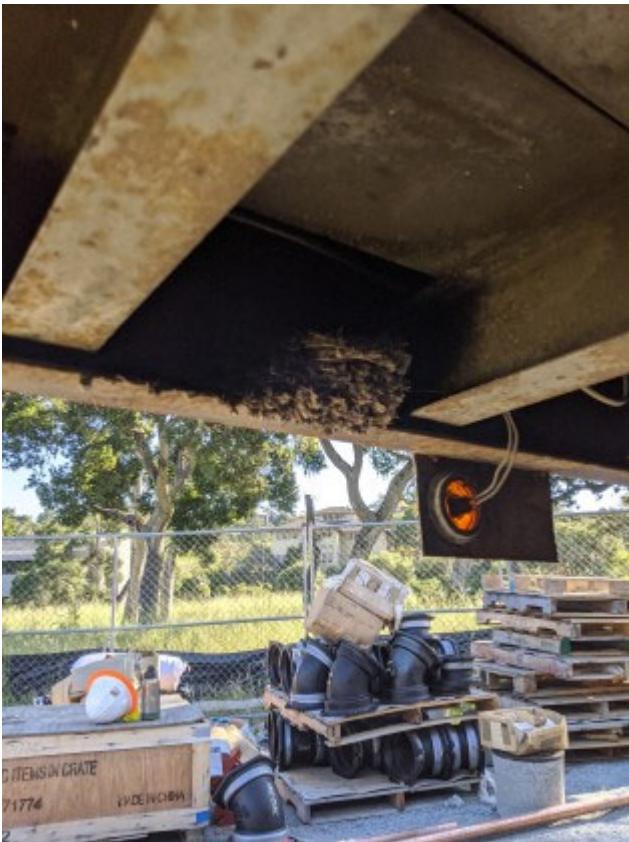
05/05/2020 - Newly identified black phoebe nest under MPE vehicle parked in staging area.

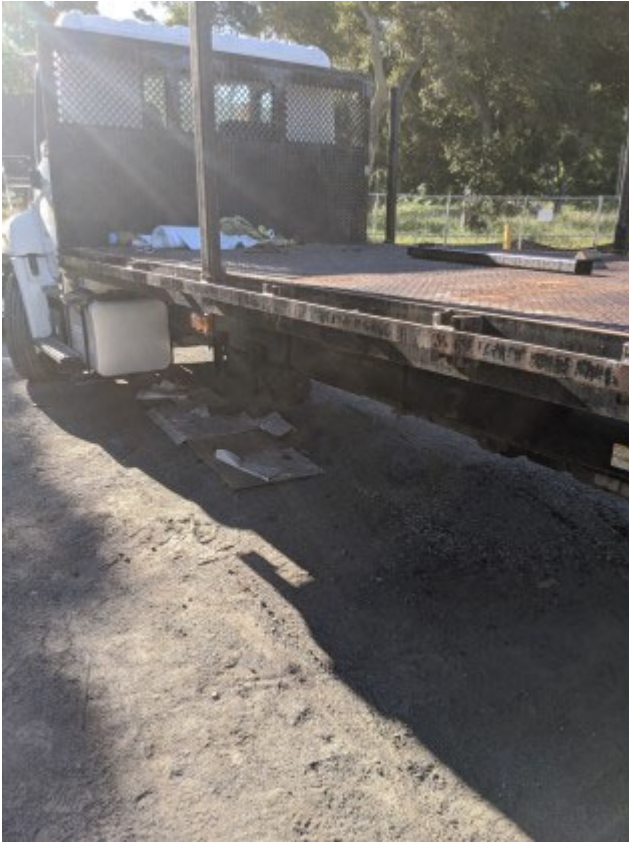
05/05/2020 - Additional view of newly identified black phoebe nest under MPE vehicle parked in staging area.

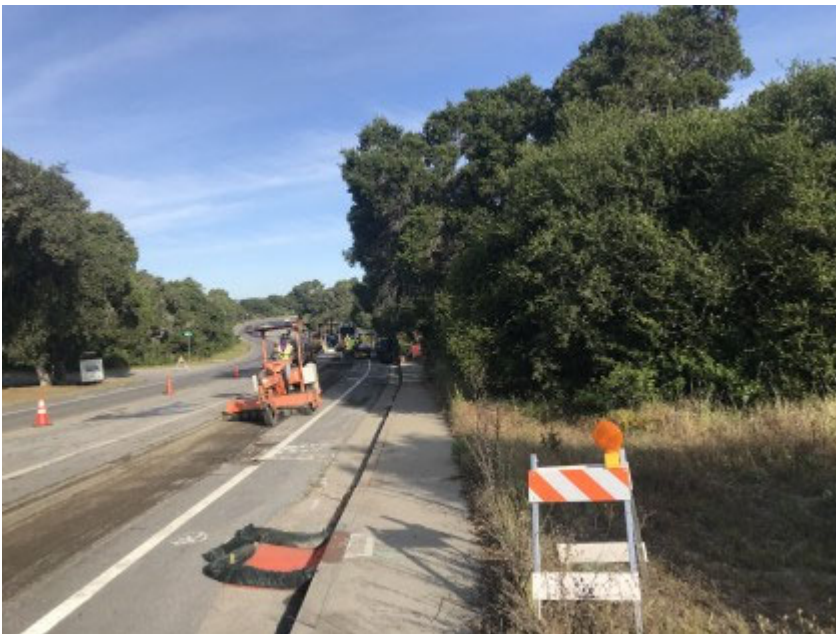
05/06/2020 - Intact stormwater BMPs in use adjacent to construction along Lower Ragsdale Drive during paving activities.

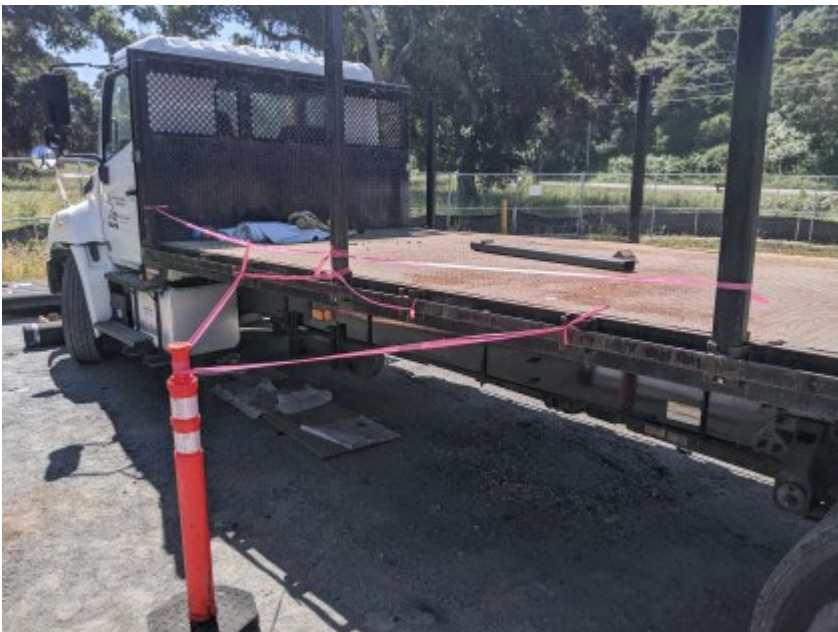
05/07/2020 - Flagging surrounding identified black phoebe nest in staging area.

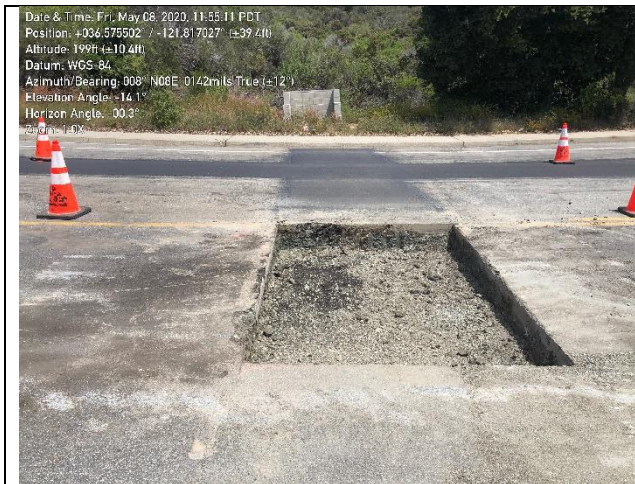
**Photo 1. MPE paving repairs on Lower Ragsdale Drive**

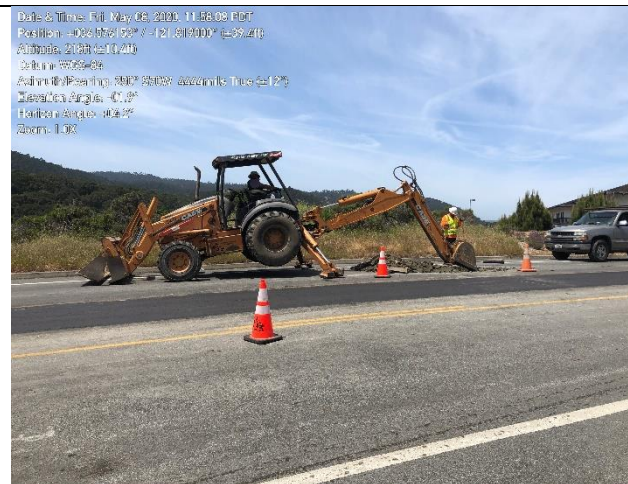
**Photo 2. MPE paving repairs on Lower Ragsdale Drive**

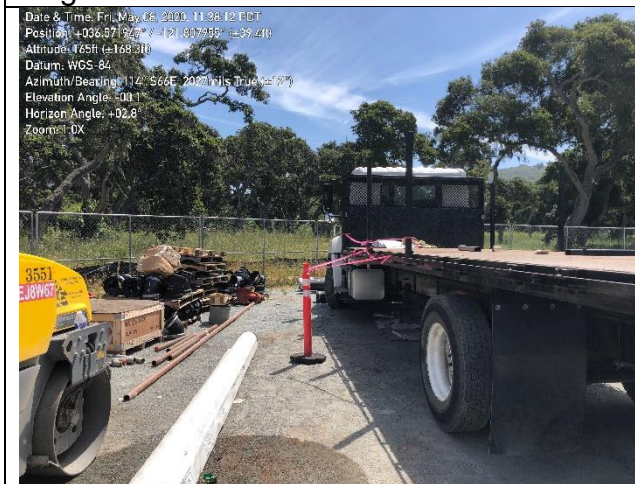
**Photo 3. Black phoebe nest under flatbed truck.**

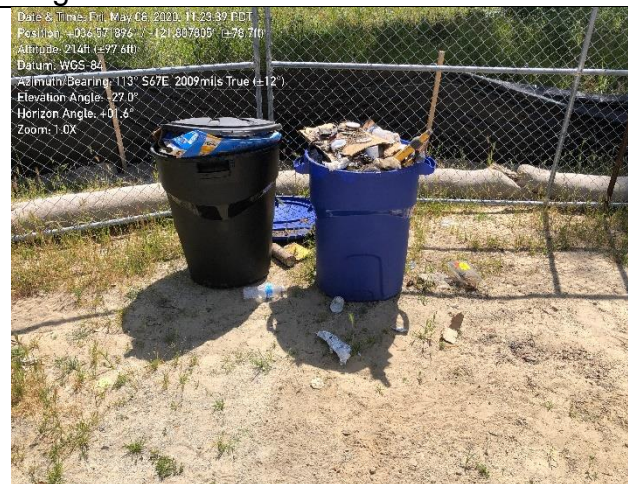
- The work staging and equipment staging area is located at an existing graveled area adjacent to the east side of York Road at Highway 68. Tree protection and silt fencing around the perimeter of the staging area are in good condition.
- ESA noted the following Level 1 Minor Incident:
  - Trash not properly contained within the staging area off York Road. Trash cans observed full and without lids, and trash was observed on the ground within the staging area. ESA monitors reported this to CalAm monitors.

**Photo 4. Trash improperly stored within staging area.**
