memorandum

subject MPWSP – Carmel Valley Pump Station Project Weekly Report (2/08/2021 – 2/12/2021)

Monterey Peninsula Water Supply Project (MPWSP)

Daily Monitoring Log

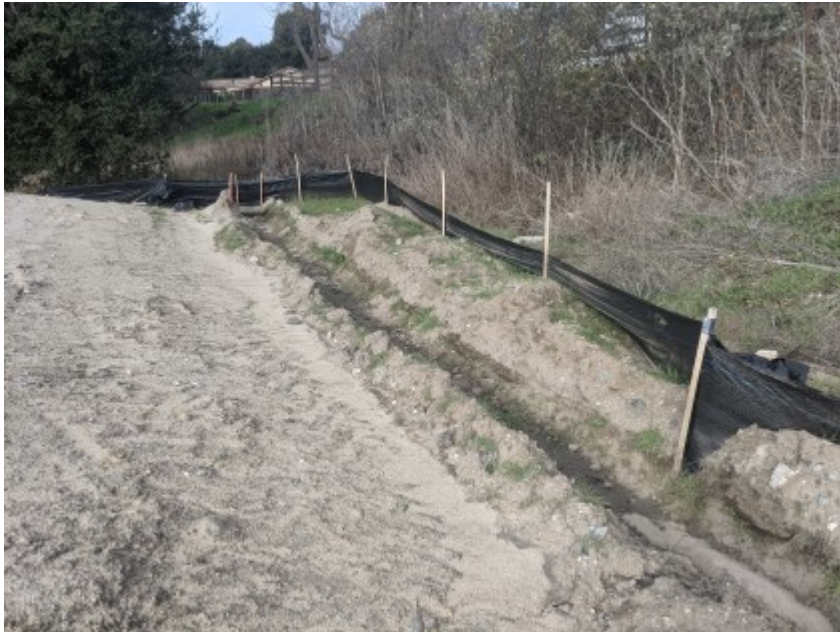
02/09/2021 - Intact exclusionary fencing surrounding work area.

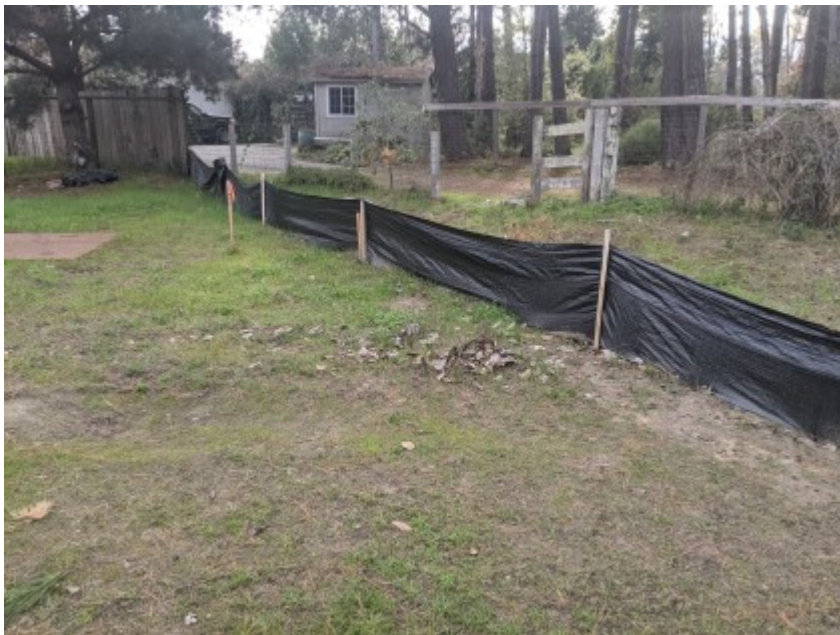
02/09/2021 - Intact exclusionary fencing surrounding work area.

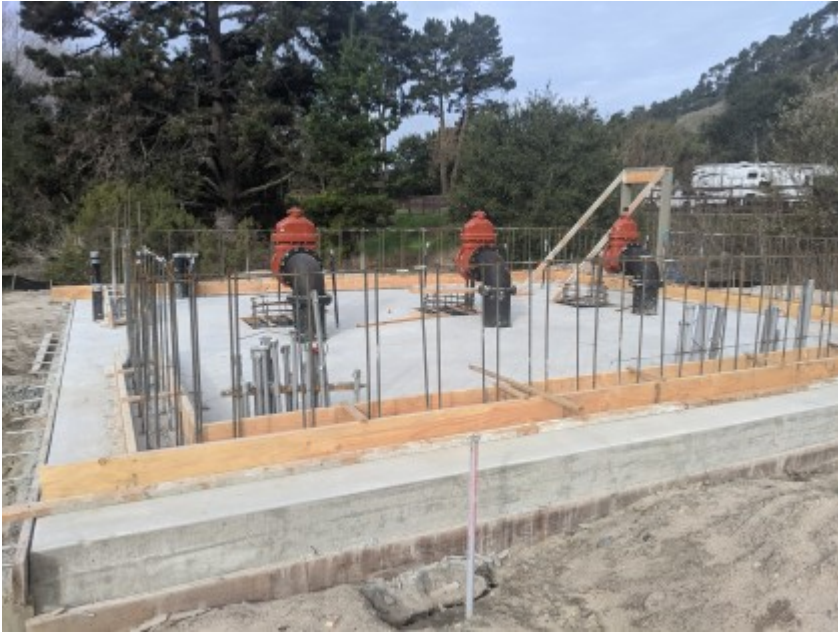
02/09/2021 - Site conditions.

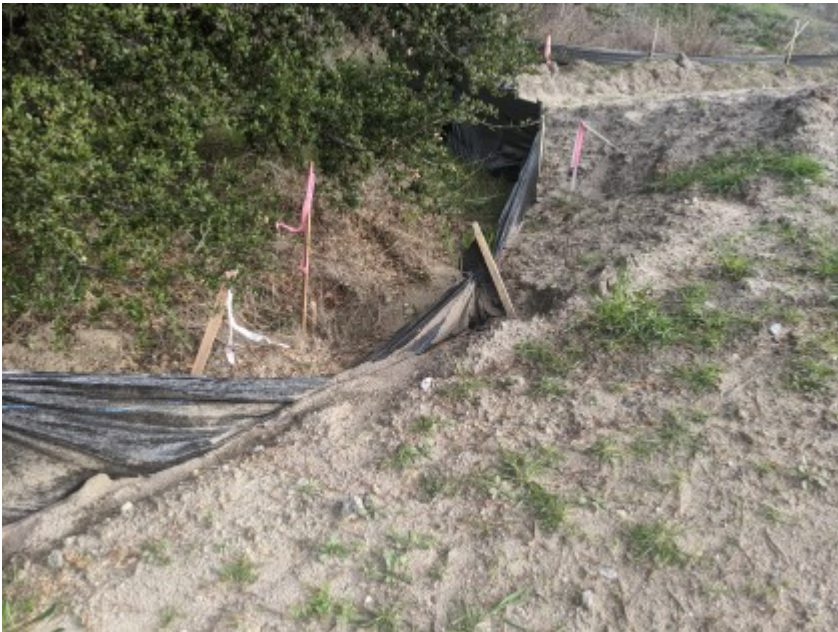
- DD&A compliance monitor inspected the status of exclusionary fencing and proper trash disposal in accordance with Mitigation Measure 4.6-1c.
- DD&A performed ongoing monitoring according to Mitigation Measure 4.6-1a.
- DD&A observed bank erosion within work area damaging exclusionary fencing in need of repair.
- DD&A communicated all identified compliance issues to MPE
- Photographed project site conditions.

02/09/2021 - Section of exclusionary fencing damaged by erosional feature.

- During the weekly progress meeting, DD&A reiterated the need to repair exclusionary fencing to MPE.
- Photographed project site conditions.

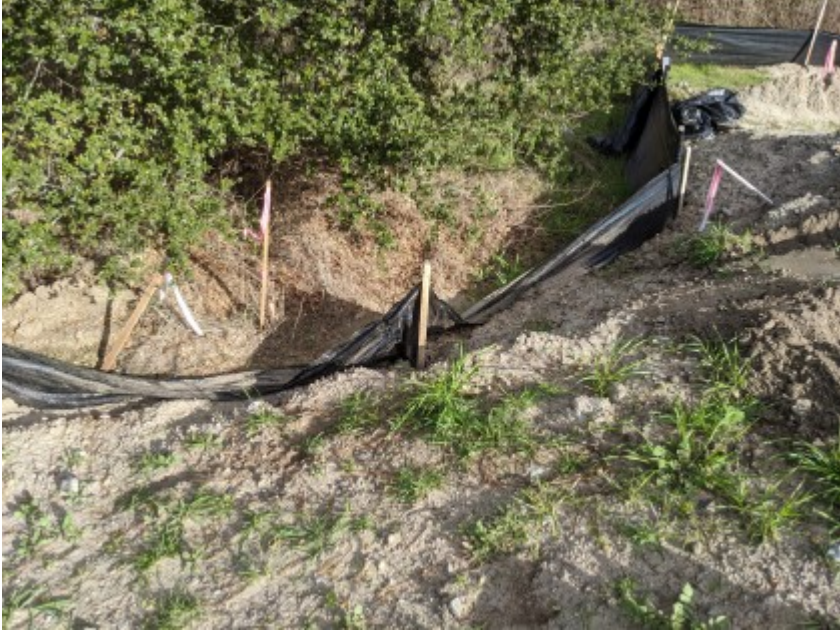
- DD&A compliance monitor observed bank erosion within work area damaging exclusionary fencing.
- DD&A compliance monitor observed section of exclusionary fencing showing signs of deterioration.

02/11/2021 - Section of exclusionary fencing damaged by erosional feature.

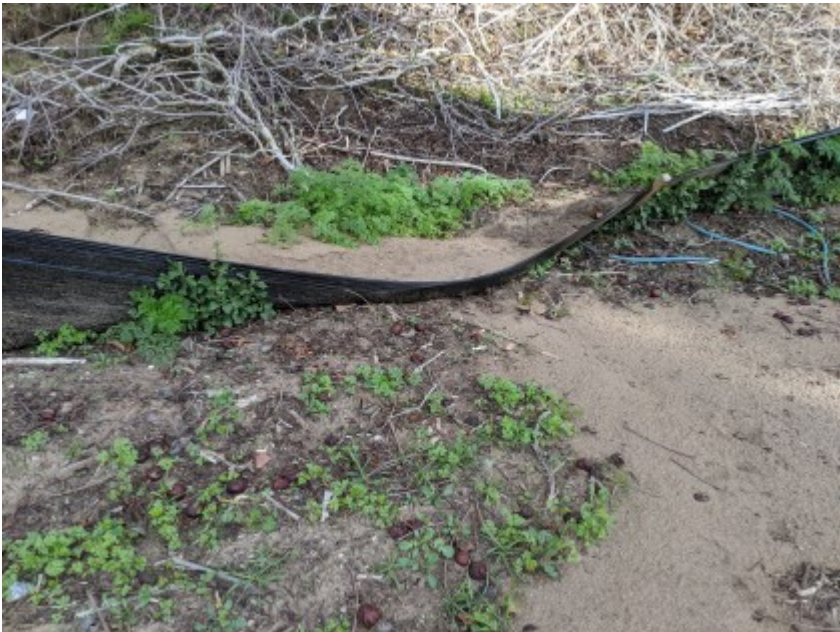
02/11/2021 - Section of exclusionary fencing damaged by erosional feature.

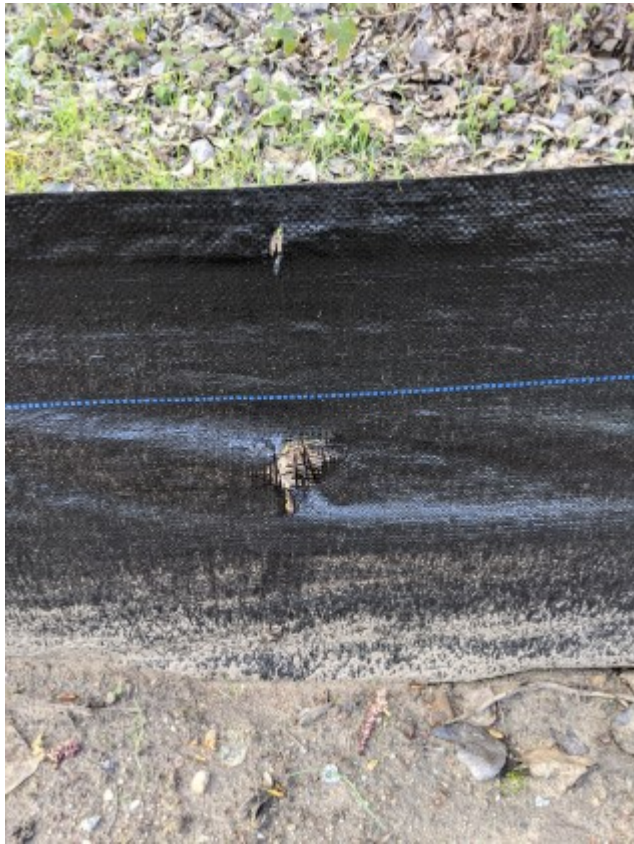
02/11/2021 - Section of exclusionary fencing showing signs of deterioration.

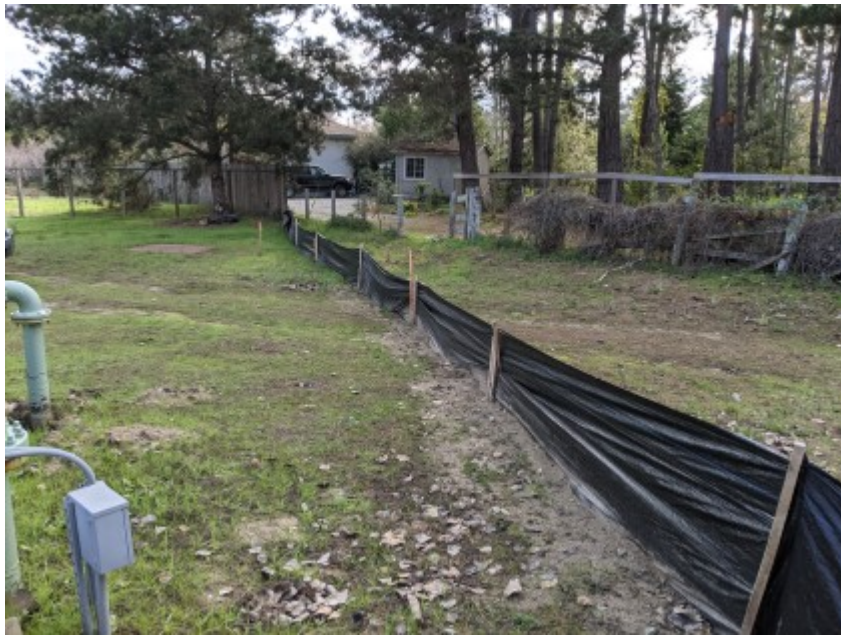
02/11/2021 - Intact exclusionary fencing surrounding work area.

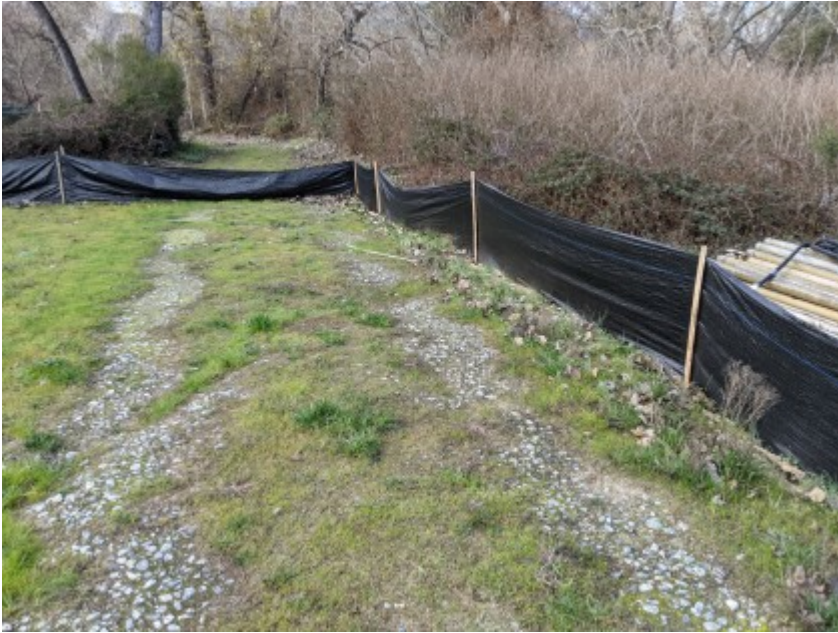
02/11/2021 - Intact exclusionary fencing surrounding work area.

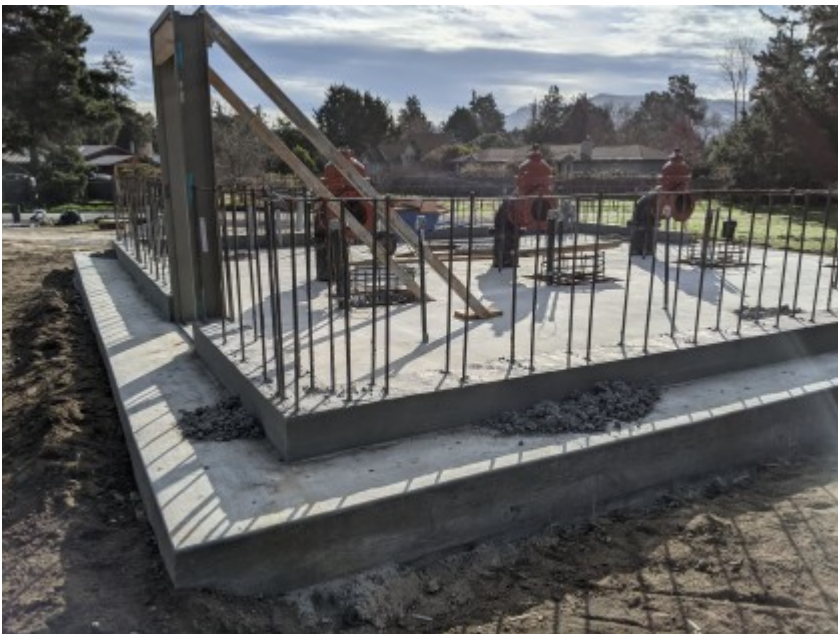
02/11/2021 - Site conditions.

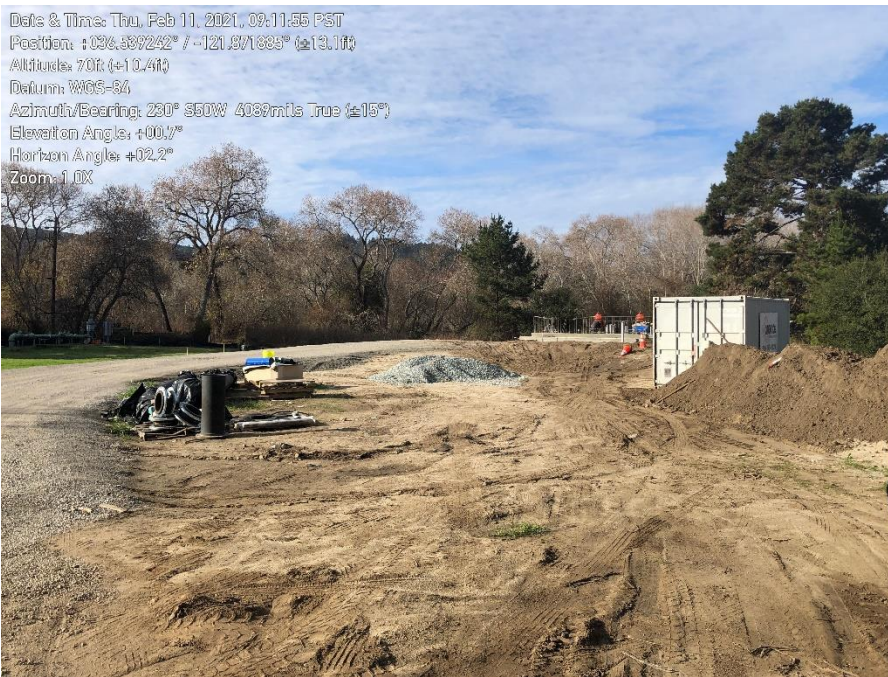
Photo 1. Site conditions.

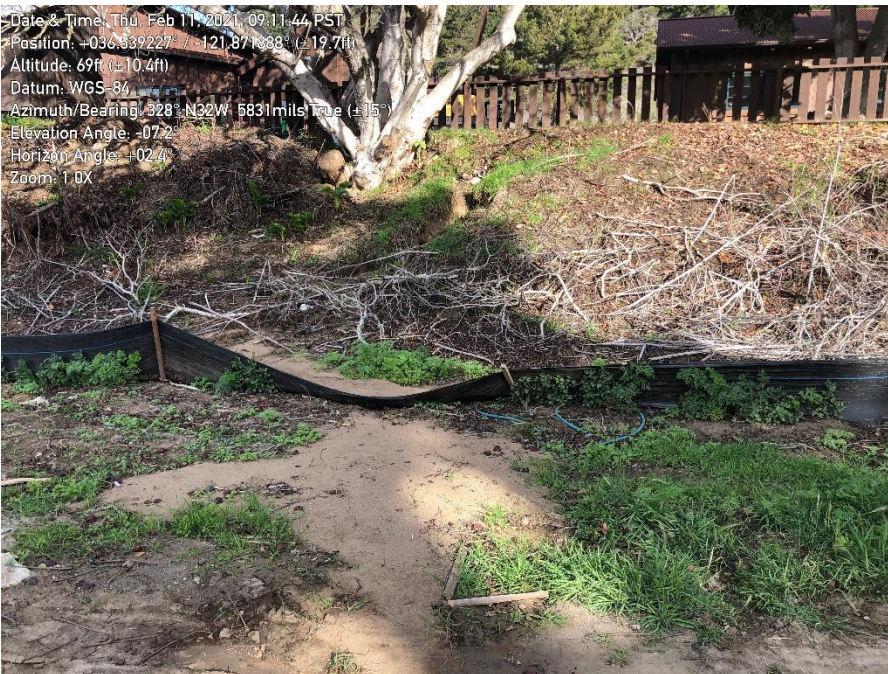
- Silt exclusion fence down in sections along north and west edges. This issue is ongoing and was first noted during the week 1/25/2021 – 1/29/2021. Silt fence is compromised along west border due to a back-up of sediment near pad. Silt fence is down in section along north edge due to erosion caused by water that had flowed from a pipe coming from the neighboring property. ESA recommends that silt fence should be repaired to prevent special-status amphibians from entering the site (**Mitigation Measure 4.6-1o**).

Photo 2. Silt fence compromised due to erosion.

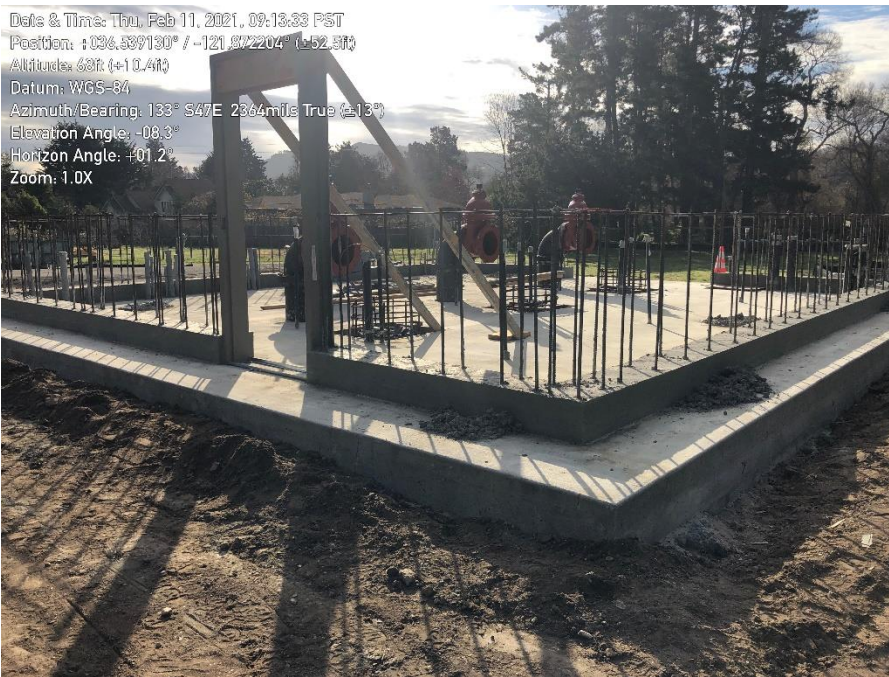
Photo 3. Partially developed pad.

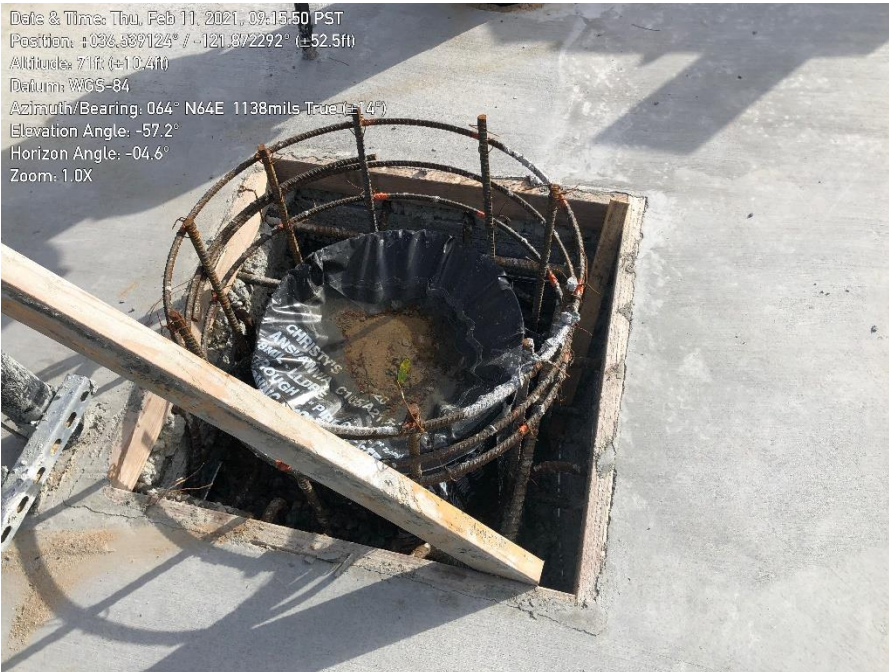
- During site inspections occurring the week of 2/01/2021 – 2/05/2021, ESA and CalAm monitors noted that approximately 2-foot deep holes on top of slab are not covered to prevent entrapment of wildlife. ESA noted that the framing and the slab itself provide a barrier and rebar in the openings provides a

climbable surface for any entrapped wildlife to escape on their own. No animals were observed within these holes. As an additional preventative measure, wooden stakes were placed in these holes at a necessary angle to provide escape ramps for wildlife.

Photo 4. Wooden stakes placed in openings on slab.

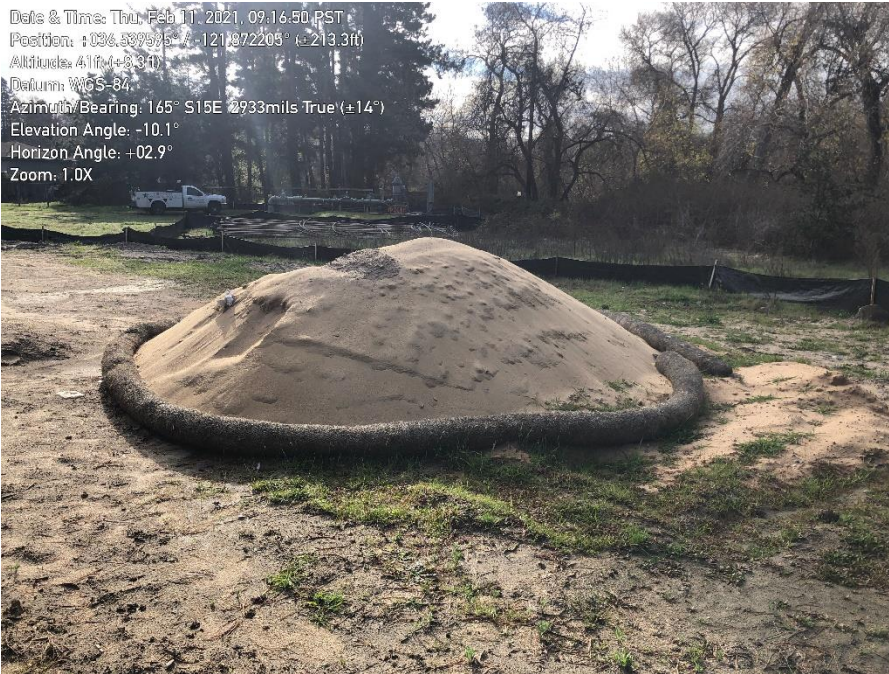
Photo 4. BMPs in place around stock pile.

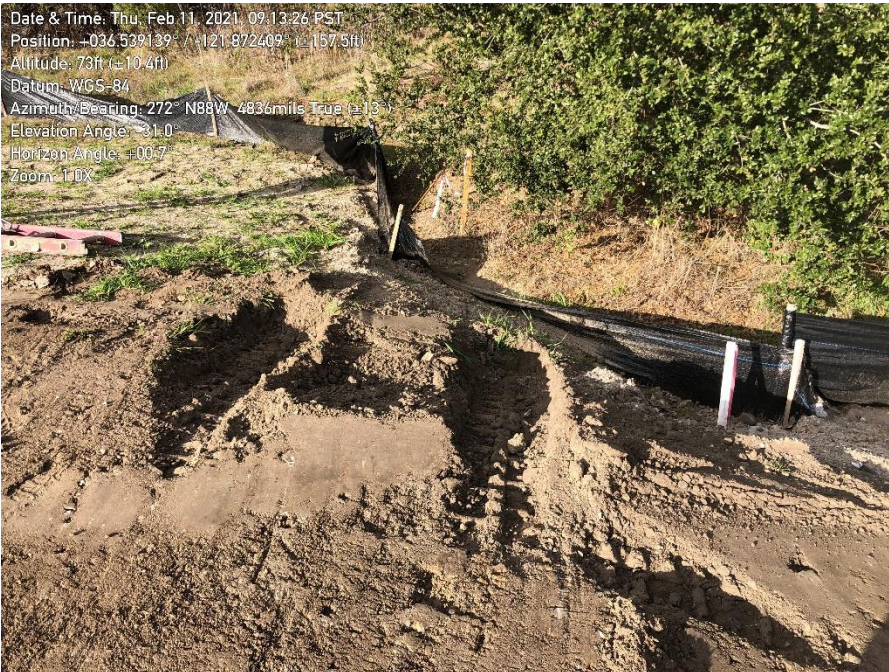
Photo 5. Silt fence down along west edge and in need of repair.
