# memorandum

subject MPWSP – Carmel Valley Pump Station Project Weekly Report (2/22/2021 – 2/26/2021)

## CalAm Weekly Report

## **Monterey Peninsula Water Supply Project (MPWSP)**

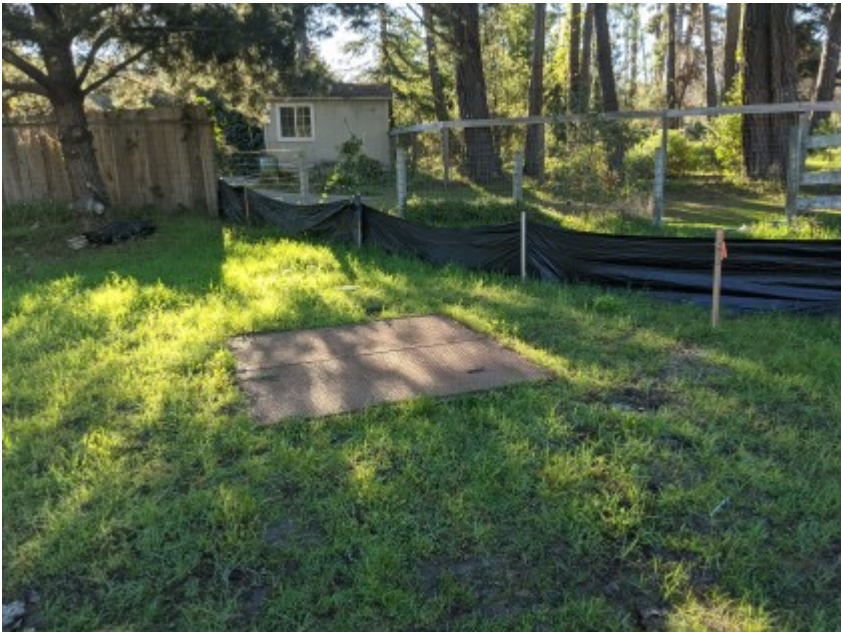
02/22/2021 - Intact exclusionary fencing surrounding work area.

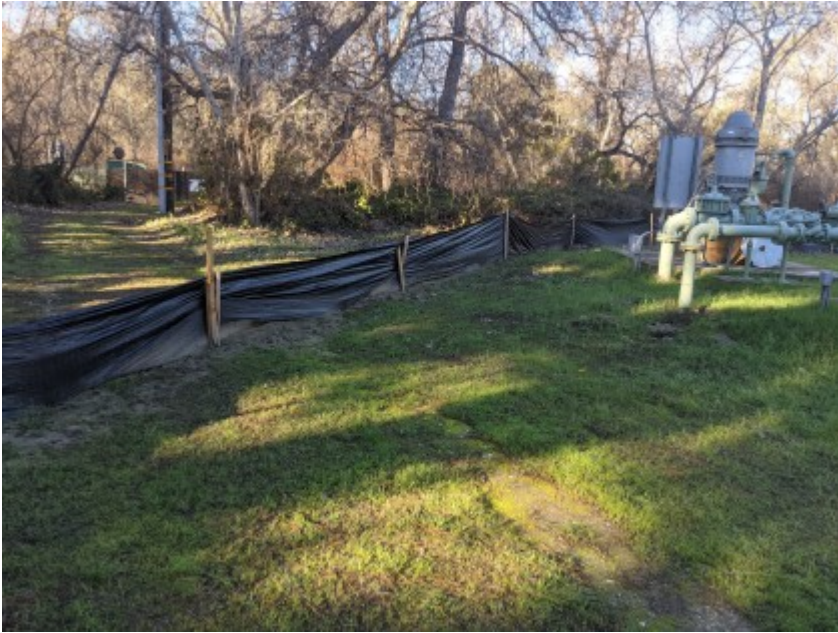
02/22/2021 - Intact exclusionary fencing surrounding work area.

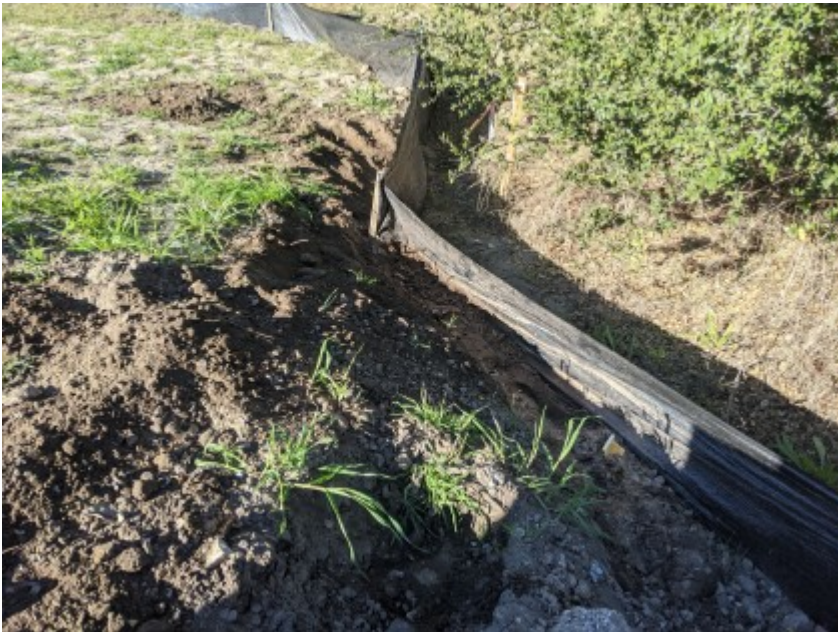
02/22/2021 - Eroded soil cleared from exclusionary fencing surrounding work area.

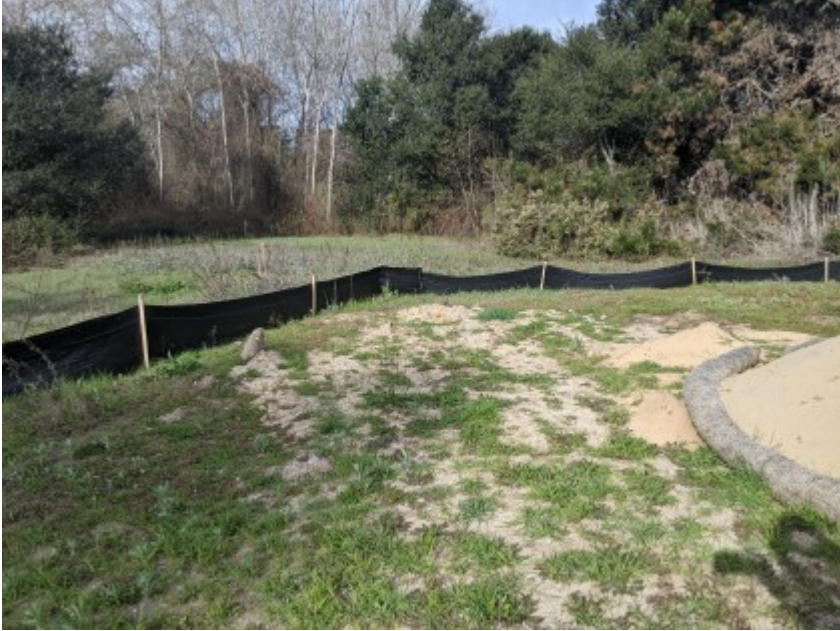
02/23/2021 - Intact exclusionary fencing surrounding work area.

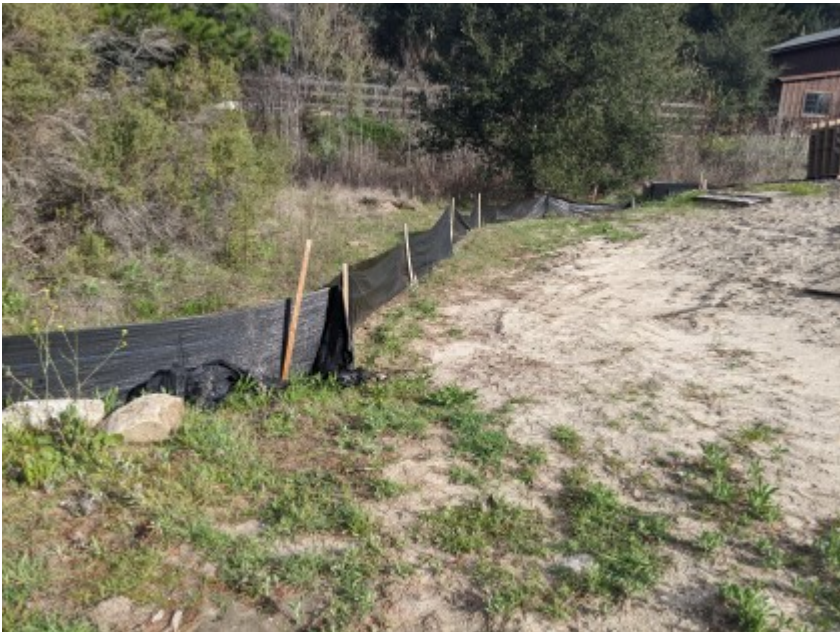
02/23/2021 - Intact exclusionary fencing surrounding work area.

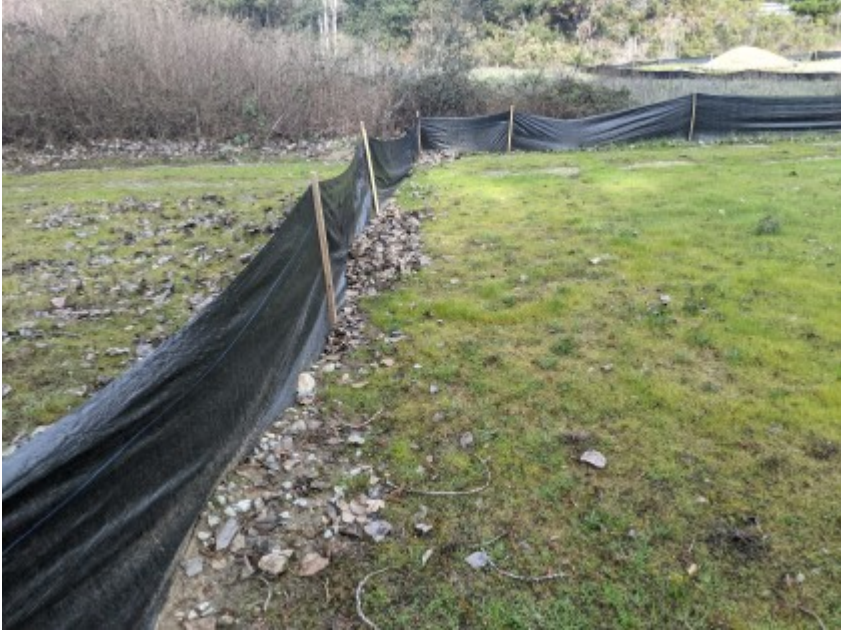
02/23/2021 - Intact exclusionary fencing surrounding work area.

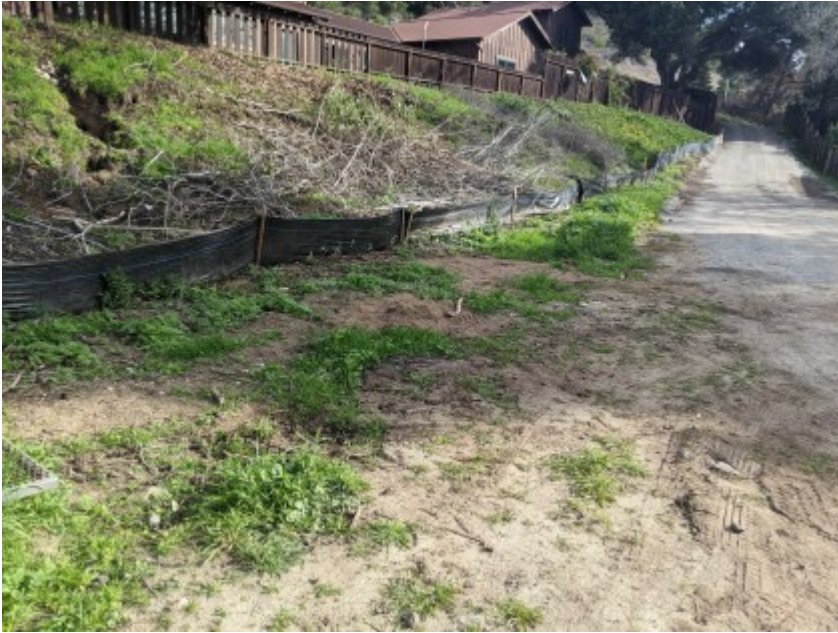
- Silt exclusion fence was down in sections along north and west edges. Silt fence was compromised along the west border due to a back-up of sediment near the pump station pad. Silt fence was also down in a section along north edge due to erosion caused by water that had flowed from a pipe coming from the neighboring property. ESA recommended that silt fence should be repaired to prevent special-status amphibians from entering the site (**Mitigation Measure 4.6-1o**). ESA and CalAm monitors confirmed on 2/25/2021 that the silt fence had been repaired in both sections and that all fenced areas were in accordance with Mitigation Measure 4.6-1o.

02/25/2021 - Confirmed repair of damaged exclusionary fencing surrounding work area.

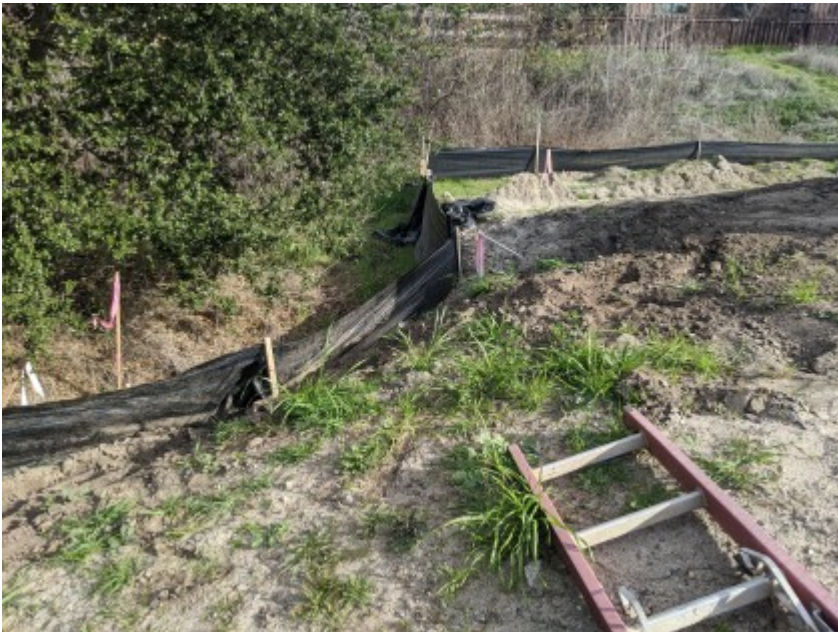
02/25/2021 - Confirmed repair of damaged exclusionary fencing surrounding work area.

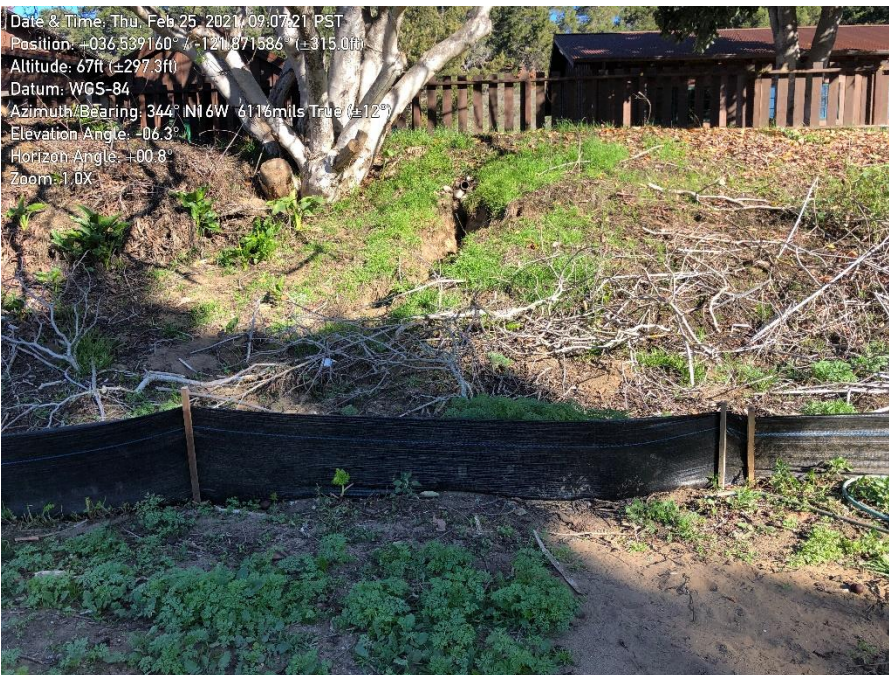
- The following compliance issue was noted by ESA on 1/27/2021 and has been resolved:
  - Silt exclusion fence down in sections along north and west edges. Silt fence is compromised along west border due to a back-up of sediment near pad. Silt fence is down in section along north edge due to erosion caused by water that had flowed from a pipe coming from the neighboring property. Silt fence should be repaired to prevent special-status amphibians from entering the site (Mitigation Measure 4.6-1o). CalAm monitors have confirmed they have discussed this need with the contractor.

Photo 2. Silt fence repaired after being compromised due to erosion.

- ESA noted that these areas have been repaired. Sediment has been removed where backed up along silt fence and fence has been reinstalled to adequately prevent special-status amphibians from entering into the site.

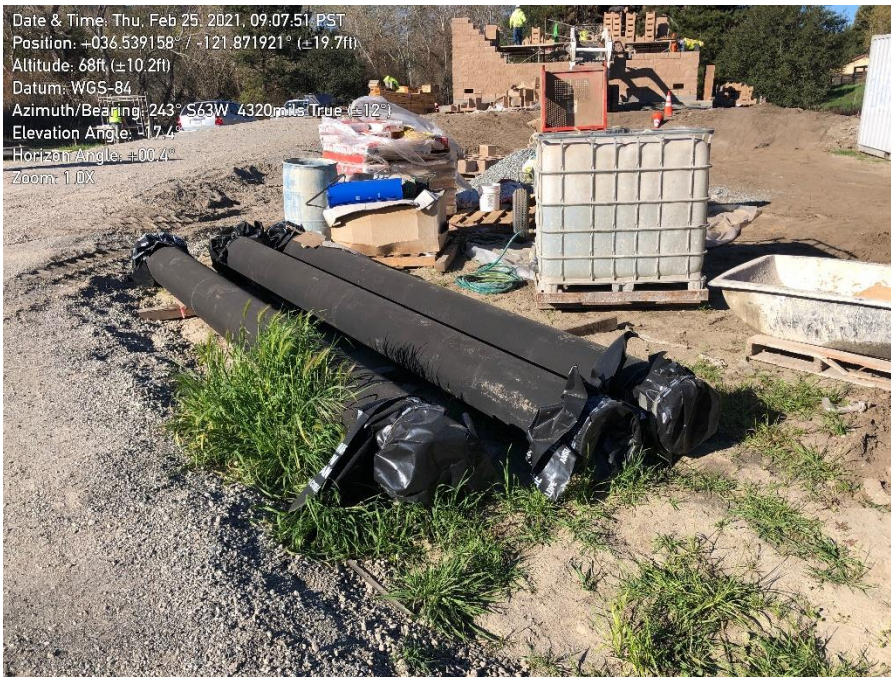
- CalAm monitor onsite to conduct weekly site inspection.
- BMPs around stock pile in place (Mitigation Measure 4.6-1o).
- Pipes in work area were capped as required by Mitigation Measure 4.6-1o.

Photo 3. Pipes capped.

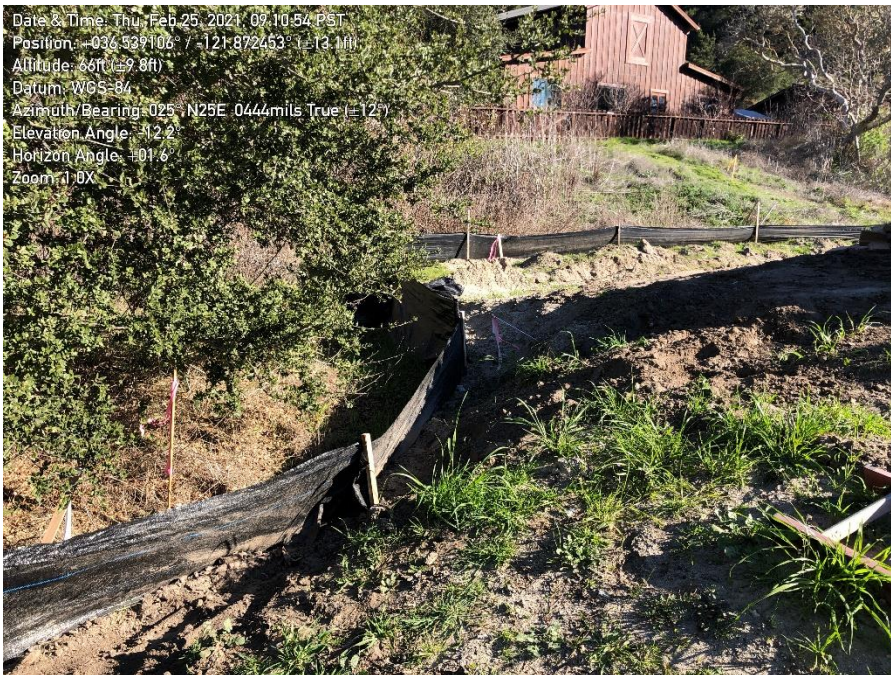
Photo 4. Silt fence along west border repaired.
