memorandum

subject MPWSP – Carmel Valley Pump Station Project Weekly Report (4/19/2021 – 4/23/2021)

CalAm Weekly Report

Daily Monitoring Log

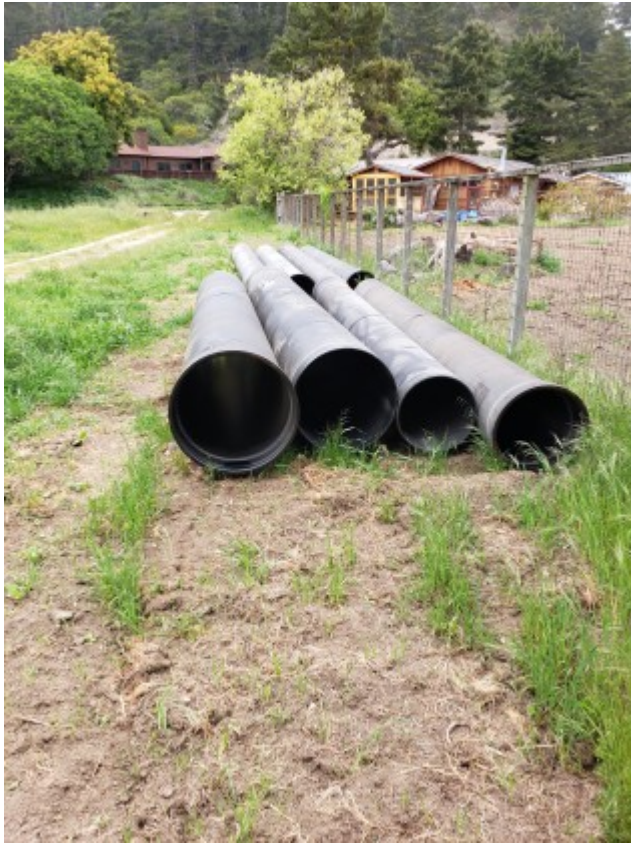
04/22/2021 - Staged pipeline.

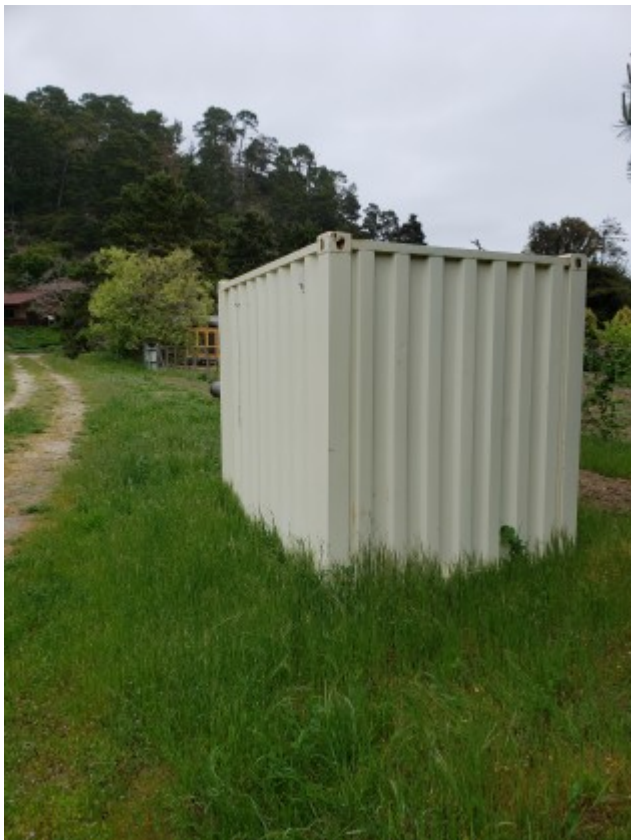
04/22/2021 - Storage box.

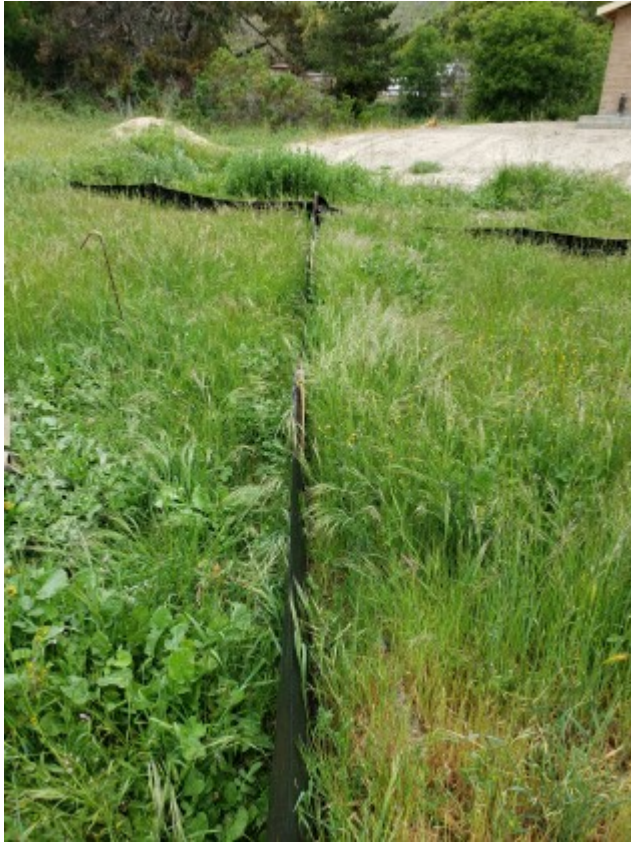
4.6-1c. 6. Fueling of construction equipment within existing paved areas and at least 50 feet from drainages and native habitats?	Yes	
4.6-1c. 7. Introduction of exotic plant species avoided through physical or chemical removal and prevention?	Yes	Manual vegetation removal along exclusion fencing completed two weeks prior. Exclusion fence partially damaged and will require repair. DD&A discussed fencing repair and additional vegetation removal with Project Contractor. Project Contractor to schedule crew and coordinate with DD&A.

04/22/2021 - Recommend vegetation removal on exclusion fence.

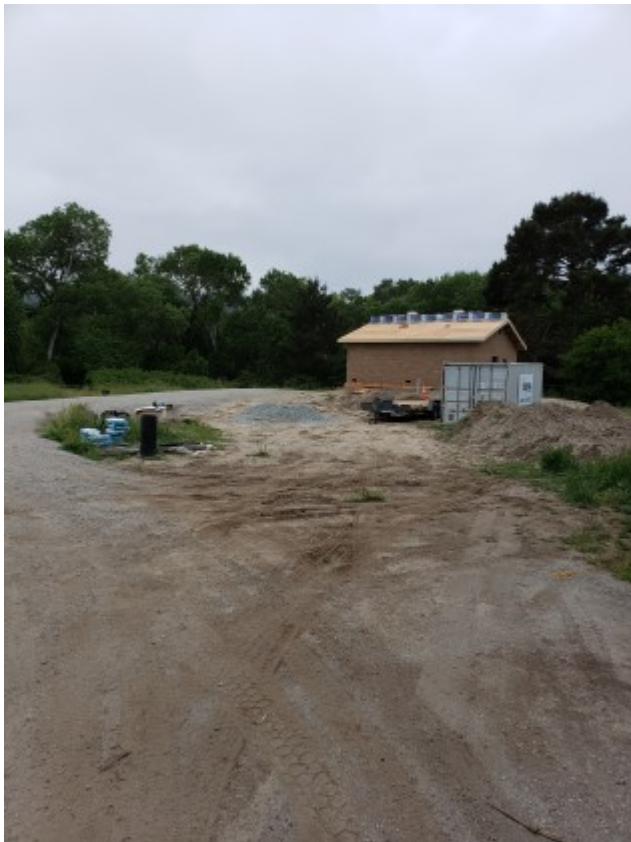
04/22/2021 - Typical site conditions.

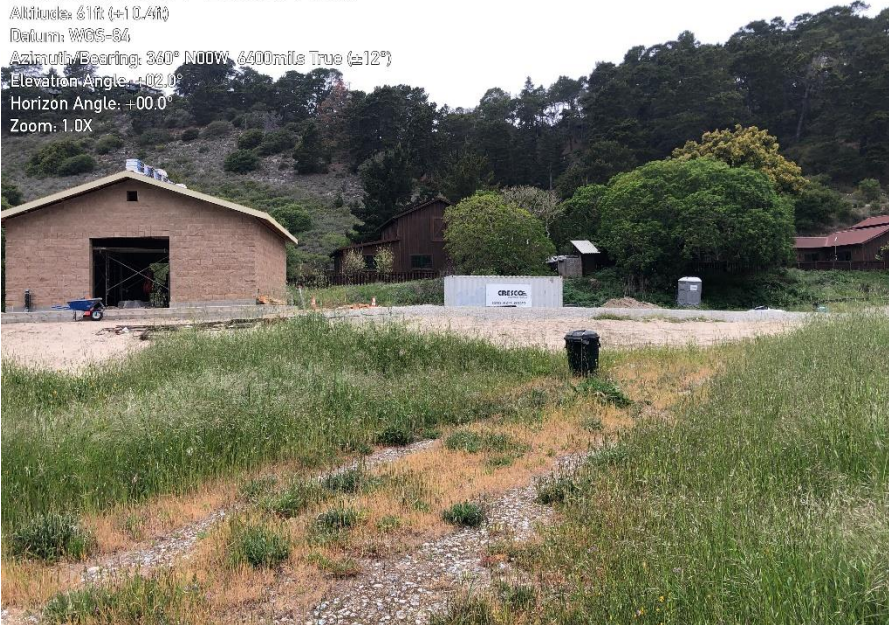
Photo 1. Pump station and overall site conditions.

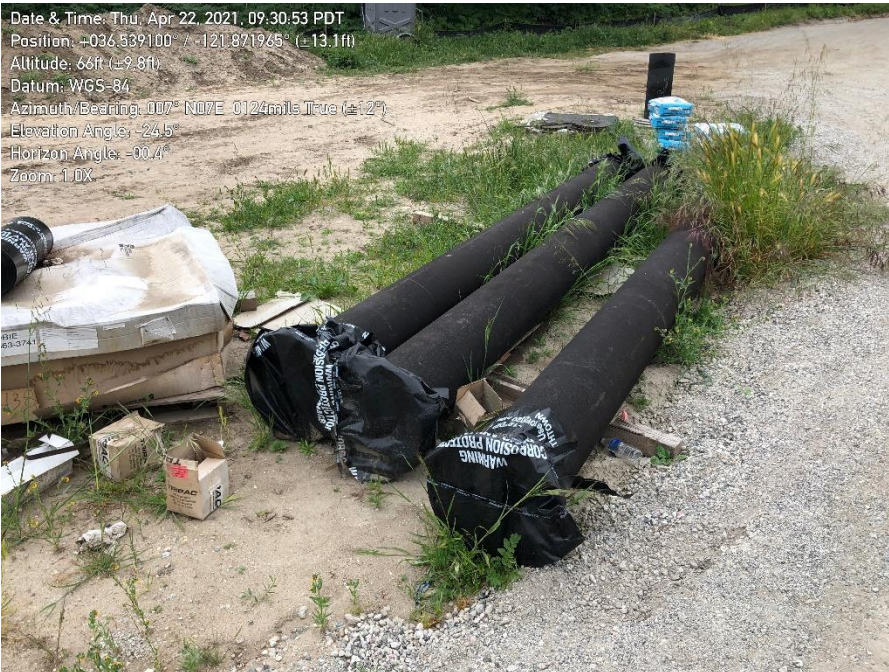
Photo 2. Capped Pipes.

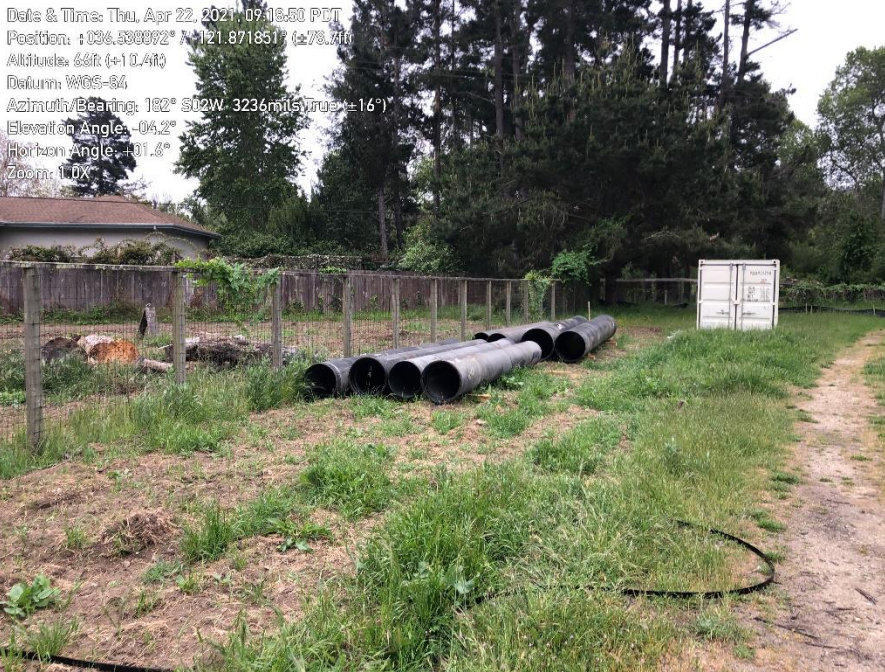
- BMPs around stock pile in place (Mitigation Measure 4.6-1o).
- Some pipes in work area were capped as required by Mitigation Measure 4.6-1o. Newly delivered pipes are not capped and should be inspected by biologist prior to be installed.
- Invasive hemlock growing along silt fence at the north border has been mowed.
- No evidence of project activity outside of approved area.
- No leaking equipment or hazardous materials storage issues observed.
- The following compliance issues were noted by ESA, and originally observed on 4/9/2021:
 - Silt fence has minor damage from recent weed control activities. Tears along silt fence should be repaired to prevent special-status amphibians from entering the site.
 - Wattle around stockpile was plastic monofilament. ESA recommends amphibian friendly wattles be installed at this site due to close proximity to river.

Photo 3. Uncapped pipes should be inspected prior to moving.

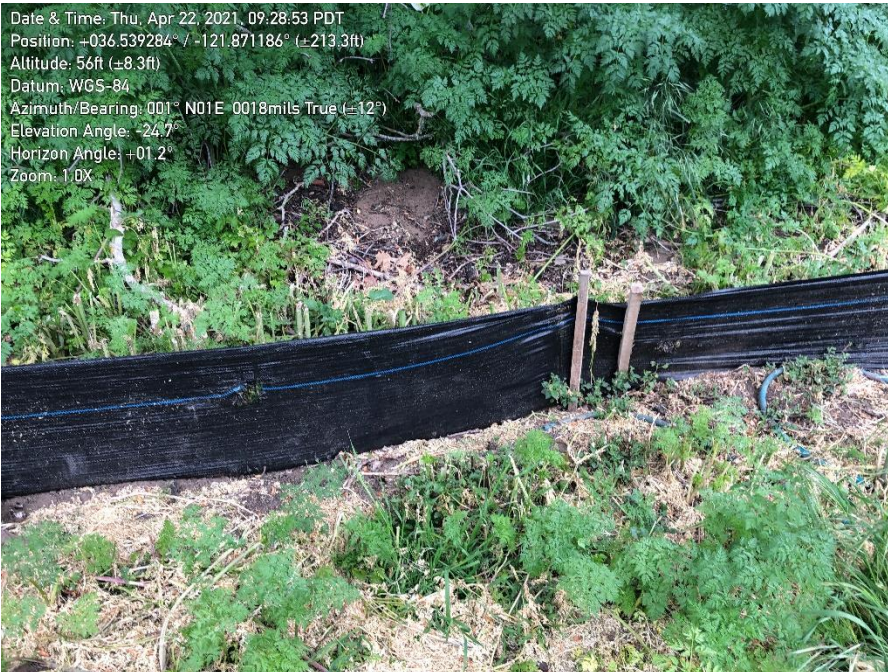
- Small sections of fence in along the north border of the site were damaged during weed removal activities targeting overgrowth of invasive hemlock (*Conium maculatum*). Repair of these sections of exclusion fence are required to prevent any special-status species from entering the site.
- ESA noted that straw wattle encased in monofilament netting is installed on the site. Per **Mitigation Measure 4.6-1p**, “Only certified, weed-free, plastic-free imported erosion control materials (or rice straw in upland areas) shall be used for the project.” ESA recommended that only amphibian-friendly wattles or other BMPs be used on the site.

Photo 4. Tear in silt exclusion fence due to weed control activities.

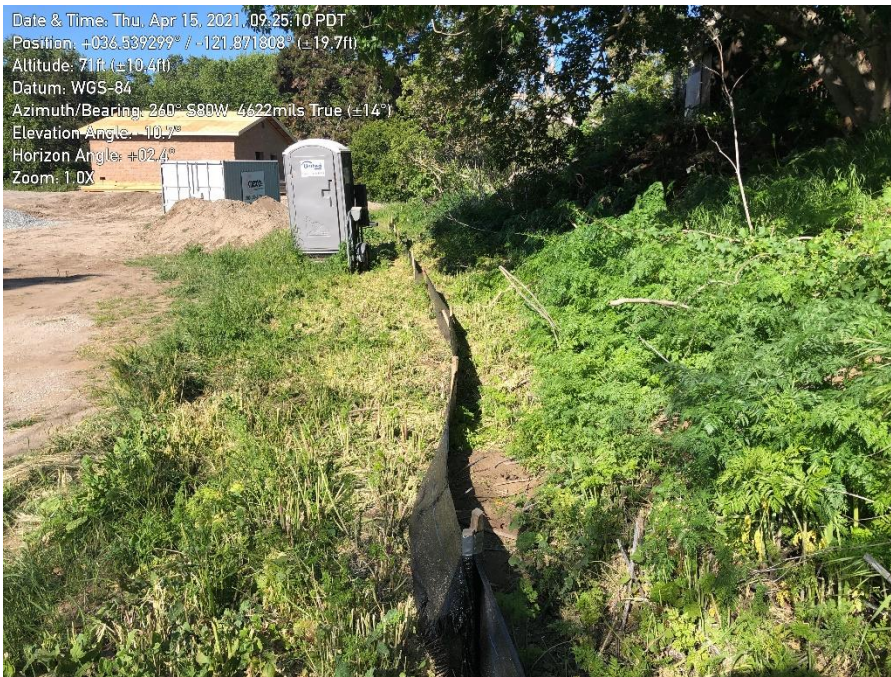
Photo 5. Hemlock growing along north border of site has been mowed.
