subject MPWSP – Carmel Valley Pump Station Project Weekly Report (5/31/2021 – 6/04/2021)

CARMEL VALLEY PUMP STATION PROJECT

RE-INITIATION OF CONSTRUCTION NESTING BIRD SURVEY AND MONITORING REPORT

Date: 6/02/2021**Time:** 12:00 – 12:40**Report Code:** MPWSP_20210602_sd**Project Site:** Carmel Valley Pump Station**Compliance Level:**Acceptable Level 0: Unanticipated Event Level 1: Minor Incident
Level 2: Moderate Incident Level 3: Major Incident **Compliance Advisory or Non-Compliance form attached** Yes
No **Photo Documentation** Yes
No **Type of Monitoring:**Full-time Spot-check SWPPP inspection
Biological Re-inspection **Construction Activity(s) Being Monitored:**

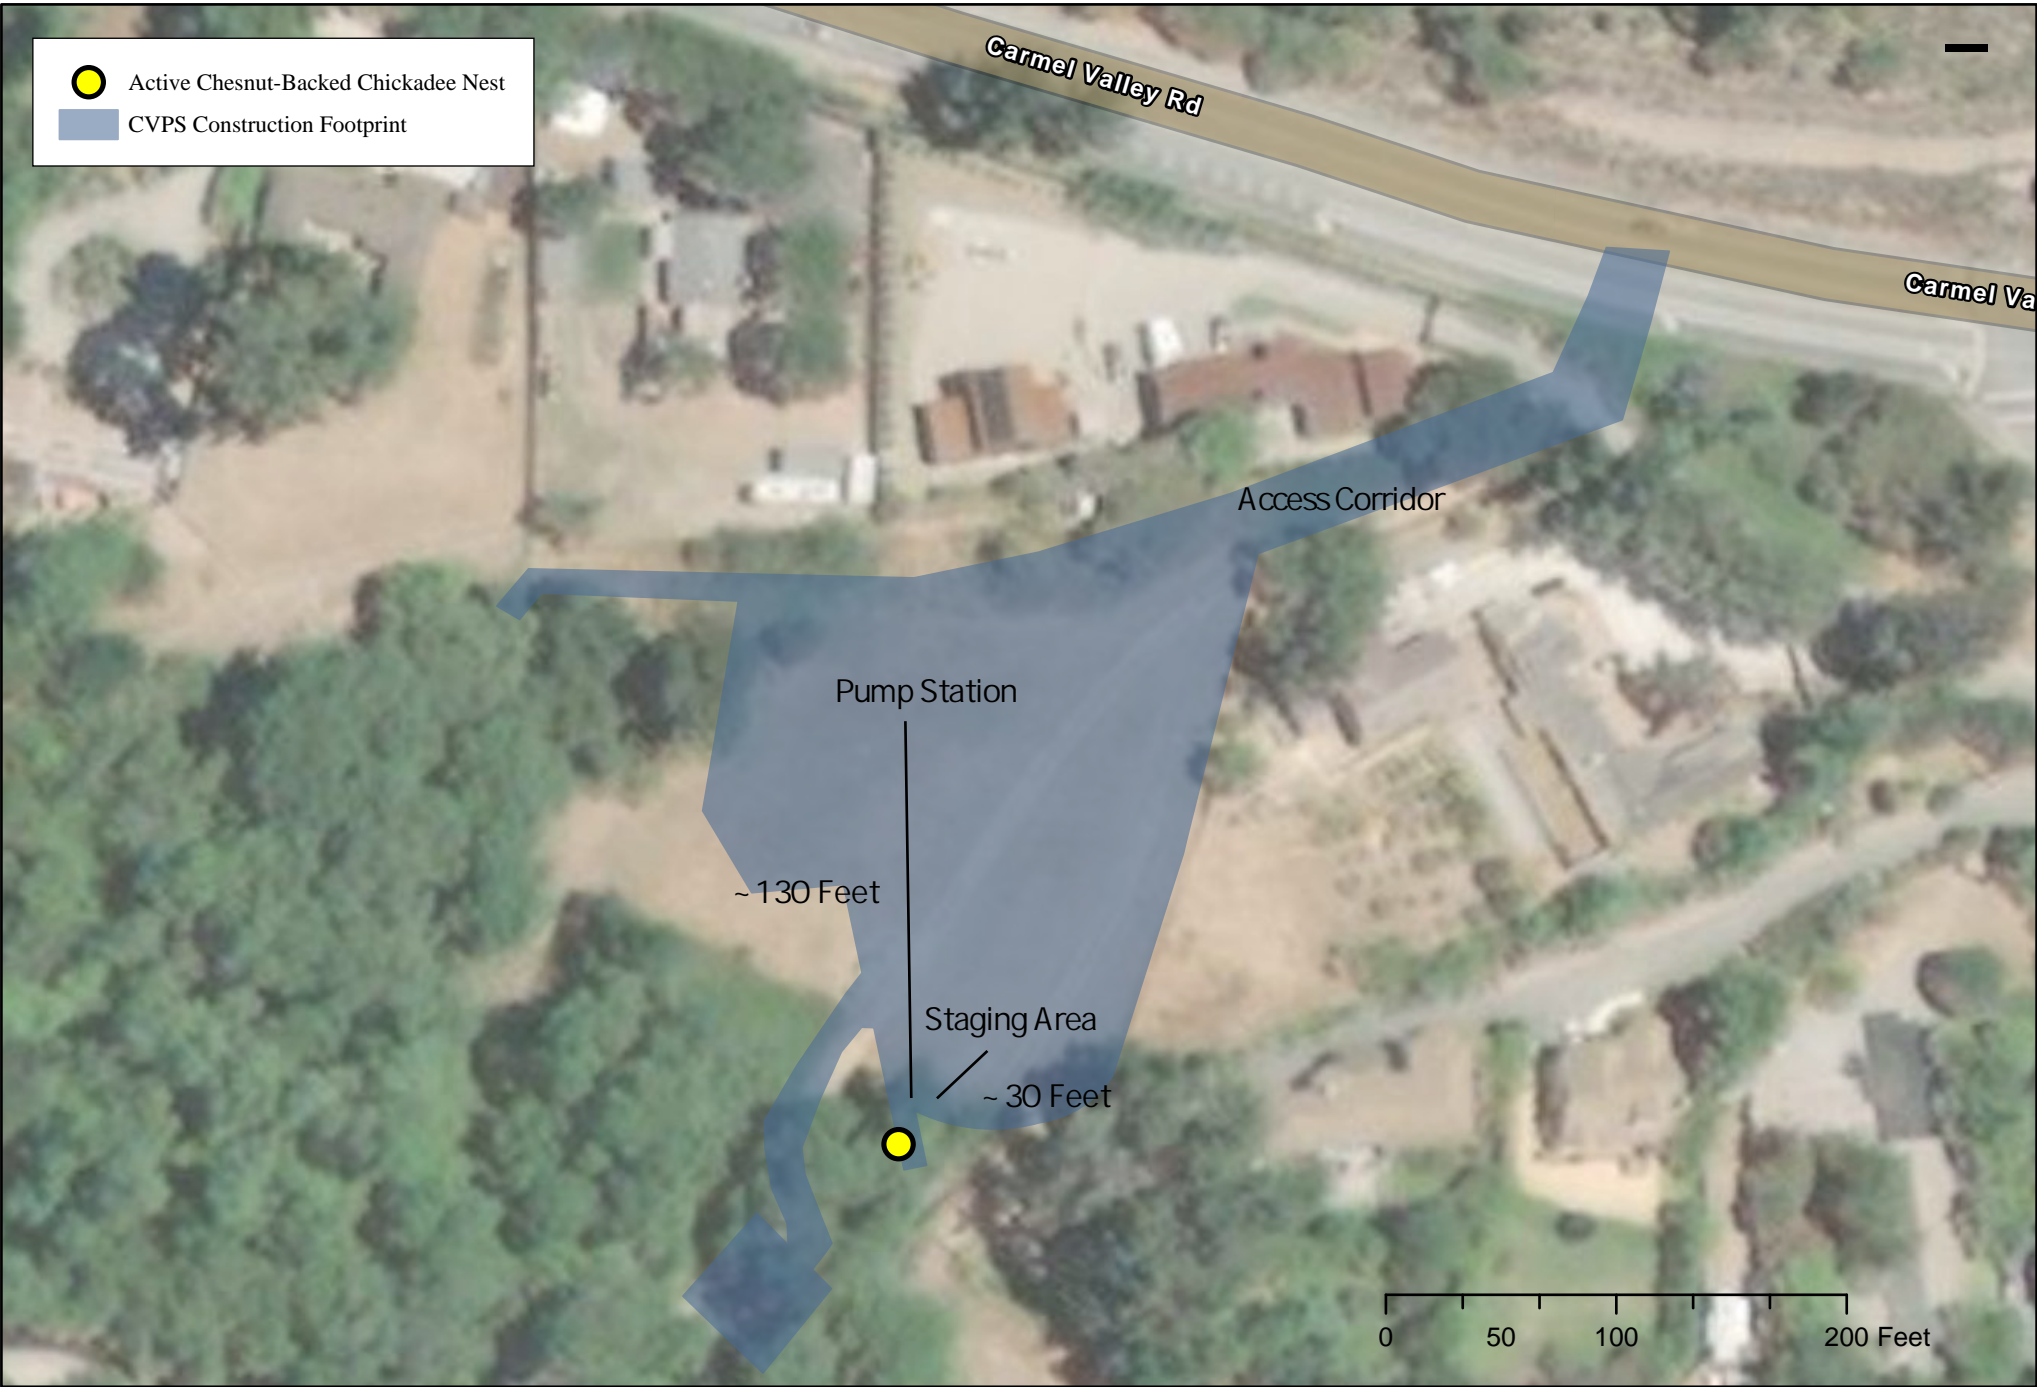
Figure
2

Pre-construction nesting bird species surveys were conducted within the nesting bird survey area for the Project on May 28, 2021. An active chestnut-backed chickadee (*Poecile rufescens*) nest was identified inside of a bird box approximately 30 feet from the CVPS staging area and 130 feet from the CVPS active construction zone (**Figure 2. Nesting Bird Survey Results**).

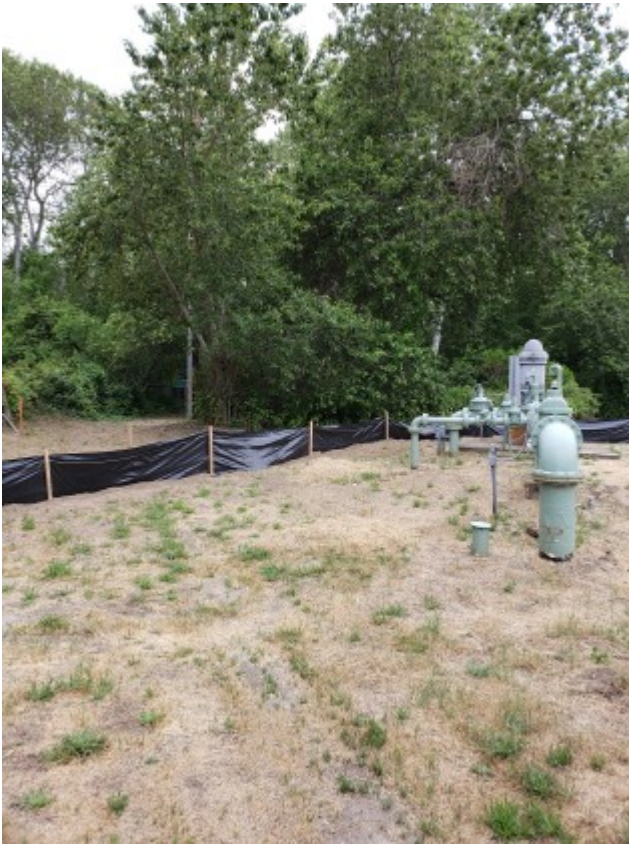
05/28/2021 - Active nest adjacent to located outside of exclusion fencing.

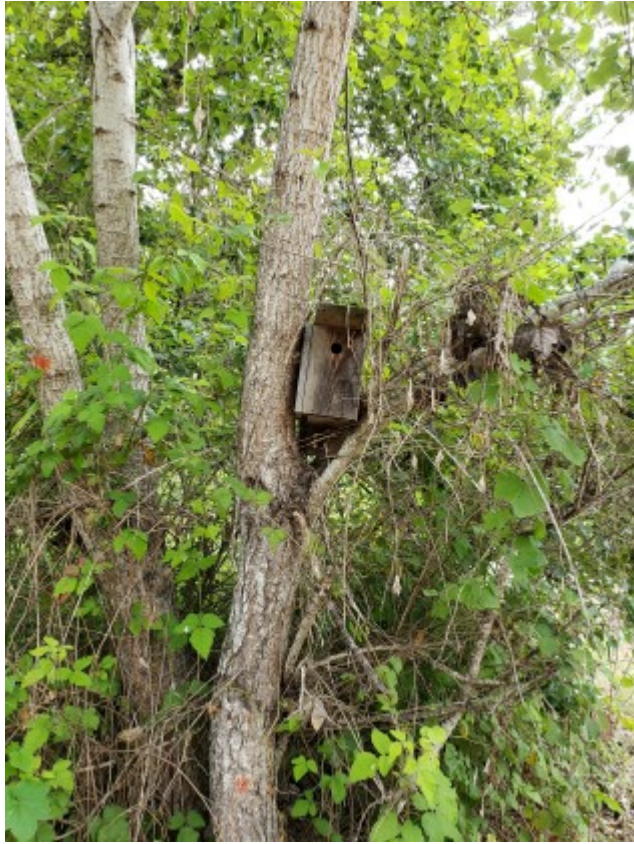
05/28/2021 - Active nest outside of exclusion fencing.

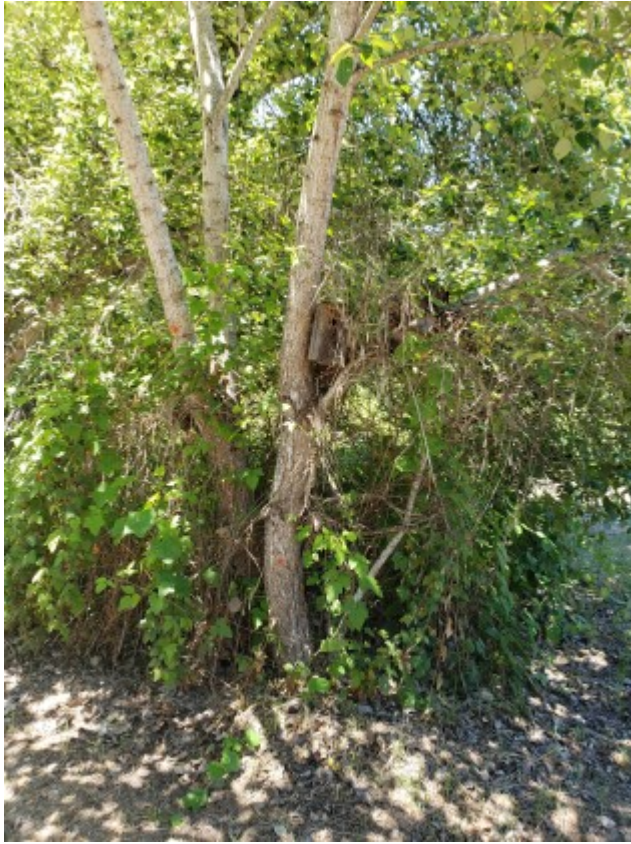
06/02/2021 - Confirmed active nest still intact and undisturbed by project activities.

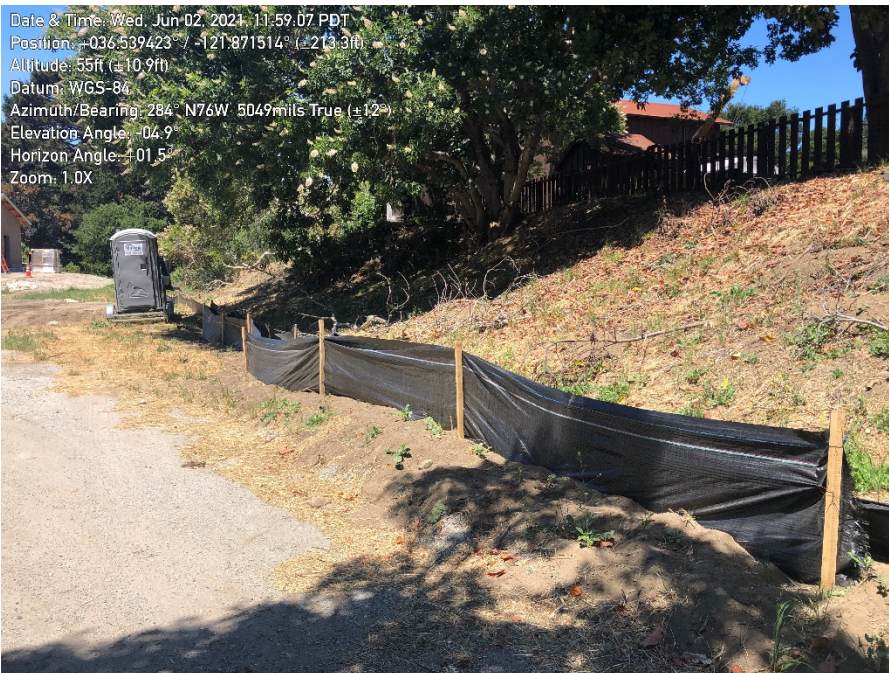
Photo 2. Exclusion fencing in acceptable condition.

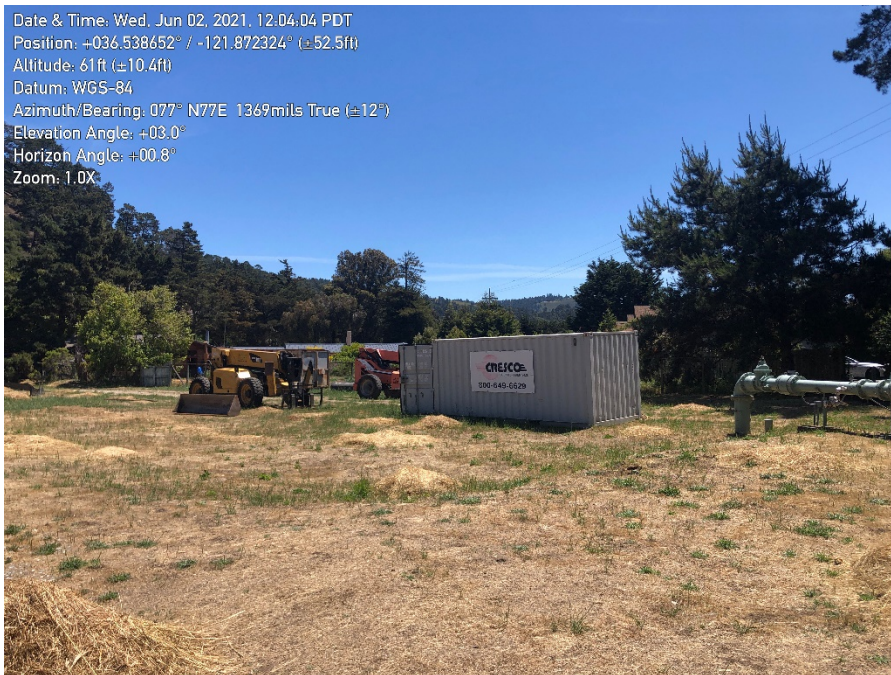
Photo 3. Equipment parked within approved project boundary and exclusion fence.
