memorandum

subject MPWSP – Carmel Valley Pump Station Project Weekly Report (8/16/2021 – 8/20/2021)

Monterey Peninsula Water Supply Project (MPWSP)

Daily Monitoring Log

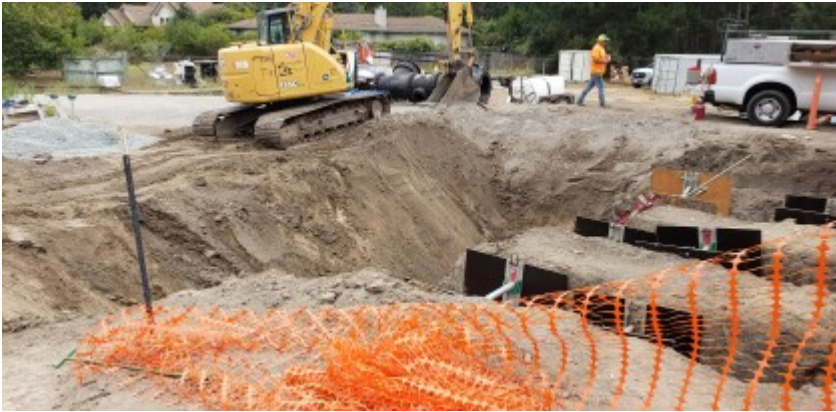
08/17/2021 - Suction manifold installation pit.

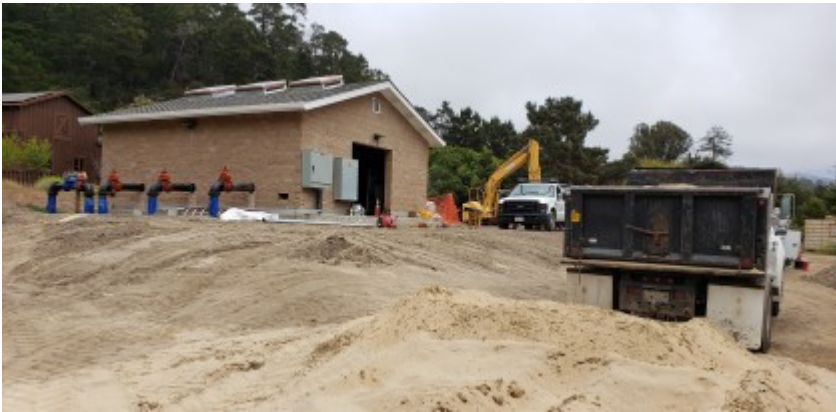
08/17/2021 - Site conditions.

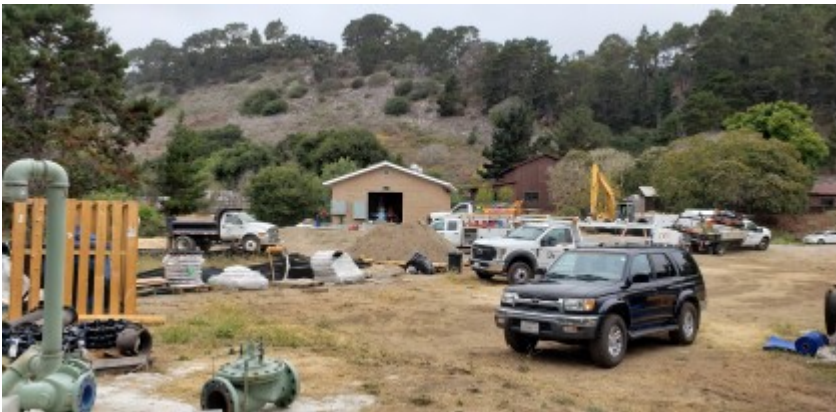
08/17/2021 - Site conditions.

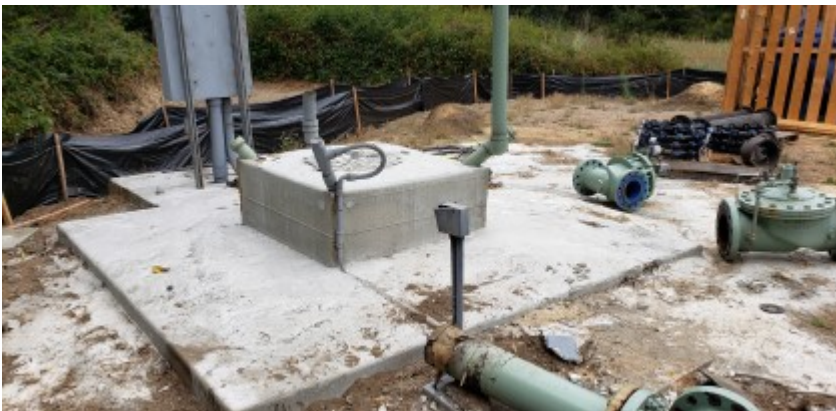
The remains of excess bentonite clay from closure of an existing well is located within the project area and is separated from the Carmel River by silt fence. Regardless, this material should be removed prior to any rain events to ensure that it cannot spread to any aquatic features.

08/17/2021 - Bentonite has not been removed yet, DD&A reminded project contractor that this area needs to be cleaned prior to any precipitation events.

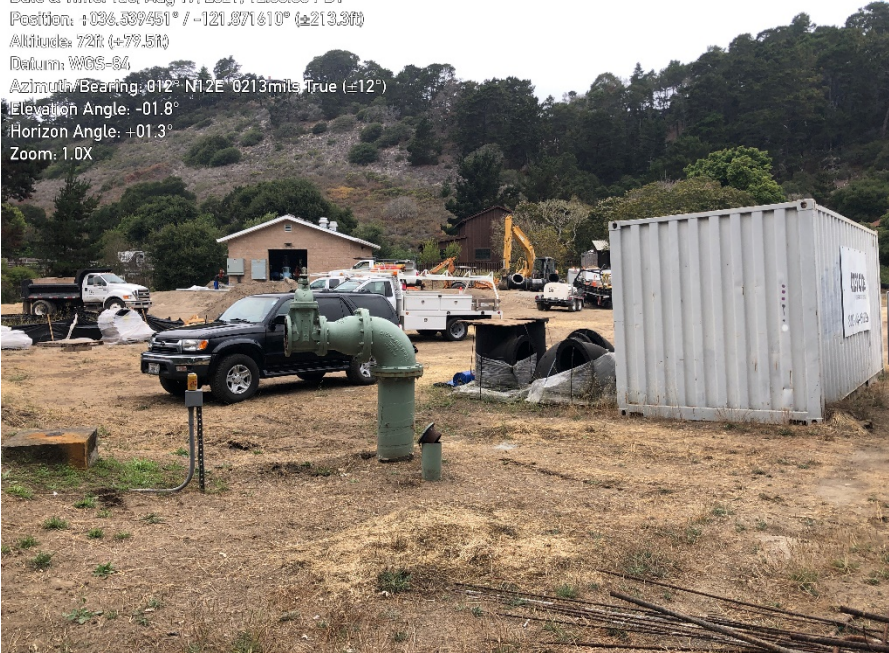
Photo 1. Site conditions.

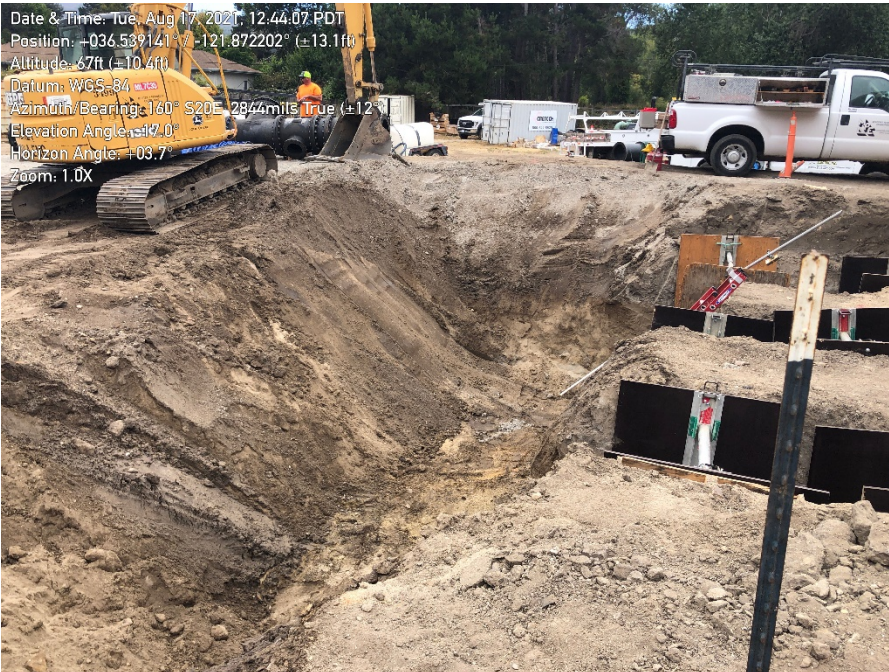
Photo 2. Trenches ramped to prevent wildlife entrapment.

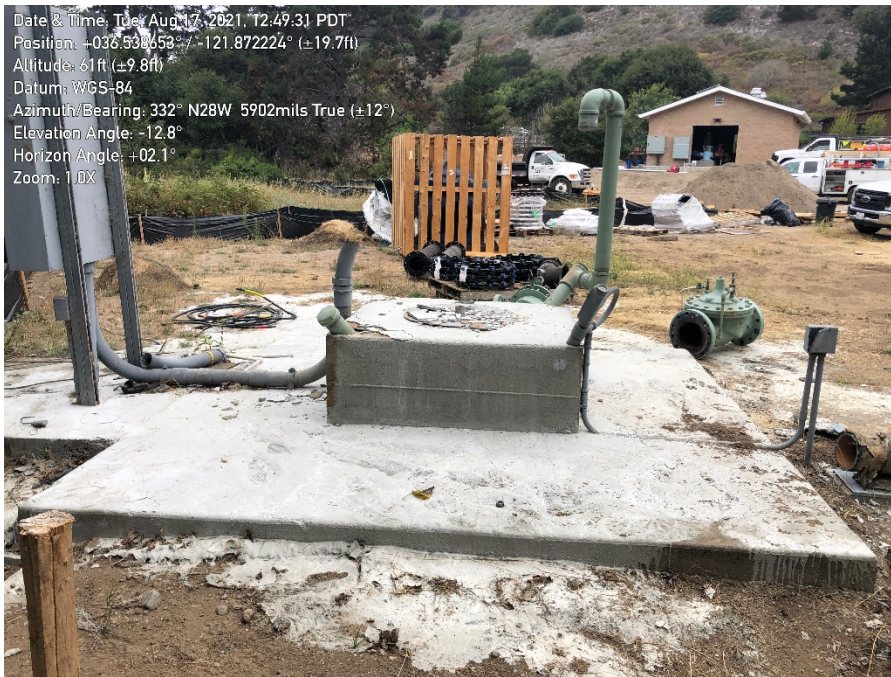
Photo 3. Excess bentonite from well closure remains on site.
