# memorandum

subject MPWSP – Carmel Valley Pump Station Project Weekly Report (11/29/2021 – 12/03/2021)

### CalAm Weekly Report

### **CPUC Inspection Logs**

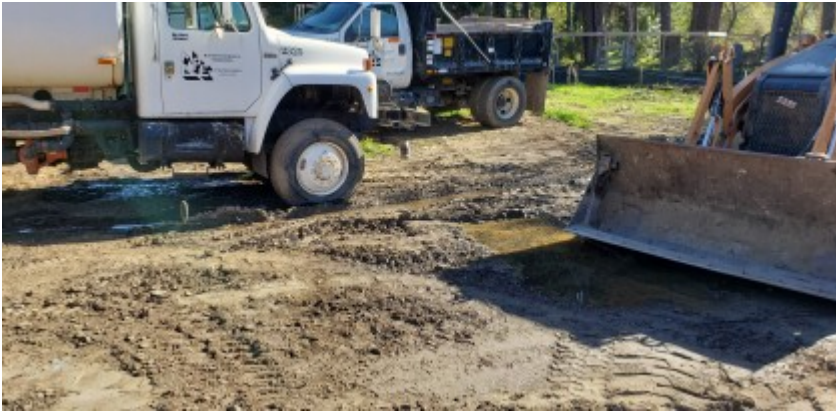
11/29/2021 - Water truck still leaking, standing water on-site.

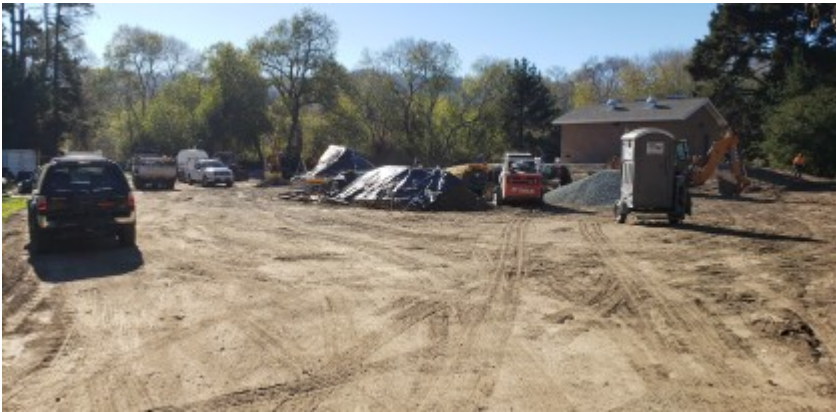
11/29/2021 - Site conditions. Advised CM to apply water for dust control.

ESA and the CalAm monitor observed a minor amount of fugitive dust due to site grading activities during the 12/2/2021 site visit (**Mitigation Measure 4.10-1c**). The CalAm monitor discussed this issue with the MPE project manager, who agreed to water the site for dust control.

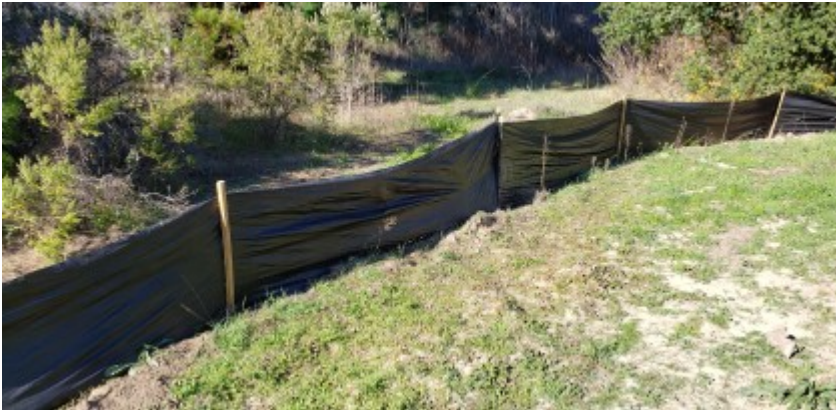
11/29/2021 - Contractor repairing exclusion fence while on site.

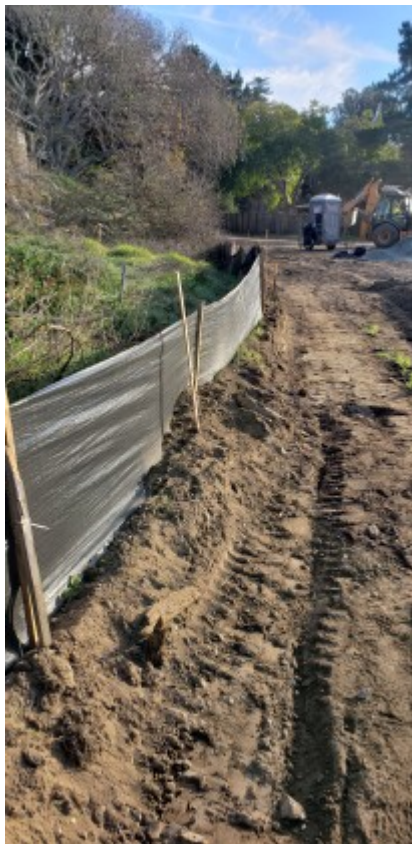
12/02/2021 - Repaired exclusion fence.

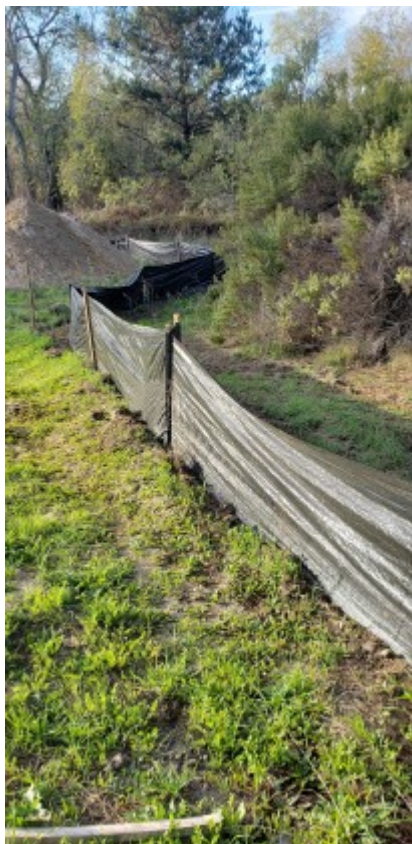
12/02/2021 - Repaired exclusion fence.

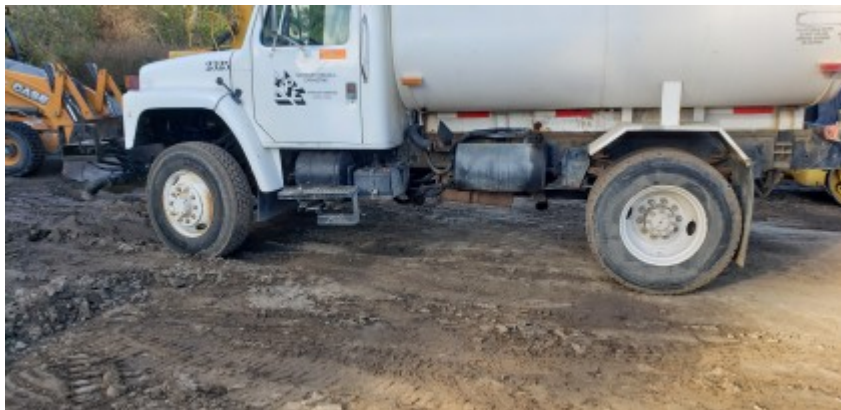
12/02/2021 - Water truck no longer discharging on site.

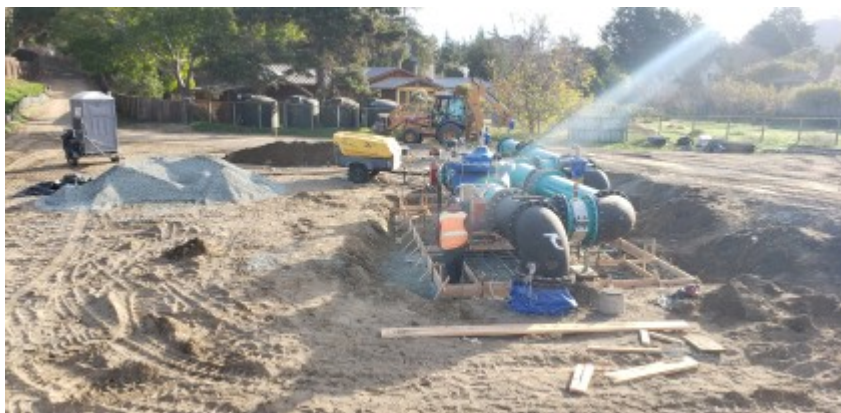
12/02/2021 - Constructing forms for concrete pour.

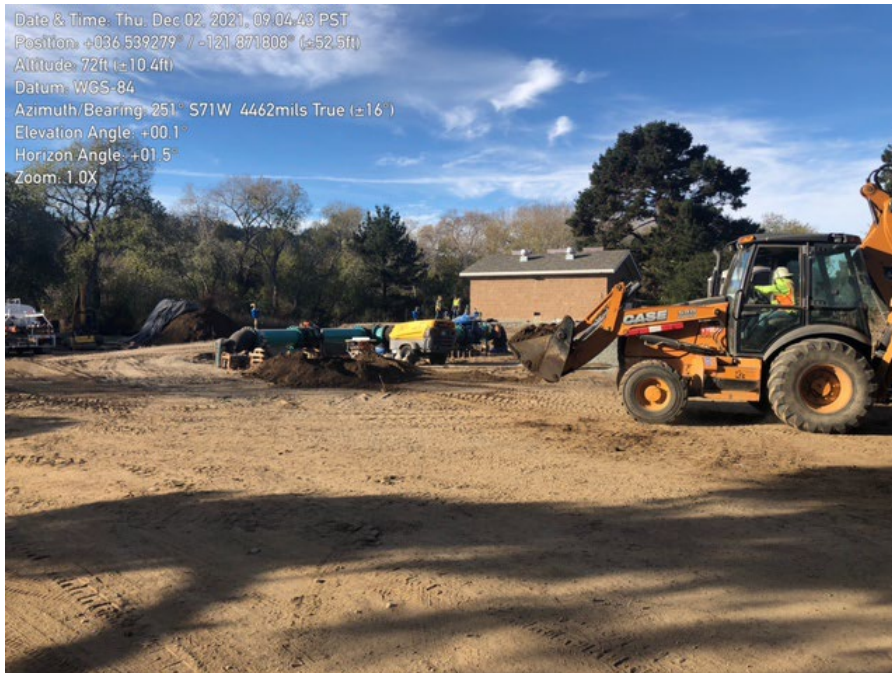
Photo 1. Site grading.

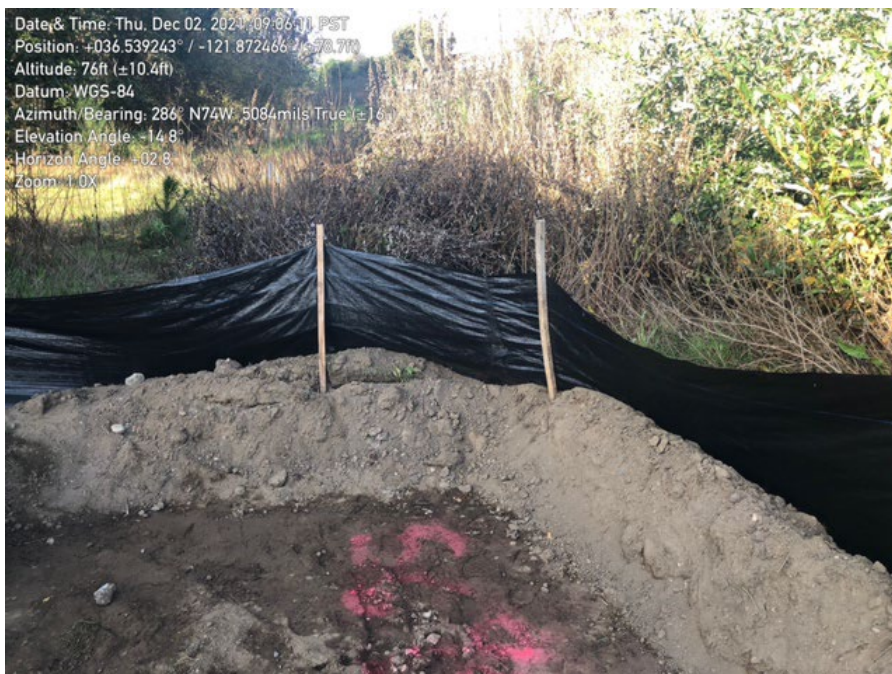
Photo 2. Damaged/downed sections of silt fence have been reinstalled.

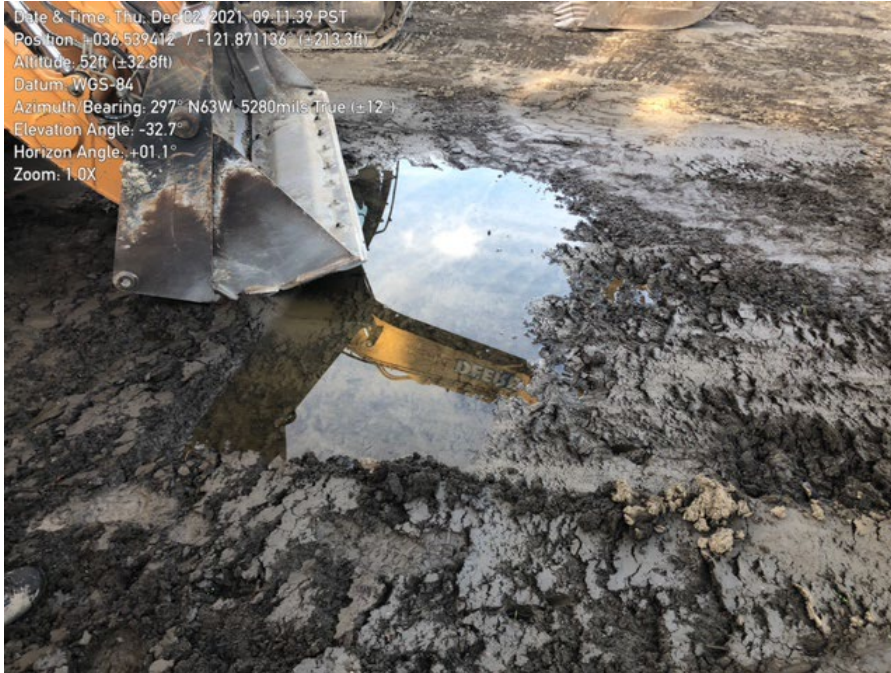
Photo 3. Puddle from leaking water truck. Water truck leak has been repaired.

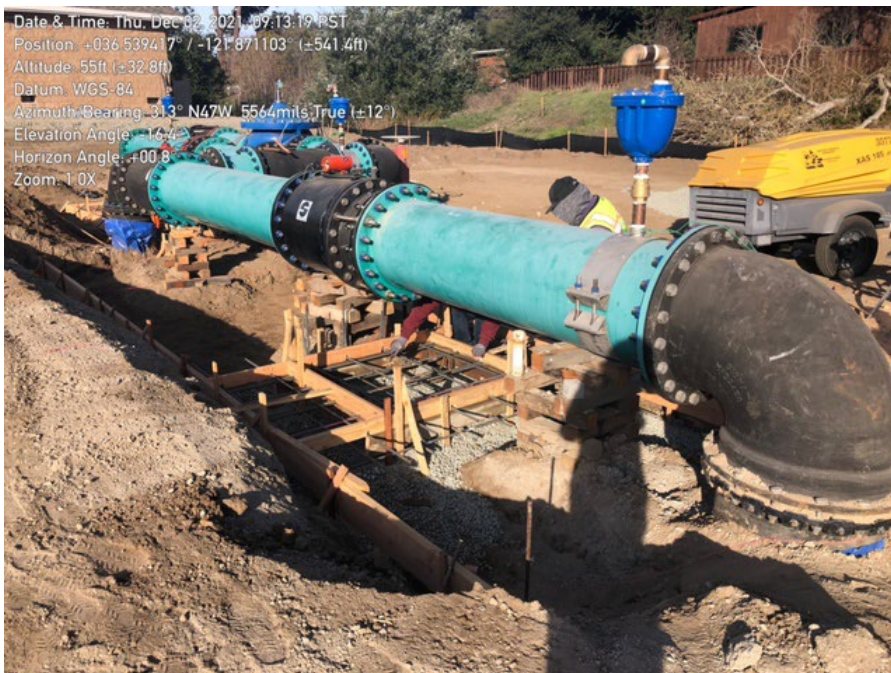
Photo 4. Installation of forms and prep for concrete.
