# memorandum

subject MPWSP – Carmel Valley Pump Station Project Weekly Report (12/06/2021 – 12/10/2021)

### CalAm Weekly Report

### Daily Monitoring Log

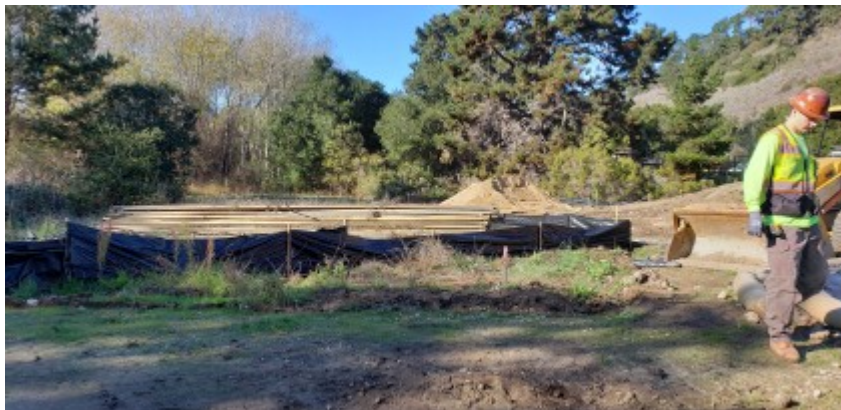
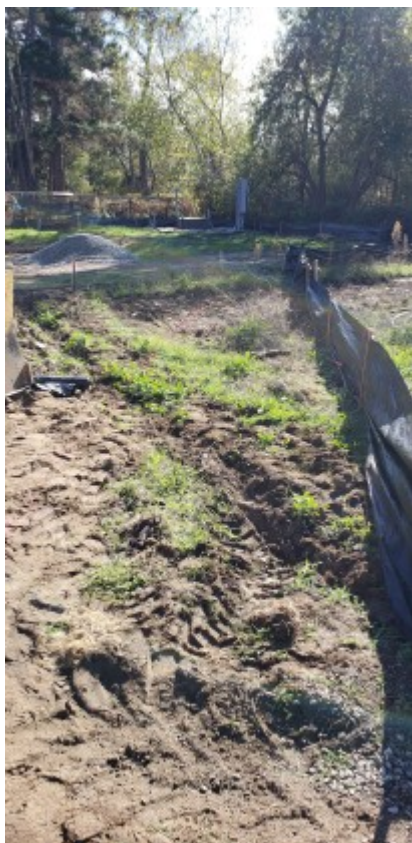
12/07/2021 - Realignment of the exclusion fencing following completion of clearance surveys.

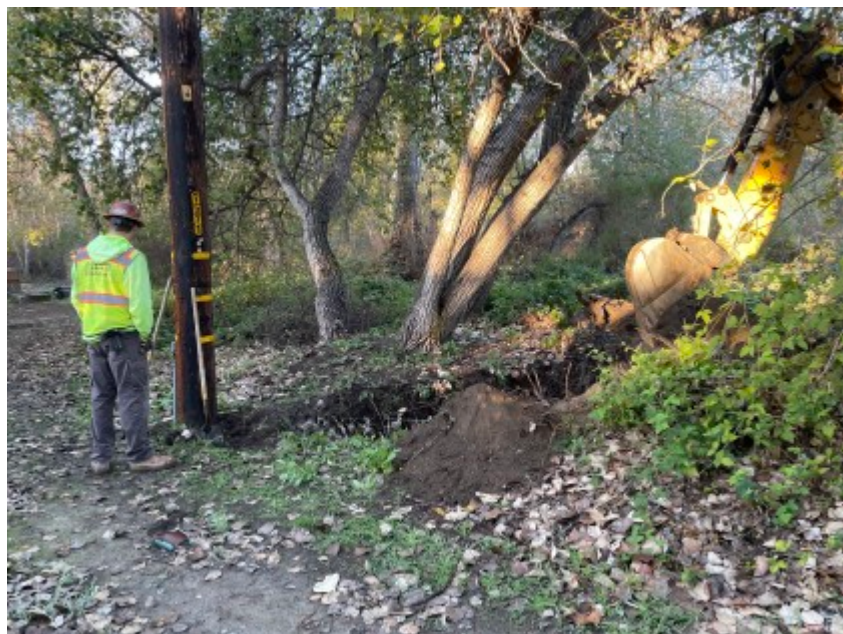
- The electrical contractor severed a water line during the trenching effort for the electrical conduit installation. The water line was located adjacent to the utility pole outside of the exclusion fencing (See Photos). MPE was able to locate the shut off valve relatively quickly to limit the amount of water that was discharged after the water line was severed. Although the discharge occurred outside of the exclusion fencing, MPE was able to contain the water to relatively small area, and no discharged water entered Carmel River. MPE ordered parts to repair the water line and the work was scheduled for the next day.

12/08/2021 - Broken waterline outside of silt fencing being contained.

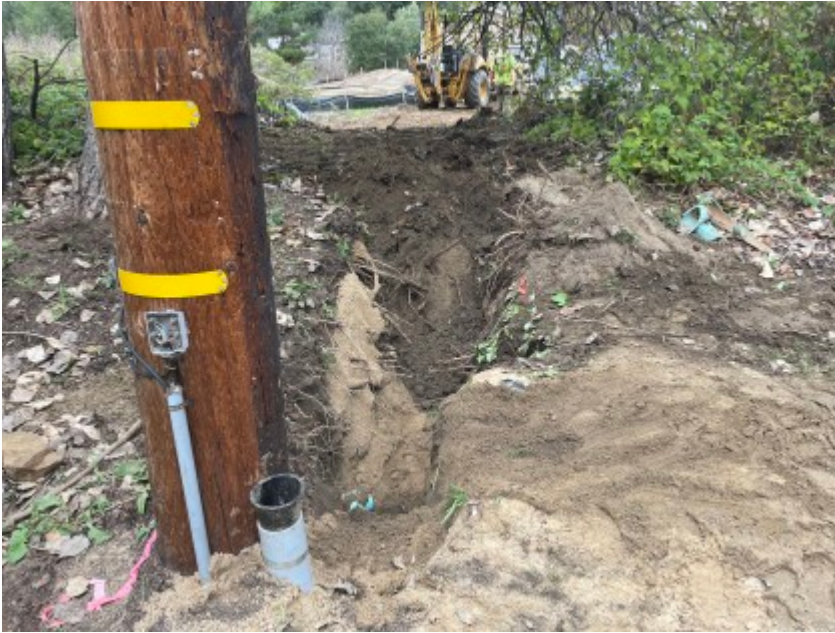
12/08/2021 - Completed electrical installation outside of silt fence, open hole left for MPE to fix broken water pipe. Ramp built for wildlife to exit and not become entrapped.

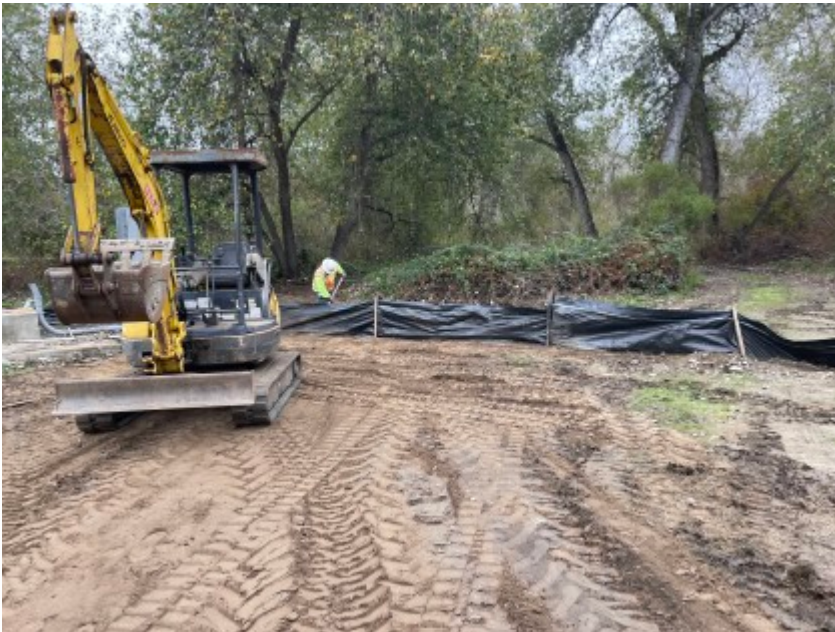
12/08/2021 - MPE re-installing silt fencing where it was taken down to install the electrical line.

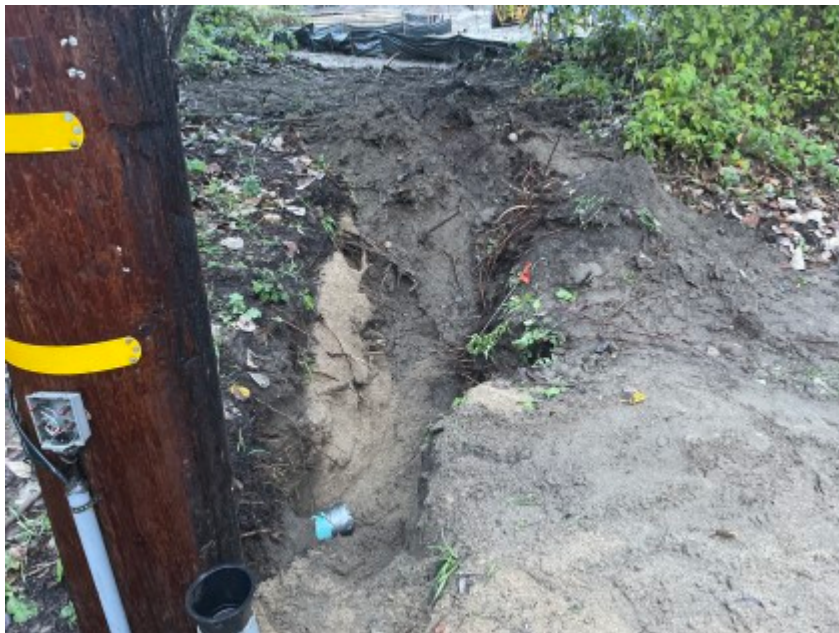
12/09/2021 - Open trench prior to any construction related activities, severed waterline shown in bottom left.

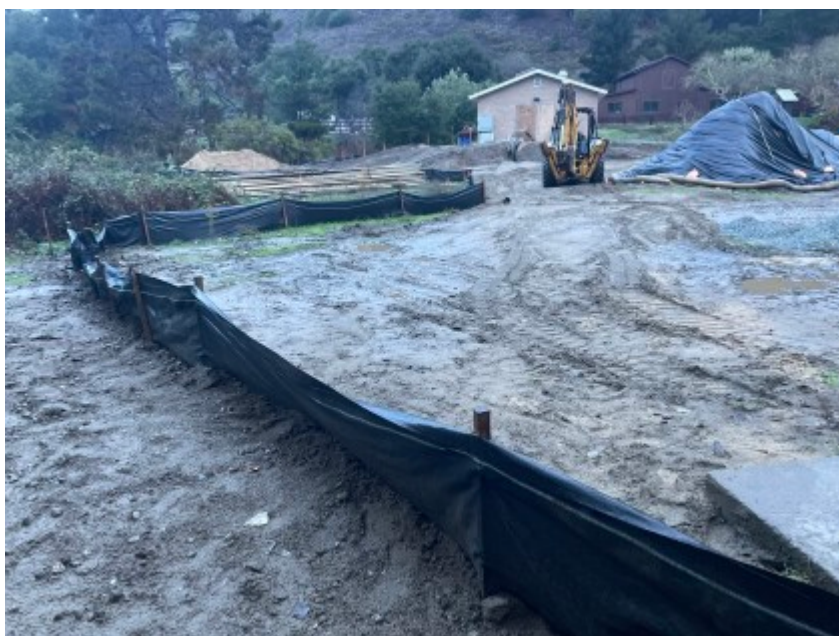
12/09/2021 - CVPS site conditions and re-installed silt/exclusion fencing.

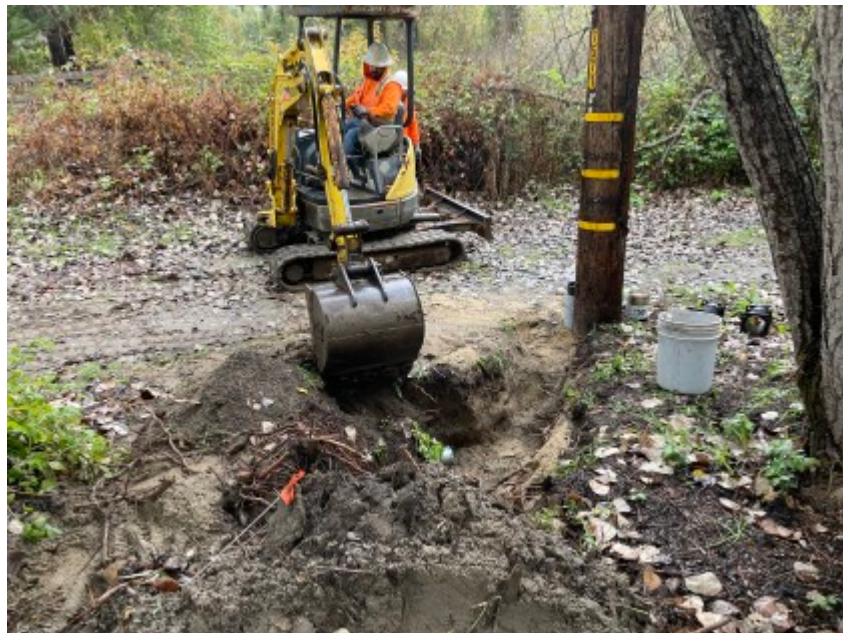
On 12/8/2021, the electrical contractor severed a water line located adjacent to the PG&E power pole. The amount of water discharged was limited and was contained within a relatively small area. None of the discharged water entered the Carmel River. The discharge was shut off shortly after the line was severed and the water line was repaired the following day on 12/9/2021.

12/09/2021 - MPE fixing broken water line outside of silt fence.

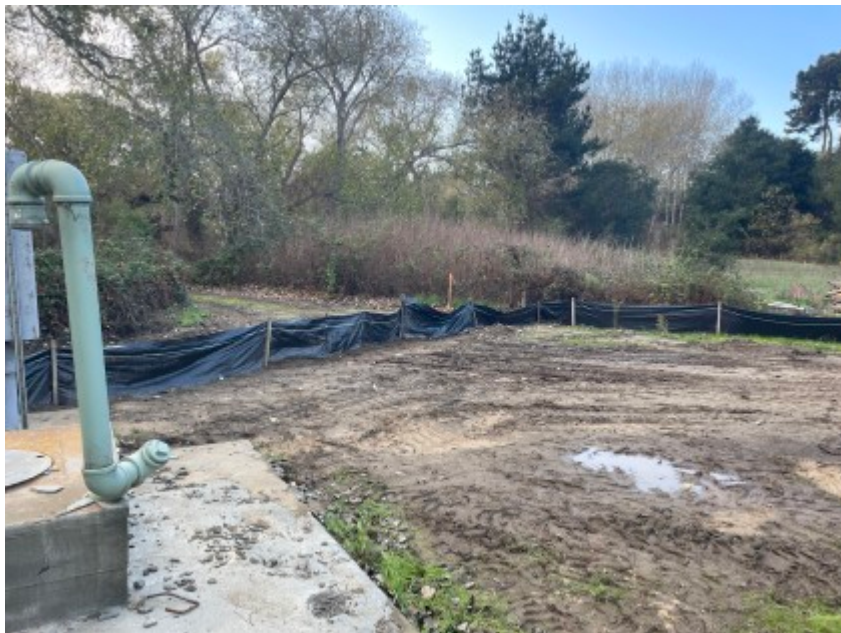
12/09/2021 - MPE re-installed silt fencing on southern edge of project.

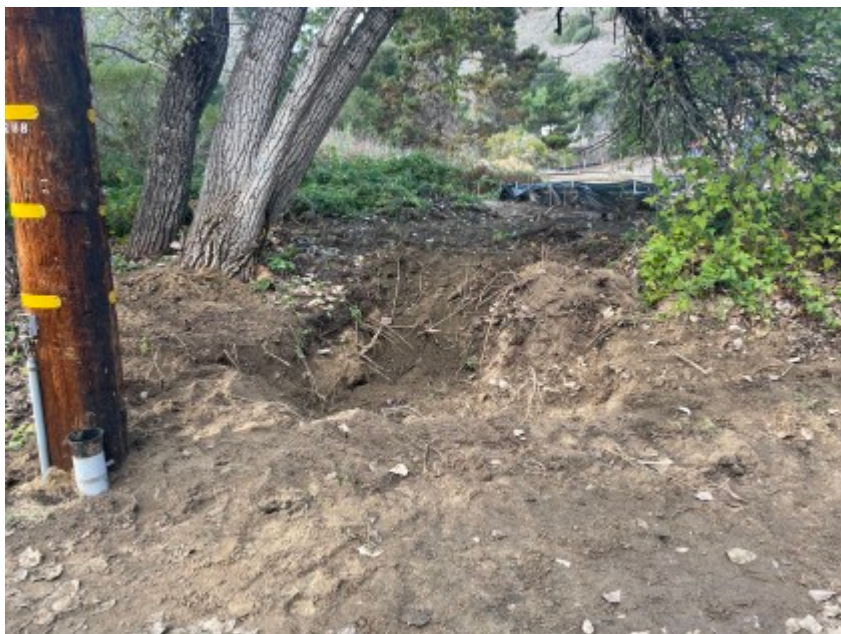
12/09/2021 - MPE completed waterline repair. MPE still needs to add soil to area to meet natural grade.

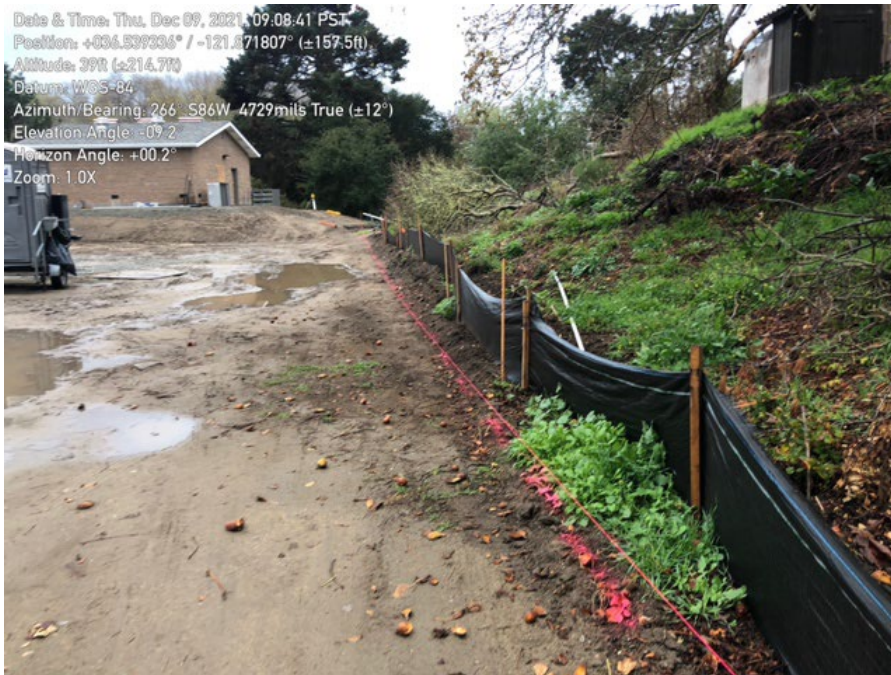
Photo 1. Pink line shows location of drainage ditch.

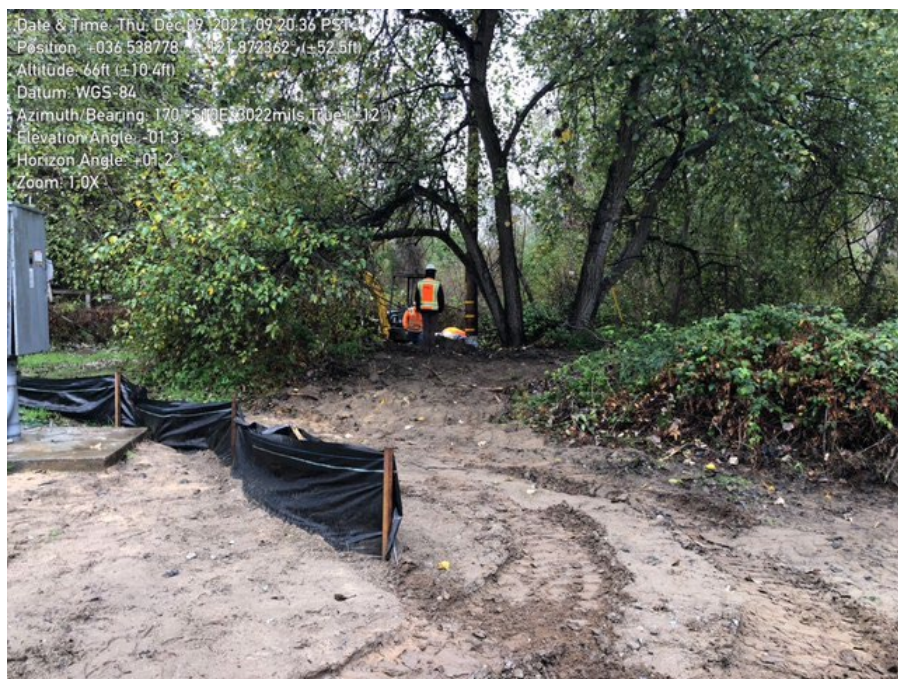
Photo 4. Location of electrical conduit outside of fenced area.
