# memorandum

subject MPWSP – Carmel Valley Pump Station Project Weekly Report (12/27/2021 – 12/31/2021)

### CalAm Weekly Report

### **CPUC Inspection Logs**

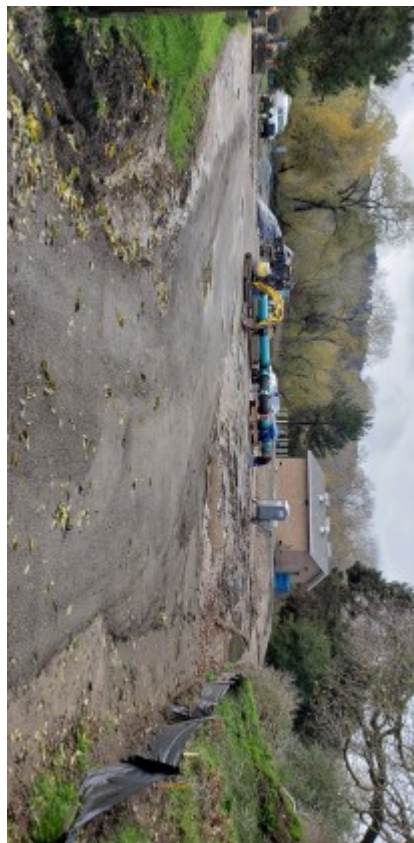
12/28/2021 - Site conditions.

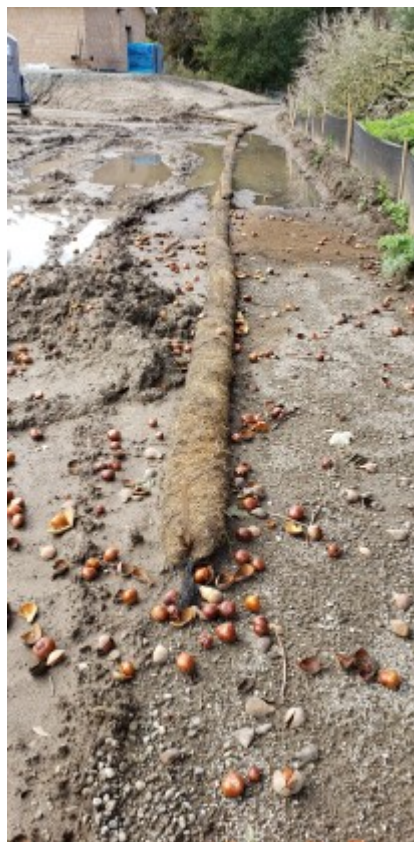
- DD&A compliance monitor inspected the status of exclusionary fencing and proper trash disposal in accordance with Mitigation Measure 4.6-1c.
- Photographed project site conditions.
- DD&A documented wattles with monofilament netting still remain on site.

12/28/2021 - Plastic wattles still on site.

| Compliance Question | Compliance Level | Note |
|---|---|---|
| 4.6-1p. 8. Only certified, weed-free, plastic-free imported erosion control materials (or rice straw in upland areas) were used for the project? | No | Plastic mono-filament wattles remain onsite. DD&A requested removal in previous report. DD&A to request removal again. |

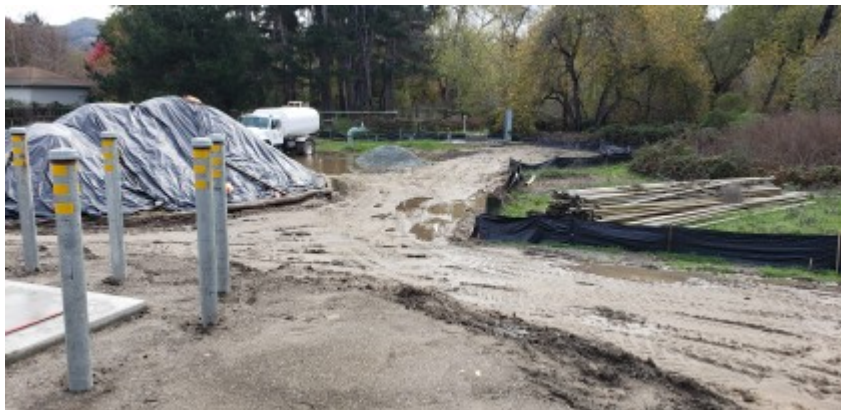
12/28/2021 - Site conditions.

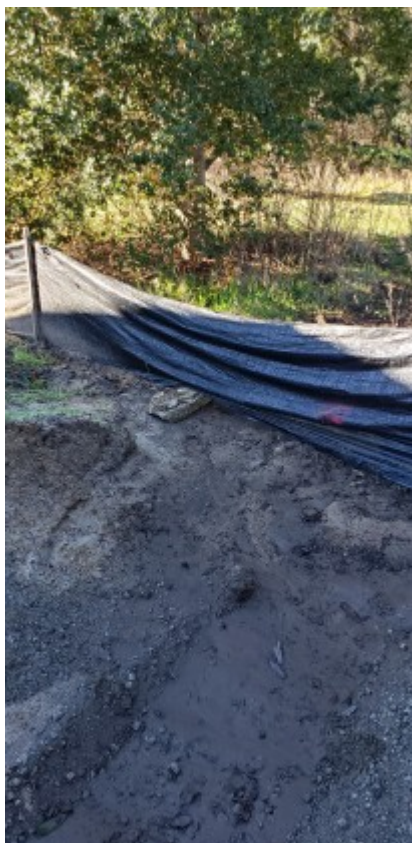
| Compliance Question | Compliance Level | Note |
|---|---|---|
| 4.6-1c. 9. Prior to construction at any site where special-status amphibians, reptiles and mammals have a moderate or high potential to occur, the construction work area boundary was fenced with a temporary exclusion fence to prevent special-status wildlife from entering the site during construction? | Yes | Exclusion fence requires repair. |

12/30/2021 - Exclusion fence pulled out of the ground.

- DD&A compliance monitor inspected the status of exclusionary fencing and proper trash disposal in accordance with Mitigation Measure 4.6-1c.
- Photographed project site conditions.
- DD&A conducted site investigation with CPUC representative.
- DD&A documented wattles with monofilament netting still remain on site.
- DD&A documented exclusion fencing had been unearthed to allow CVPS site to drain. Exclusion fencing should be reinstalled.
- DD&A provided WEAT to HVAC/Gutter Installation Contractor.

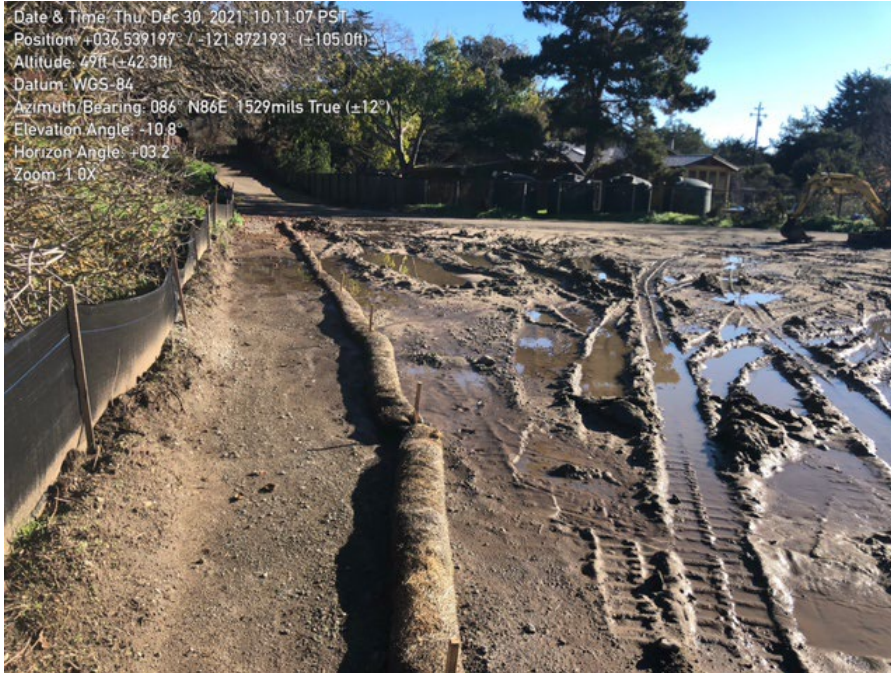
On 12/16/2021, ESA and the CalAm monitor observed that monofilament-encased straw wattle had been installed on site. This wattle was still in place during the 12/30/2021 site inspection and should be replaced with amphibian-friendly straw wattle or other amphibian-friendly erosion control materials (**Mitigation Measure 4.6-1p**). CalAm monitors confirmed that this issue has been reported to the contractor, Monterey Peninsula Engineering.

Photo 1. Monofilament straw wattle installed on site.

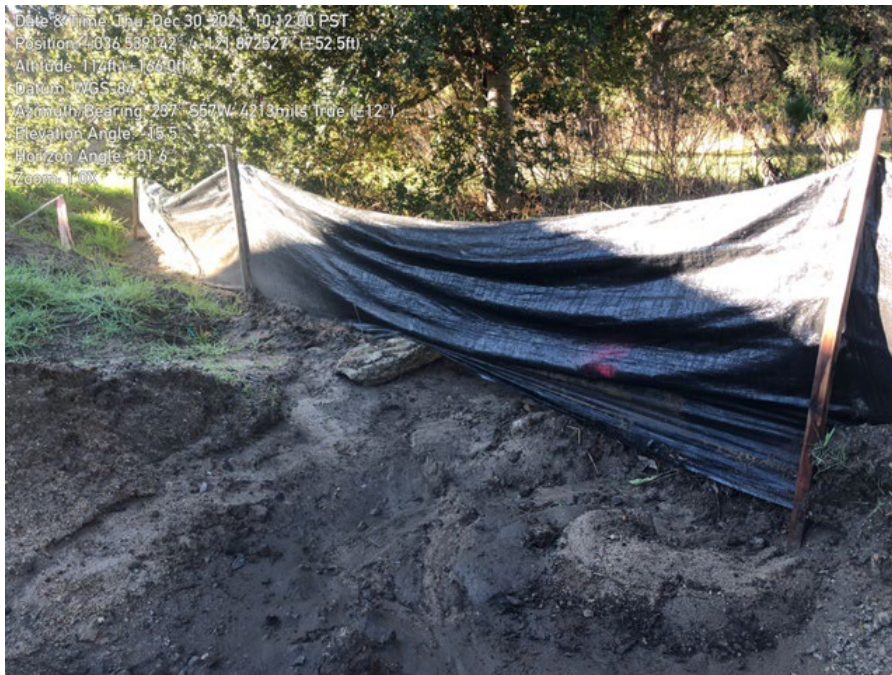
During the 12/30/2021 site inspection, ESA and CalAm monitors observed that a section of silt fence near the northwest corner of the site was in need of repair. The lower part of the silt fence appeared to have been raised to

allow drainage of water away from the site. Per **Mitigation Measure 4.6-1c. 9**, the construction area boundary must be fenced to prevent entry of special-status species.

Photo 3. Gap under silt fence.

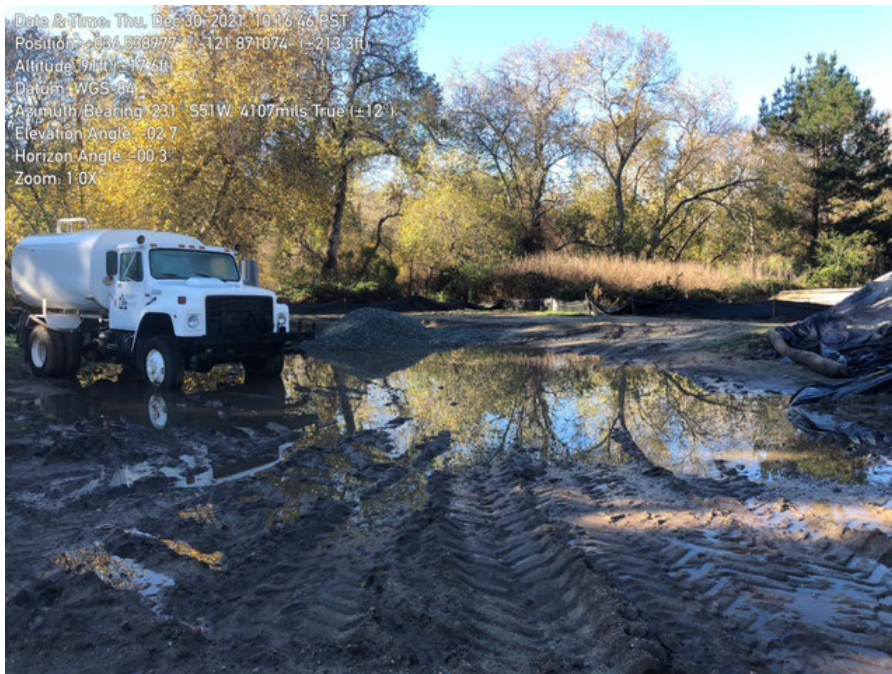
Photo 4. Ponding from recent rain events.
