# memorandum

subject MPWSP – Carmel Valley Pump Station Project Weekly Report (01/24/2022 – 01/28/2022)

## Monterey Peninsula Water Supply Project (MPWSP)

### Daily Monitoring Log

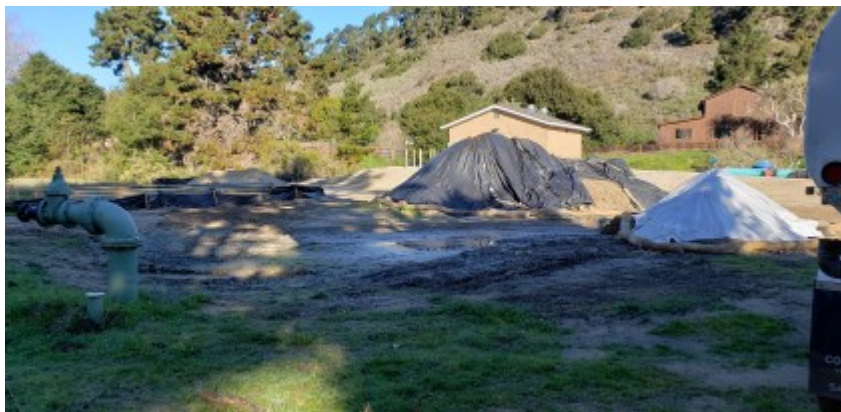
01/27/2022 - Site conditions.

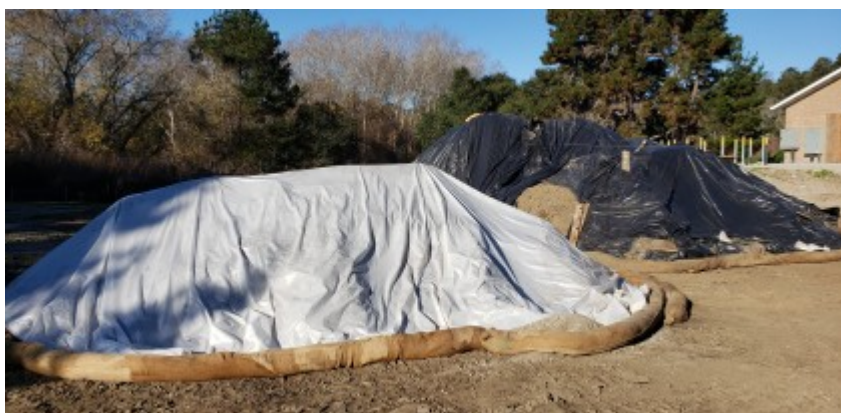
01/27/2022 - Staged spoils.

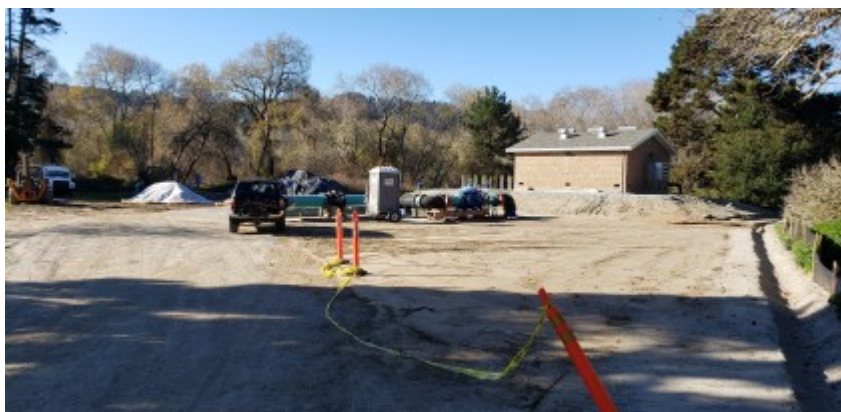
01/27/2022 - Site conditions.

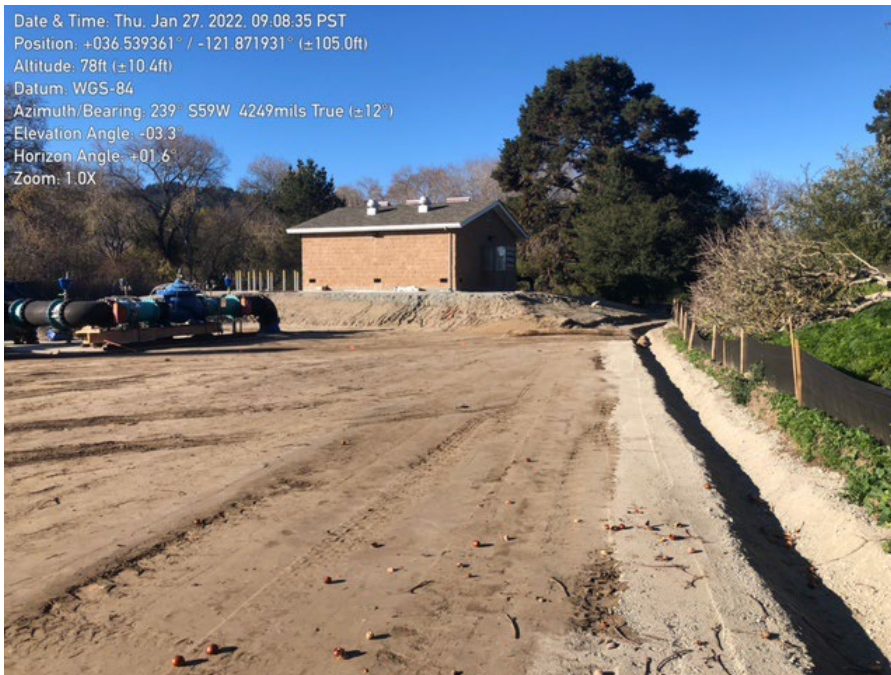
Photo 1. Overall site conditions.

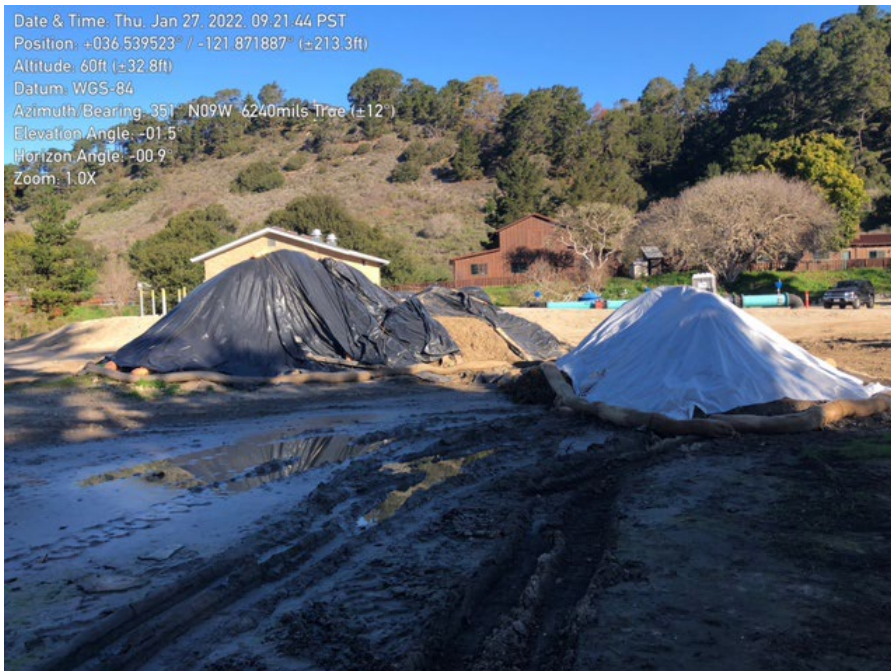
Photo 2. Spoils stock piles covered.

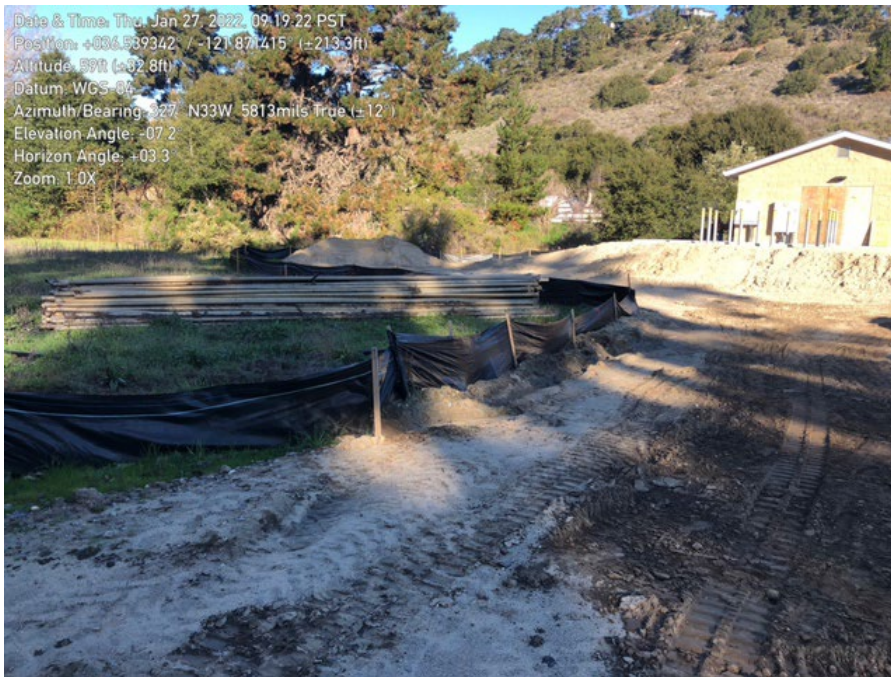
Photo 3. Silt fence in acceptable condition.
