# memorandum

subject MPWSP – Carmel Valley Pump Station Project Weekly Report (03/07/2022 – 03/11/2022)

### CalAm Weekly Report

### Daily Monitoring Log

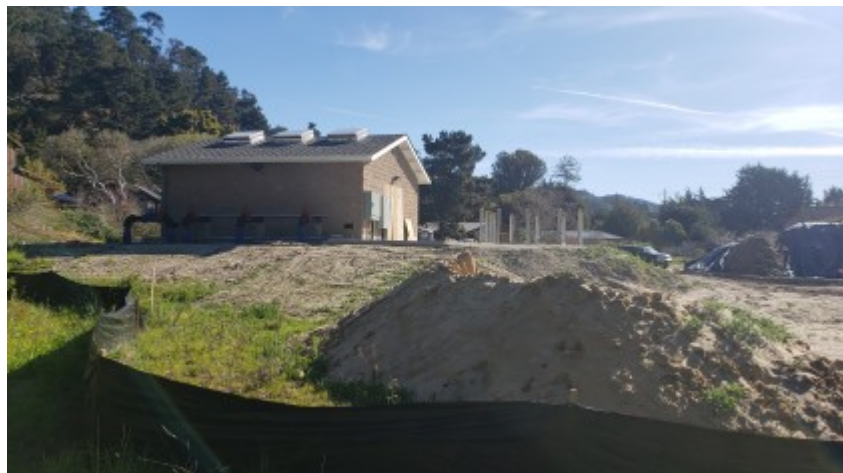
03/11/2022 - Project site conditions.

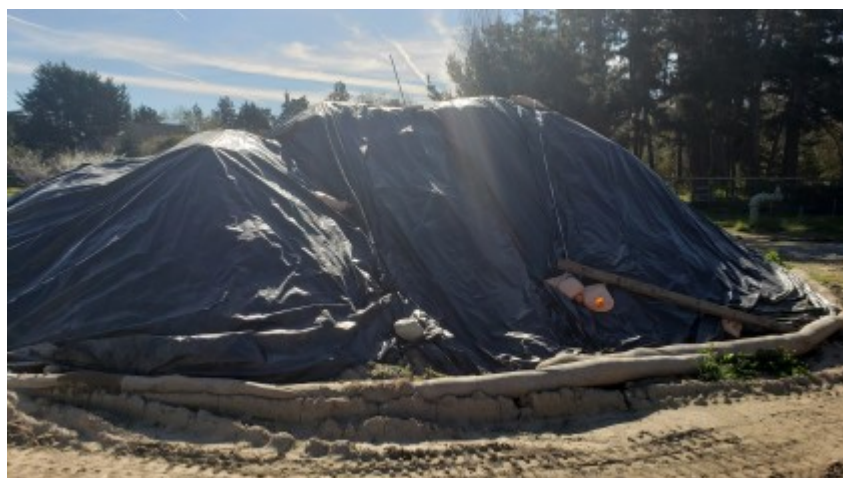
| Compliance Question | Compliance Level | Note |
|---|---|---|
| 4.6-1p. 8. Only certified, weed-free, plastic-free imported erosion control materials (or rice straw in upland areas) were used for the project? | Yes | The erosion control materials covering the spoils piles required some maintenance. Maintenance was performed by DD&A. |

03/11/2022 - Erosion control in tact on spoils pile.  
DD&A performed maintenance on plastic sheeting.

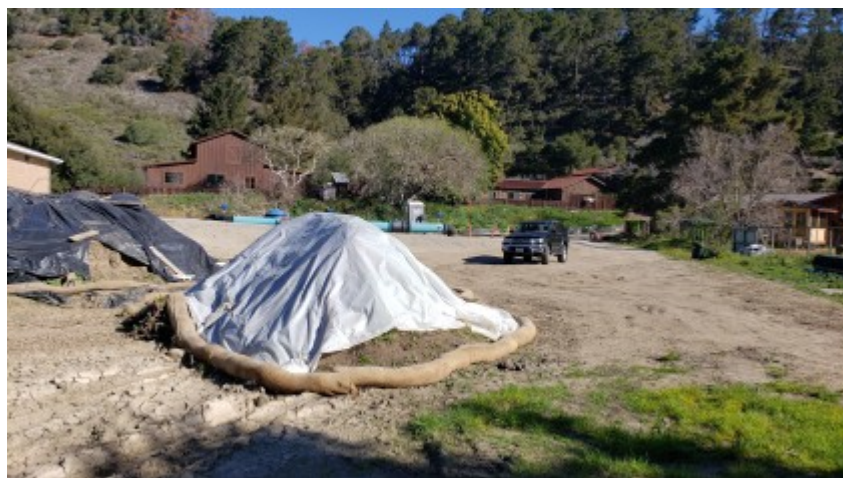
03/11/2022 - Erosion control on spoils pile.

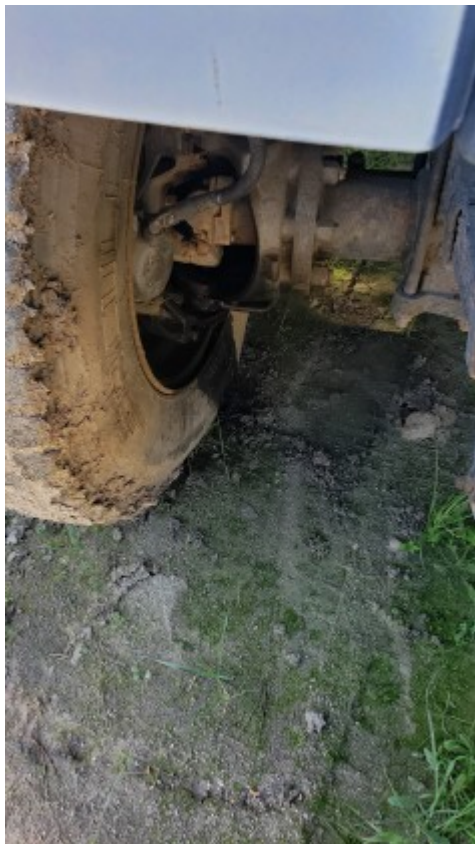
During the site inspection, ESA and the CalAm monitor observed a leaking fluid from the front axle of a water truck that has been staged on site (**Mitigation Measure 4.6-1c. 17**). CalAm monitors contacted the contractor, Monterey Peninsula Engineering (MPE) and requested the truck either be moved offsite or repaired. The CalAm monitor also conducted some minor maintenance of erosion control materials covering the spoils pile (**Mitigation Measure 4.6-1p**). No other compliance issues were observed.

| Compliance Question | Compliance Level | Note |
|---|---|---|
| 4.6-1c. 17. All vehicles and equipment were in proper working condition to ensure that there was no potential for fugitive emissions of motor oil, antifreeze, hydraulic fluid, grease, or other hazardous materials? | No | DD&A documented a leak of fluid from the front passenger wheel of a water truck that has been staged on site. DD&A contacted MPE and requested that the truck either be removed from site or repaired. |

03/11/2022 - Water truck staged on site leaking fluid.  
DD&A contacted MPE to request removal or repair.

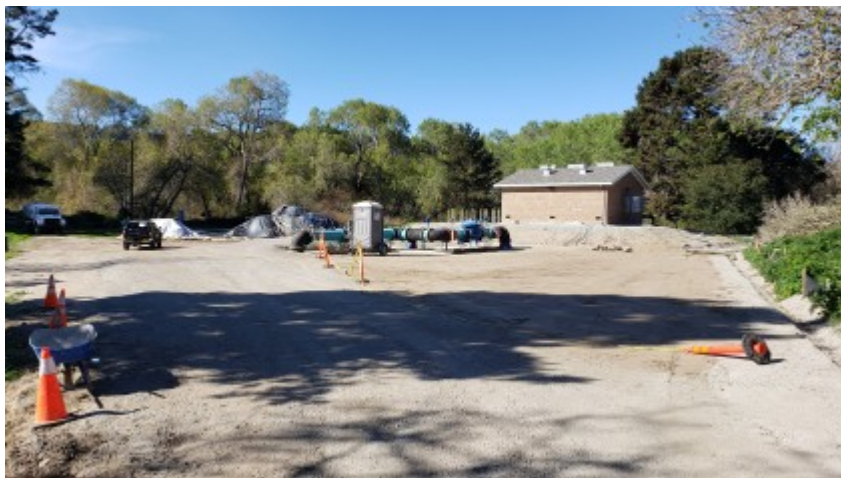
03/11/2022 - Project site conditions.

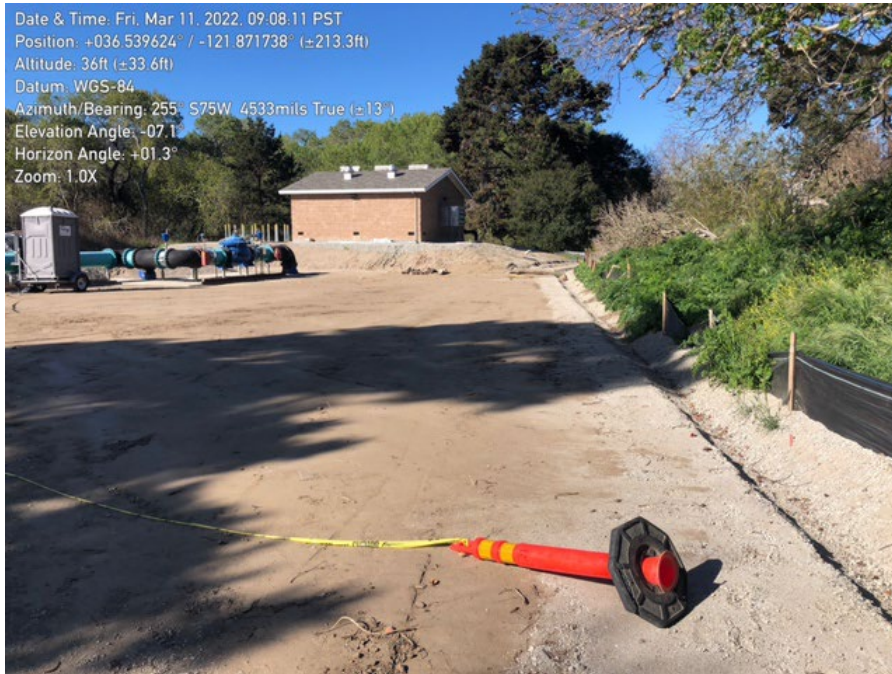
Photo 1. Overall site conditions.

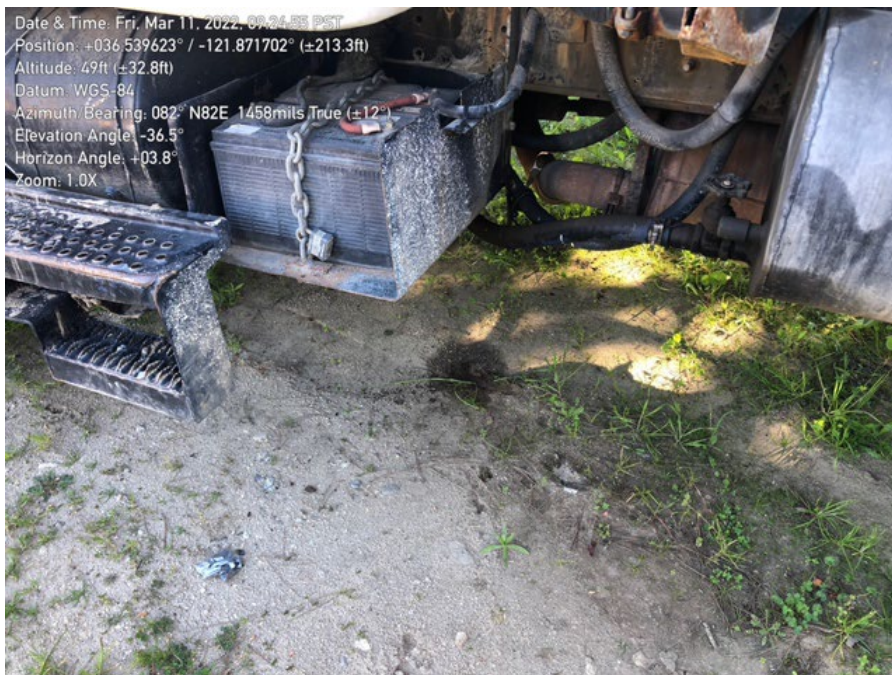
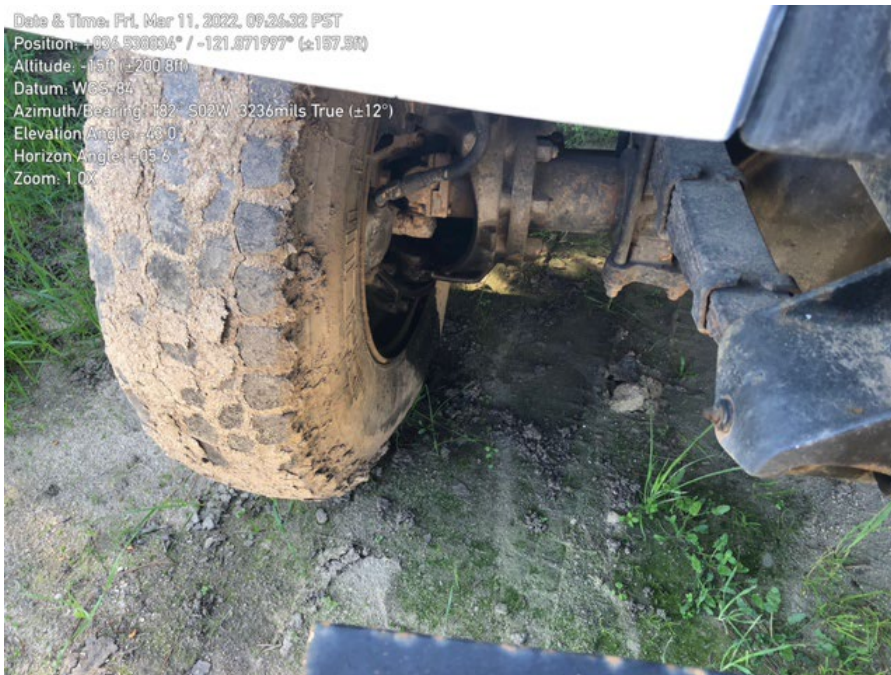
- DD&A compliance monitor on site for spot check.
- Spoils stock piles covered with plastic sheeting and surrounded with amphibian friendly straw wattle.
  - DD&A compliance monitor repaired loose cover while on site.
- Amphibian-friendly BMPs remain installed along access road at pipeline connection point.
- No hazardous materials storage issues observed.
- No food waste issues observed.
- No special-status species observed on-site.
- Wildlife exclusion fence in adequate condition to prevent animal entry.
- Minor Issue:
  - A minor hydraulic fluid leak was observed under a water truck parked on site. DD&A monitor reported the issue to MPE.

Photo 2. Minor hydraulic leak under water truck.

Photo 3. Minor hydraulic leak under water truck.

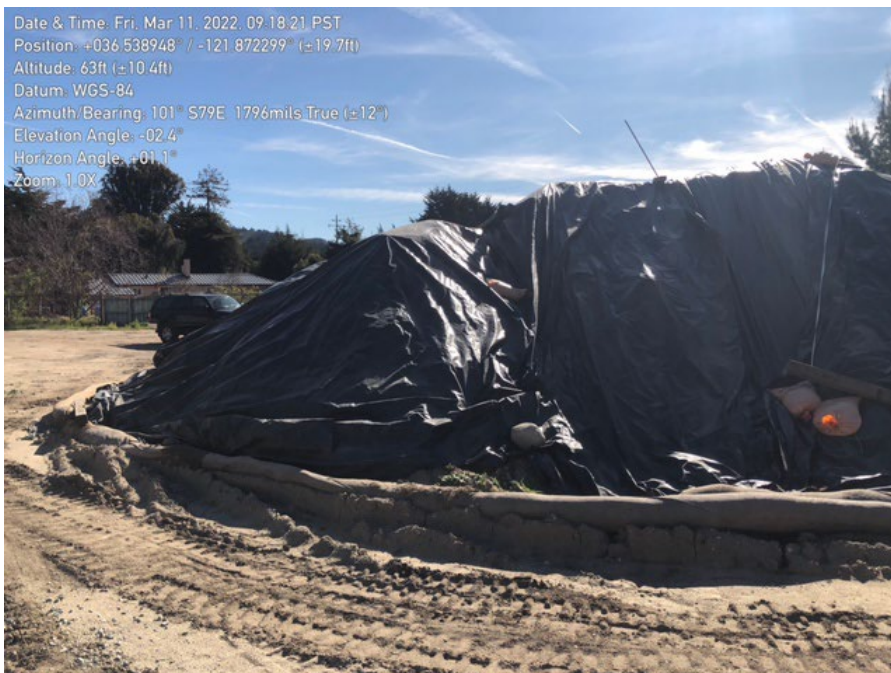
Photo 4. BMPs in place on spoils/materials.
