SDG&E SALT CREEK SUBSTATION PROJECT

CPUC MONITORING SUMMARY REPORT

January, 2017

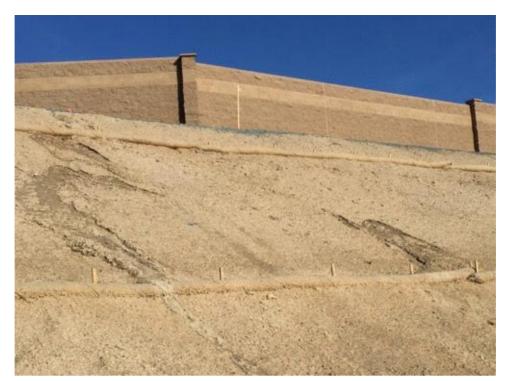
Erosion on center west slope.

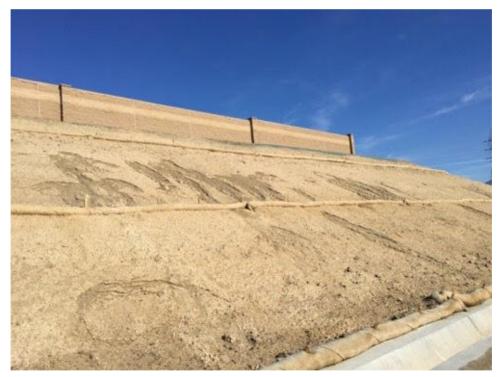
Erosion on west slope.

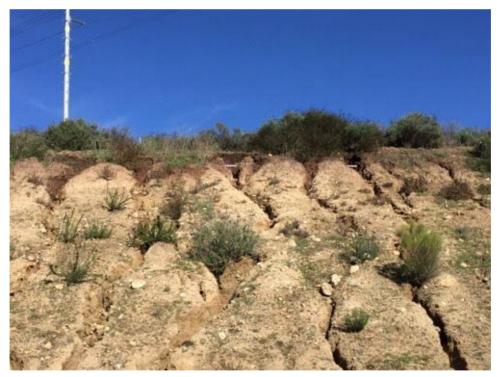
Caption Offsite erosion.

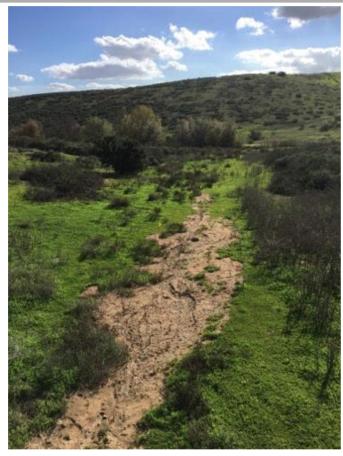
Caption Offsite erosion area

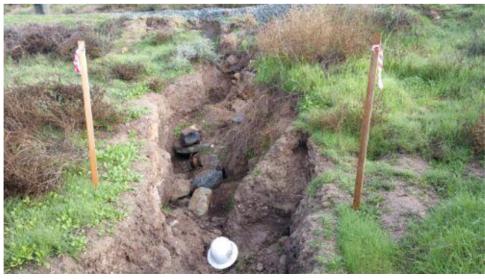
Caption Gully to east of site has not been repaired.

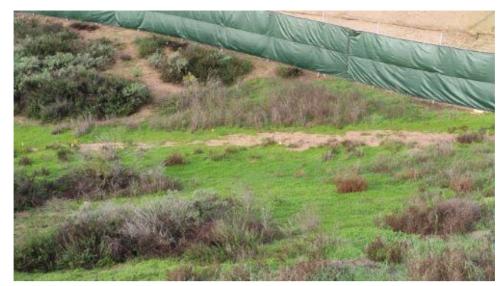
Caption Sediment plume to south of site unchanged.

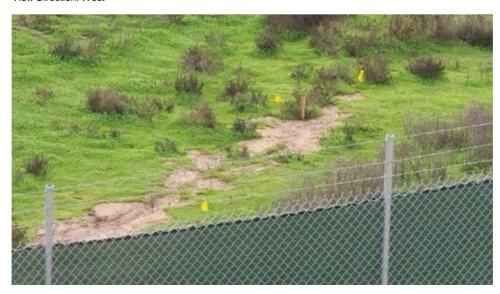
Caption Sediment plume outside of south fence appears unchanged

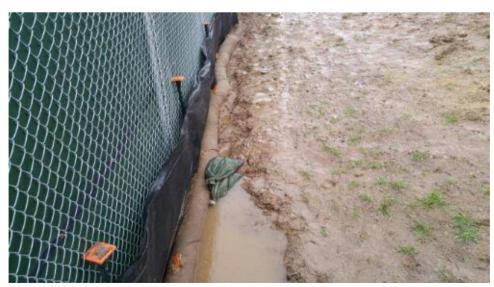
Caption Water flowing around or over gravel bags in multiple locations.

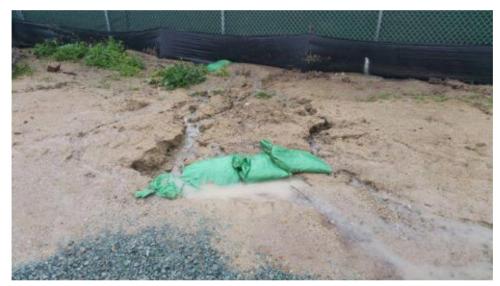
Caption BMPs for runoff from side of east entrance road have been circumvented.

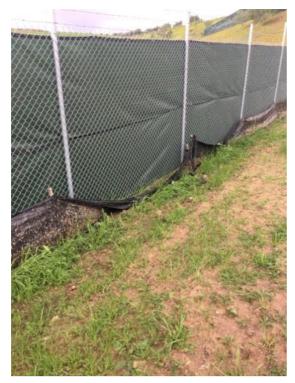
Silt fence repair needed

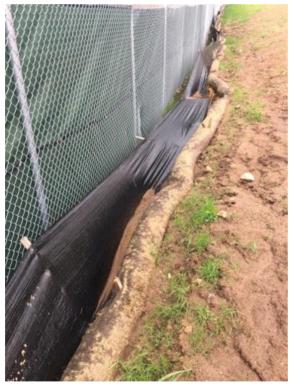
Silt fence damage

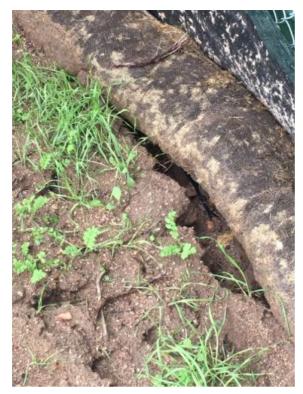
Caption Silt fence repair needed

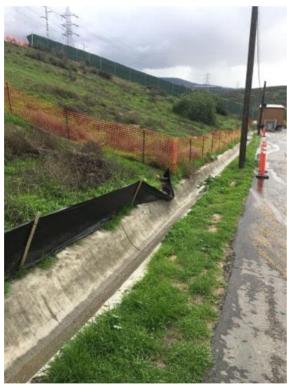
Silt fence needs repair

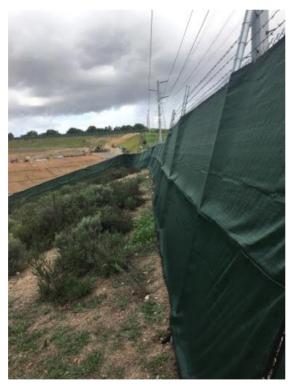
Caption Fence post failure

Perimeter fence needs to be repaired. Mesh screening on eastern boundary needs to be replaced.

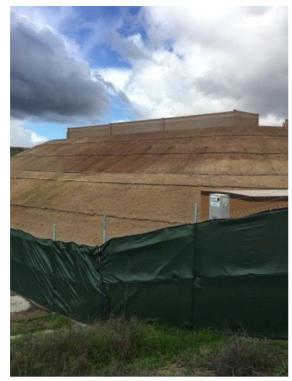
Caption Southern slope with erosion.

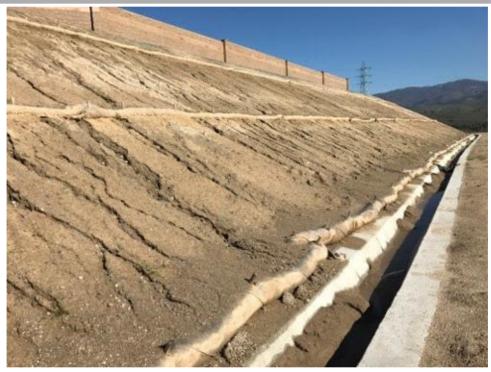
Caption Erosion on west slope. BMPs need maintenance.

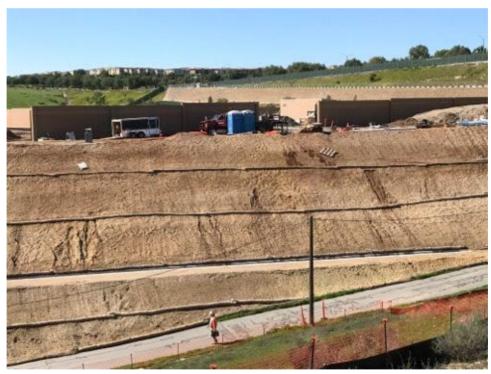
Caption Erosion on east slope.

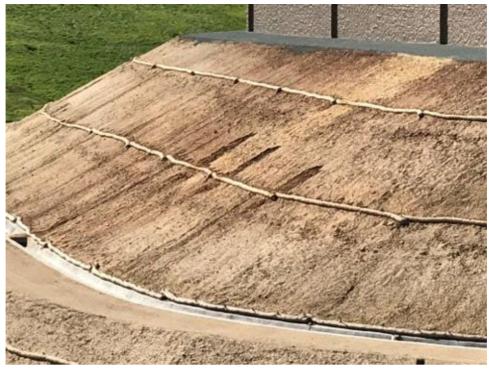
Caption Erosion on south slopes.

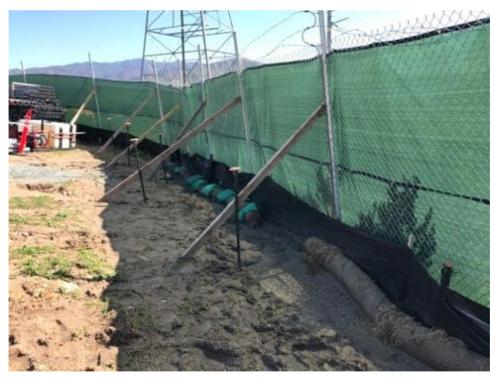
Caption Perimeter fence shored up until fence contractor can do repairs.

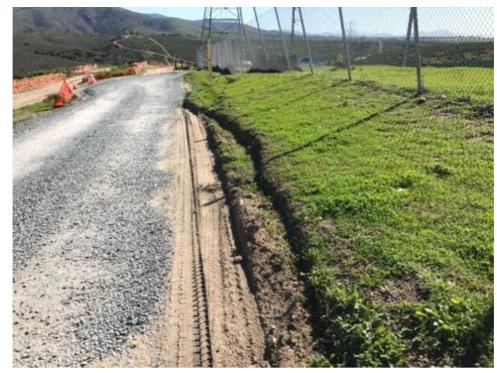
On January 25th, two sets of truck tracks were found outside the limits of the western-most of the two transmission access roads near the Project east gate. No special-status species were impacted. To prevent a recurrence of the problem, on days that only the west access road is in use, the contractors will have a flagger at each end of the road (at Hunte Parkway and the east project gate) controlling traffic to prevent two vehicles from meeting in the middle. This was recorded by SDG&E as a Level 2: Minor Problem.

Area where first truck drove off transmission access road.

Trucks had driven off of access road in two locations. Posts and rope were installed on the upper side of the road but may also be required on the lower side. Orange fencing needs repair.

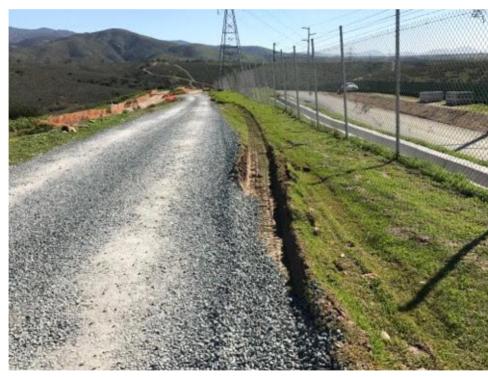
Area where second truck drove off lower transmission access road.

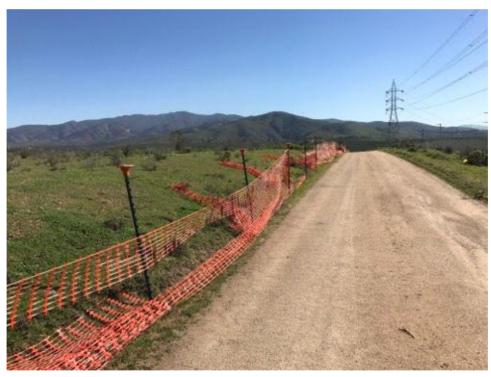
Caption Sections of construction fencing along upper transmission access road needing repair

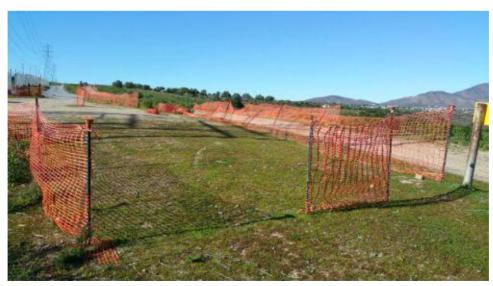
Caption Orange fencing around outside parking area and east exit road in need of repair.

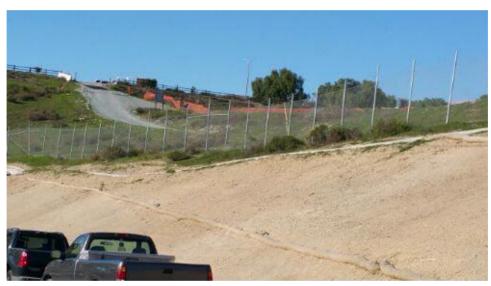
Caption Screening fence along east access road has been removed after wind caused damage to chain link fence.

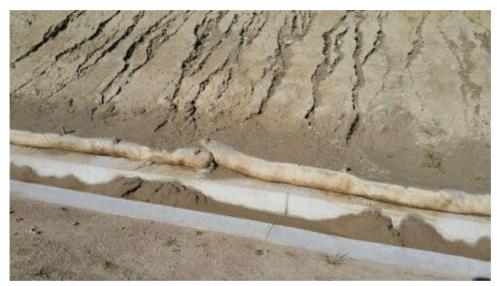
Caption Sediment buildup behind fiber rolls on west slope.
