PROJECT MEMORANDUM SYCAMORE-PEÑASQUITOS 230-KV TRANSMISSION LINE PROJECT

Date:	January 20, 2017
To:	Billie Blanchard, CPUC Project Manager
From:	Sheila Hoyer, CPUC Monitoring Supervisor
Subject:	Weekly Report #2 – January 9 to January 14, 201

2017-01-13 SycPen Inspection Report

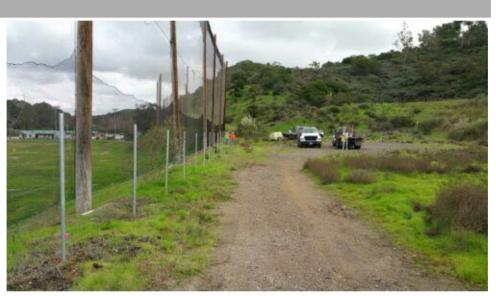
Fence installation at Driving Range yard.

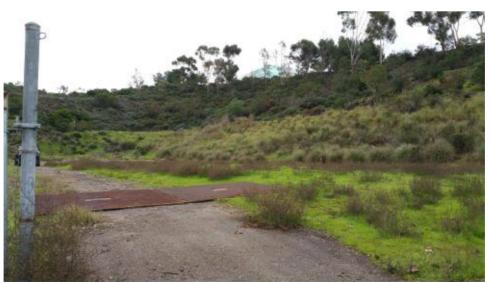
Caption Driving Range yard. Photo Attributes Capture Date/Time: Fri Jan 13 2017 11:11:50 GMT-0800 (PST) Coordinates: 32.891189, -117.191681 View Direction: East

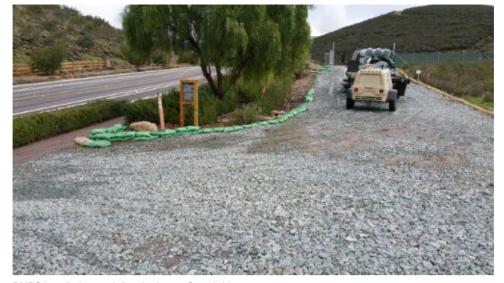
BMPS installed around disturbed area. Stonebridge.

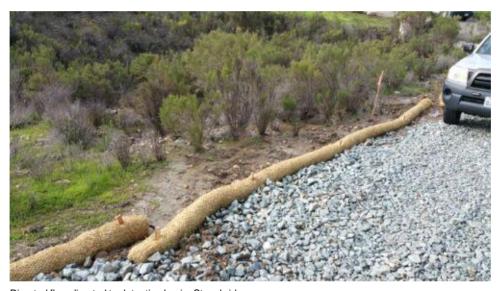
Diverted flow directed to detention basin. Stonebridge. Photo Attributes Capture Date/Time: Fri Jan 13 2017 09:56:08 GMT-0800 (PST) Coordinates: 32.921802, -117.031803 View Direction: South

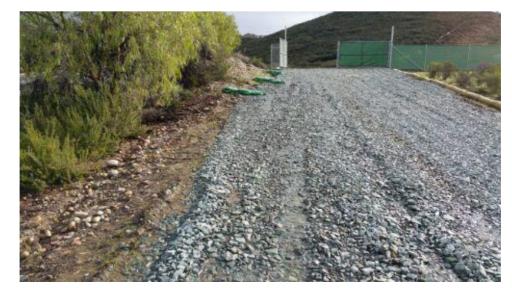
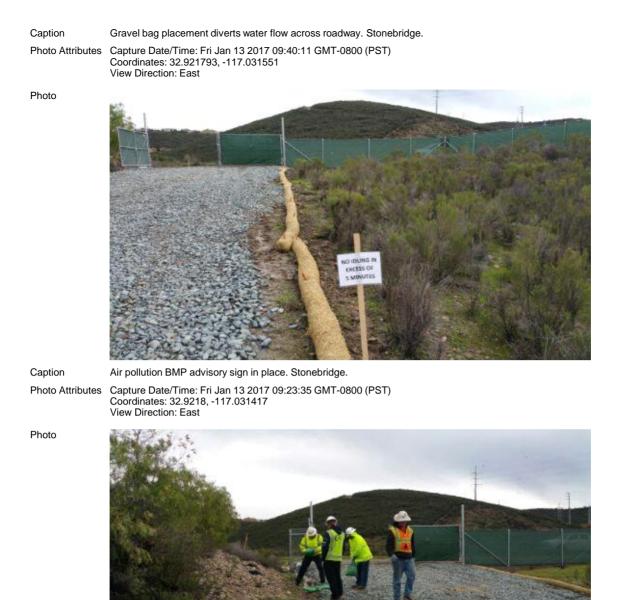
Crew installing gravel bags to filter runoff. QSP is consulting with crew chief. Stonebridge.

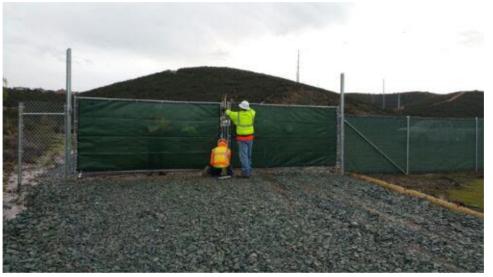
Caption Gate installation, Stonebridge.
