PROJECT MEMORANDUM SYCAMORE-PEÑASQUITOS 230-KV TRANSMISSION LINE PROJECT

Date:	April 24, 2017
To:	Billie Blanchard, CPUC Project Manager
From:	Sheila Hoyer, CPUC Monitoring Supervisor
Subject:	Weekly Report #15 – April 10 to April 15, 2017

SDG&E Sycamore-Peñasquitos 230-kV Transmission Line Project: Daily Inspection Report

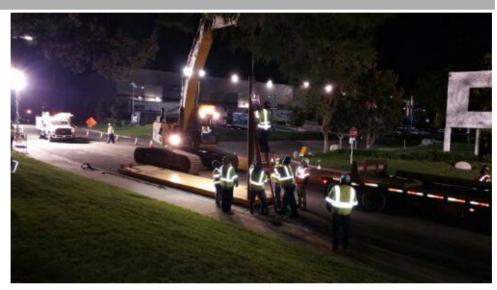
Preparing shield for vault excavation.

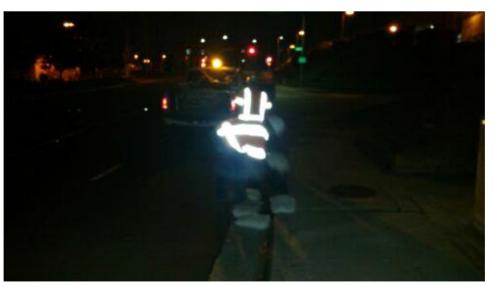
Crew installing inlet protection on Carroll Rd.

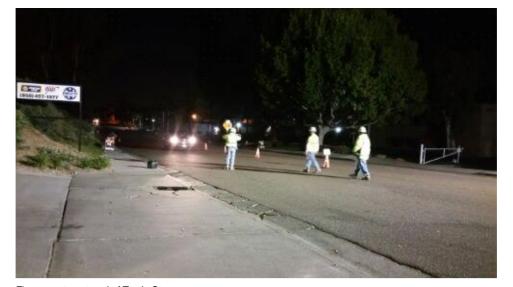
n Flaggers at west end of Trade St.

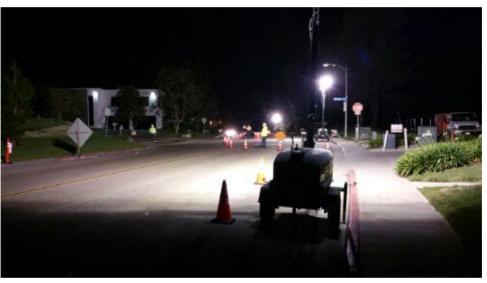
Three flaggers at east end of work zone (Carroll & Trade St.).

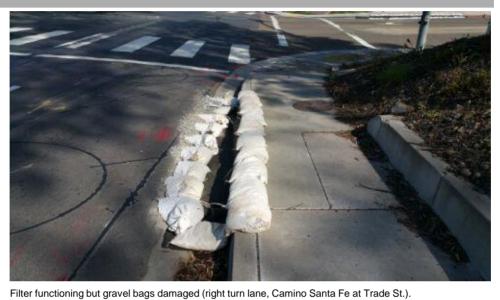
protections BMPs (gravel bags) were frequently being damaged by vehicles running over the gravel bags. As a result, damaged gravel bags were being frequently replaced. The QSP suggested more durable BMP (Durabags) to mitigate repetitive gravel bag breakage in high traffic areas. On April 11 and April 12, 2017, the contractor installed Durabags in high traffic areas. Additionally, the contractor installed and maintained BMPs along the right-of-way (ROW) in Segment 5. The installed BMPs consist of gravel bags and filter fabric protection used for storm drain inlet protection during vault excavation, potholing, and sawcutting activities. During saw-cutting activities, a vacuum is used to collect water runoff, and a street cleaner is used during and at the end of the work day to mitigate excess sediment accumulation on the ROW.

Filter functioning but gravel bags damaged (right turn lane, Camino Santa Fe at Trade S

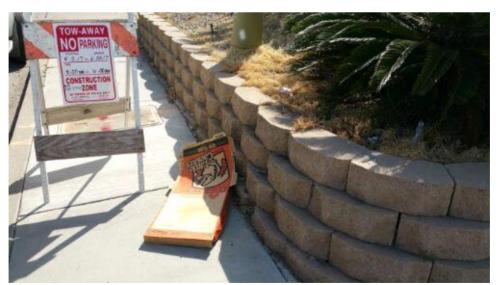
Trash and organic waste. (I don't recall seeing this last night).

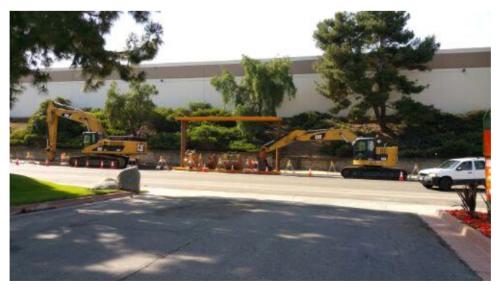
CaptionStorage for vault shoring and equipment (Trade St. East of Carroll).Photo AttributesCapture Date/Time: Mon Apr 10 2017 09:45:08 GMT-0700 (PDT)

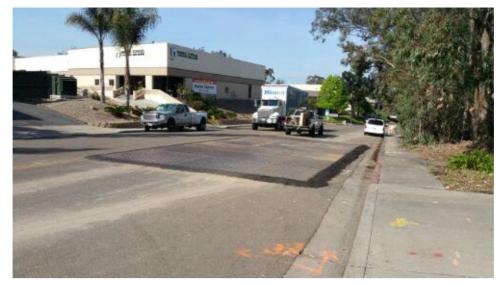
Caption Vault cover does not impede traffic.

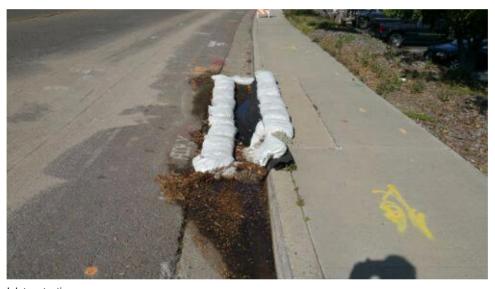
Inlet protection.

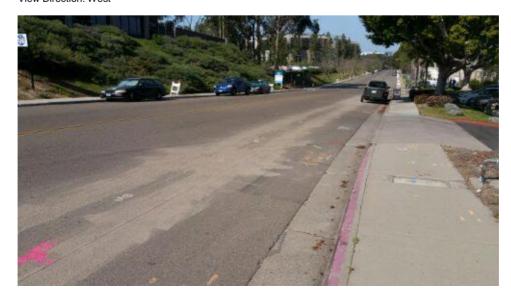
Caption	Saw cut area.	
	Capture Date/Time: Mon Apr 10 2017 09:35	:21 GMT-0700 (PDT)
	Coordinates: 32.88876, -117.161193 View Direction: Southwest	
	Daily Checklist	
Q1 – General Avoidance and Minimization: (a) Were the limits of work areas and access roads clearly marked? (b) Were construction activities limited to CPUC-approved work areas?		Met Requirements
minimization requ adequately? (b) V thresholds? (c) V and operated in a organic waste co	GHG: (a) Were dust avoidance and uirements implemented and monitored Was dust generation below required Vere equipment and vehicles maintained a manner to limit emissions? (d) Was llected and separated from non-organic riate composting or recycling, as	Met Requirements
Q2 Notes		I observed pizza box, orange peels and napkin near job site. I don't recall seeing this when I walked the area (twice) last night.
minimization requ	tus Plants: Were impact avoidance and uirements for special-status plants equately (e.g., avoiding sensitive areas)?	Met Requirements

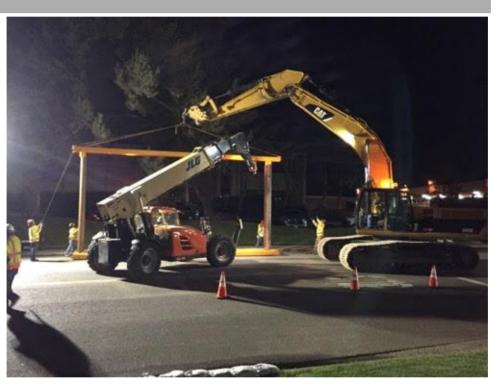
Lighting and flaggers in place.

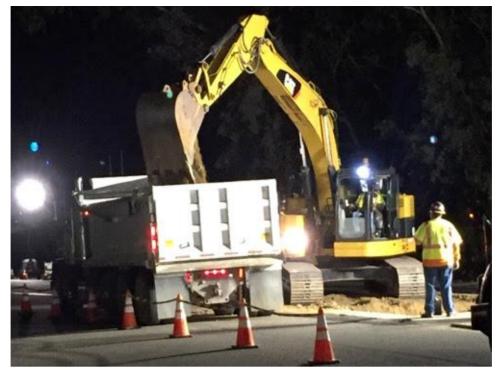
n Little to no dust being created.

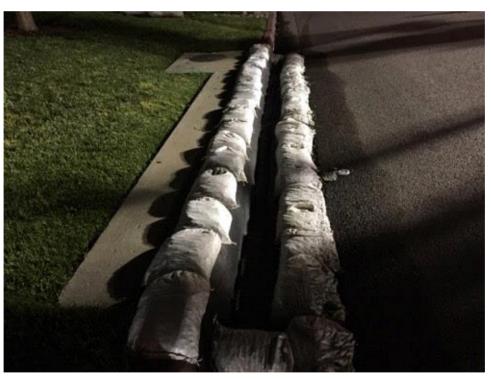
Caption BMP's in place for SWPPP

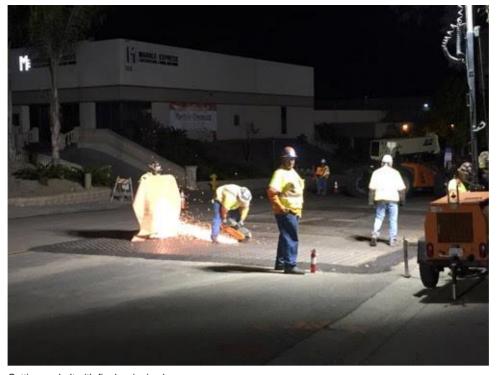
Cutting asphalt with fire barrier in place. Capture Date/Time: Mon Apr 10 2017 21:19:54 GMT-0700 (PDT) Coordinates: 32.889067, -117.159520 Photo Attributes

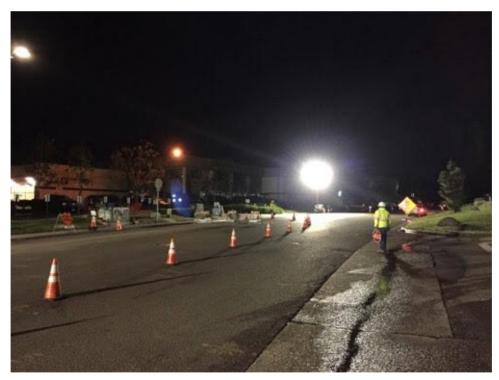
Cones, lighting, and flaggers in place.

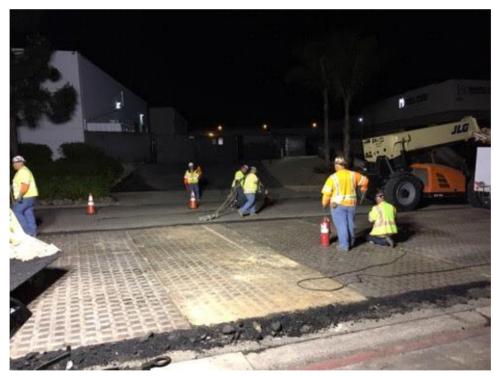
Steel plates installed to cover trenches.

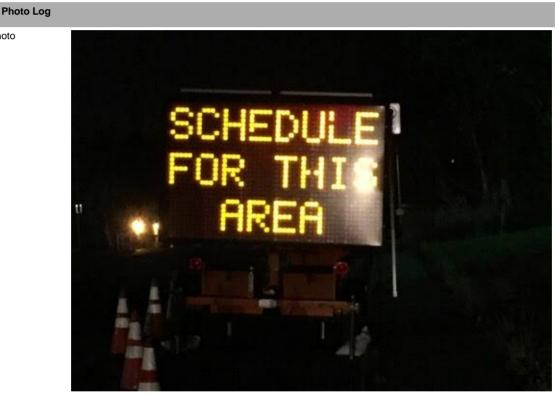
Digital signage in place at entrances to work areas.

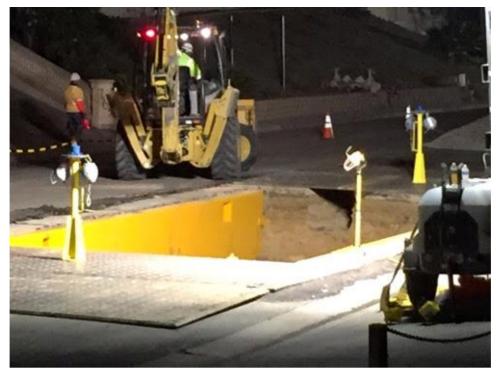
Excavation of trench with shoring in place. Photo Attributes Capture Date/Time: Tue Apr 11 2017 22:48:42 GMT-0700 (PDT) Coordinates: 32.889152, -117.159430 View Direction: Southwest

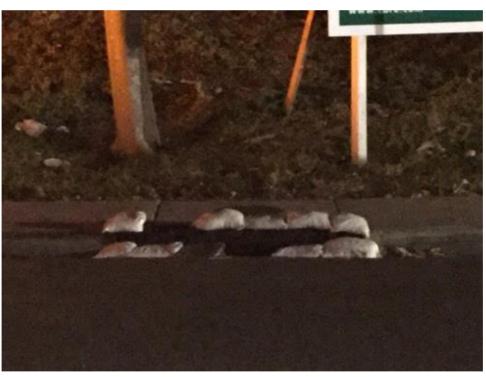
Caption BMP's in place for SWPPP.

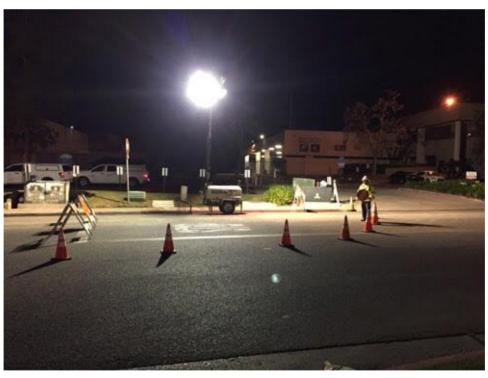
Lighting, cones, and flaggers in place for traffic safety.

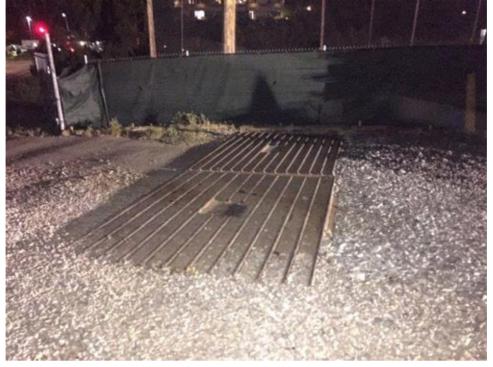
Shaker plates in place to prevent track out.

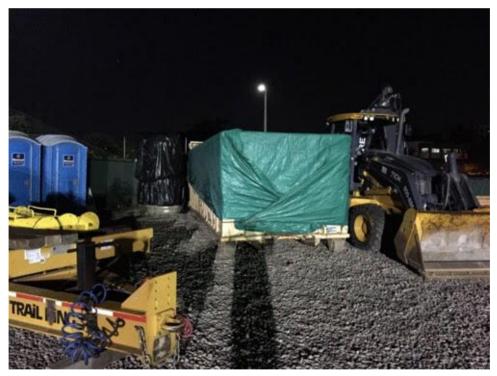
Dumpsters were covered to contain debris.

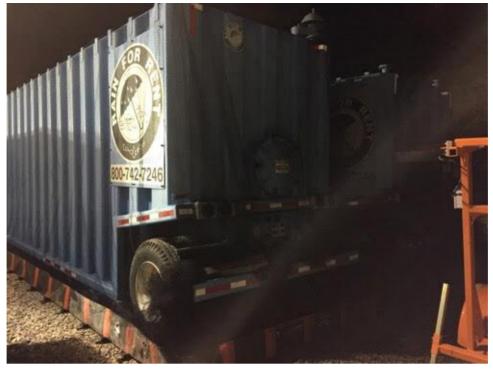
Bird netting in place to prevent nesting in equipment. Capture Date/Time: Wed Apr 12 2017 05:12:16 GMT-0700 (PDT) Photo Attributes Coordinates: 32.891106, -117.191351

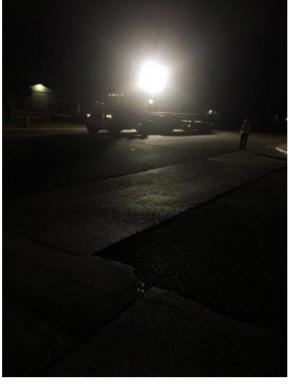
Truck delivering beams to next vault site.

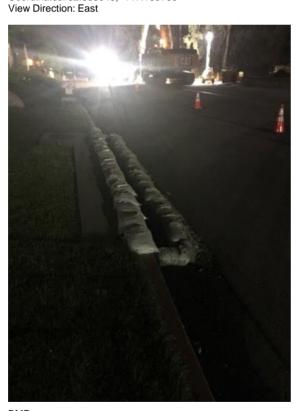
BMPs

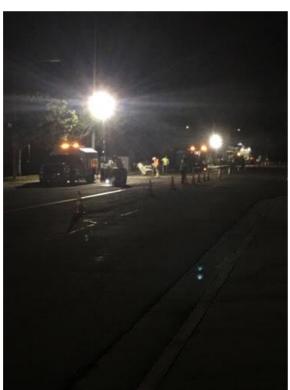
Asphalt cutting site along Trade Place.

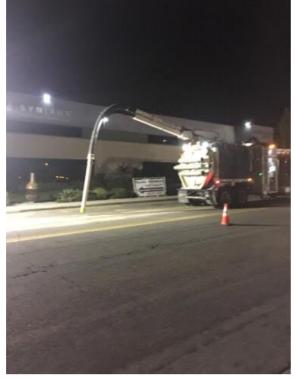
Pot hole vacuum truck along Trade Place.

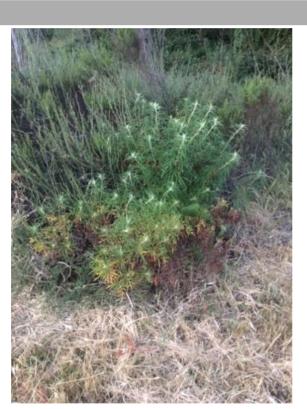
Rare plant population along Carrol Road near NBBR #3. Species = Atemisia palmeri.

Rare plant population observed adjacent to work site on Carrol Road. No impacts observed.

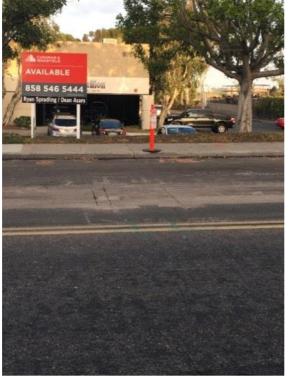
Asphalt cut work site on Trade Place, work completed.

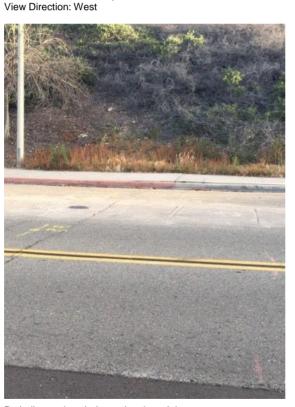
Potholing and asphalt cut site along Arjons.

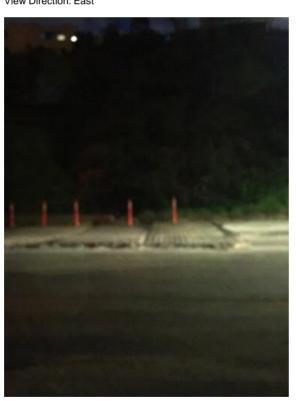
Excavation site along Carrol Road. Note construction not occurring. Capture Date/Time: Fri Apr 14 2017 06:41:33 GMT-0700 (PDT) Coordinates: 32.892986, -117.202854 View Direction: West

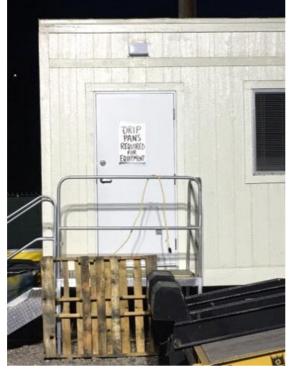
Hazardous material sign at driving range yard.
