**PROJECT MEMORANDUM  
SYCAMORE-PEÑASQUITOS 230-KV  
TRANSMISSION LINE PROJECT**

Date: July 14, 2017  
To: Billie Blanchard, CPUC Project Manager  
From: Sheila Hoyer, CPUC Monitoring Supervisor  
**Subject:** Weekly Report #27 – July 2 to July 8, 2017

## SDG&E Sycamore-Peñasquitos 230-kV Transmission Line Project: Daily Inspection Report

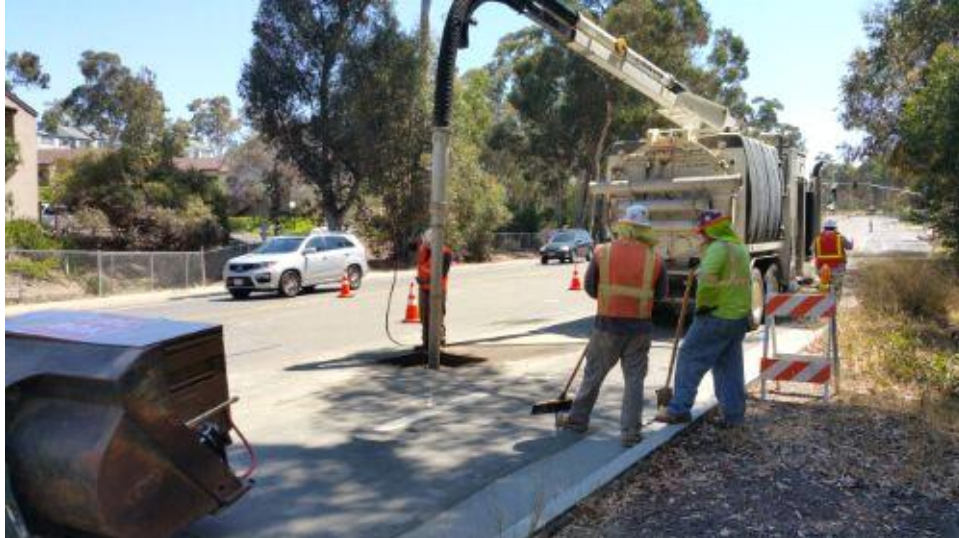
Caption Potholing.

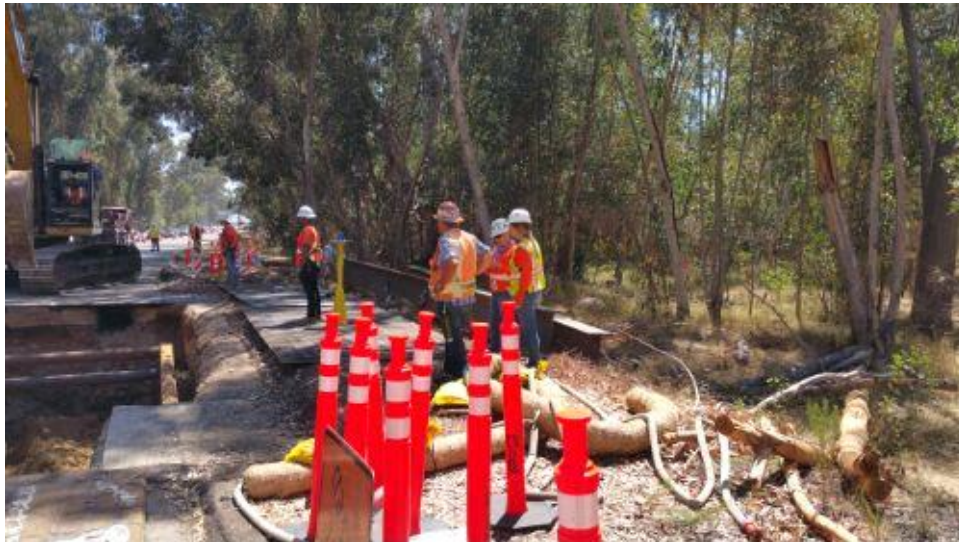
Caption Archaeological and paleontology monitors at excavation.

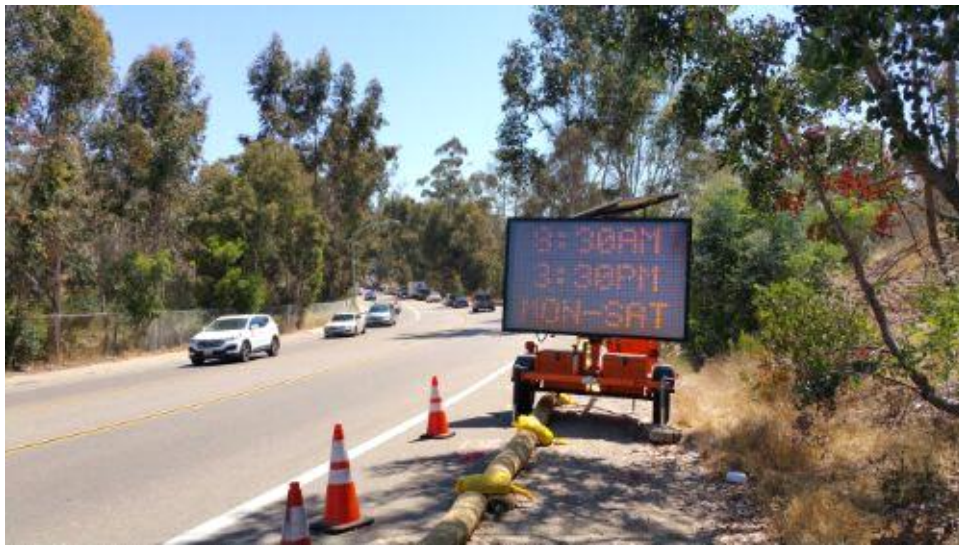
Caption Traffic control signage.

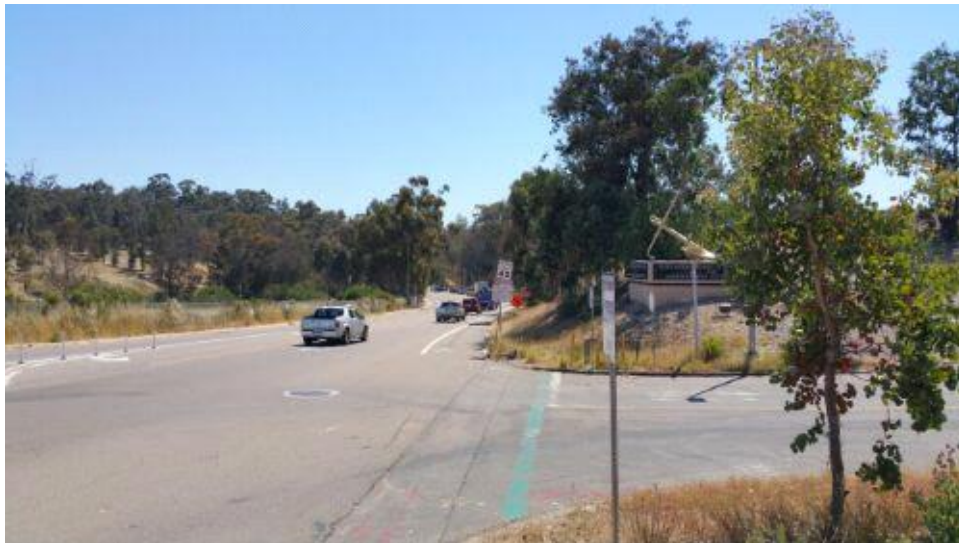
Caption Maximum traffic backup on Pomerado Road

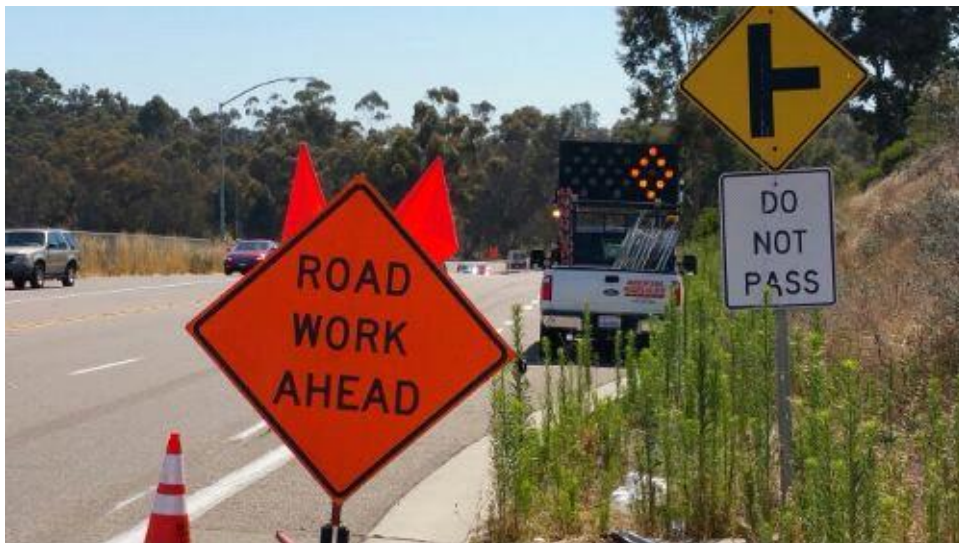
Caption First traffic control sign approx. 1000 feet east of offramp.

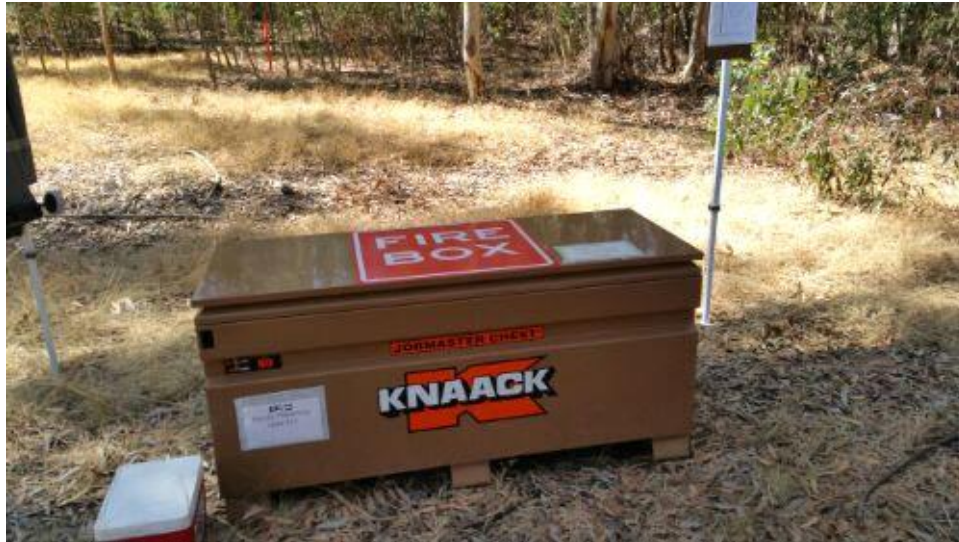
Caption Fire boxes approximately 150 feet from excavation. Precluded from close placement due to unique requirements of traffic control.

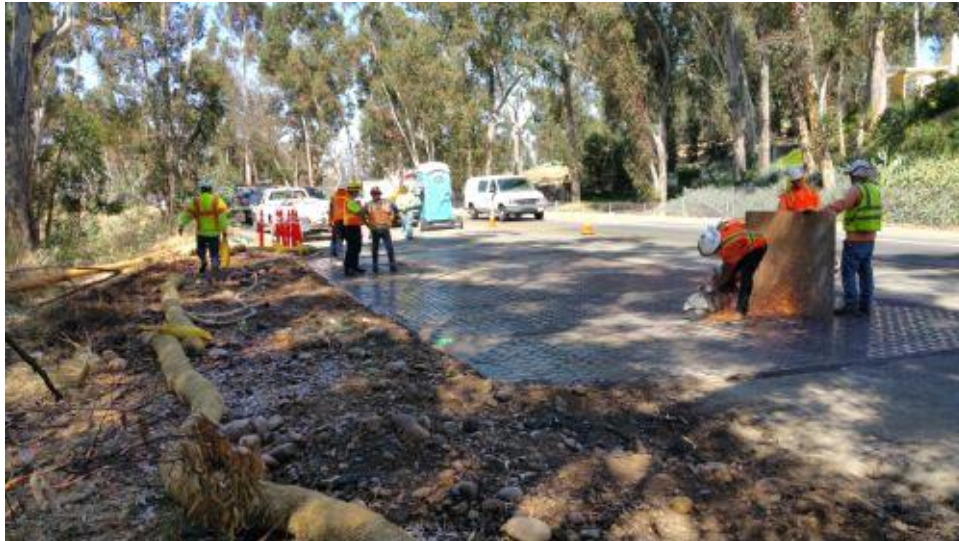
Caption Hose present, used to wet adjacent vegetation near plate cutting.

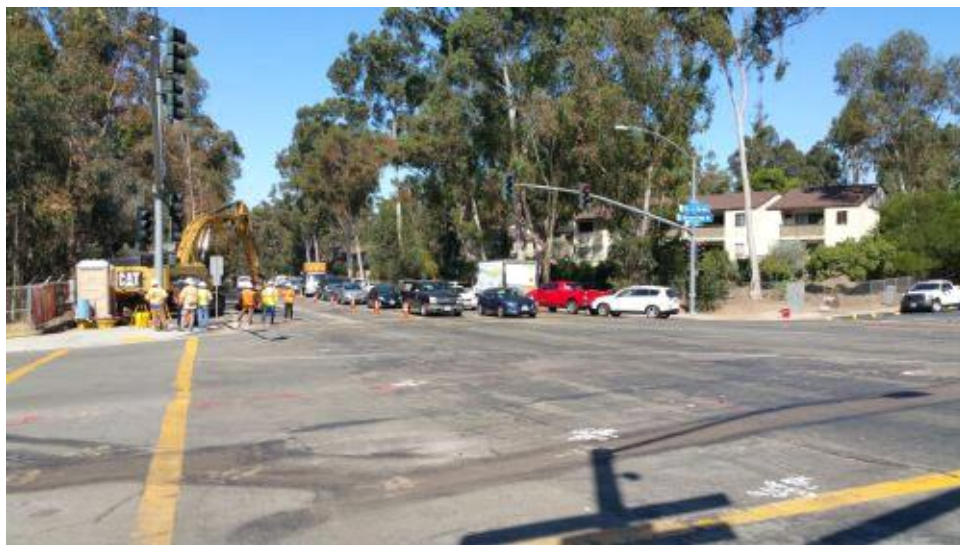
Caption Traffic controls in place, signals not adjusted, excavator starting to move.

City did not set signals to flash at 9 am. Crews waited until 9:30 to start setting cones. Traffic did not back up excessively. Lights set to flash about 10:30.

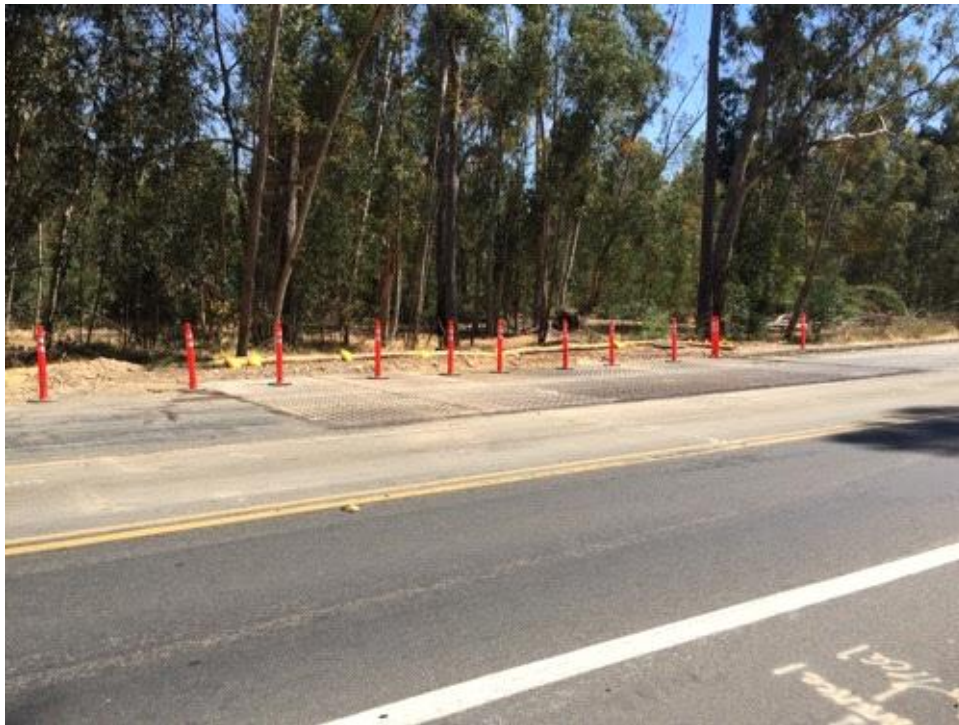
Caption Vault covered with steel plates and thoroughly swept at end work day.

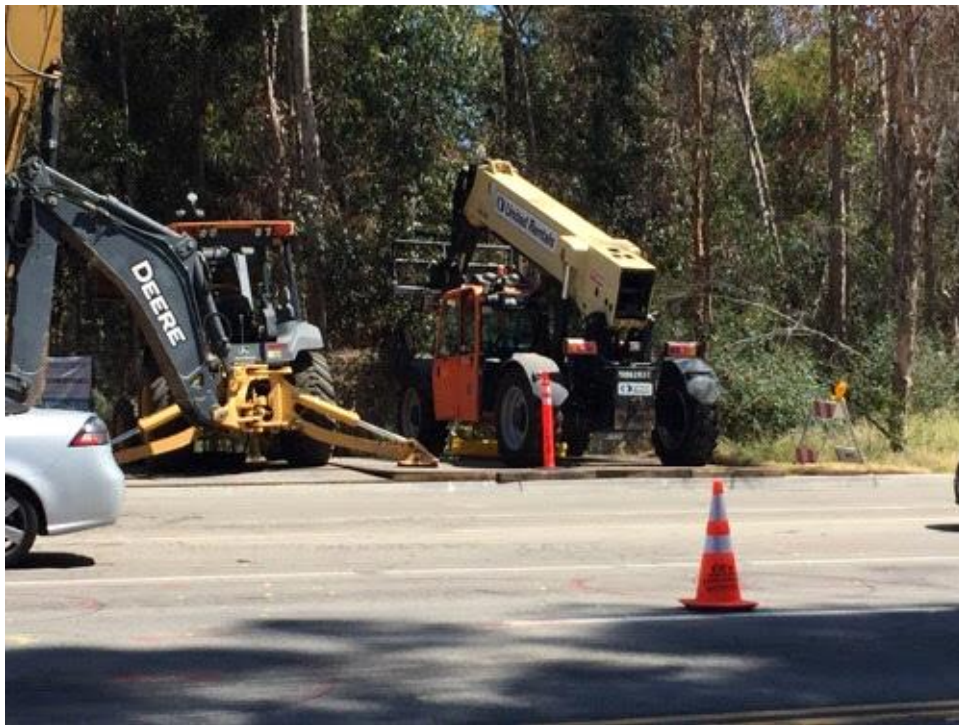
Caption Drip pans in place on Pomerado Road.

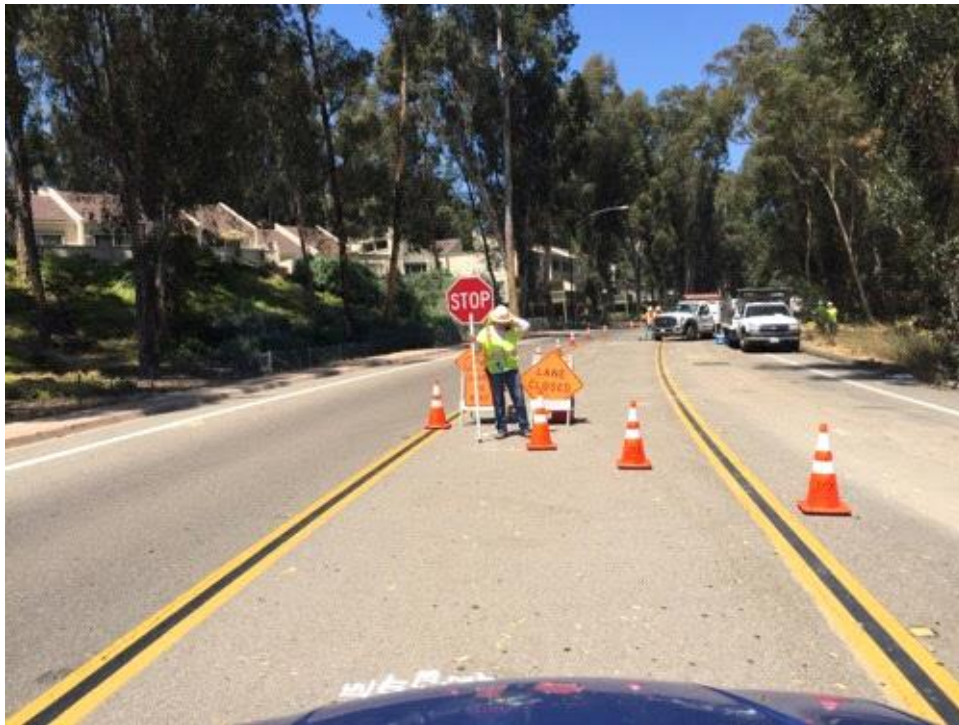
Caption Cones and markers in place on Pomerado Road.

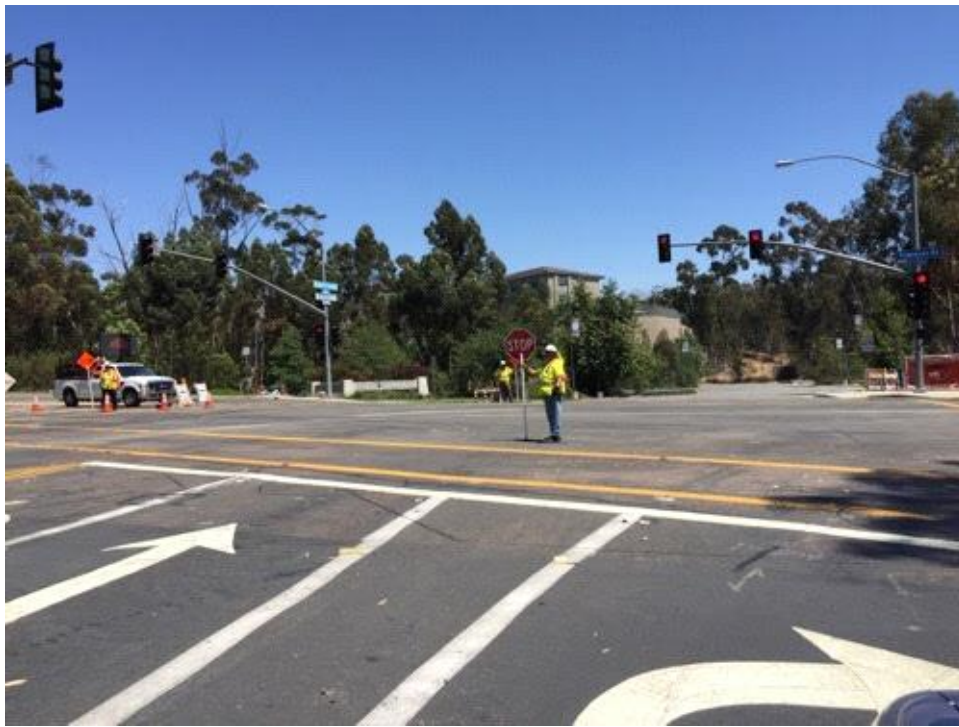
Caption Traffic flaggers in place on Pomerado Road and Willow Creek Road.

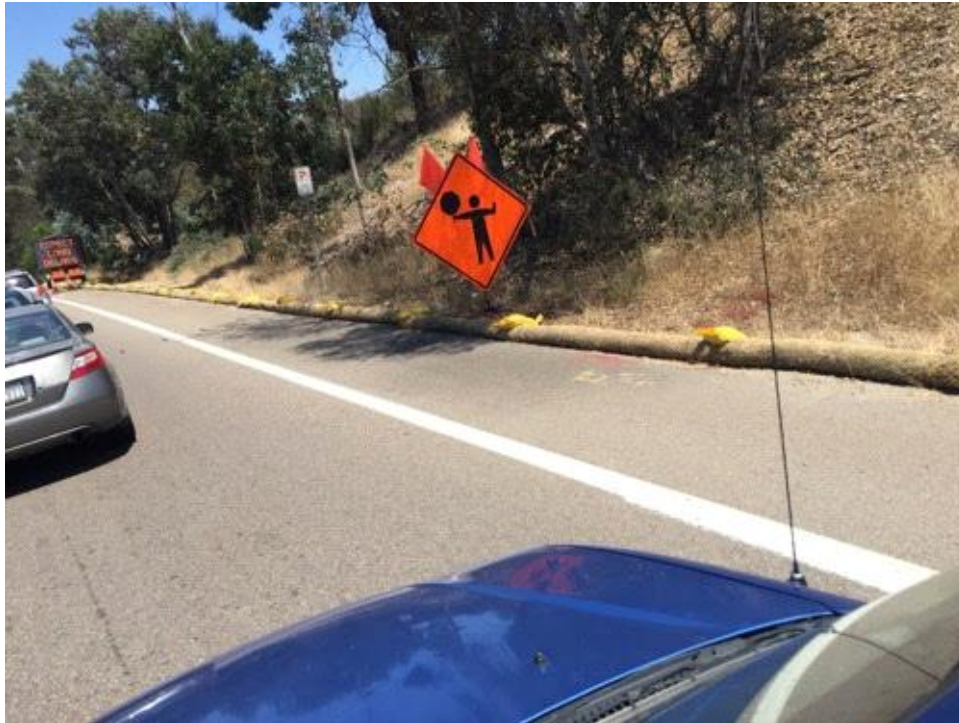
Caption BMPs in place on Pomerado Road.

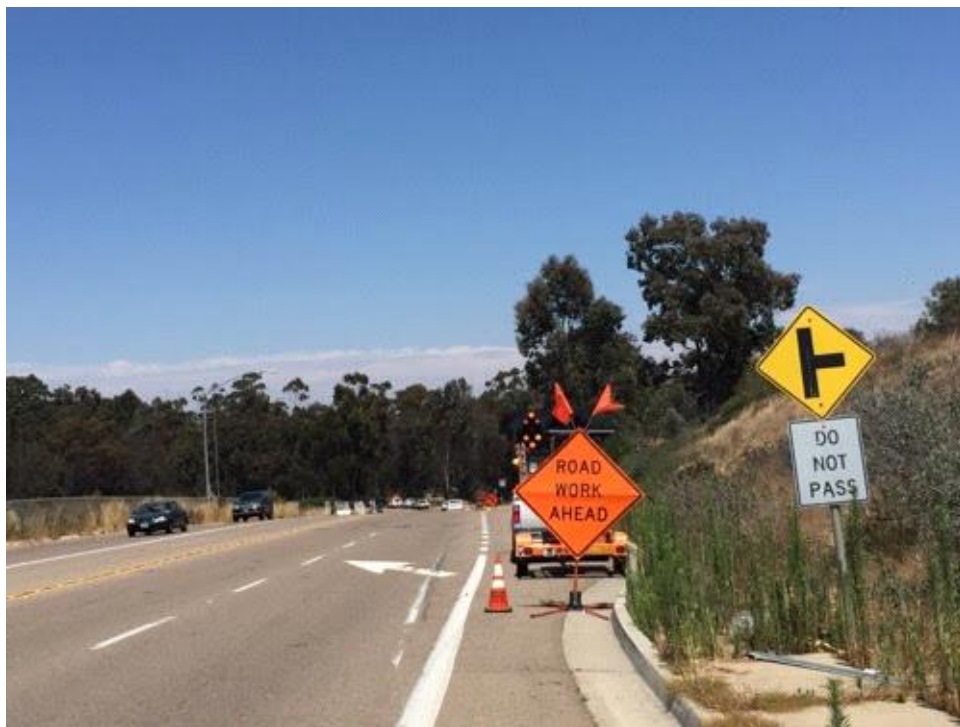
Caption Signage in place on Pomerado Road.

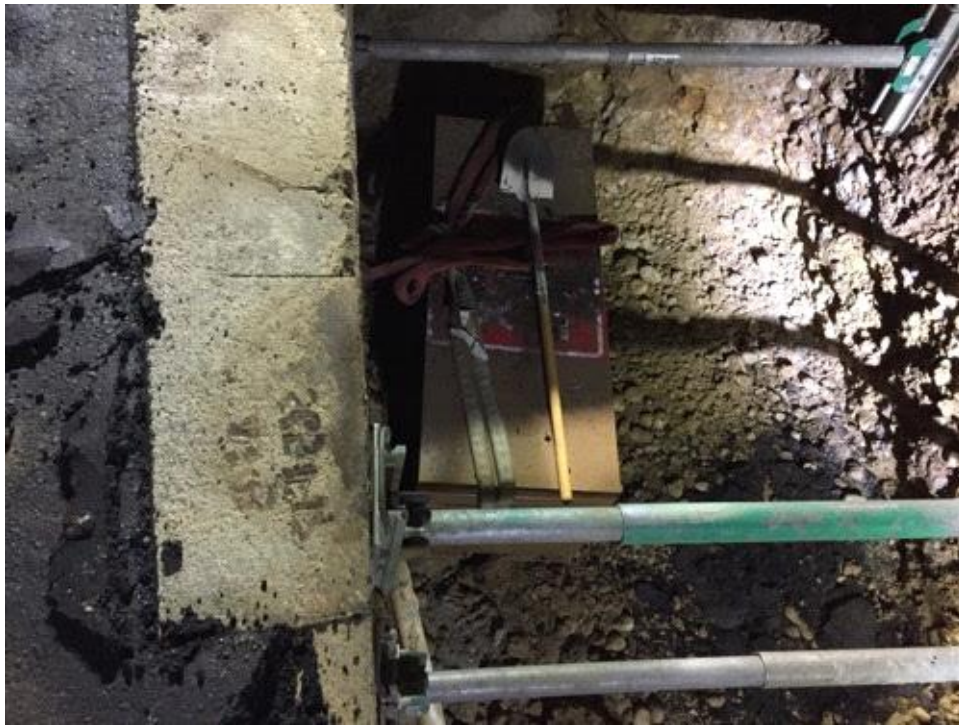
Caption Fire equipment in the vault on Trade Place and Trade Street.

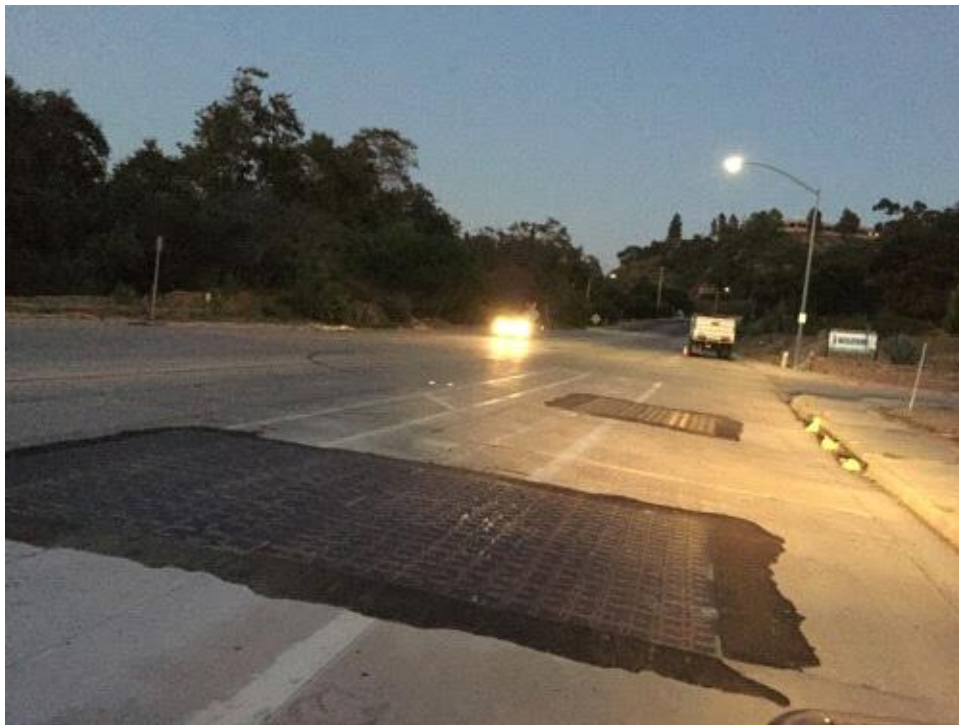
Caption Steel plates covering excavations when not in use on Carroll Canyon Road.

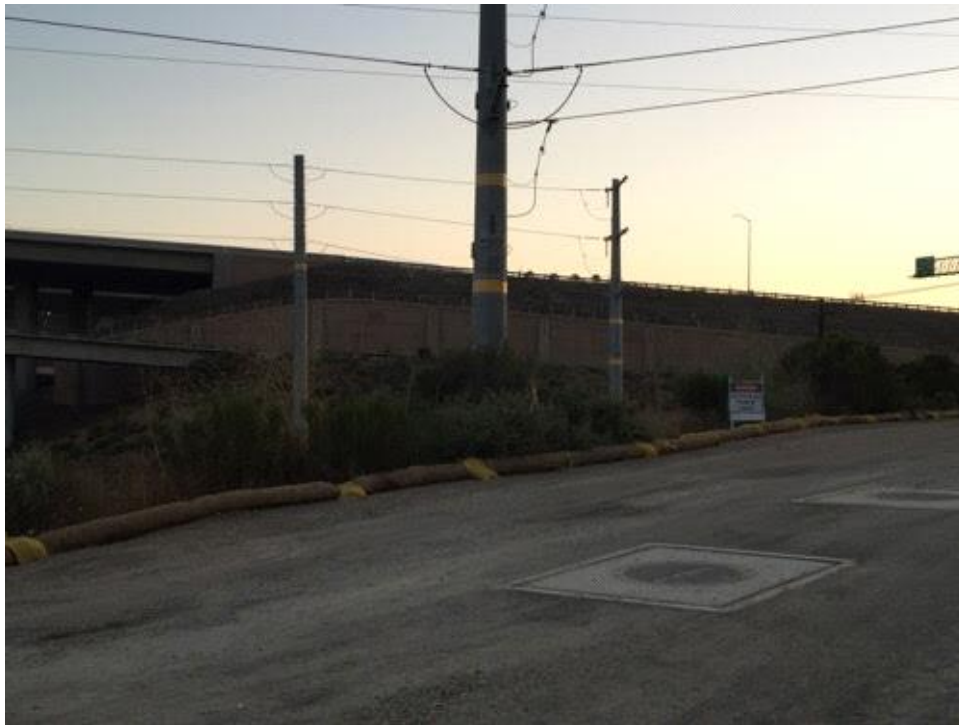
Caption BMPs in place and in good working order on Carroll Road near the 805 freeway.

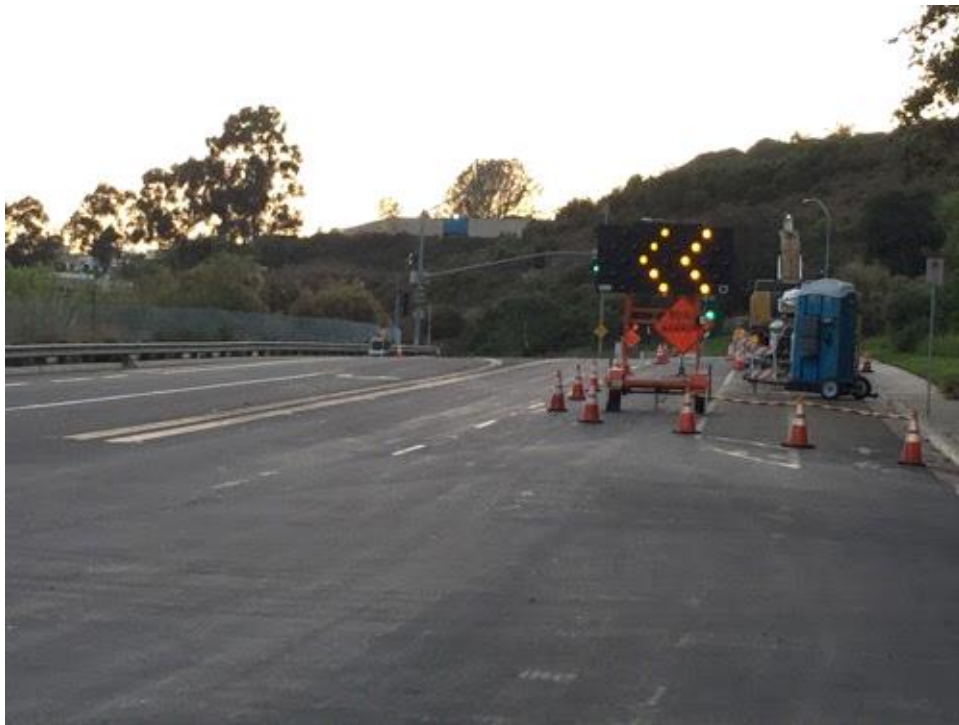
Caption Digital signage on Carroll Road.

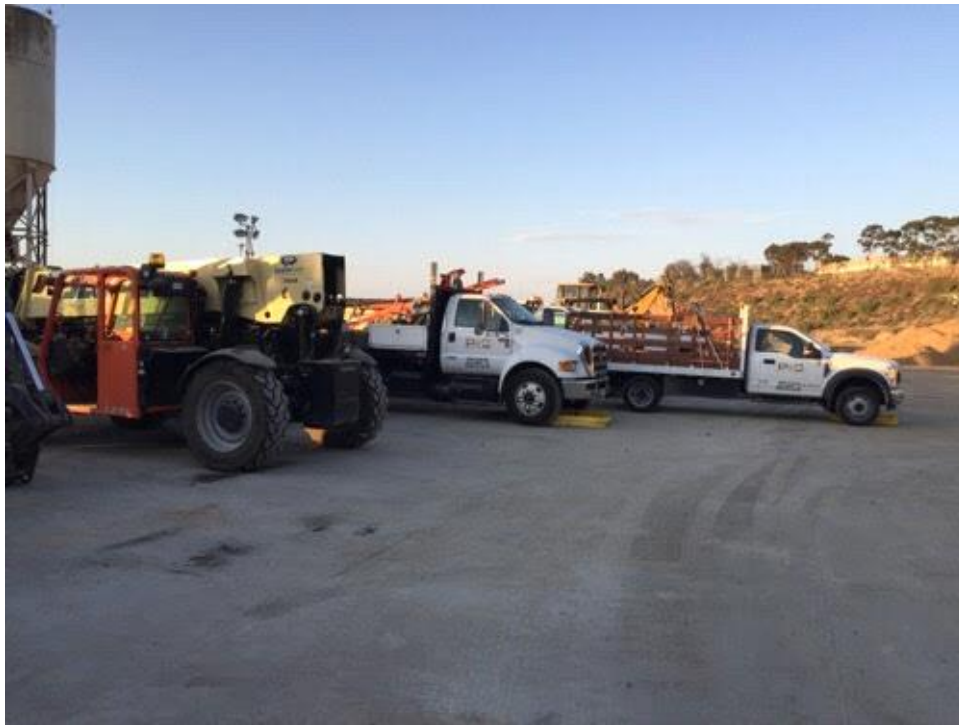
Caption Drip pans in place at construction yard off of Santa Fe.

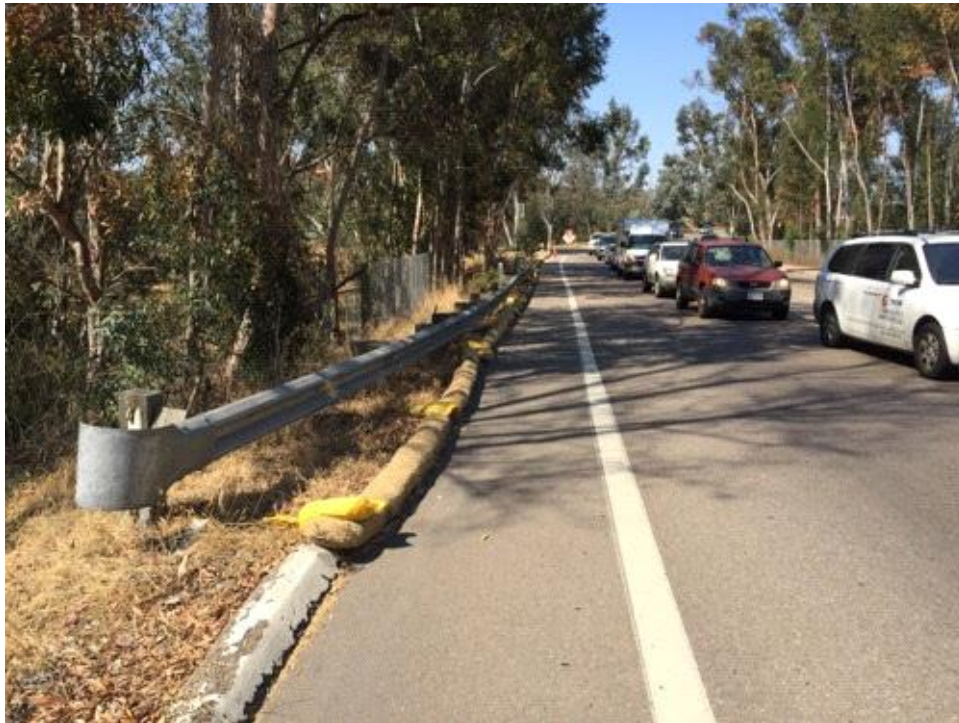
Caption Wattles in place on Pomerado Road.

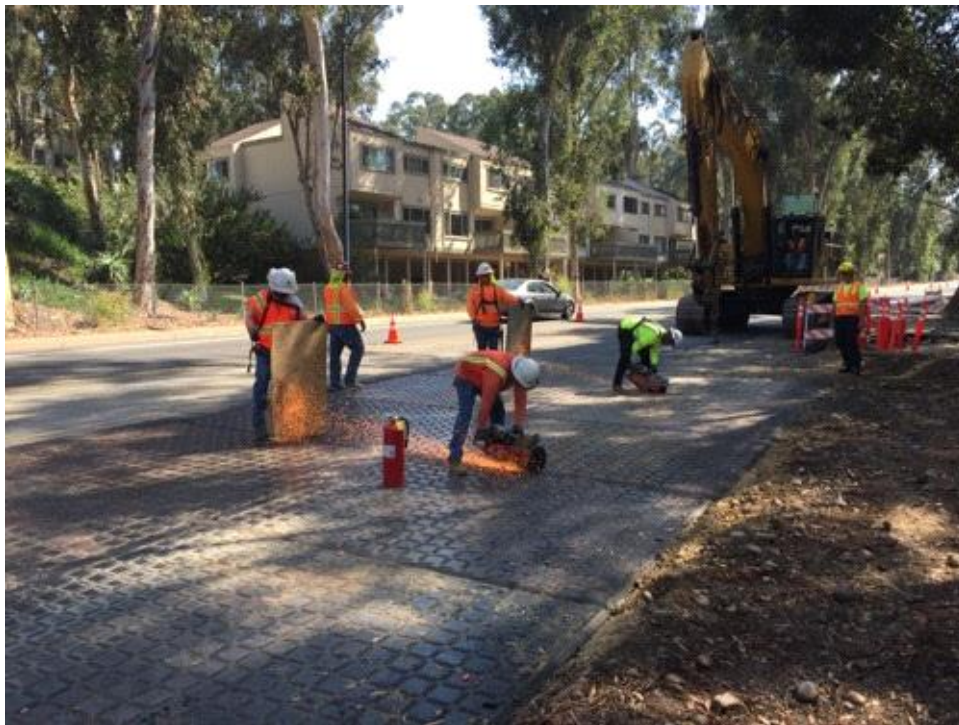
Caption Fire prevention measures in practice on Pomerado Road.

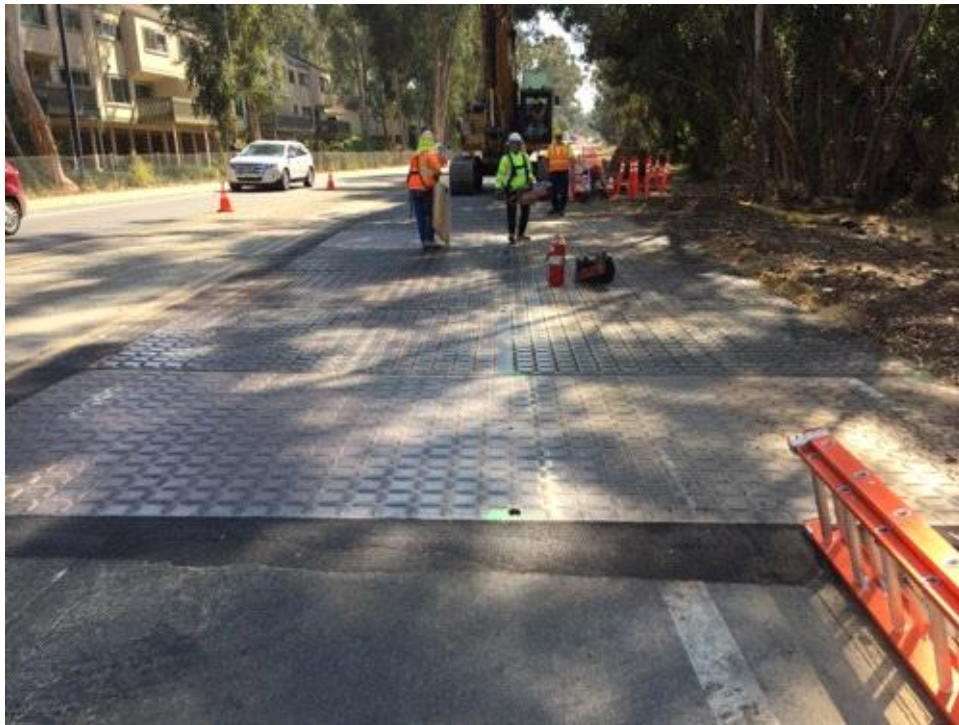
Caption Steel plates covering vault on Pomerado Road.

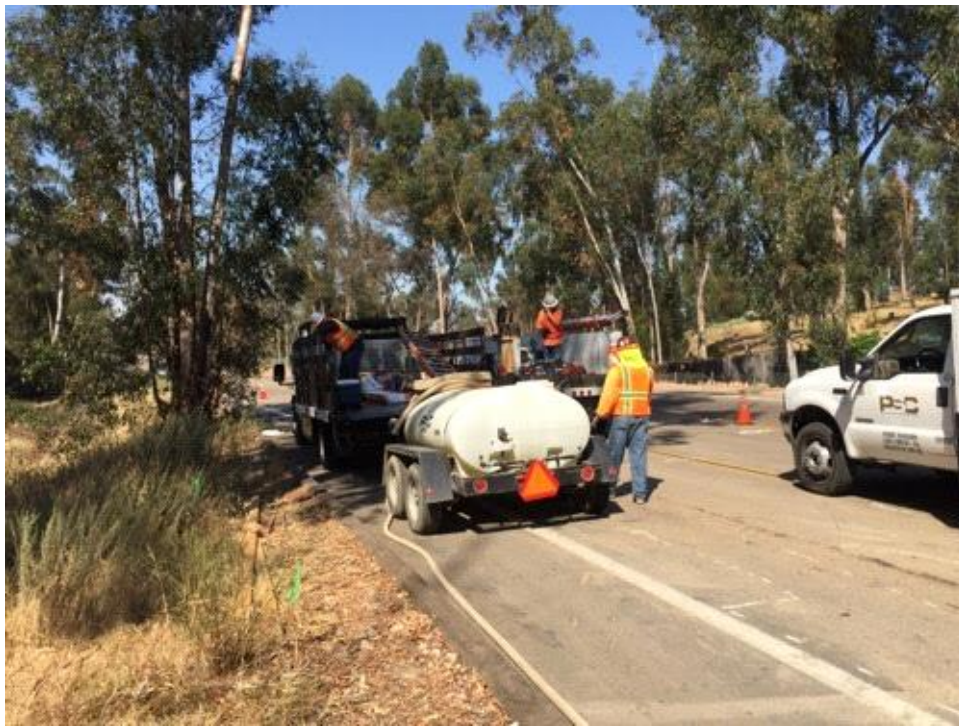
Caption Fire safety tech on site on Pomerado Road.

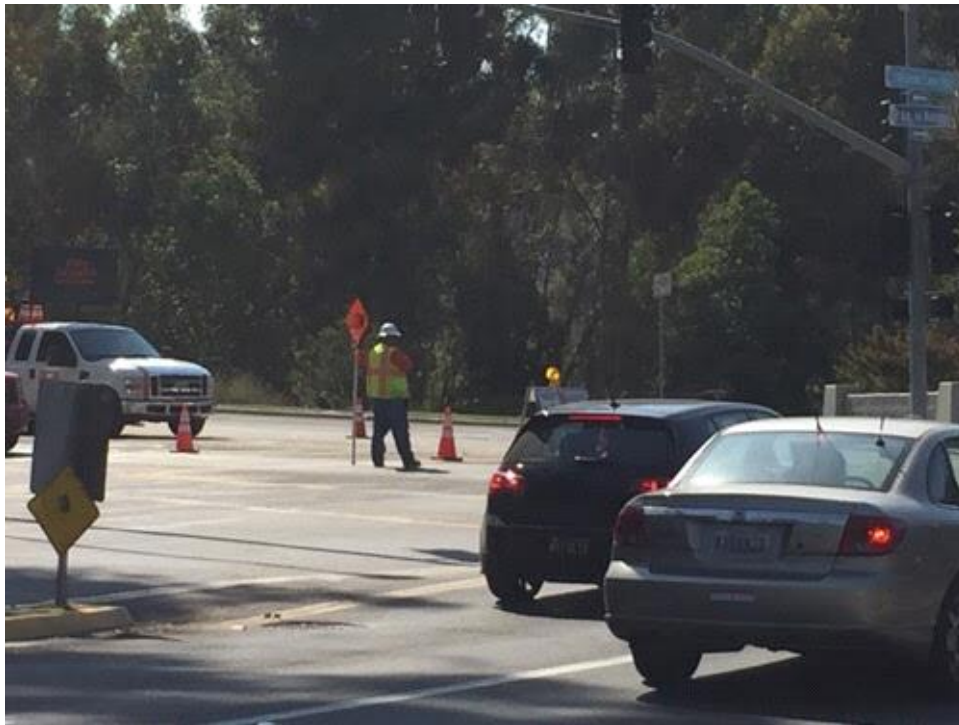
Caption Traffic flaggers on site at the intersection of Pomerado Road and Willow Creek.

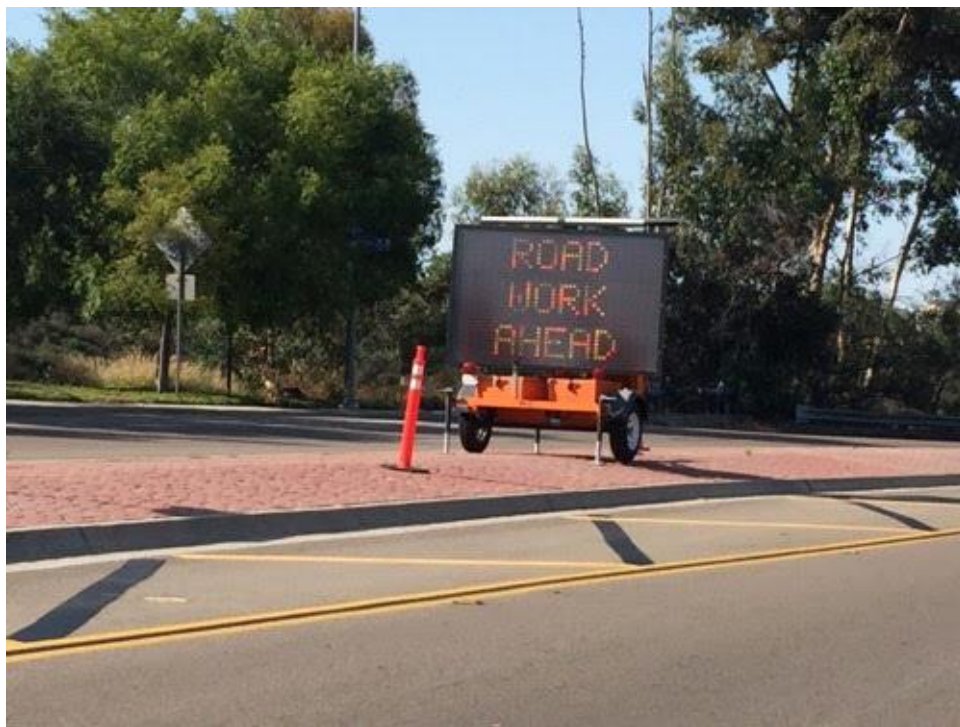
Caption Digital signage in place on upper Pomerado Road.

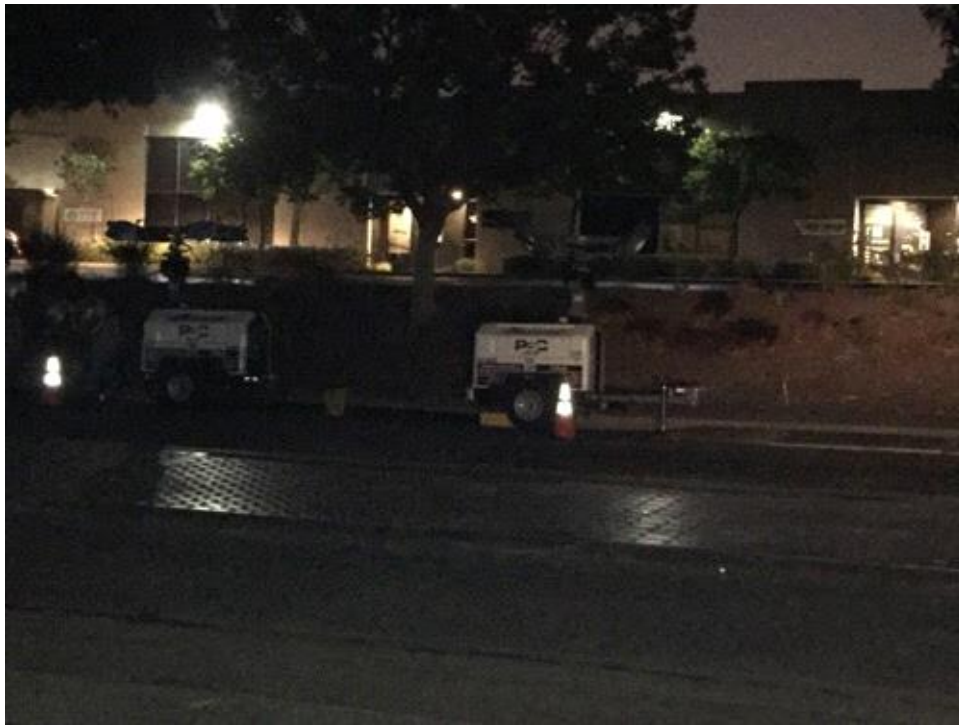
Caption Drip pans in place on Trade Place.

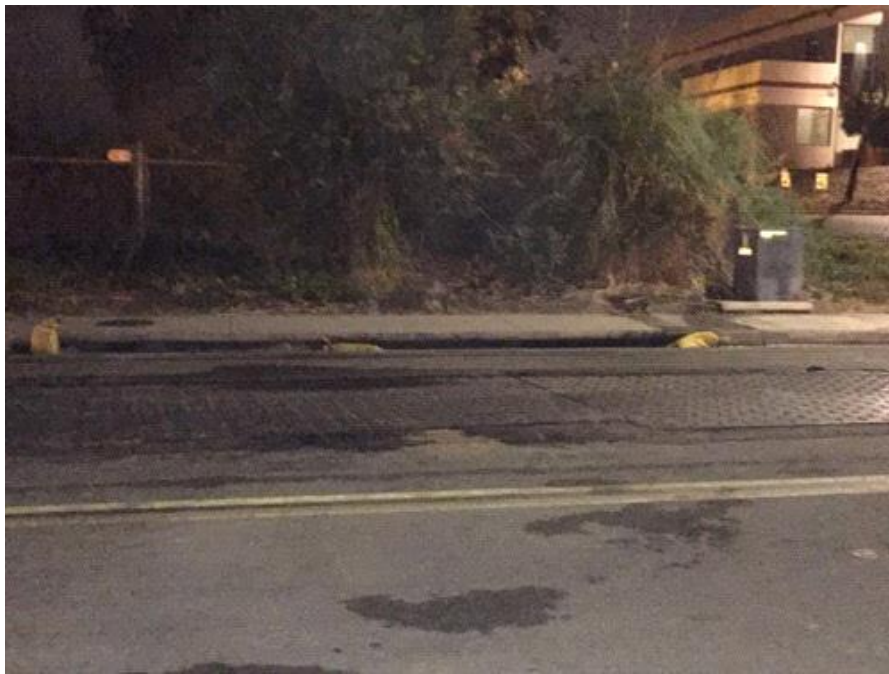
Caption BMPs in place and in good working order on Arjons Drive.

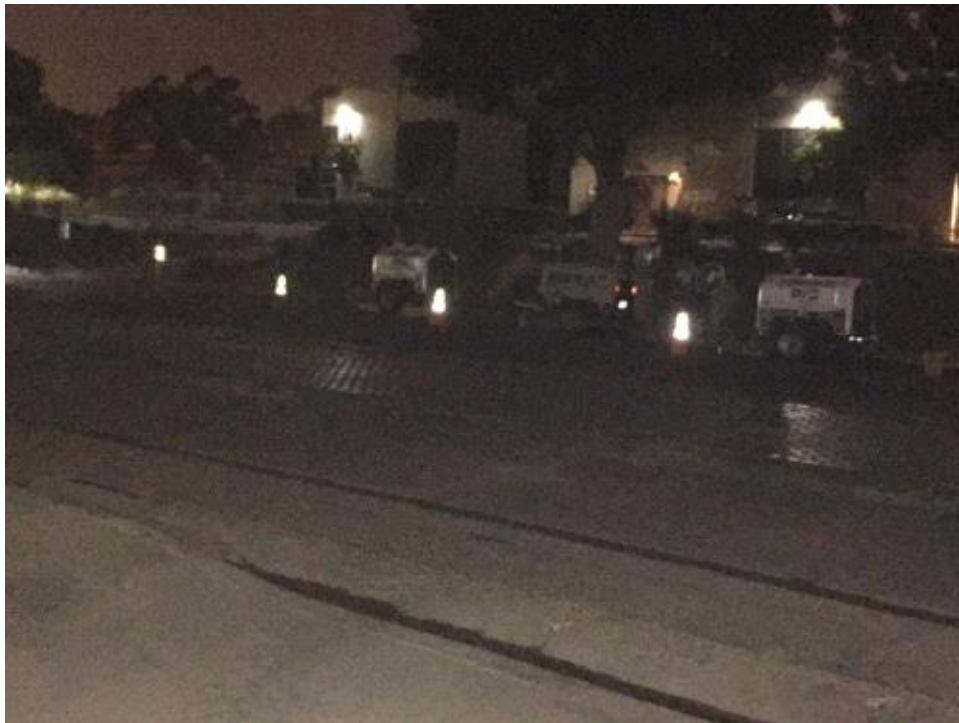
Caption Excavations covered with steel plates when not in use.

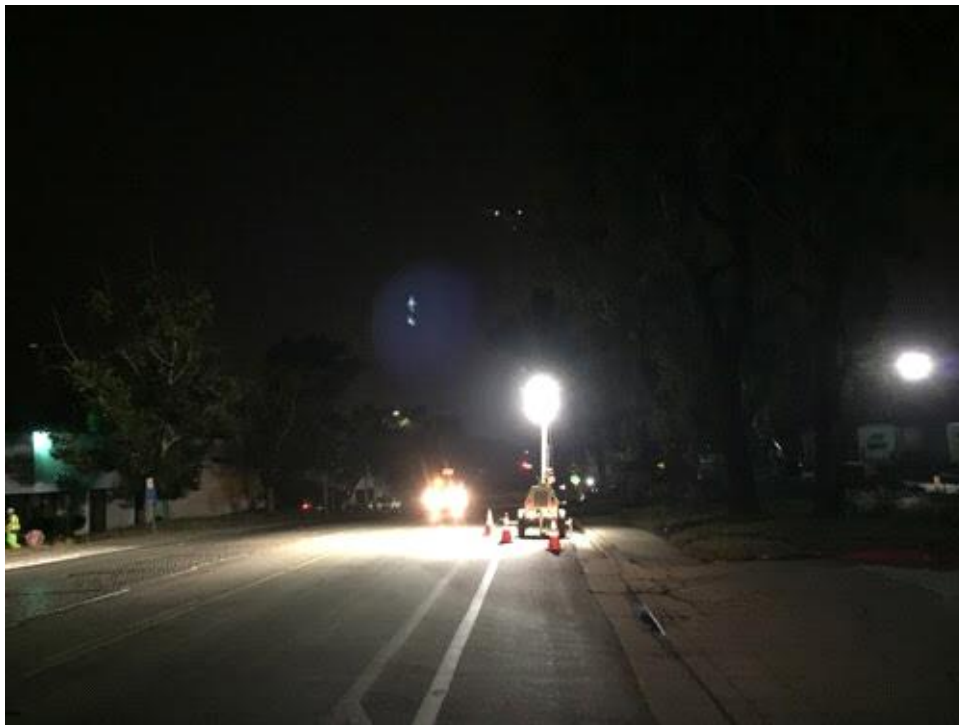
Caption Downward-facing lighting on upper Carroll Canyon Road.

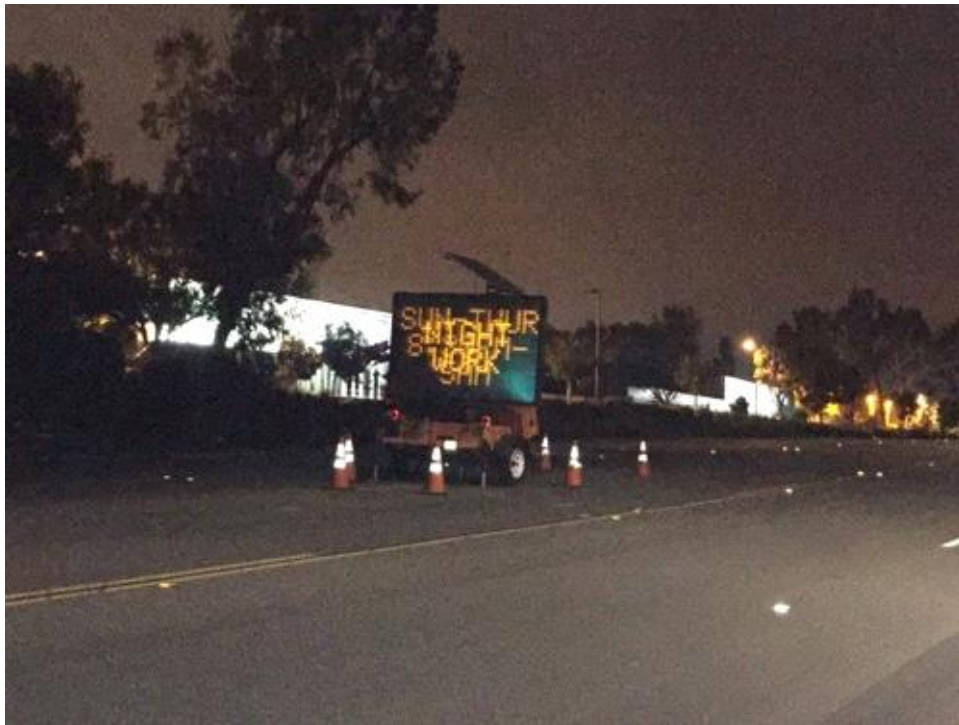
Caption Digital signage on Carroll Canyon Road.
