## PROJECT MEMORANDUM SYCAMORE-PEÑASQUITOS 230-KV TRANSMISSION LINE PROJECT

Date: July 20, 2017  
To: Billie Blanchard, CPUC Project Manager  
From: Sheila Hoyer, CPUC Monitoring Supervisor  
**Subject:** Weekly Report #28 – July 9 to July 15, 2017

## SDG&E Sycamore-Peñasquitos 230-kV Transmission Line Project: Daily Inspection Report

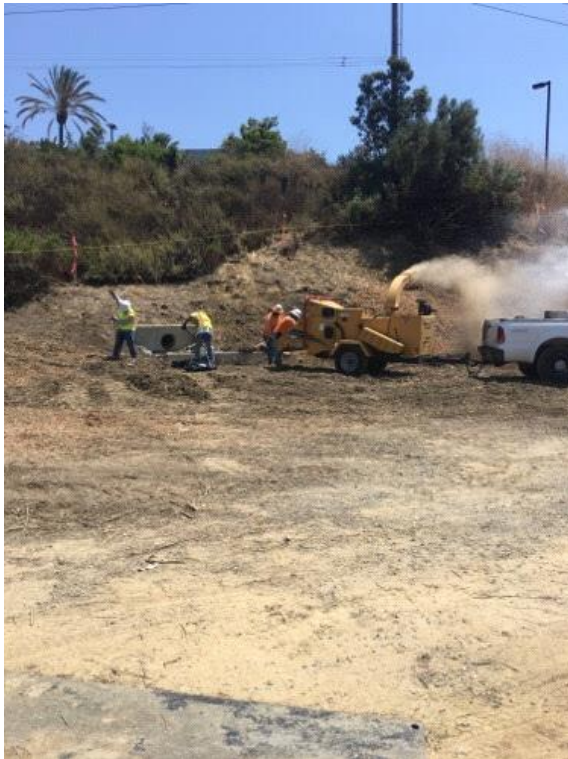
Caption Mulching at CCCMP  
Photo Attributes Capture Date/Time: Mon Jul 10 2017 11:31:18 GMT-0700 (PDT)  
Coordinates: 33.134508, -117.190868  
View Direction: North

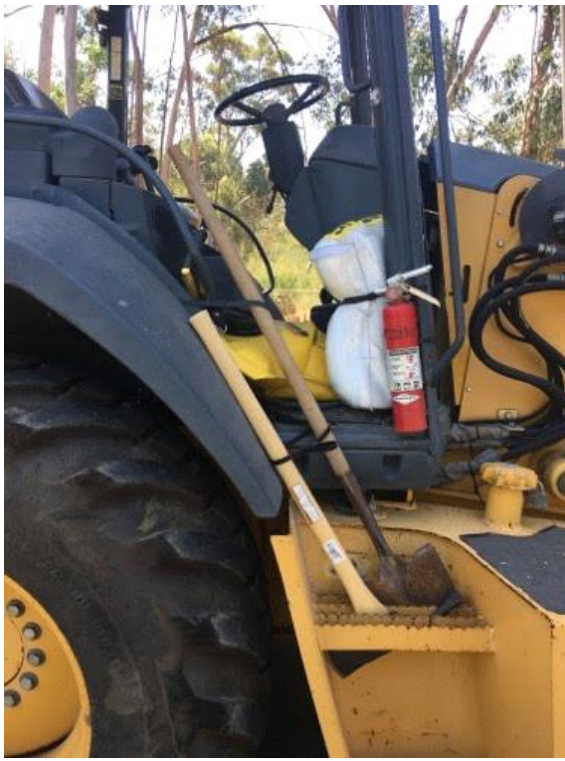
Caption Fire equipment

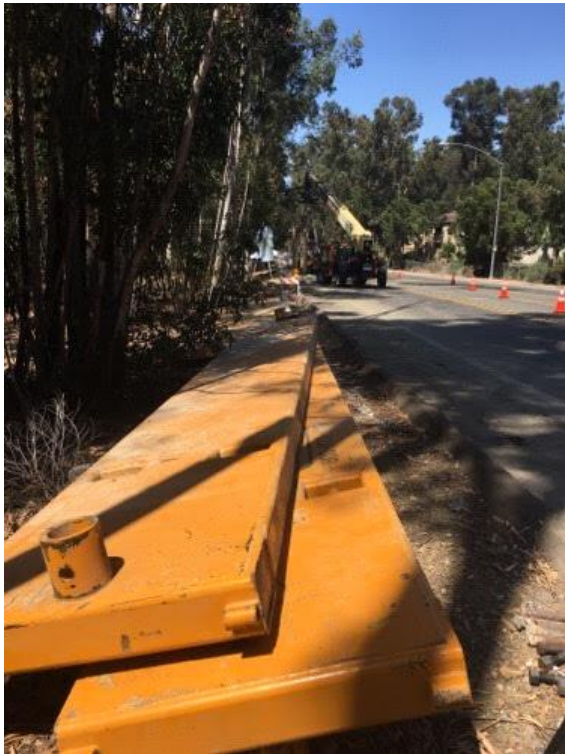
Caption Site storage and prep work for vault, Pomerado Road.

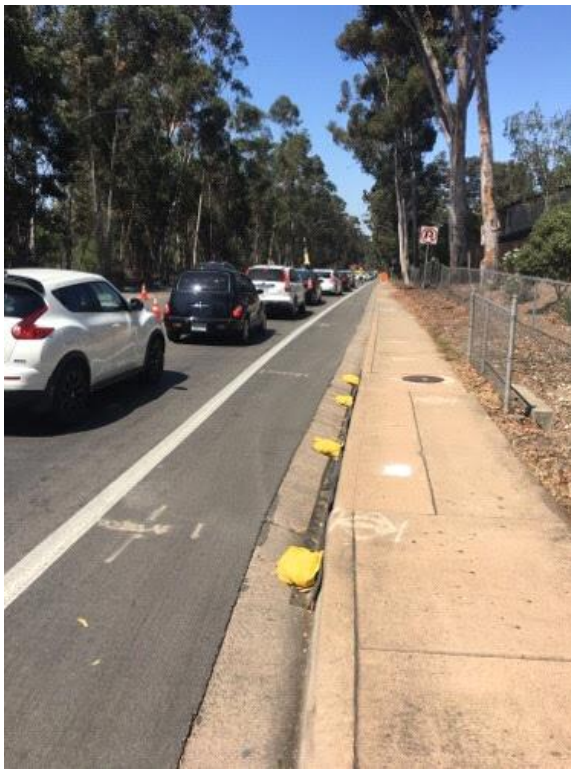
Caption BMPS and Traffic on Pomerado Road.

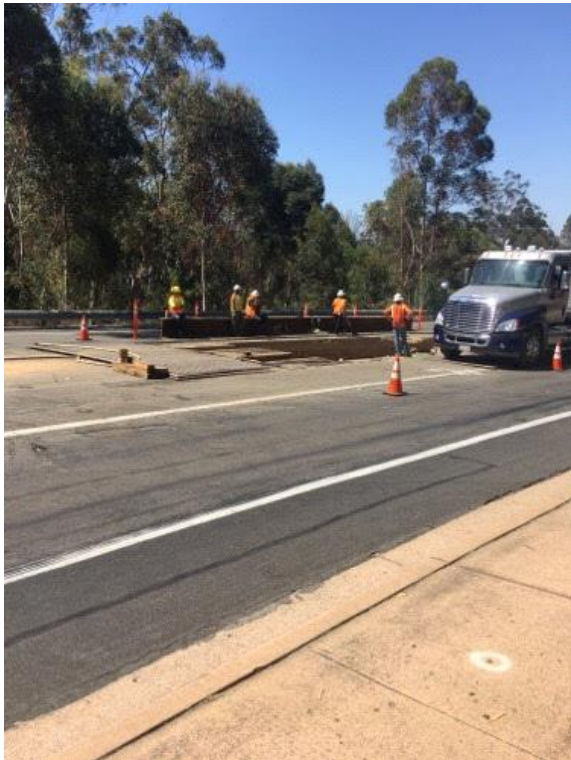
Caption Vault work on Pomerado Road.

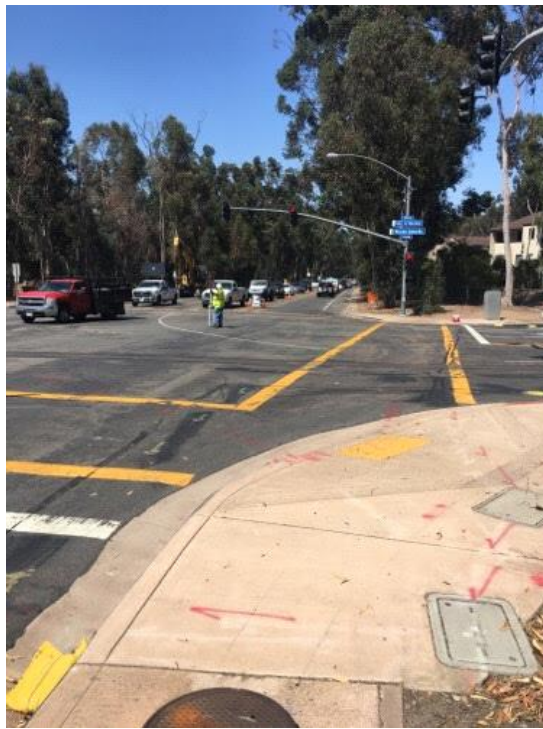
Caption Traffic control at Ave. of Nations and Pomerado Rd.

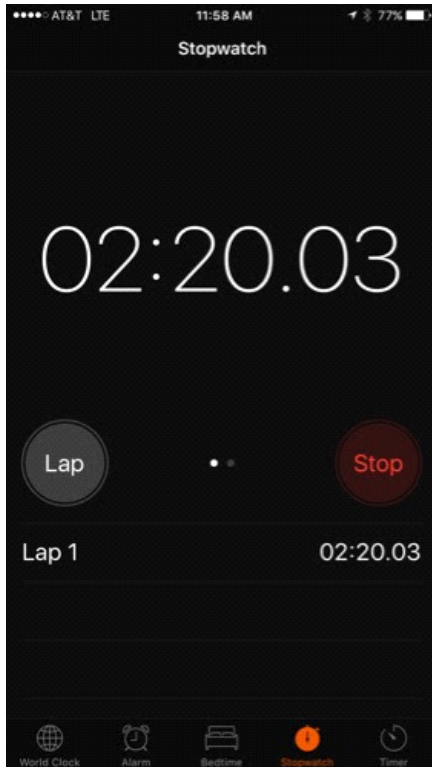
Caption Traffic stoppage time for east-bound traffic (approximately 35 vehicles in line)

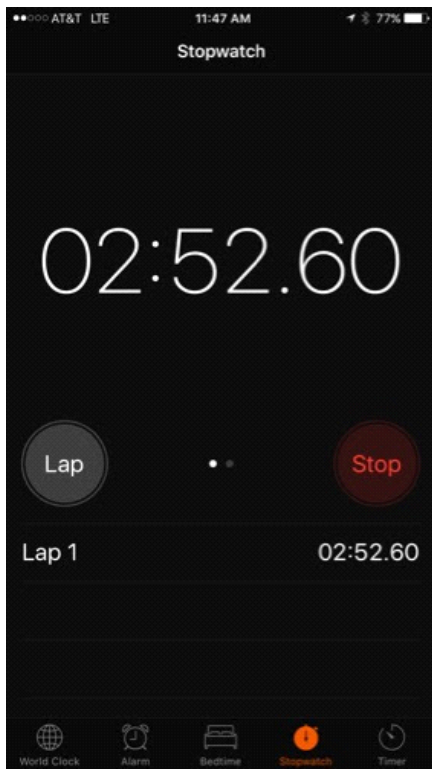
Caption Traffic stoppage time at eastern end of Pomerado Road vault.

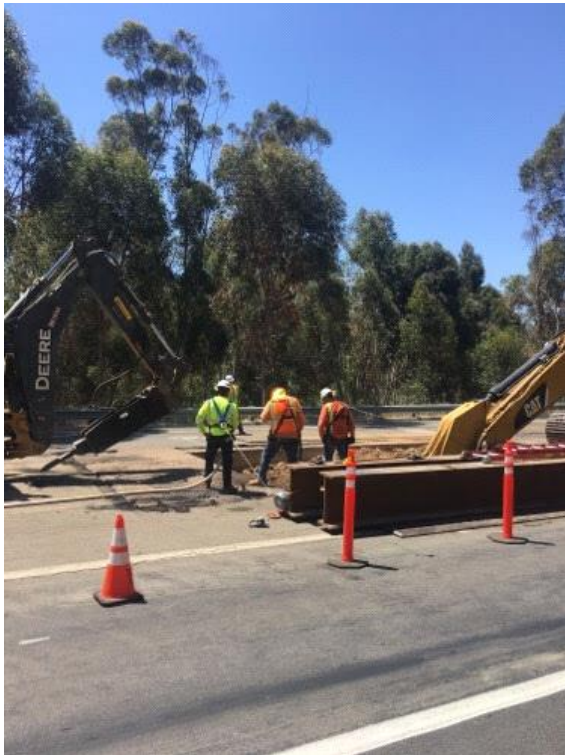
Caption Excavation and paleo monitoring on Pomerado Road.

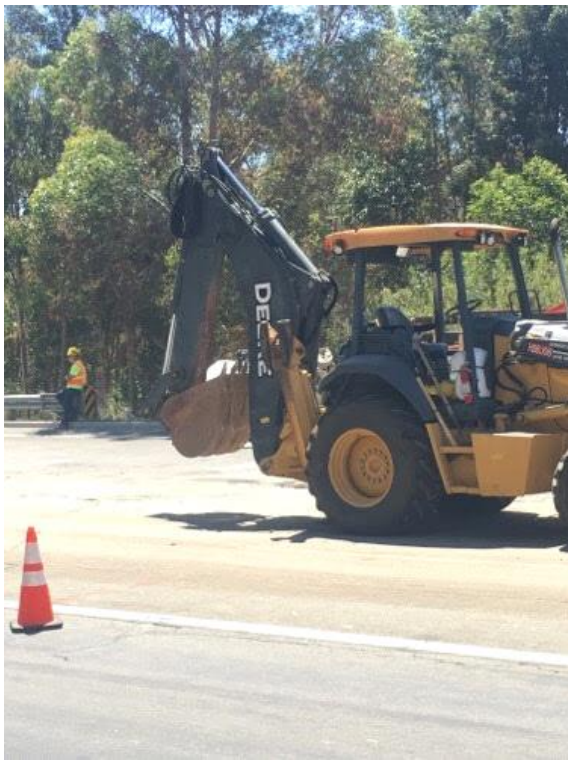
Caption Fire tools and fire technician onsite at Pomerado Road vault excavation.  
Photo Attributes Capture Date/Time: Tue Jul 11 2017 11:40:51 GMT-0700 (PDT)  
Coordinates: 32.897831, -117.102360  
View Direction: Southeast

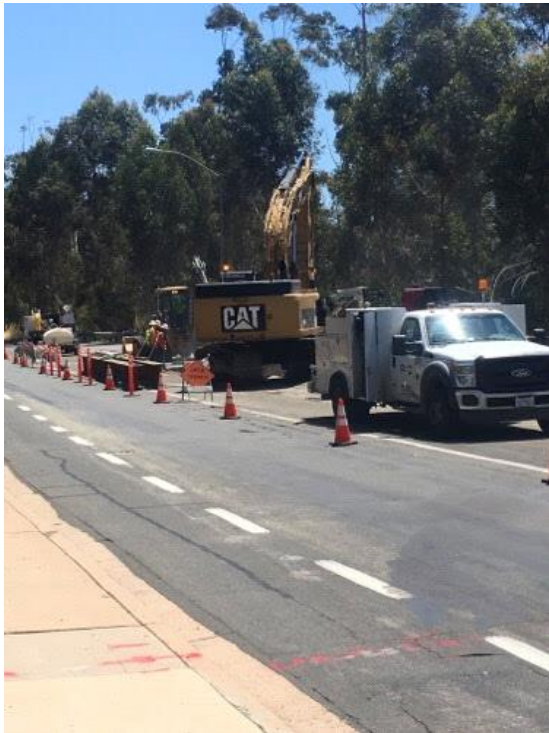
Caption Excavation on Pomerado Road.  
Photo Attributes Capture Date/Time: Tue Jul 11 2017 11:40:21 GMT-0700 (PDT)  
Coordinates: 32.897826, -117.102354  
View Direction: East

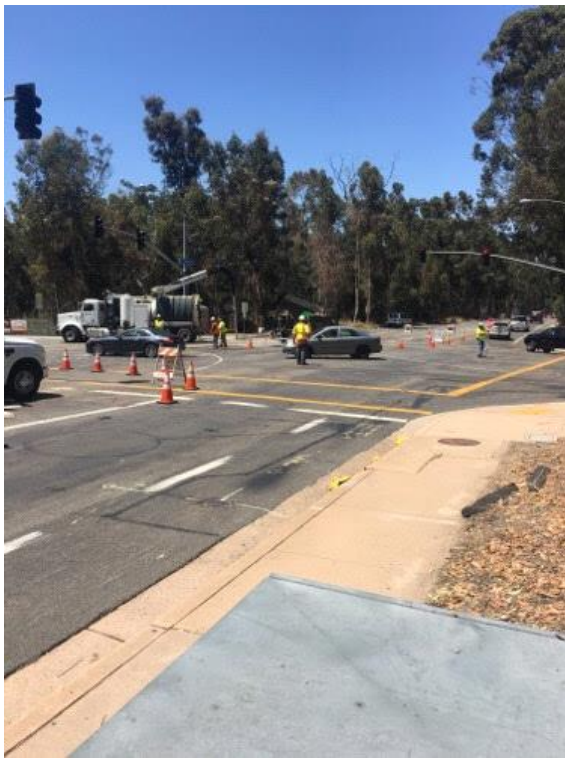
Caption Traffic control and potholing on Ave Nations/Pomerado Road intersection.

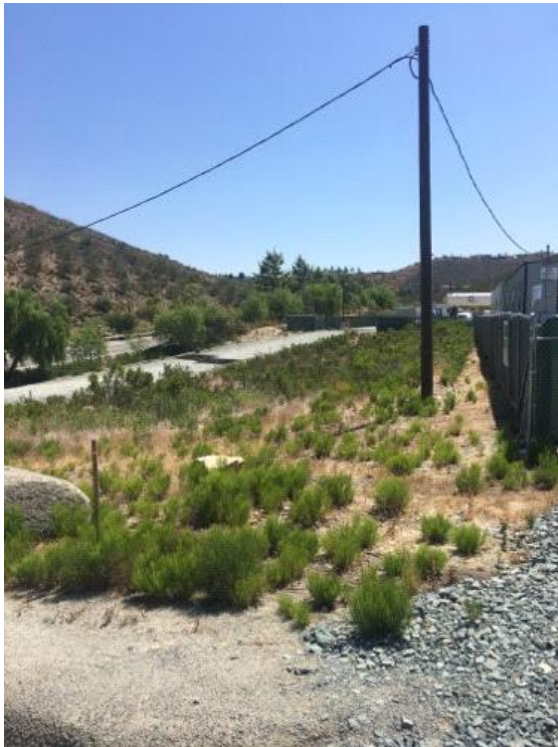
Caption Stonebridge Yard entrance.

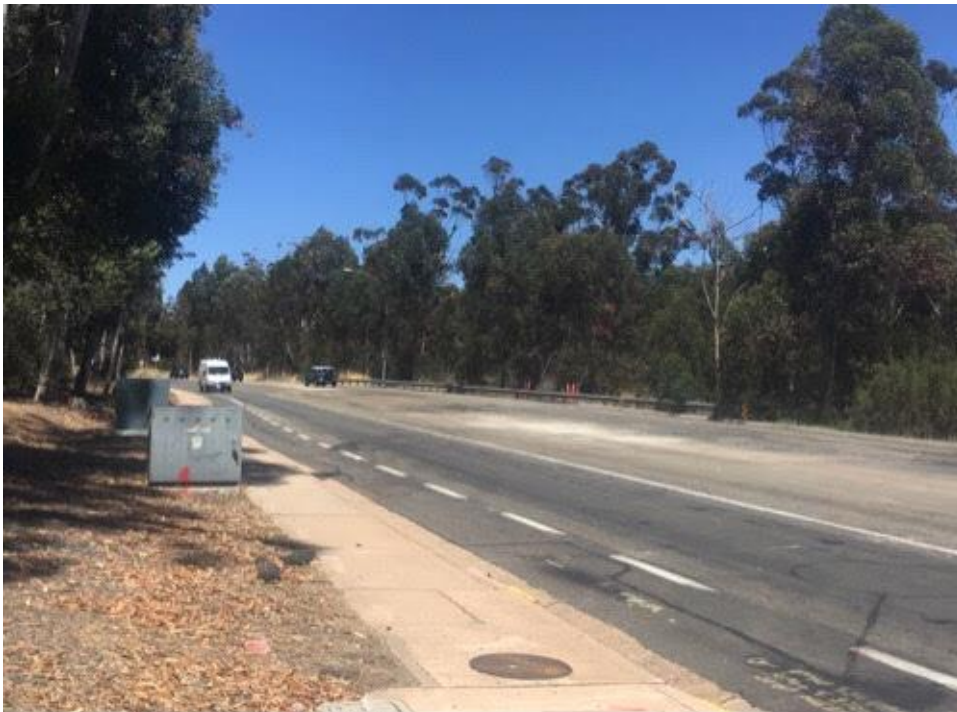
Caption Pomerado Rd. post work vault site

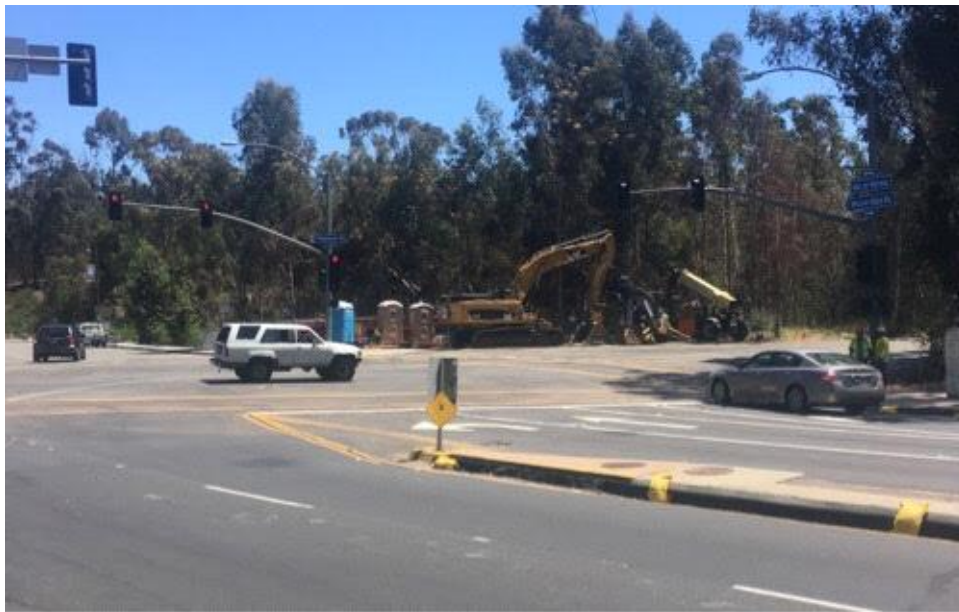
Caption Intersection Ave Nations and Pomerado Rd. post work, traffic control removed

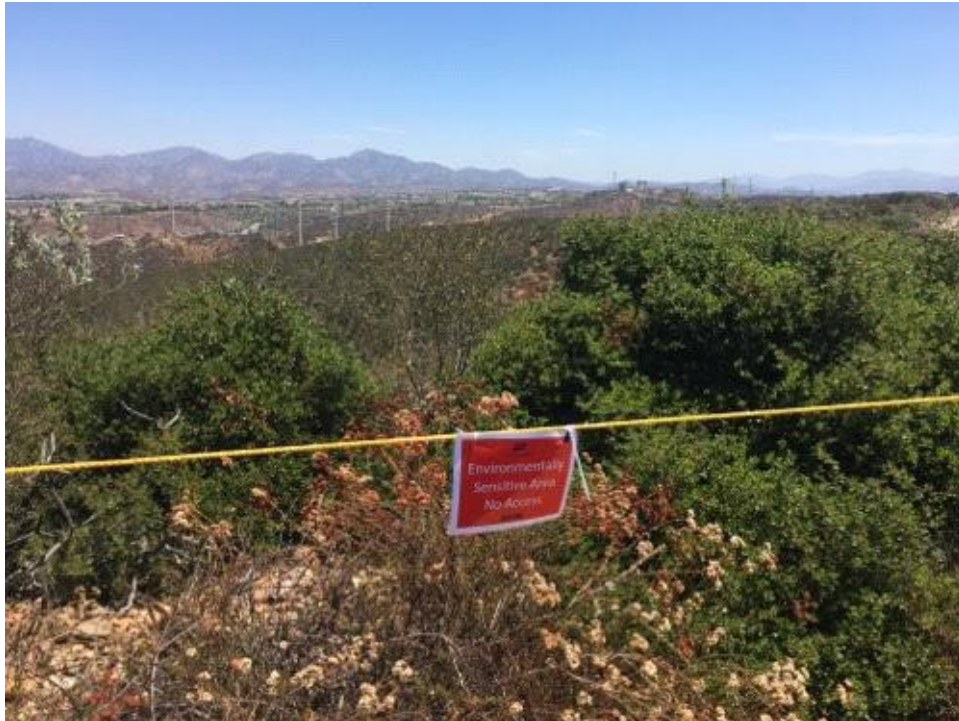
Caption Environmental sign along P03 access road

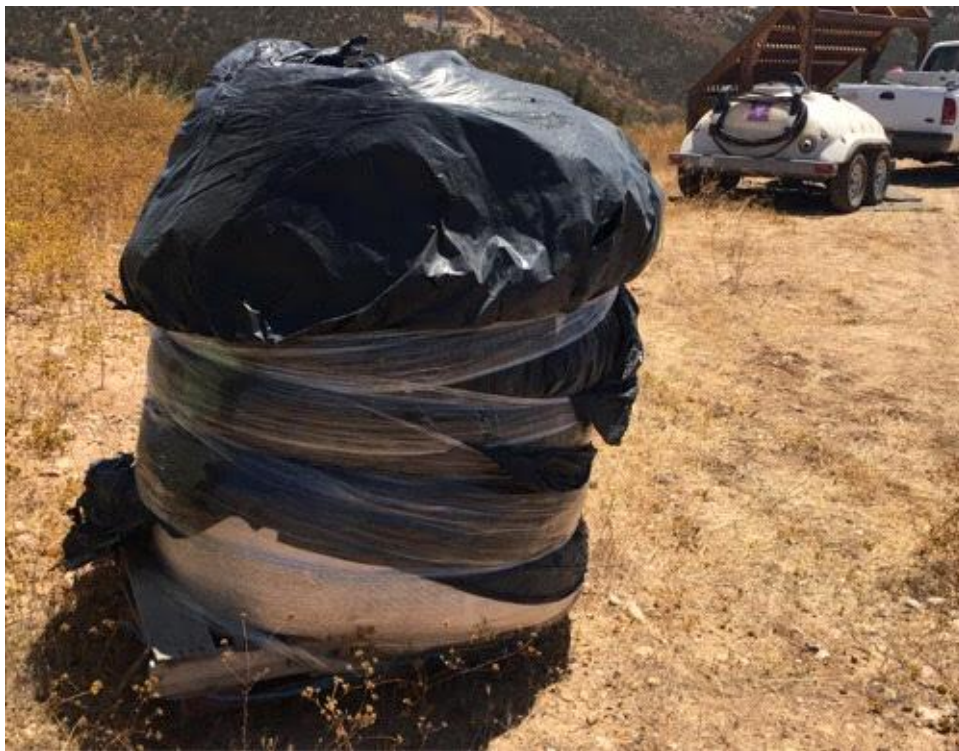
Caption BMPs at 0P3

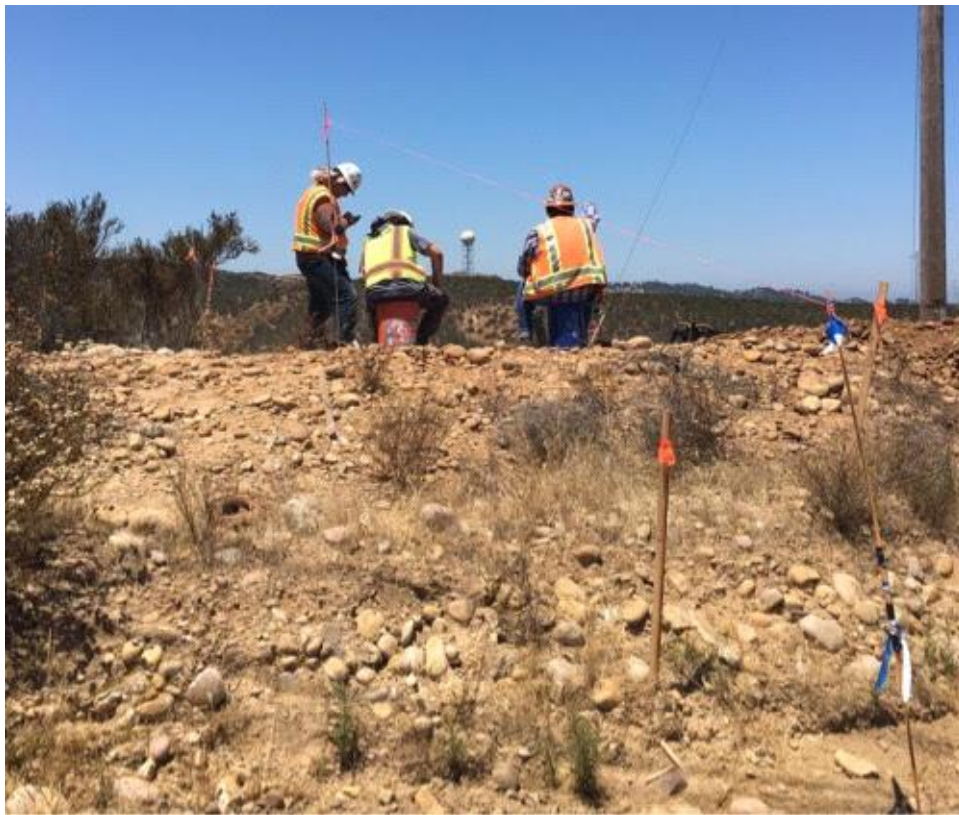
Caption Monitors at OP3 site

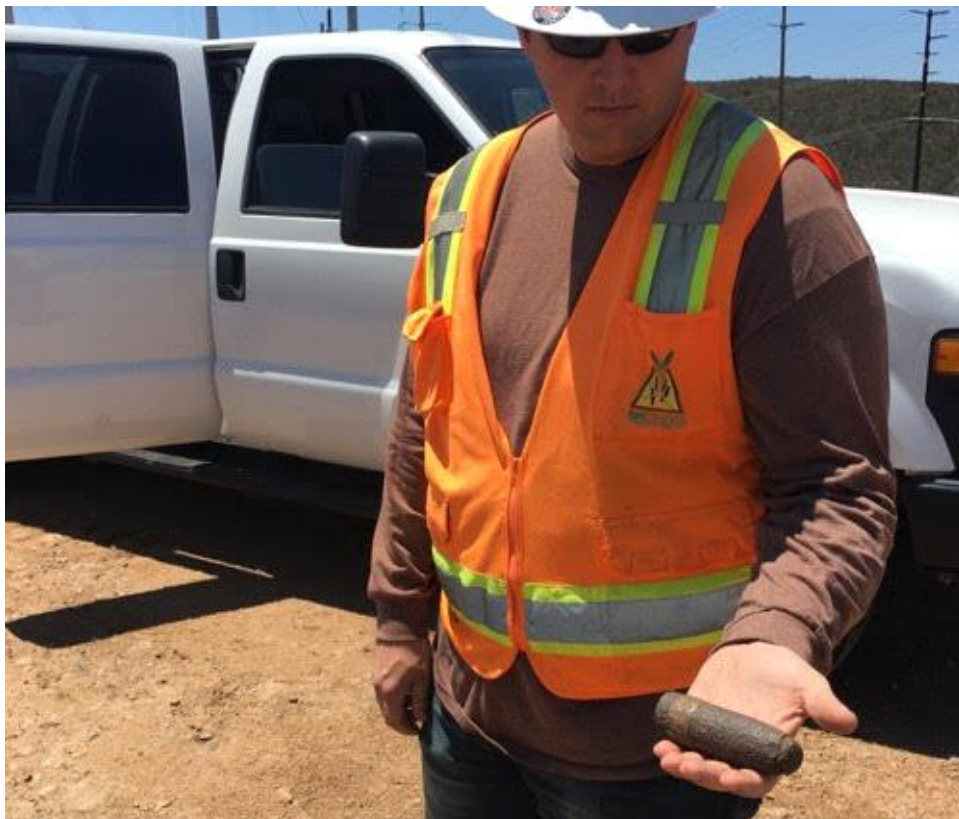
Caption UXO consultant and sample UXO

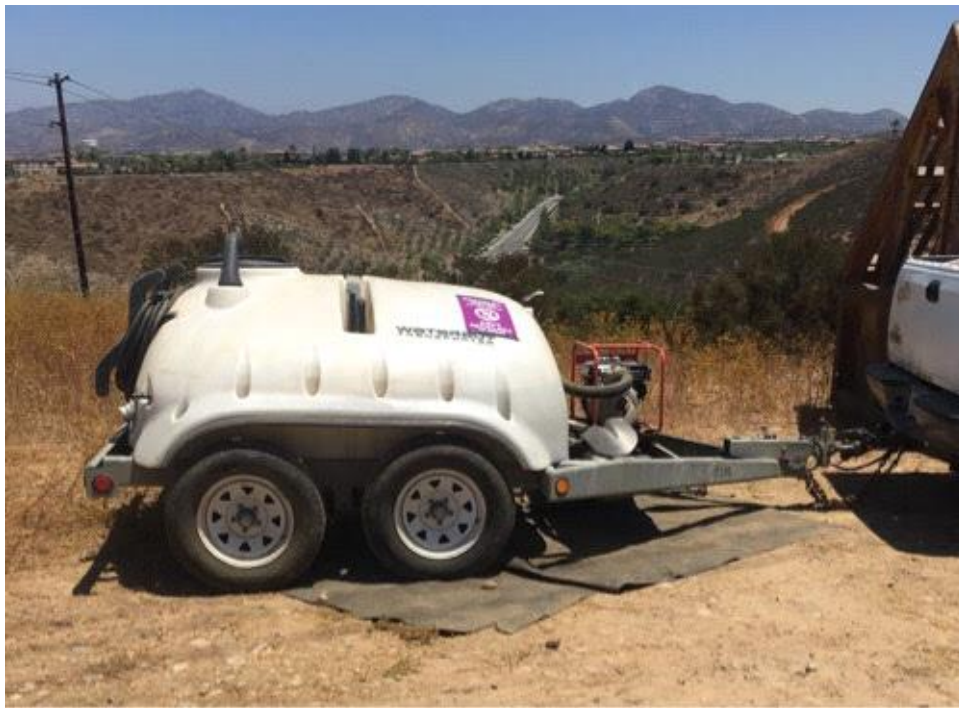
Water buffalo at 0P3

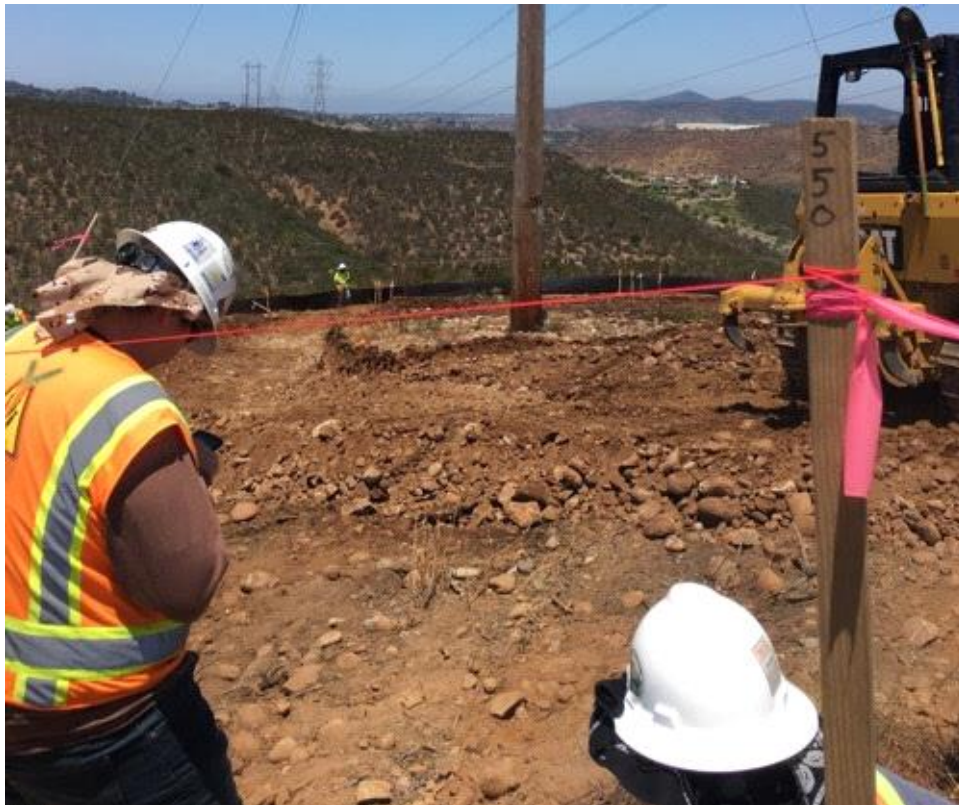
P03 clearing and grubbing...with silt fence in background.

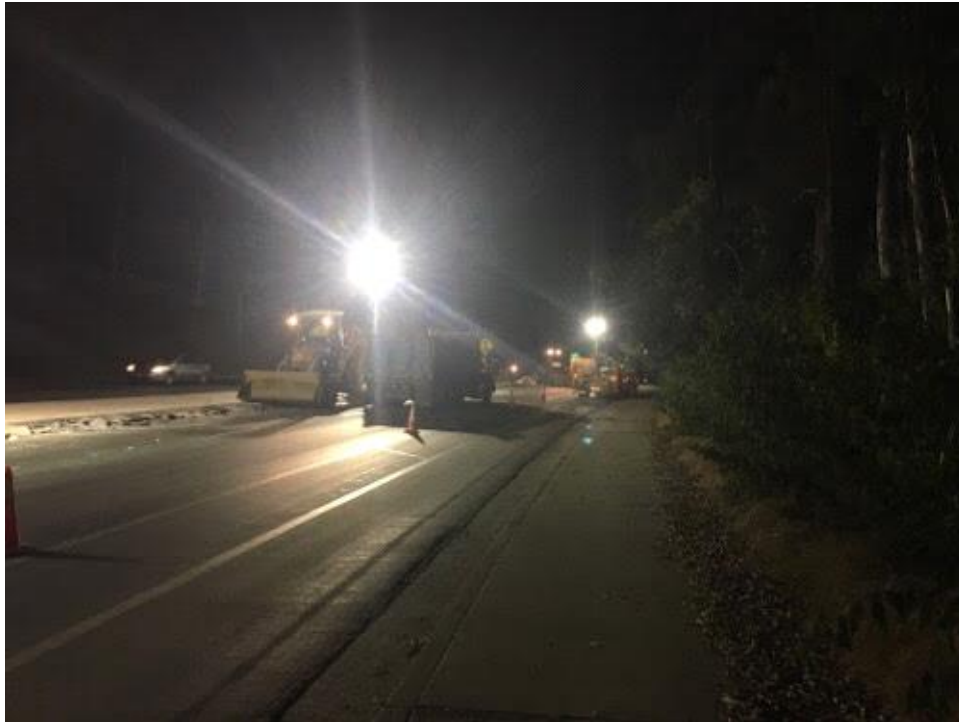
Caption Excavation Camino Ruiz

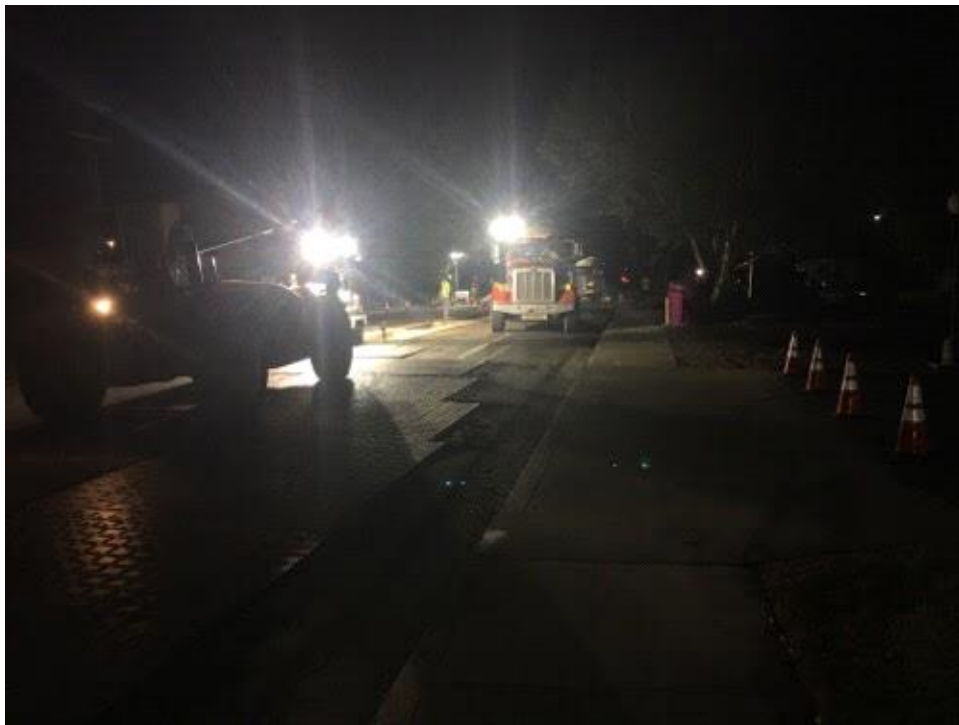
Caption Concrete work on Carrol near Crestmar Pt.

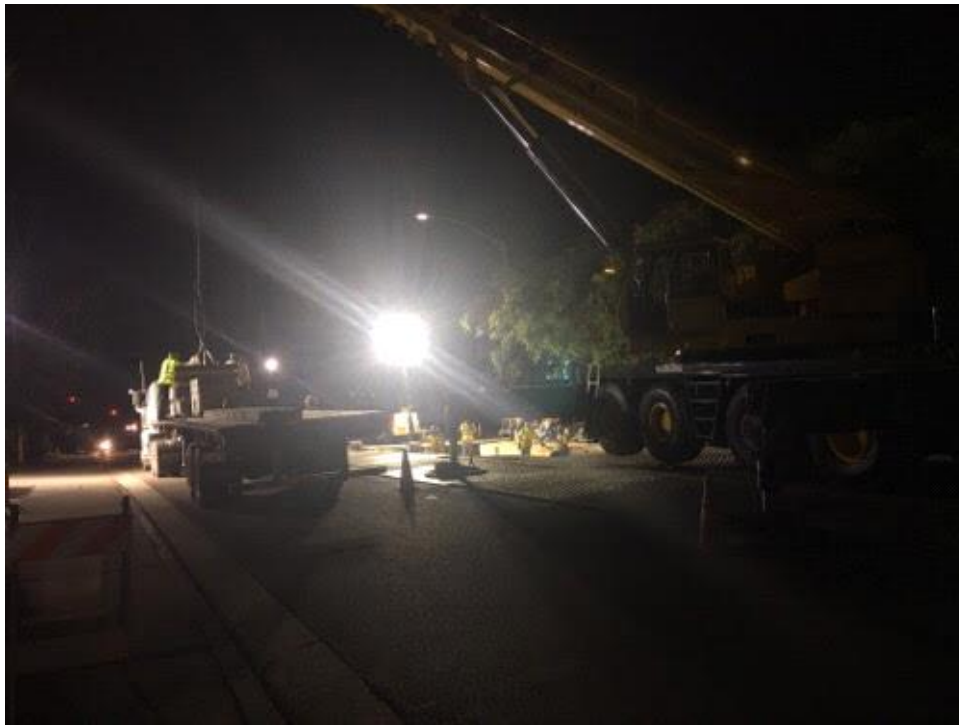
Caption Crane and vault installation

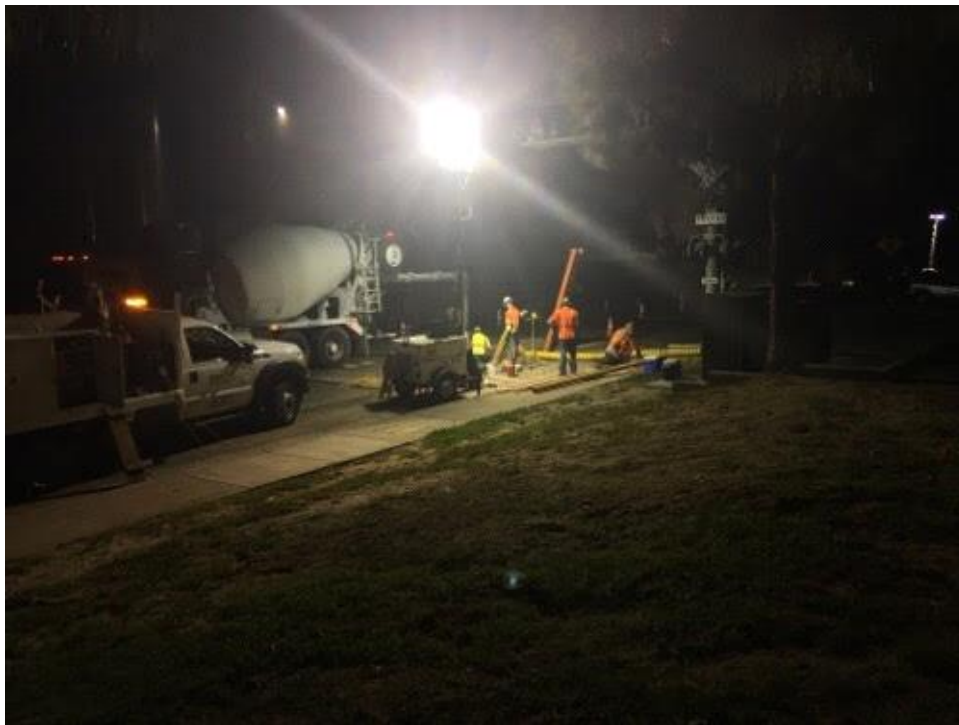
Caption Work on Trade street and railroad intersection.

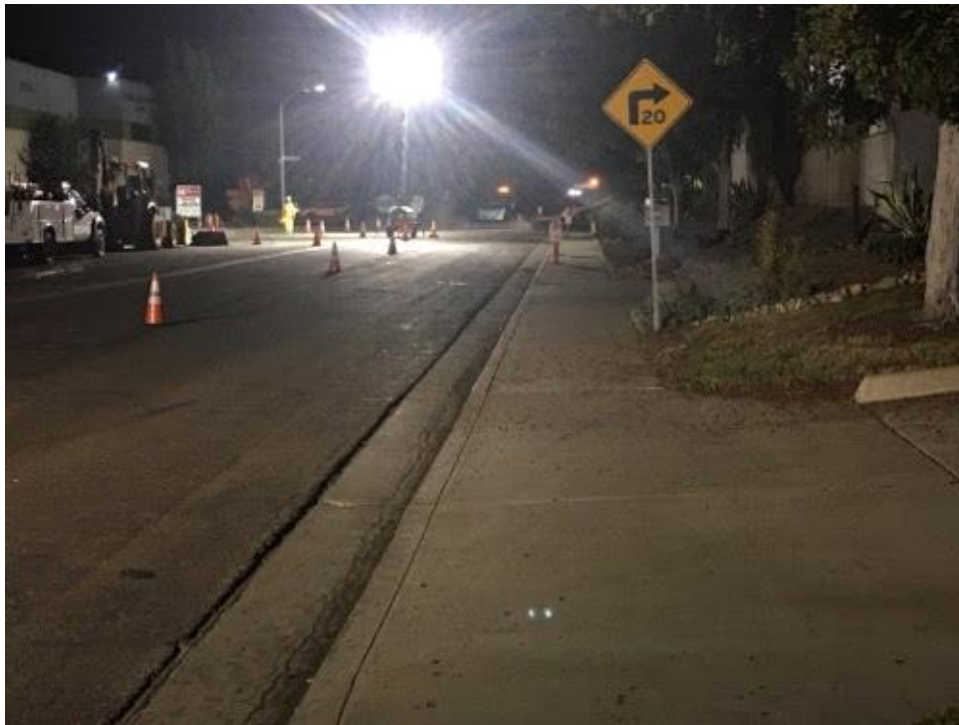
Caption Road resurfacing Trade Place.

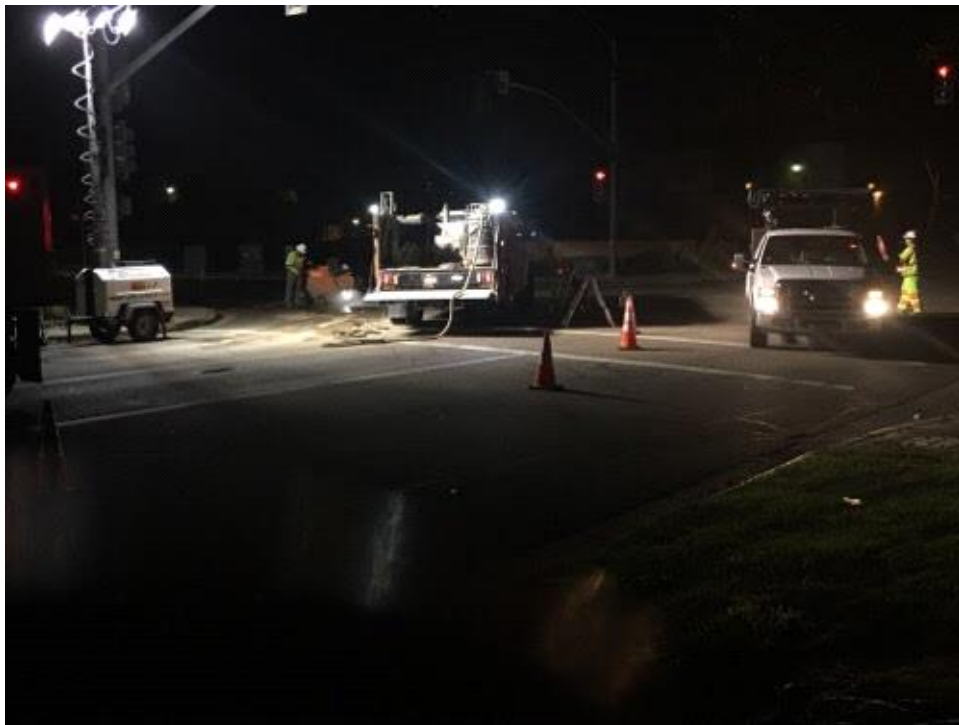
Caption Asphalt cutting Arjons Dr/Miraloni Dr intersection.

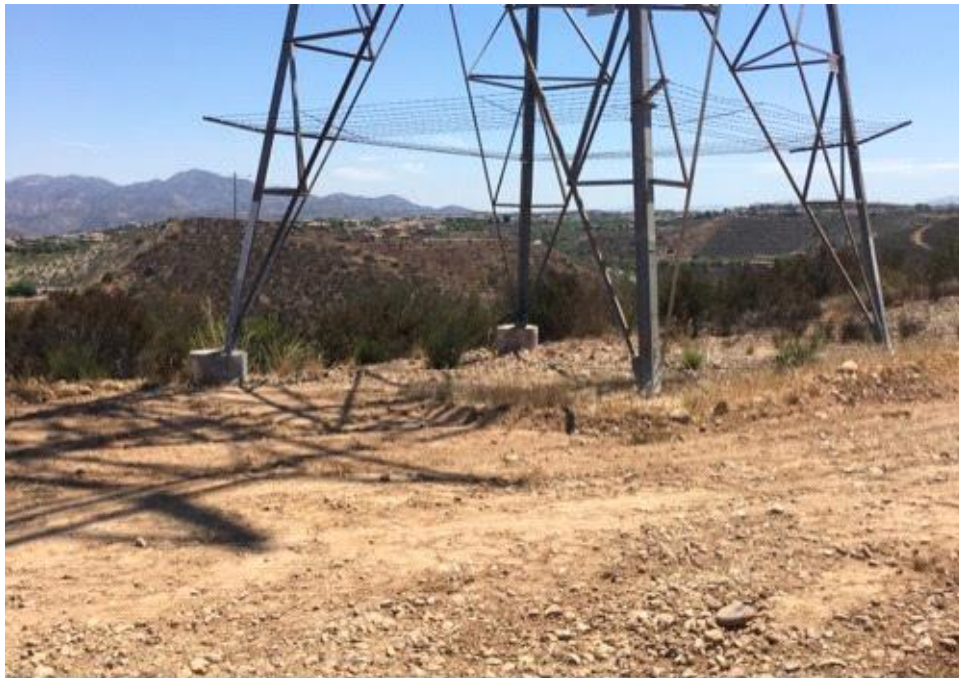
Caption P04 location, no work conducted here today.

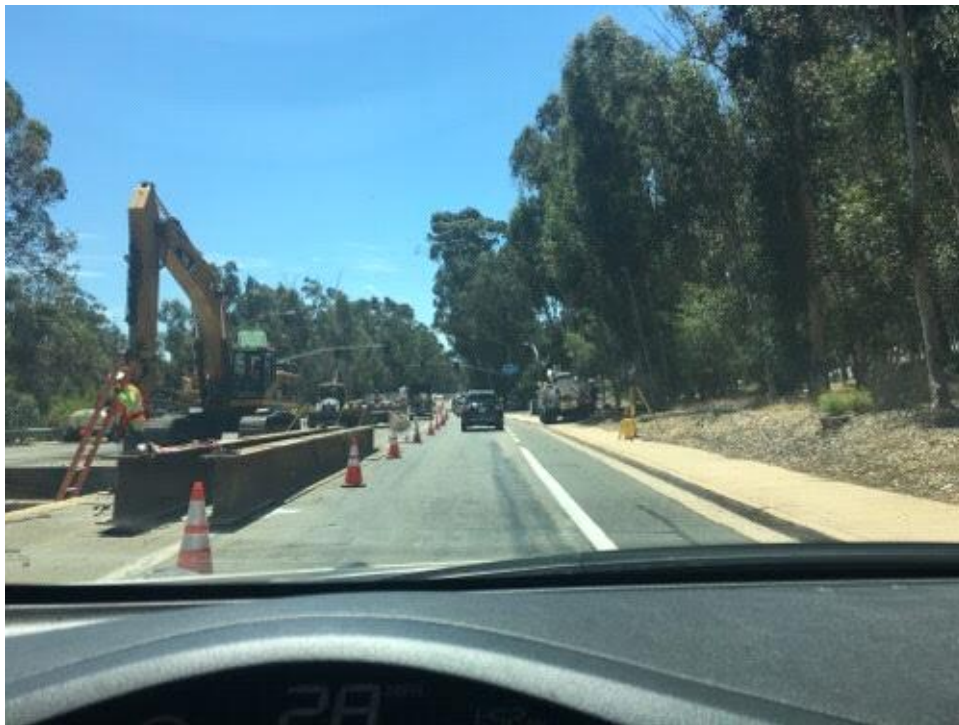
Caption Vault work on Pomerado Rd.

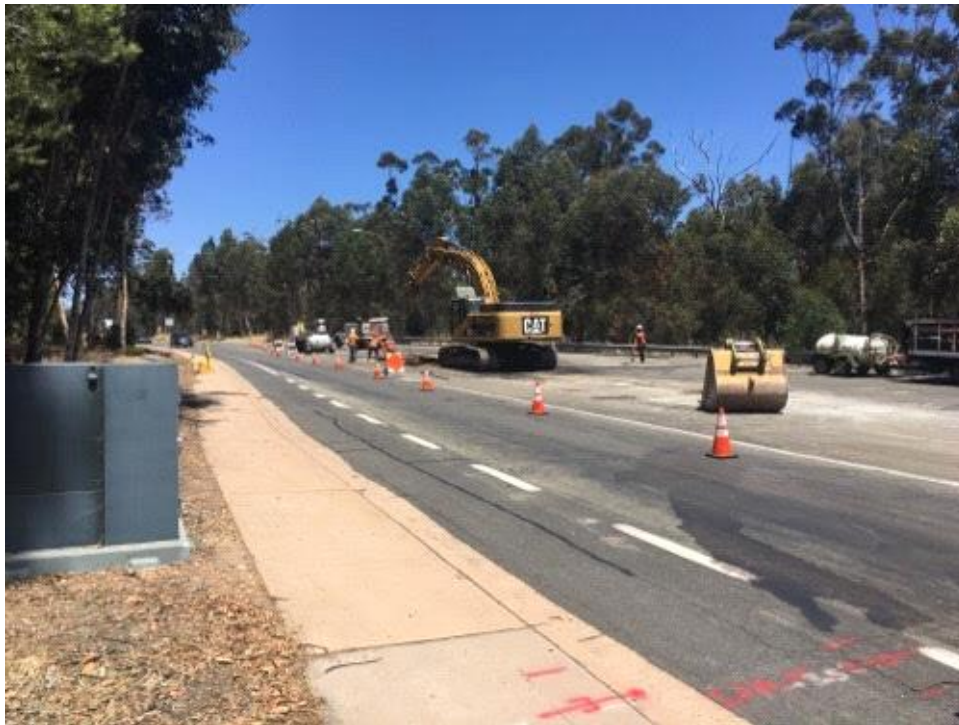
Caption Vault on Pomerado Rd.

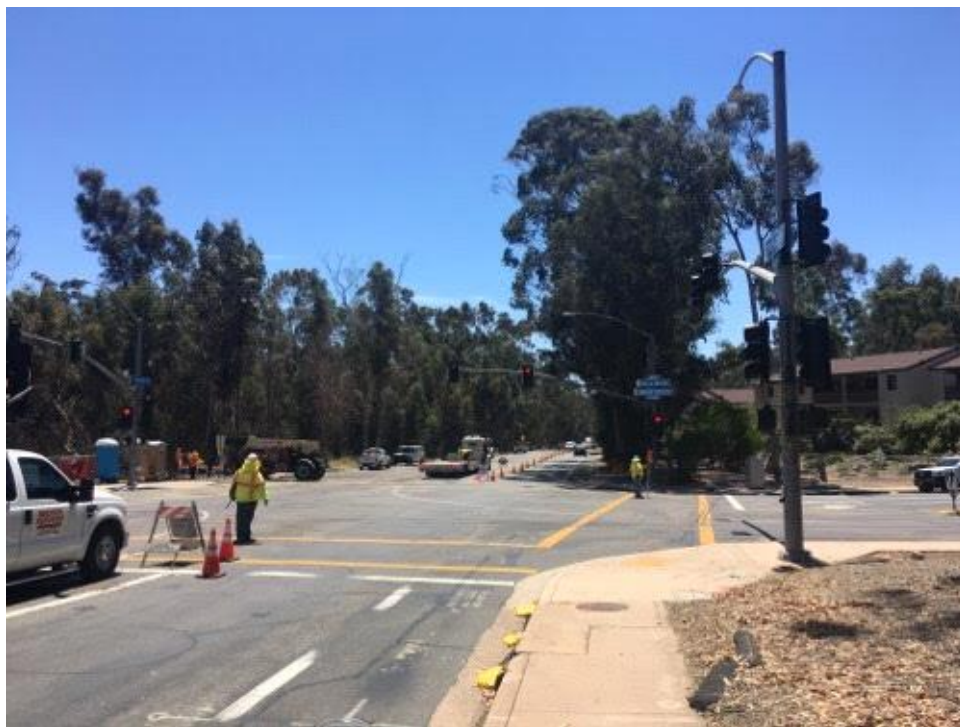
Caption Ave of Nations traffic control.

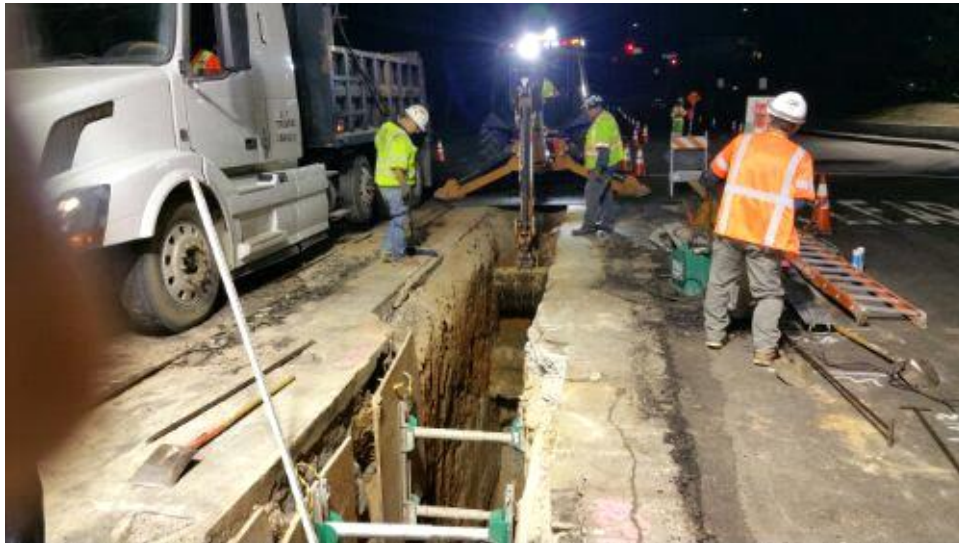
Caption Excavation on Carroll Rd. No monitors present at time of visit.

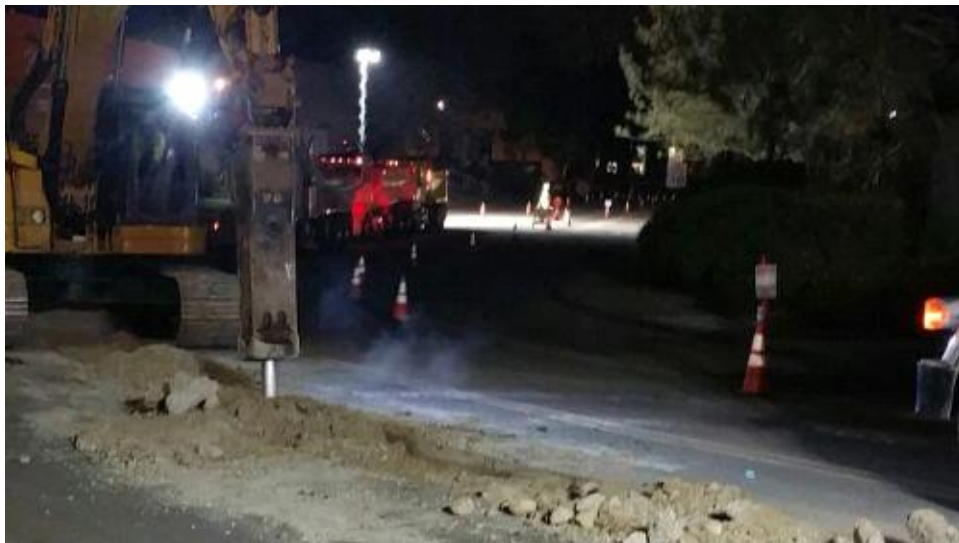
Caption Breaking asphalt to begin trenching (Miralani Dr).

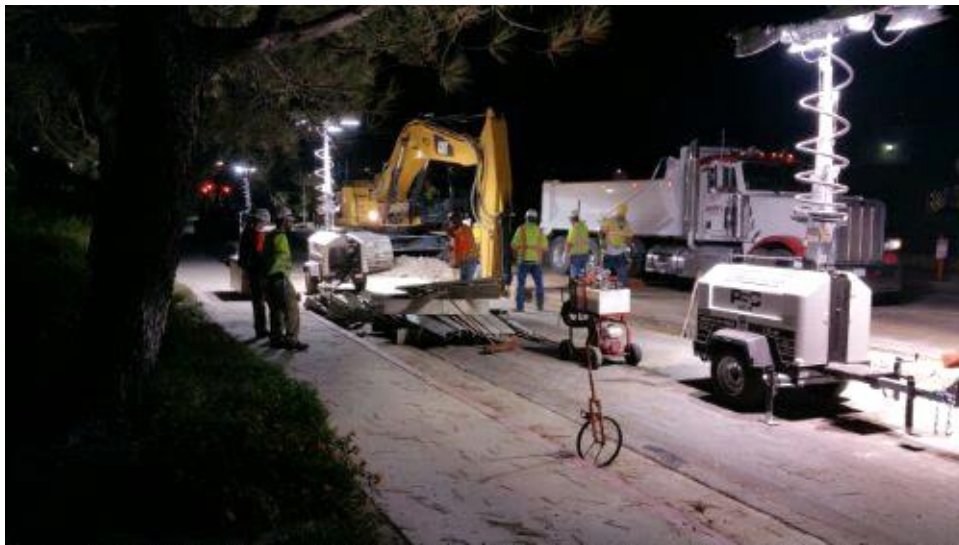
Caption Excavation (Miralani Dr.). Cultural resource monitors present.

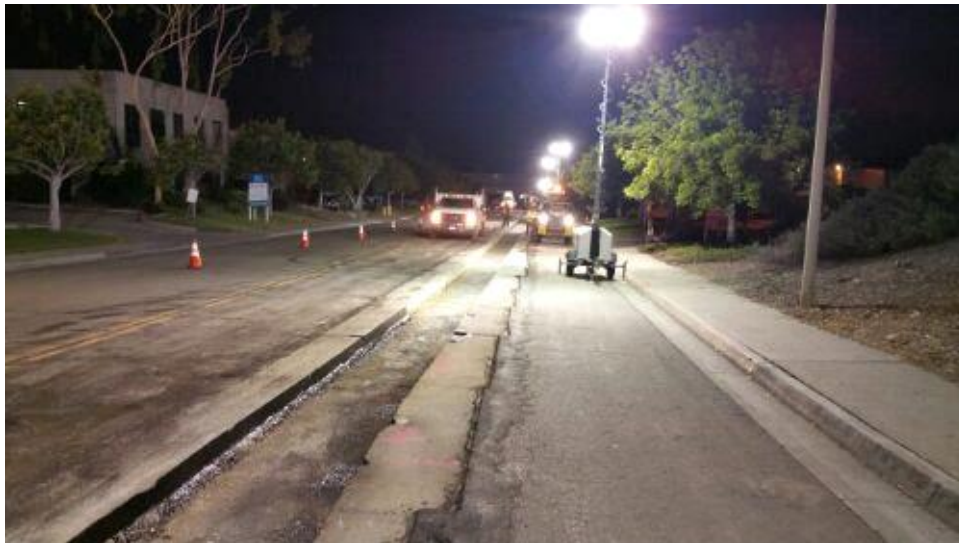
Caption Refilled trench (Arjons St.).

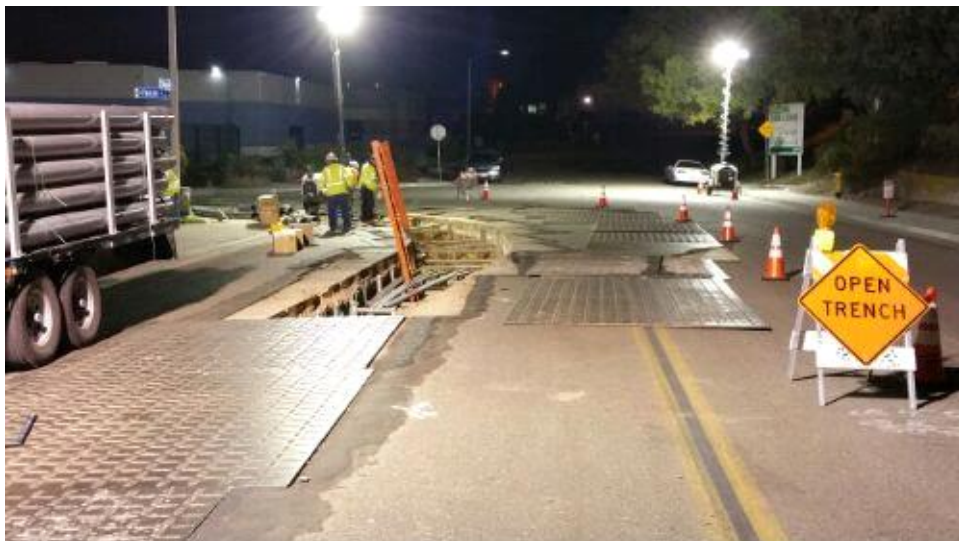
Caption Shoring trench (Trade St & Trade Pl.)

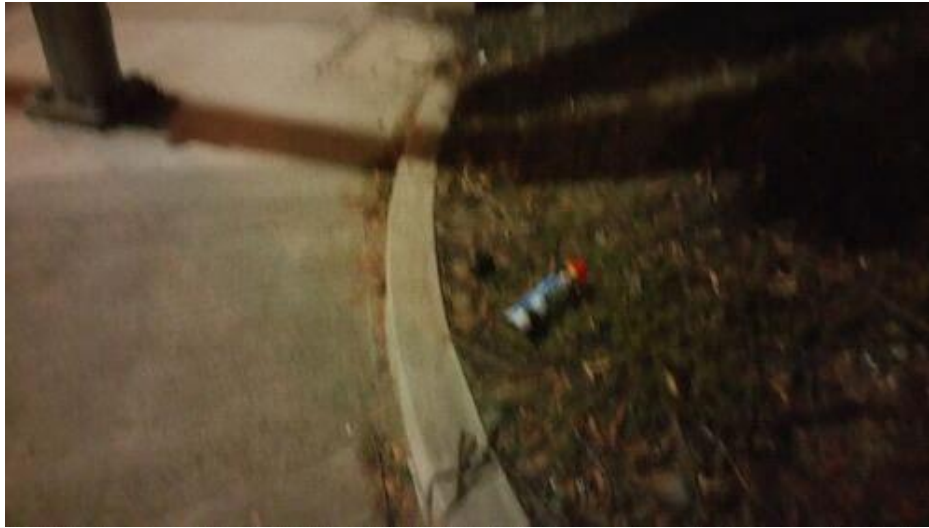
Caption Discarded Quick Mark container (Cam Santa Fe & Trade St.).

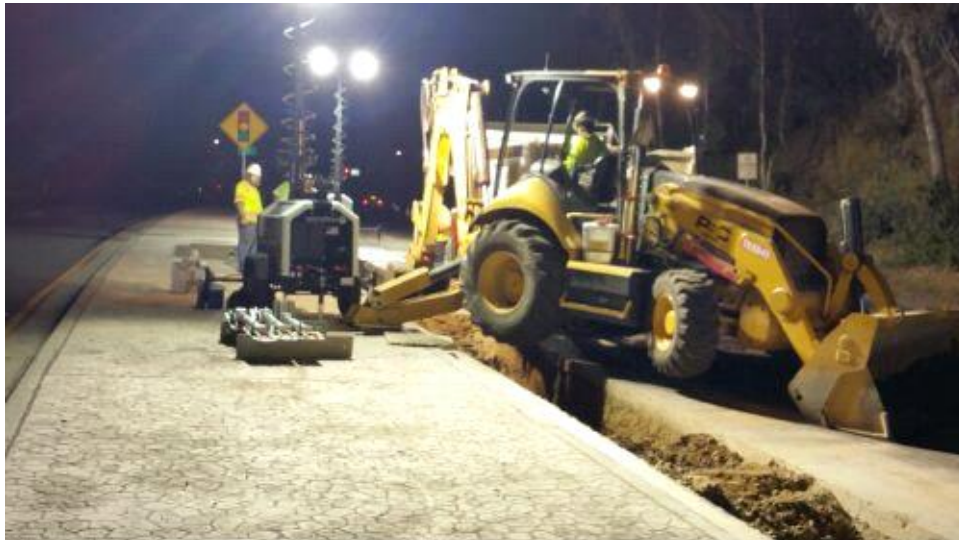
Caption Paleo monitor observing trenching (Camino Santa Fe).

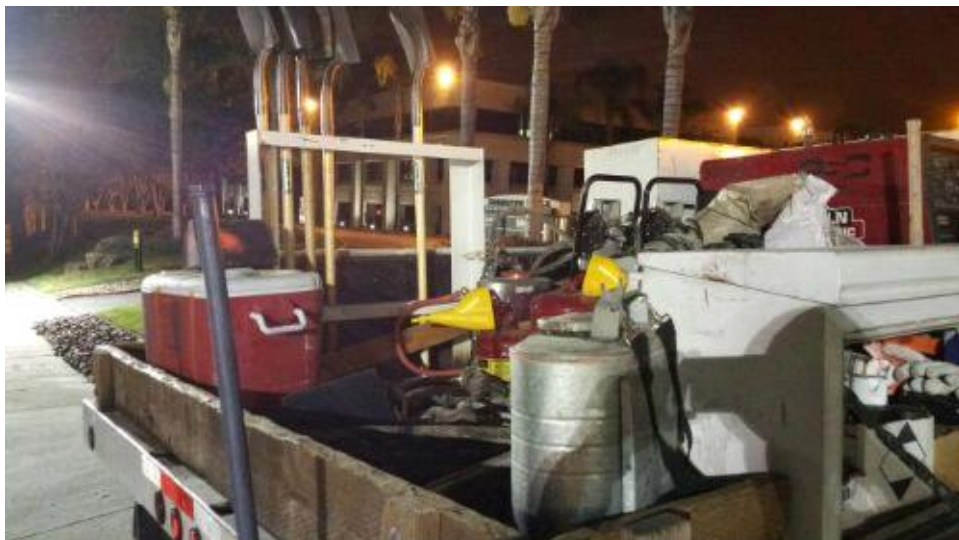
Caption Fire-fighting equipment on crew truck.  
Photo Attributes Capture Date/Time: Thu Jul 13 2017 21:19:35 GMT-0700 (PDT)  
Coordinates: 32.888756, -117.166073  
View Direction: Northwest
