## PROJECT MEMORANDUM SYCAMORE-PEÑASQUITOS 230-KV TRANSMISSION LINE PROJECT

Date: July 20, 2017  
To: Billie Blanchard, CPUC Project Manager  
From: Sheila Hoyer, CPUC Monitoring Supervisor  
**Subject:** Weekly Report #28 – July 9 to July 15, 2017

## SDG&E Sycamore-Peñasquitos 230-kV Transmission Line Project: Daily Inspection Report

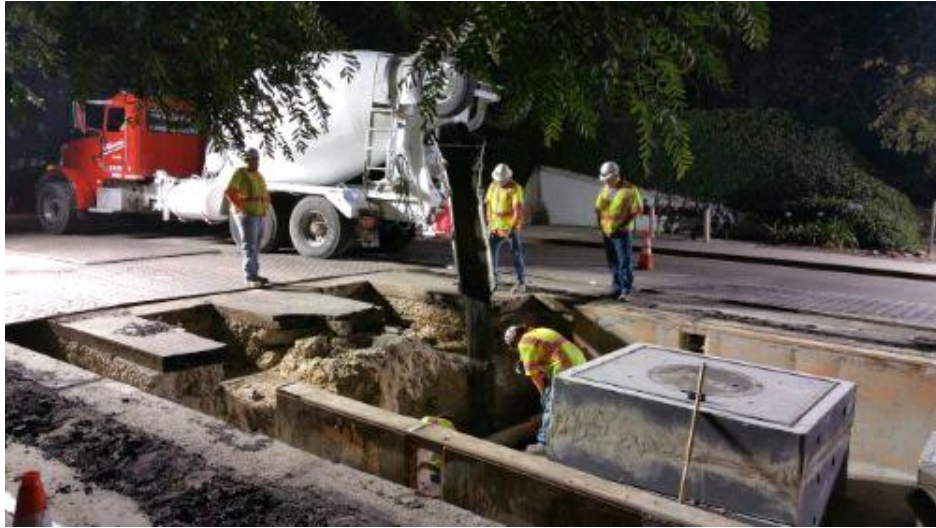
Caption Concrete pour into vault (Trade St.).  
Photo Attributes Capture Date/Time: Thu Jul 13 2017 21:15:18 GMT-0700 (PDT)  
Coordinates: 32.888781, -117.165494  
View Direction: South

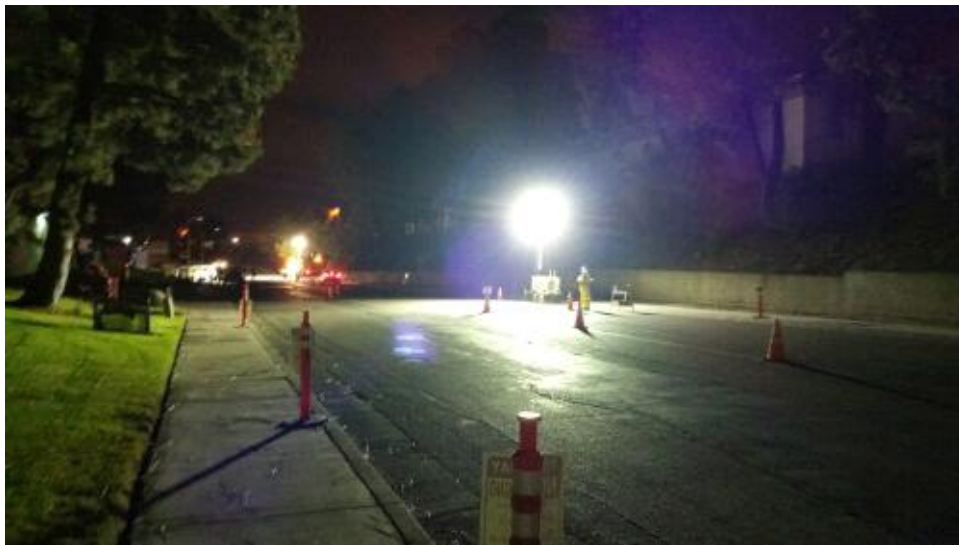
Caption Lights placed first for traffic control, then for trenching (Trade St.).  
Photo Attributes Capture Date/Time: Thu Jul 13 2017 20:58:26 GMT-0700 (PDT)  
Coordinates: 32.889353, -117.154867  
View Direction: Southeast

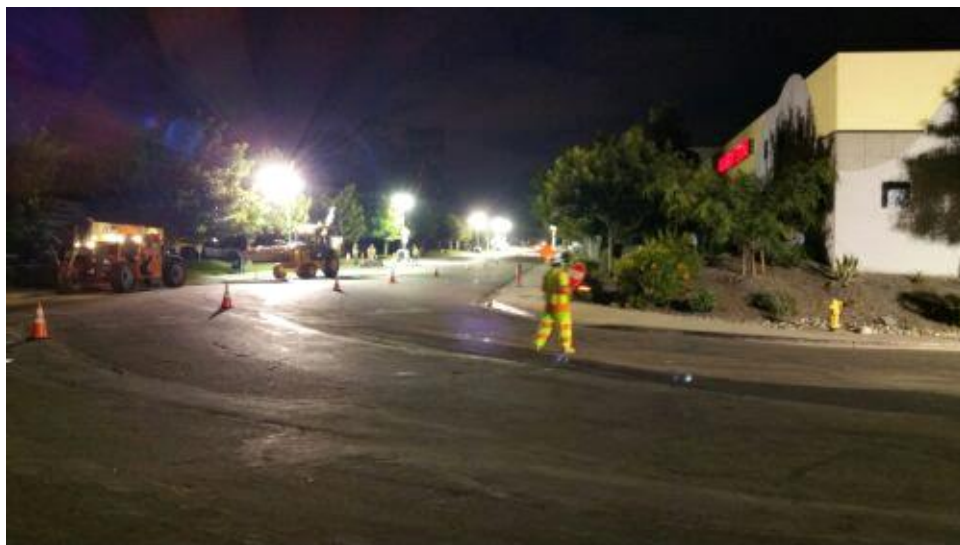
Caption Traffic control set before start of work.

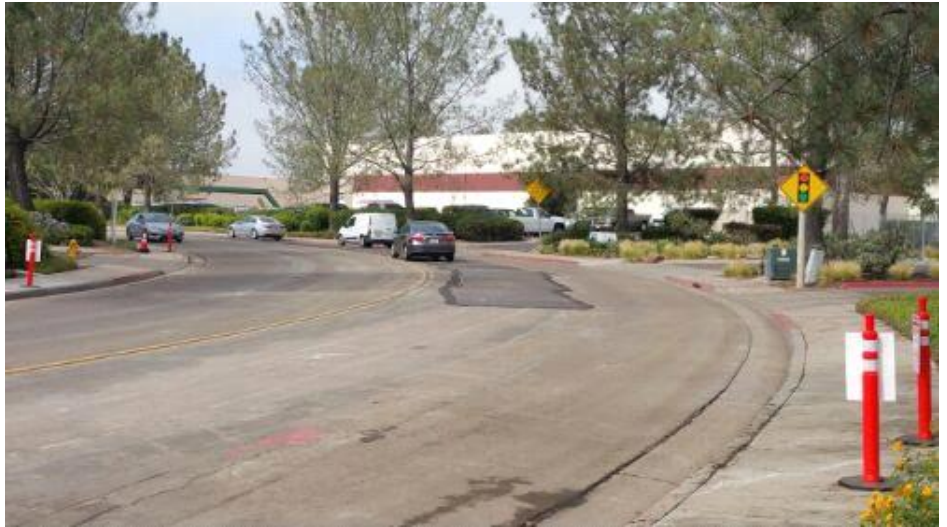
Caption End of trenching (Miralani D.r).

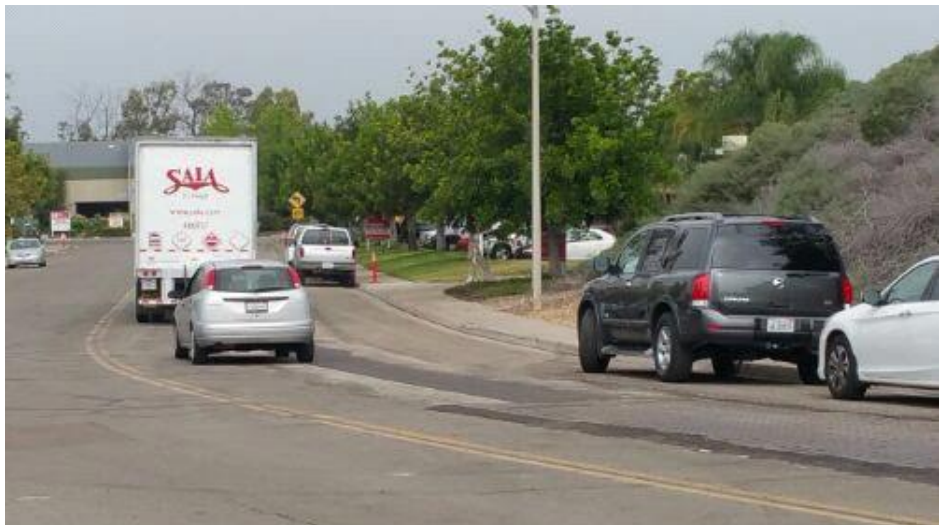
Caption Road patch and steel plates (Arjons St).

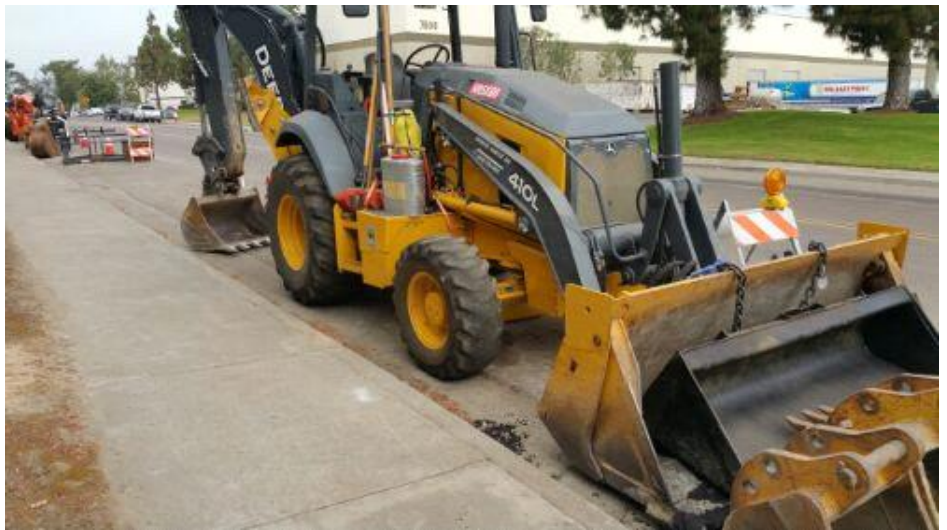
Caption Equipment storage (plus fire tools, Trade St.).

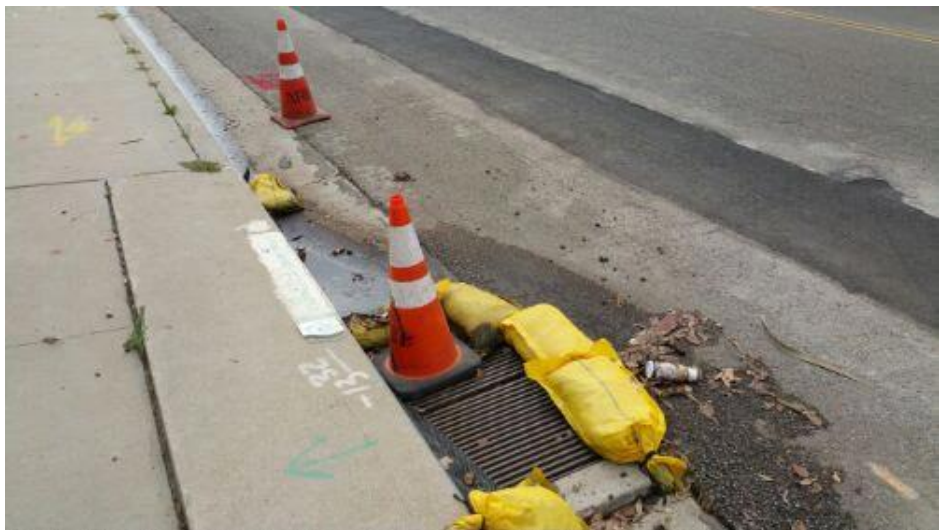
Caption Sediment detention at storm drain inlet (Trade St.).

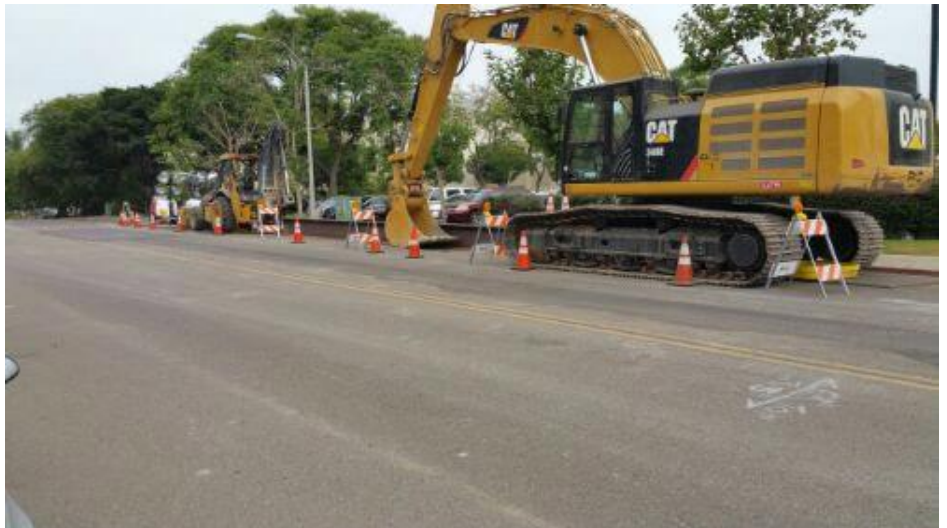
Caption Equipment storage (Trade St.).

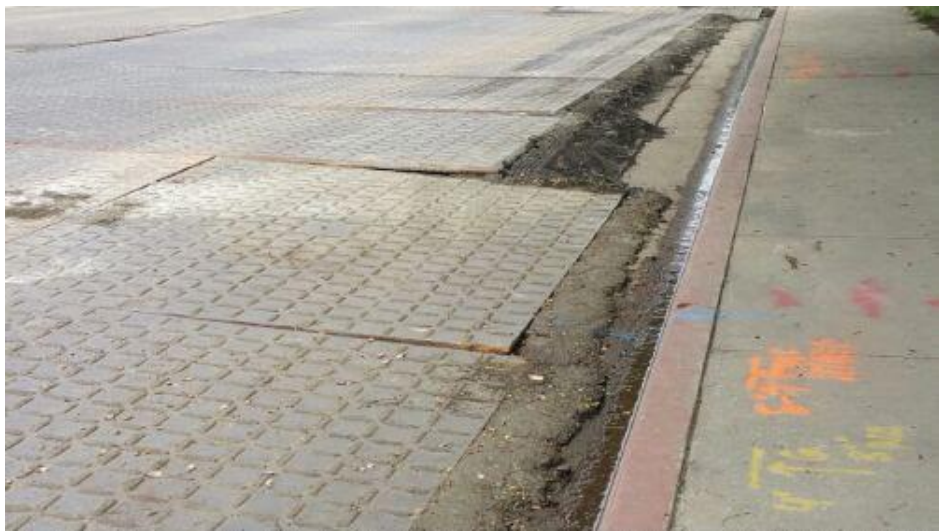
Caption Loose plate placement (Trade St.).

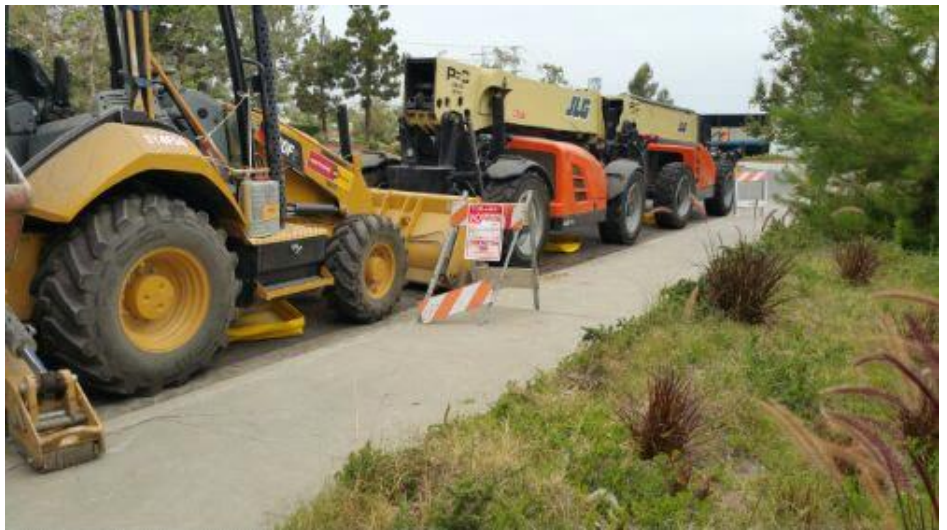
Caption Drip pans beneath equipment off Carroll Rd.
