PROJECT MEMORANDUM SYCAMORE-PEÑASQUITOS 230-KV TRANSMISSION LINE PROJECT

Date: July 28, 2017
To: Billie Blanchard, CPUC Project Manager
From: Sheila Hoyer, CPUC Monitoring Supervisor
Subject: Weekly Report #29 – July 16 to July 22, 2017

SDG&E Sycamore-Peñasquitos 230-kV Transmission Line Project: Daily Inspection Report

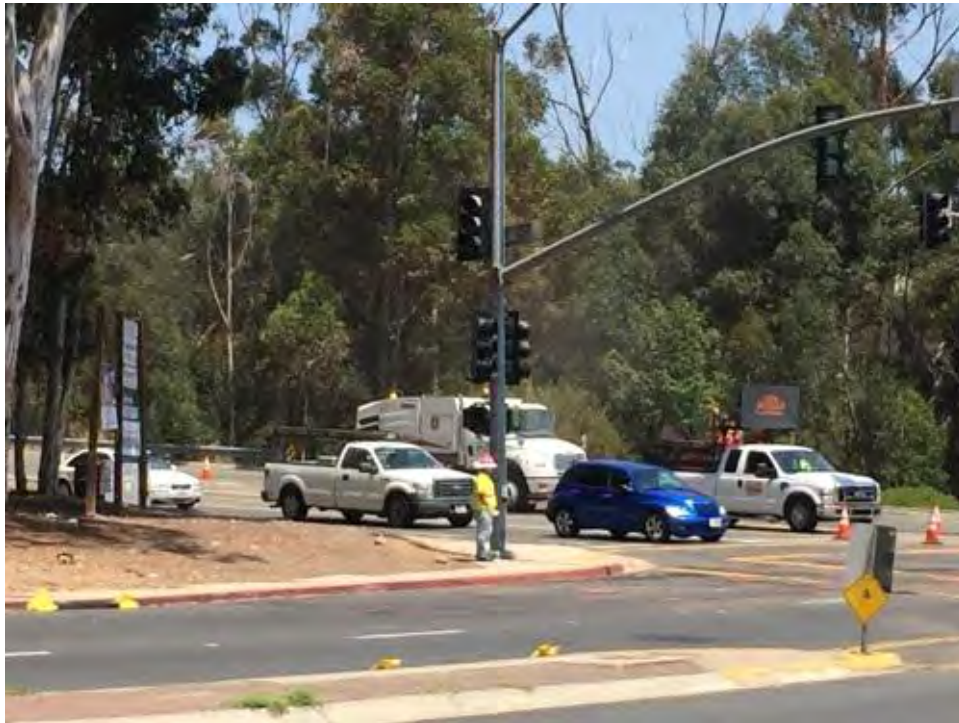
Caption Street sweeper begins sweeping on Pomerado Road.

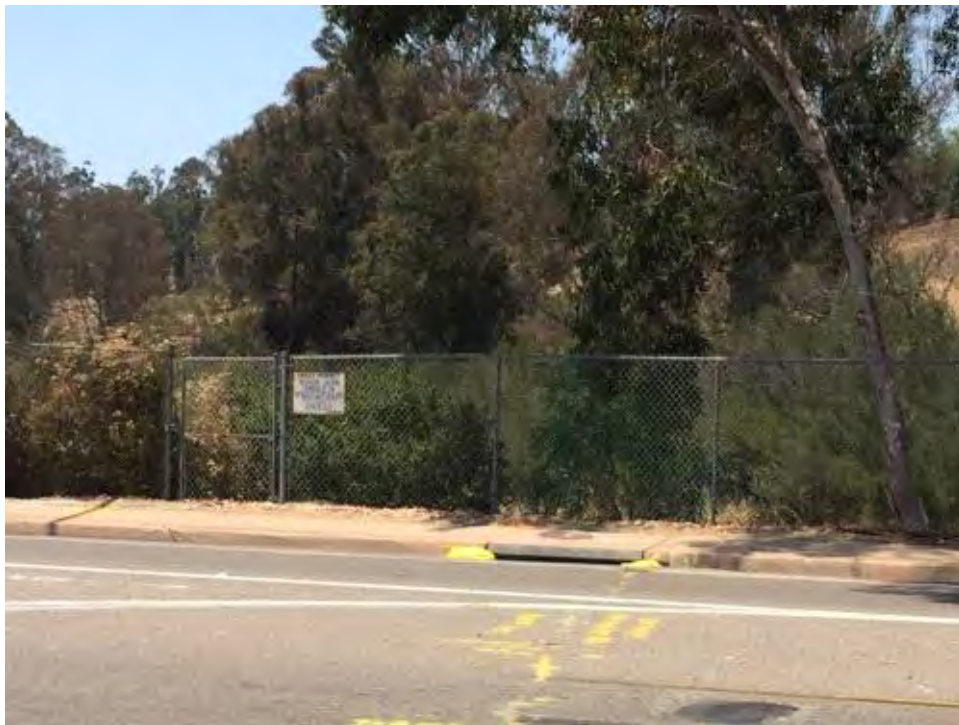
Caption BMPs in place on Pomerado Road.

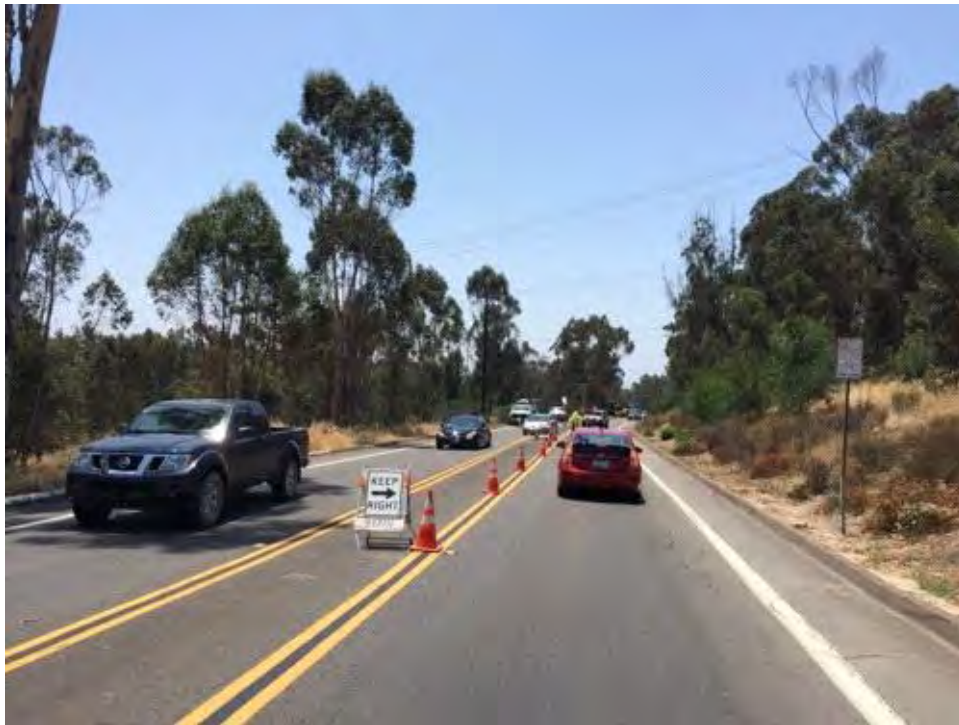
Caption Cones and signage in place on Pomerado Road.

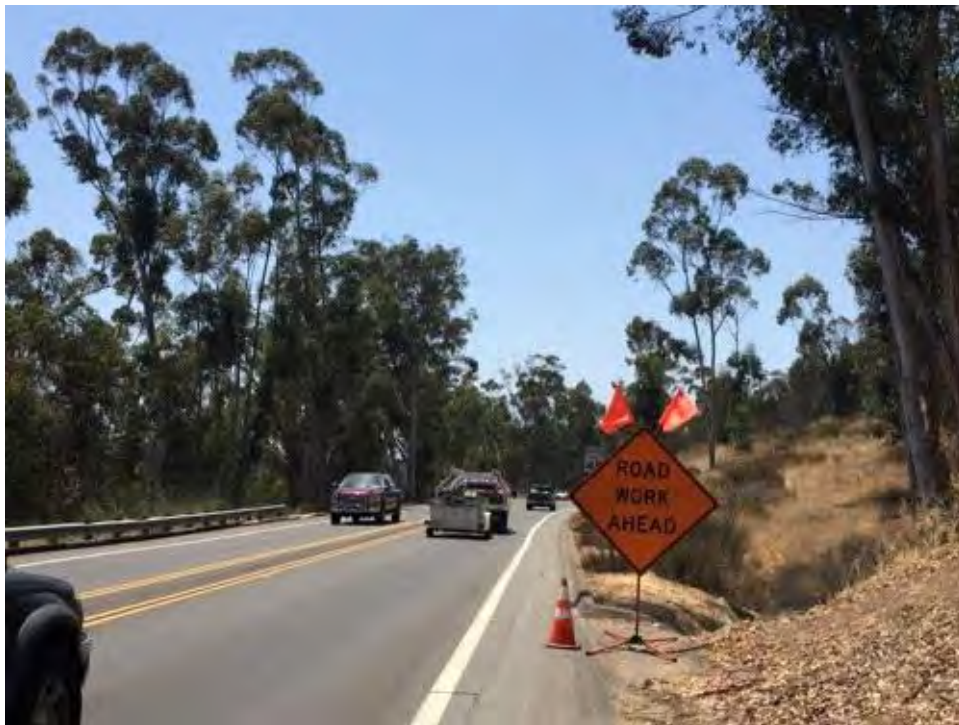
Caption Work areas clearly marked on Pomerado Road.

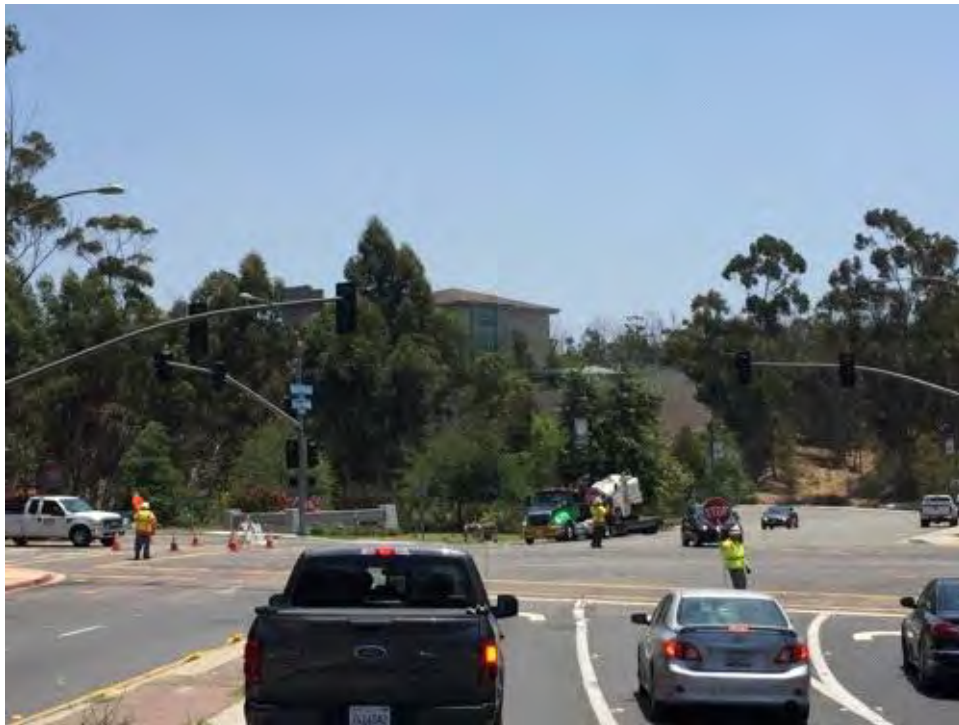
Caption Traffic flaggers in place on Pomerado Road

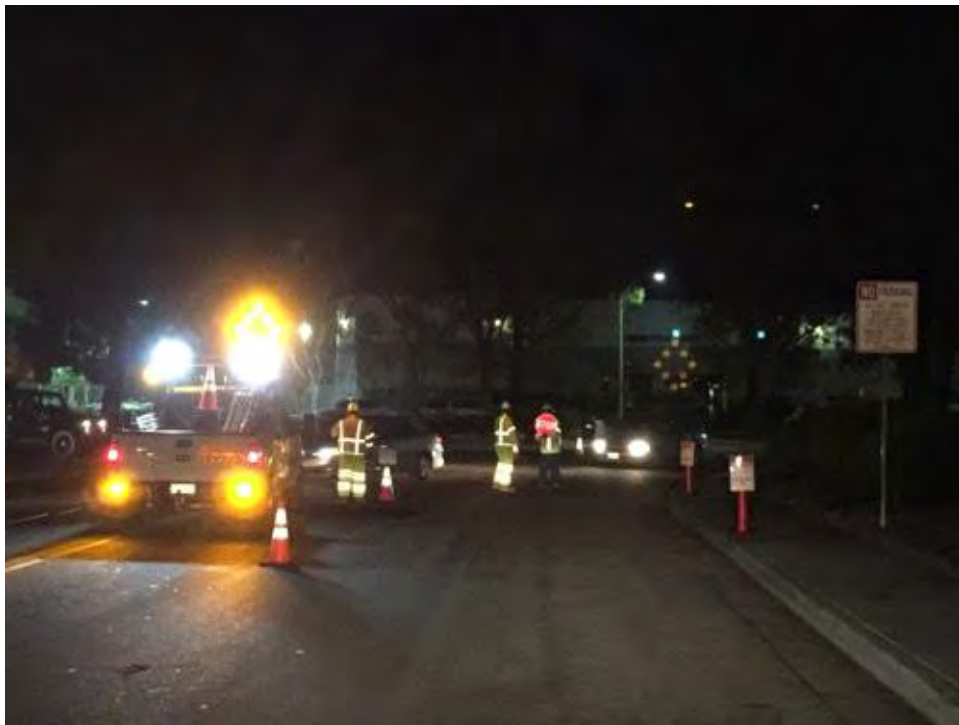
Caption Flaggers in place on Miralani Drive.

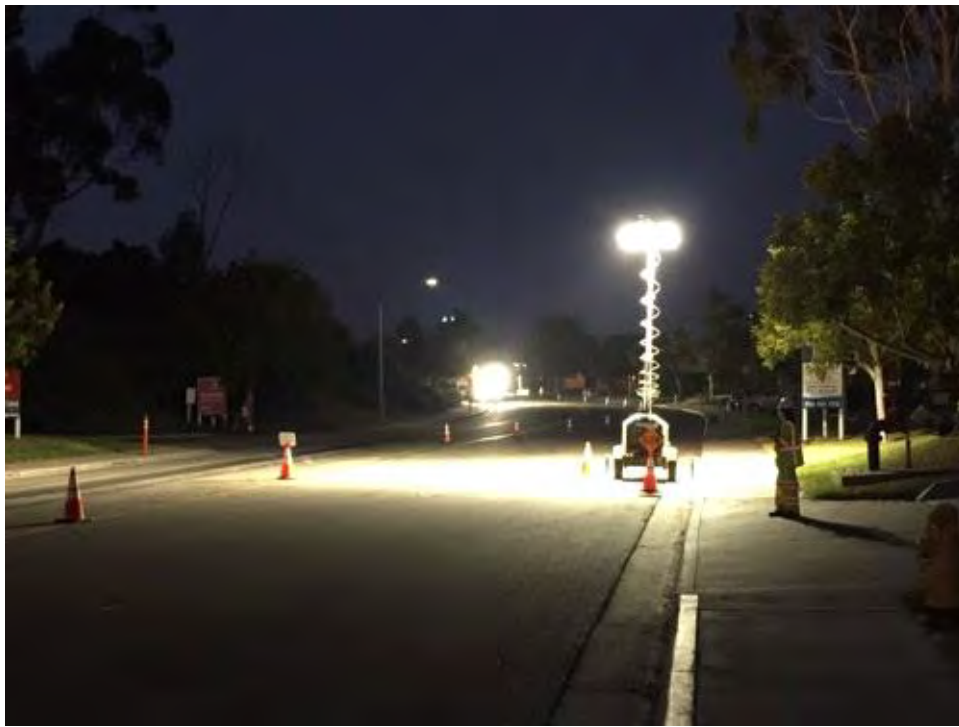
Caption Lighting in place on Arjohns Drive.

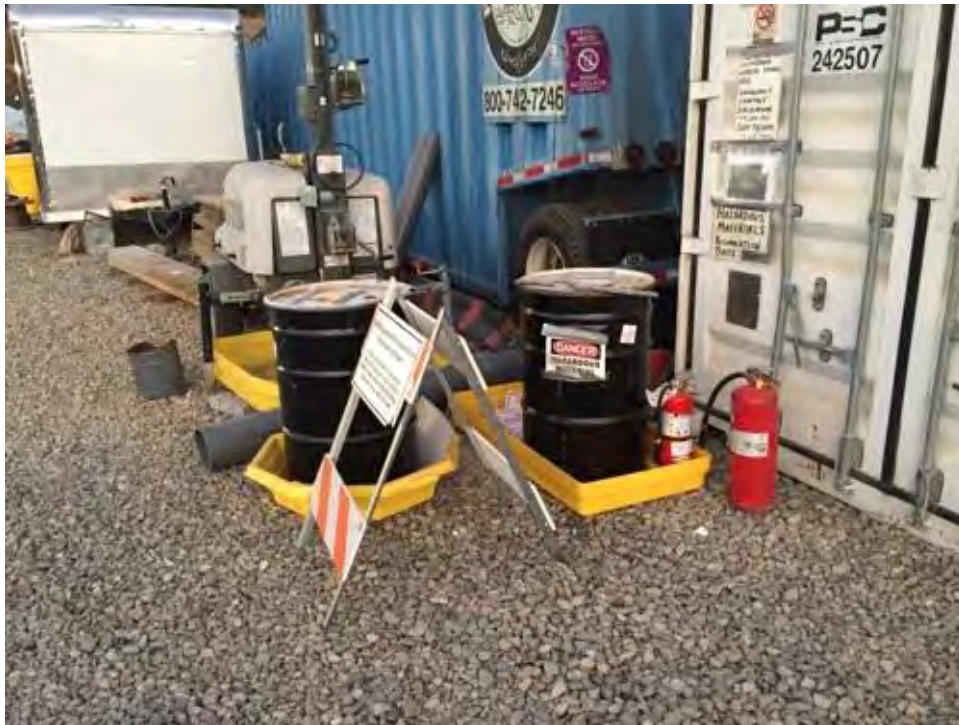
Caption Hazardous materials clearly labeled and stored within secondary containment.

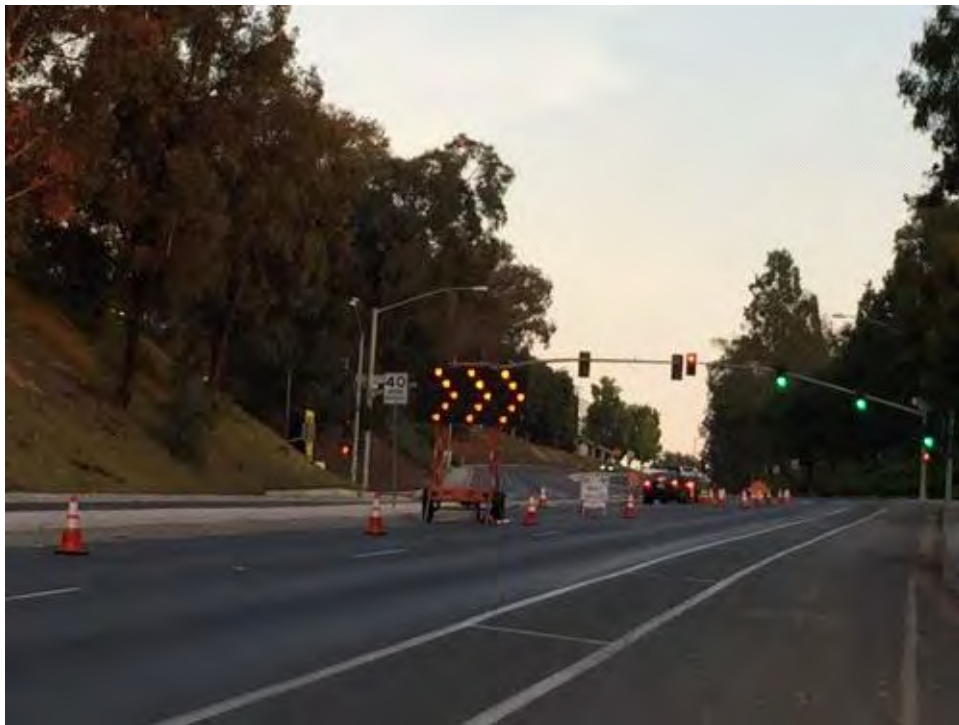
Caption Digital signage in place on Camino Santa Fe.

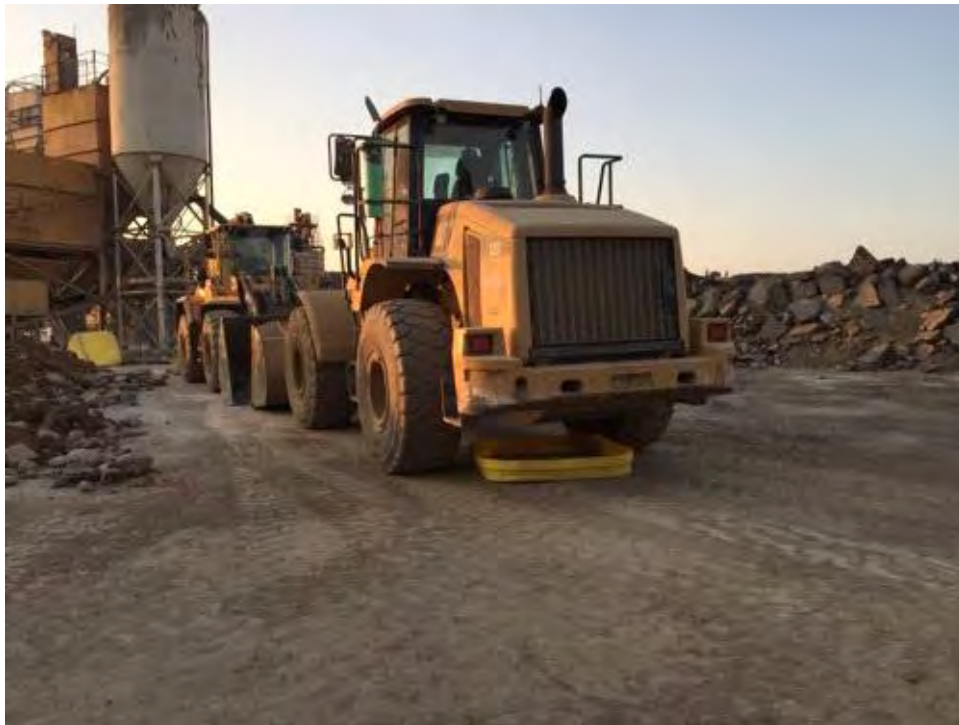
Caption Drip pans in place under equipment at construction yard off of Camino Ruiz.

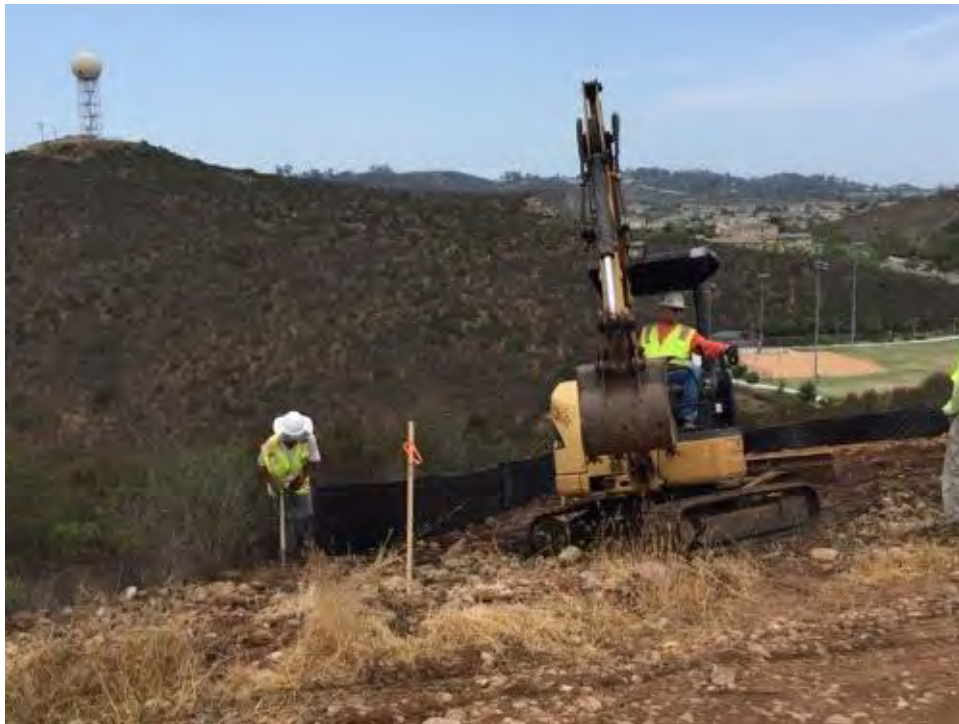
Caption Erosion fencing being installed at Pole 04.

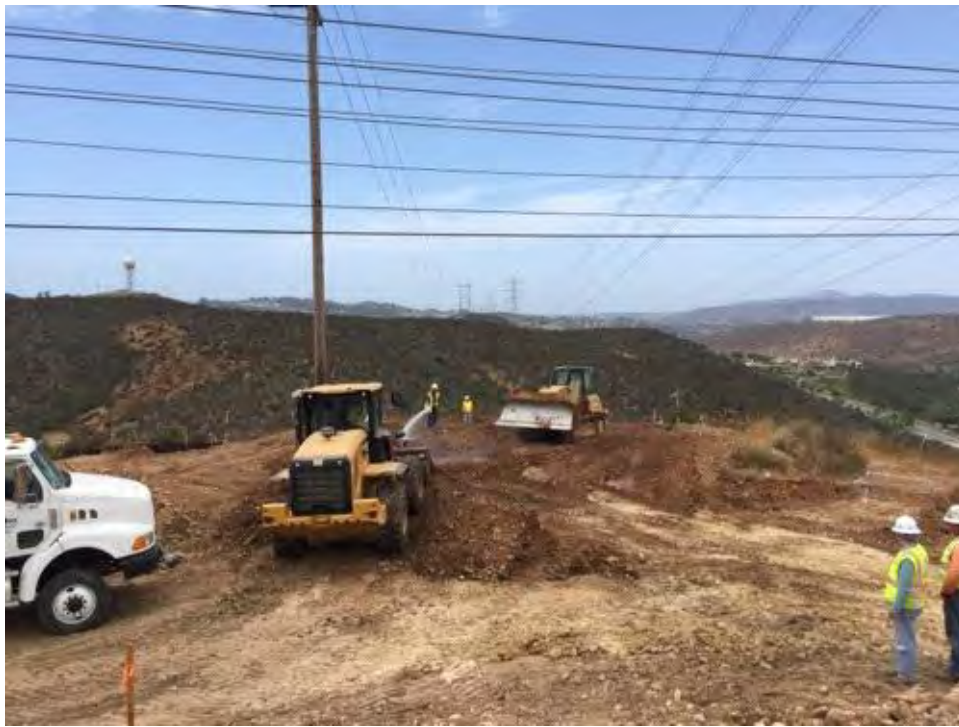
Caption Dust control measures in practice at Pole site 03.

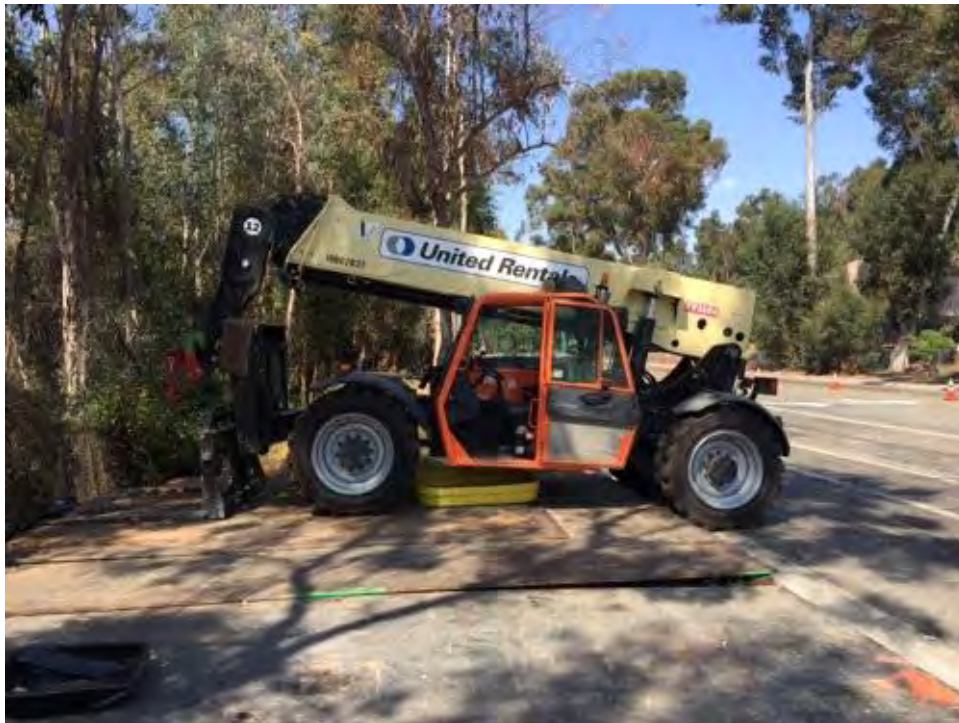
Caption Drip pans in place on Pomerado Road.

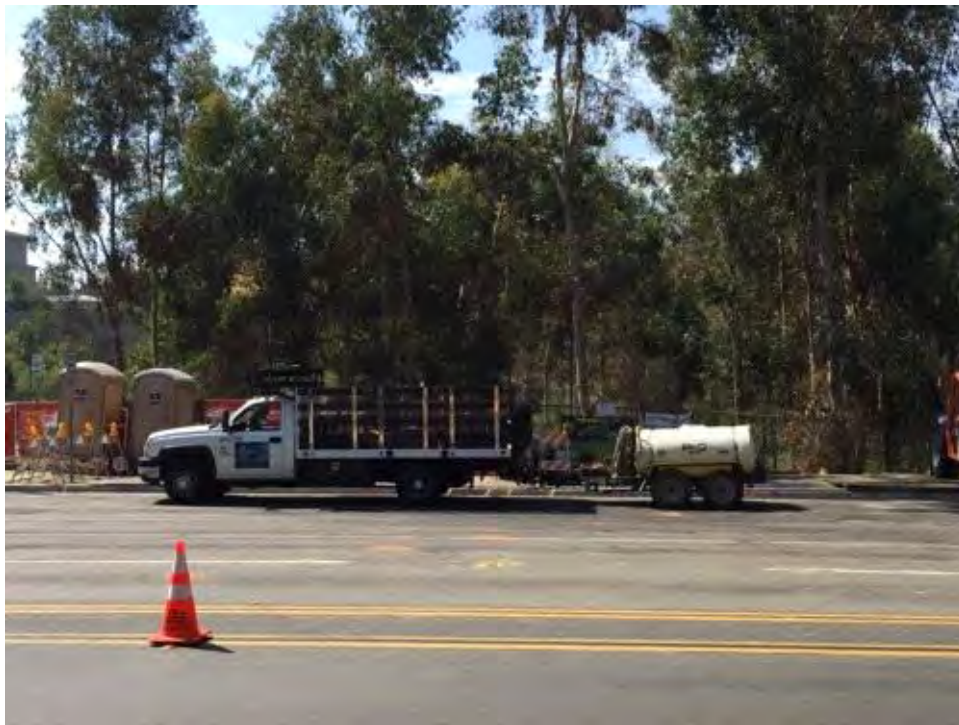
Caption Fire safety tech on site on Pomerado Road.

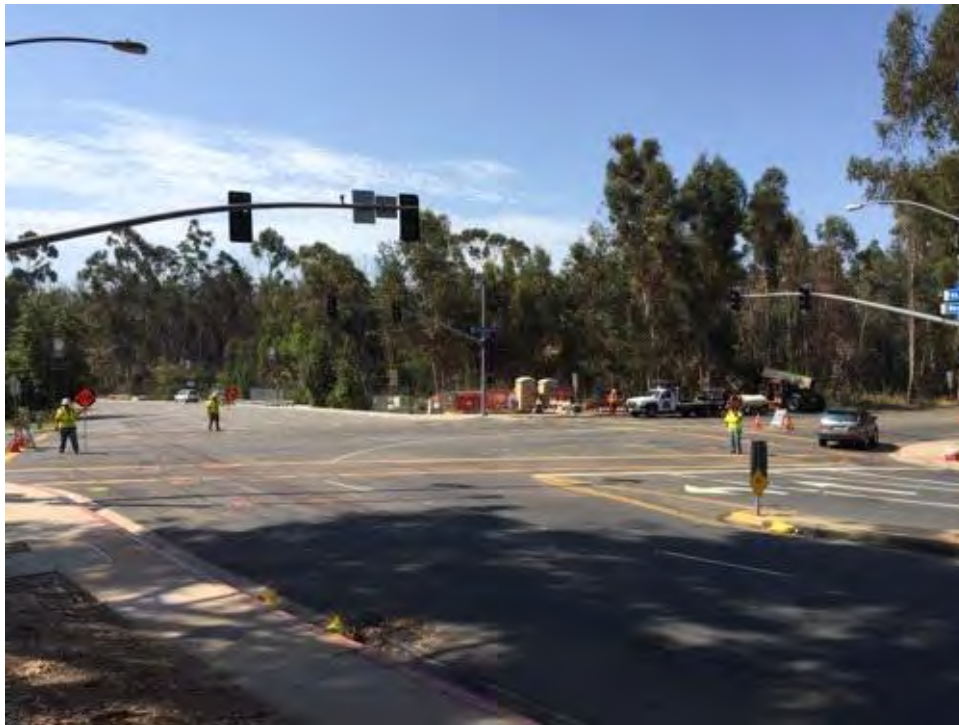
Caption Traffic flaggers in place on Pomerado Road at Ave of Nations.

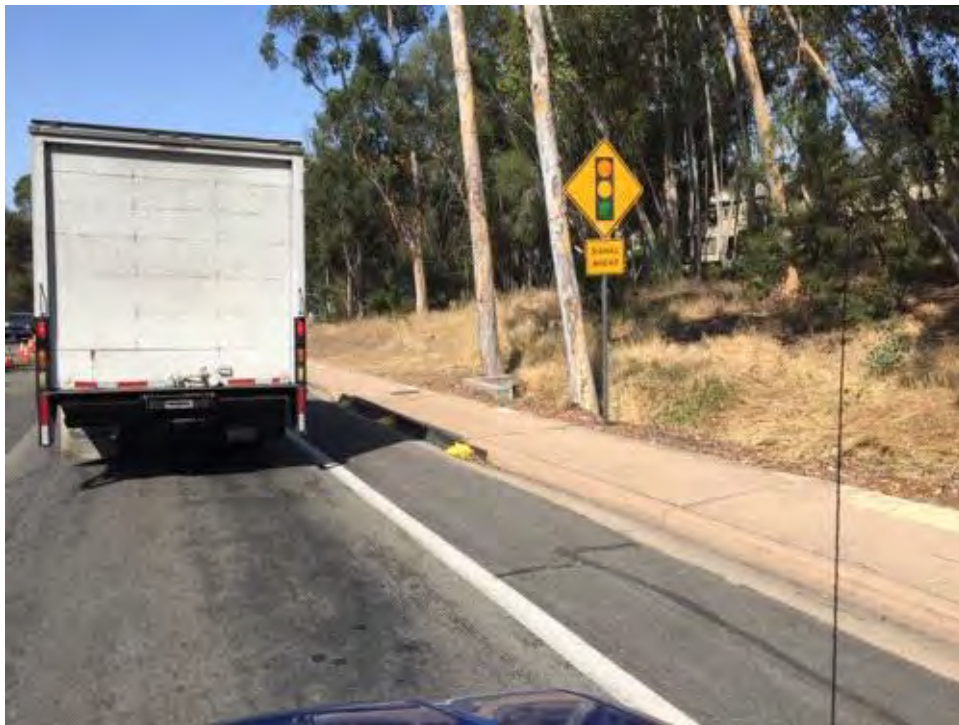
Caption BMPs in place on Pomerado Road.

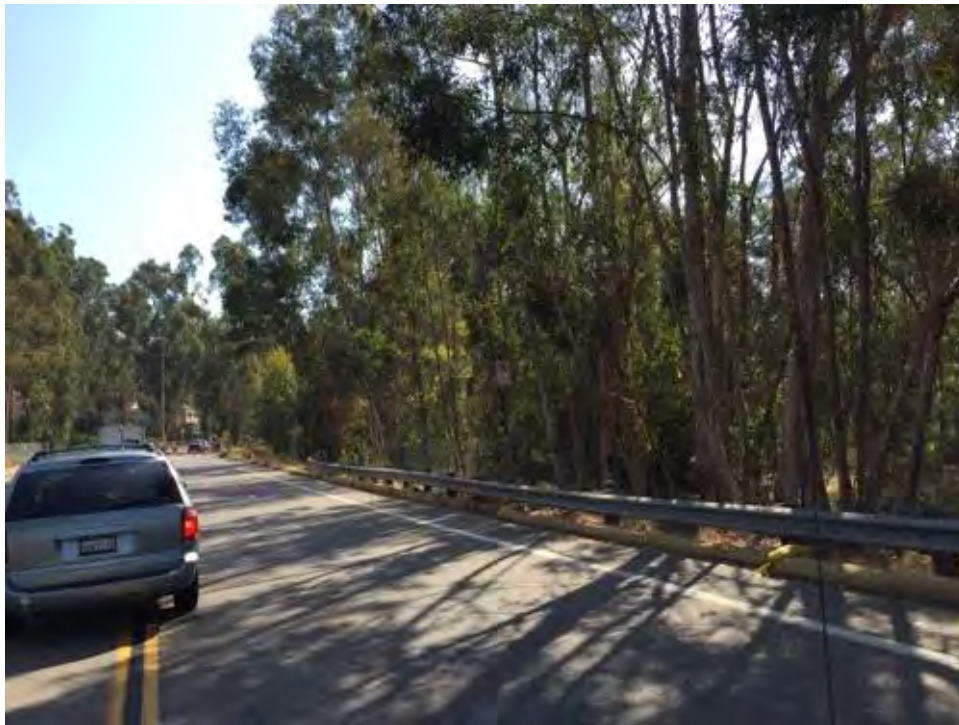
Caption BMP wattles in place on Pomerado Road.

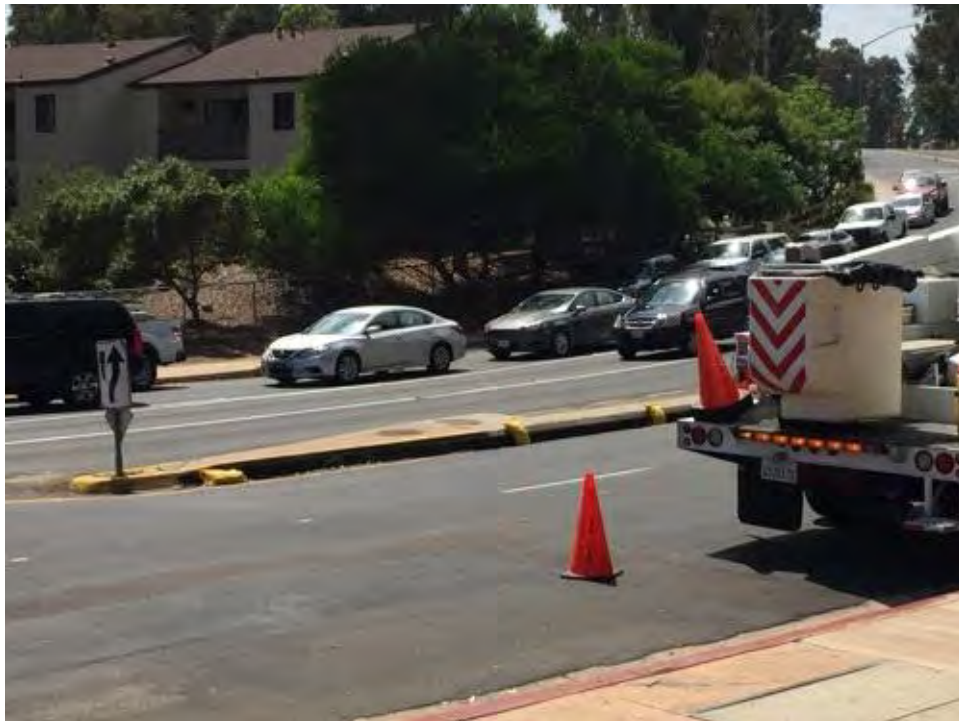
Caption BMP's in place on Willow Creek Road.

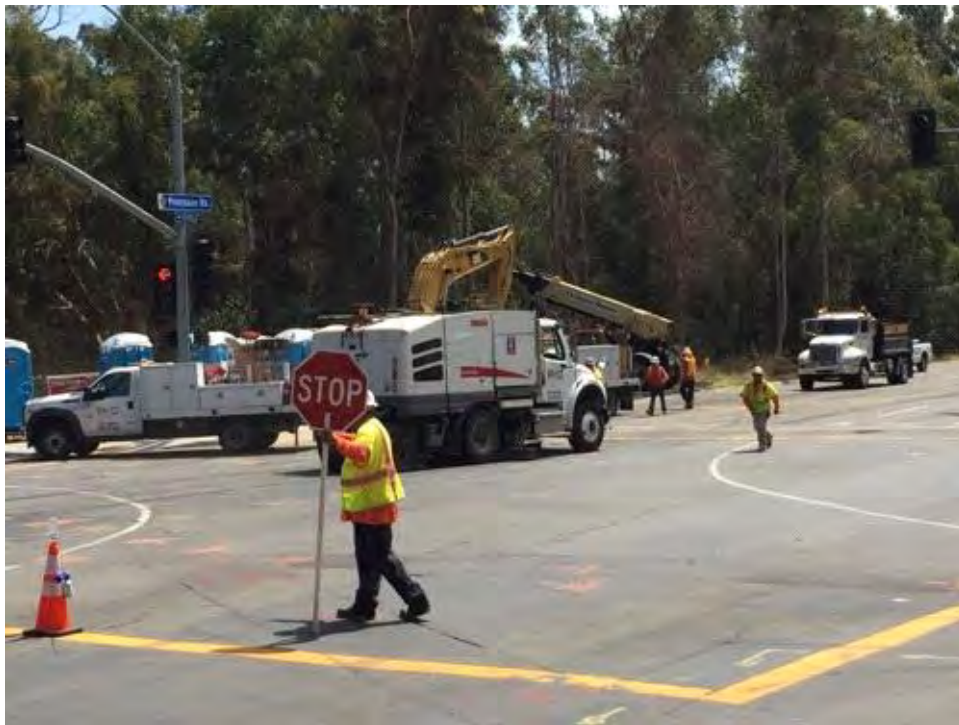
Caption Street sweeper in service on Pomerado Road.

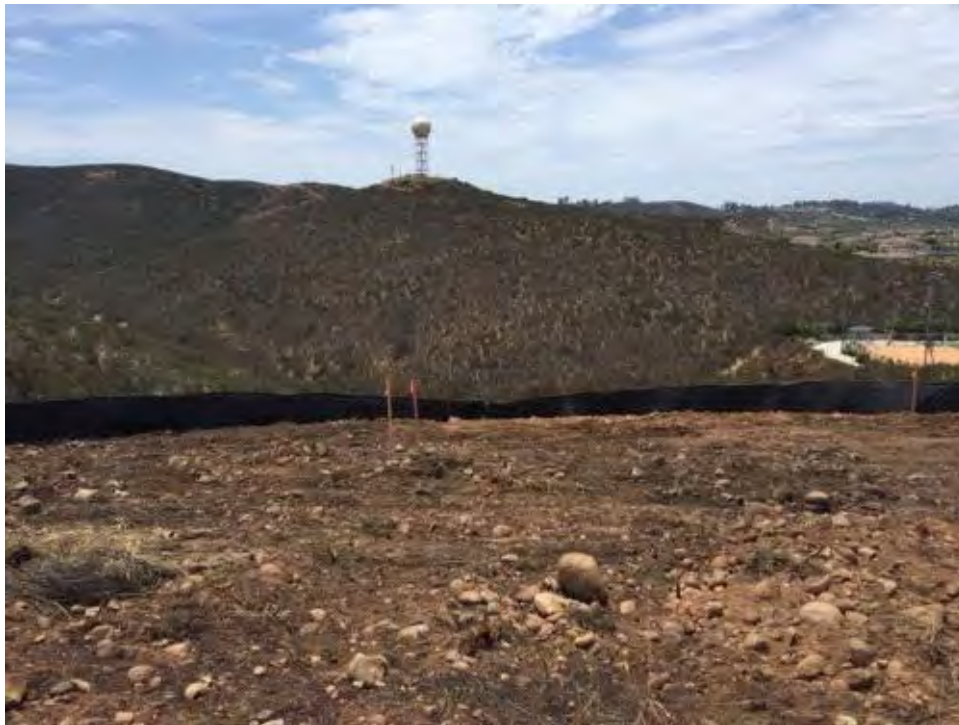
Caption Silt/erosion fencing installed at Pole 04.

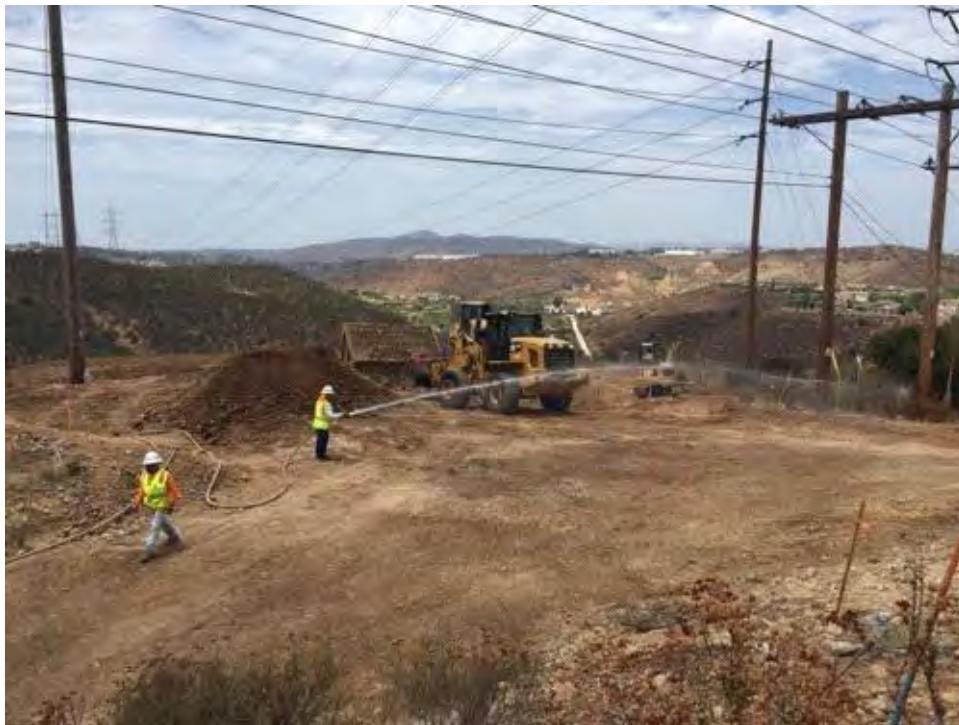
Caption Dust control in practice at Pole 03.

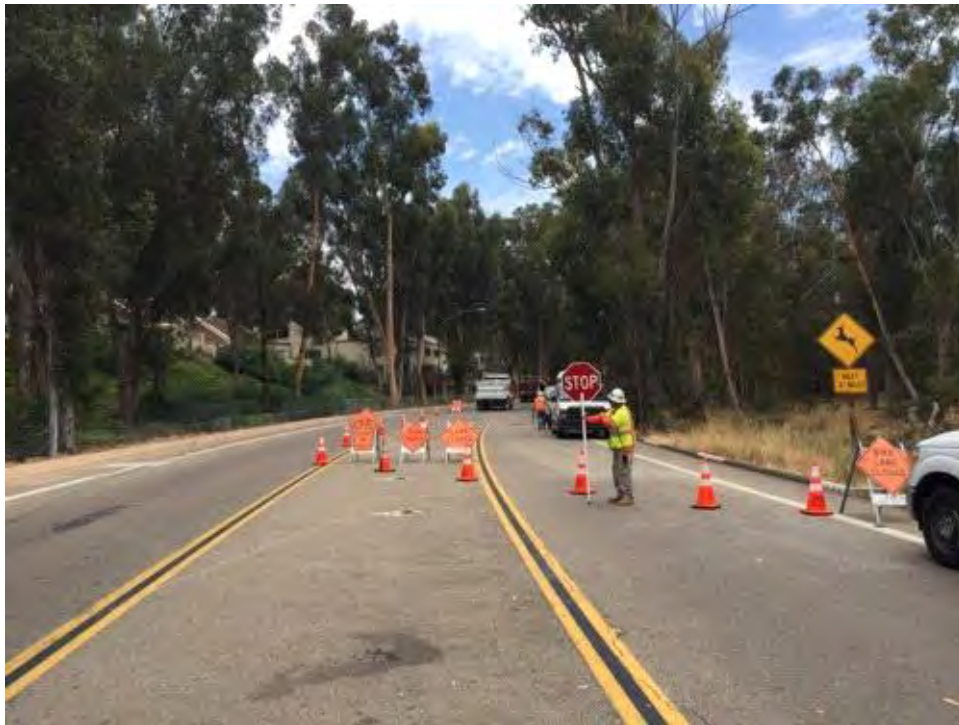
Caption Traffic flaggers on site at Pomerado Road.

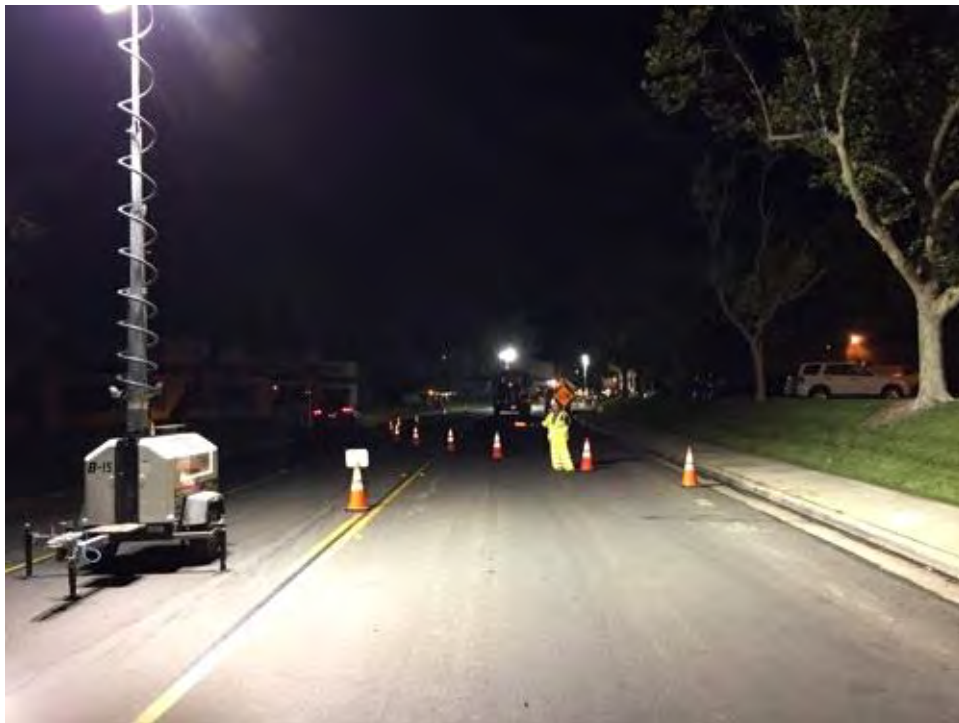
Caption Traffic flaggers in place on Activity Road

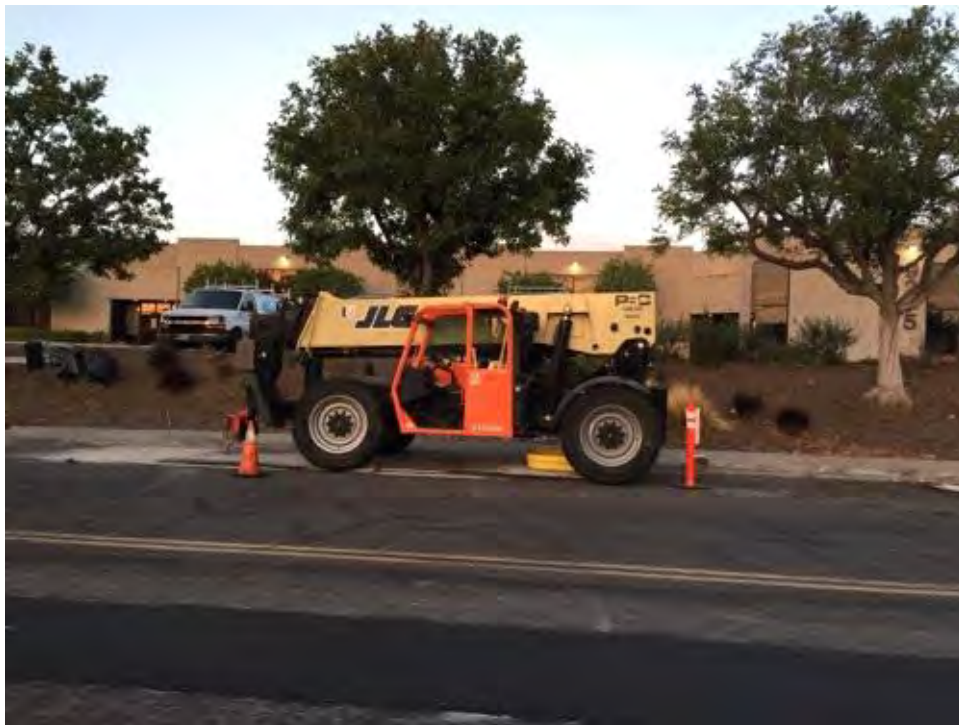
Caption Drip pans in place on Trade Place.

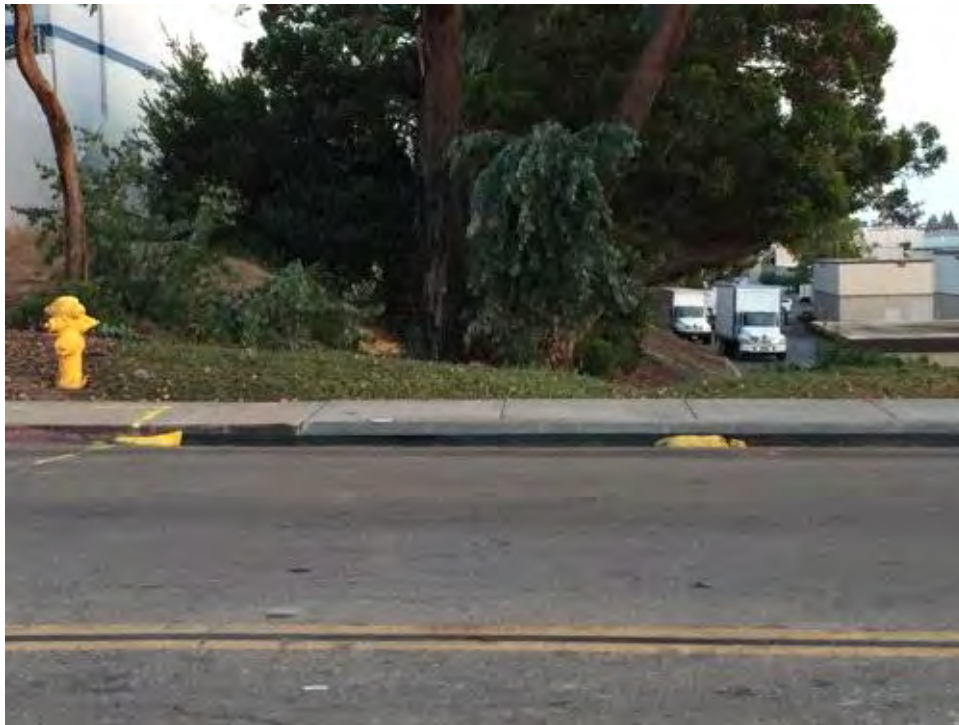
Caption BMPs in place on Arjons Drive.

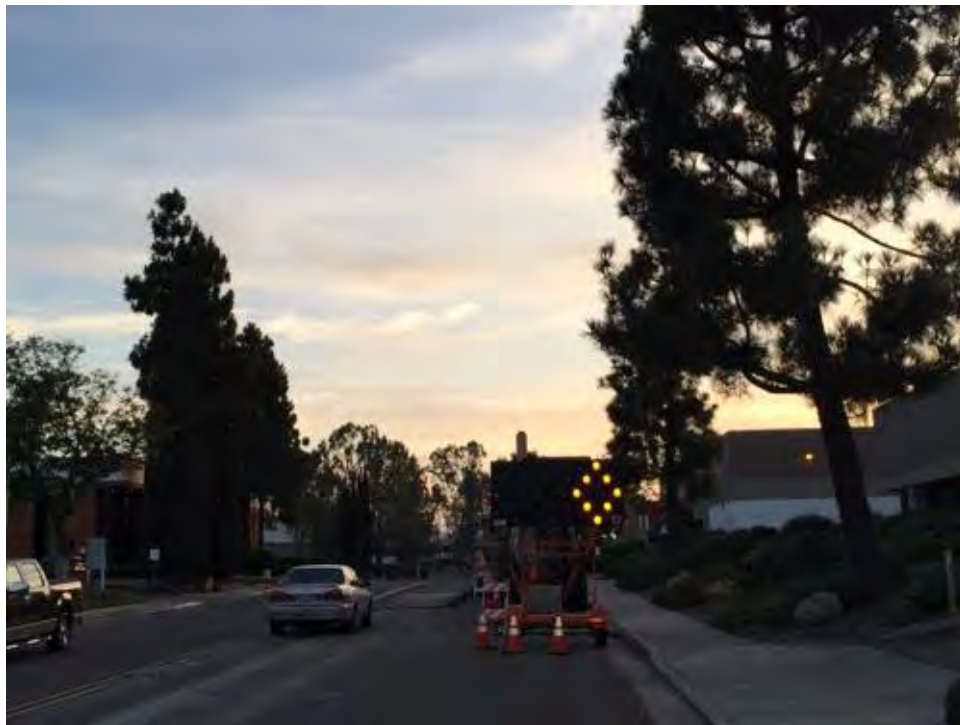
Caption Digital signage in place on Miralani Drive.

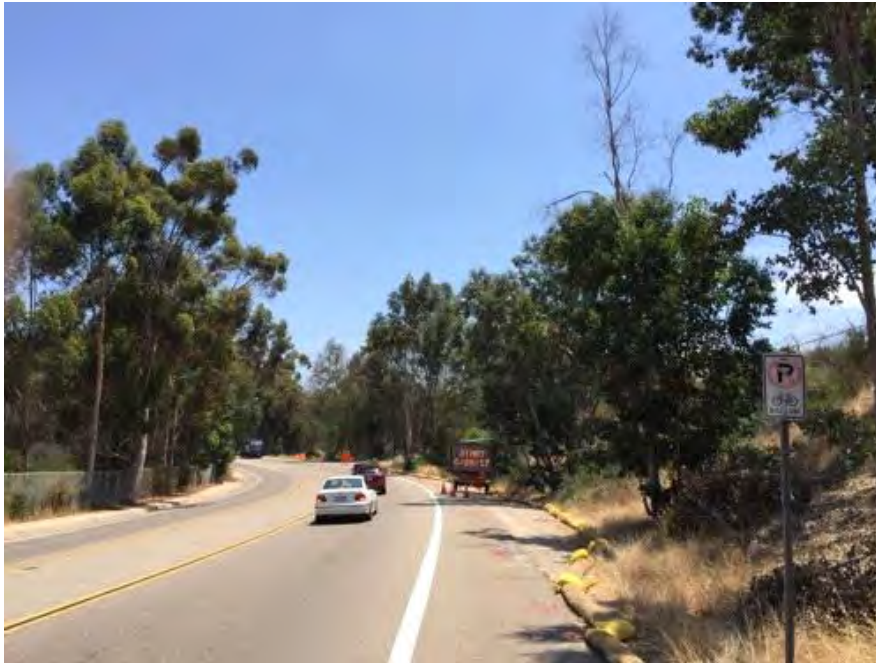
Caption Digital signage in place at entrance to construction zone on Pomerado Road.

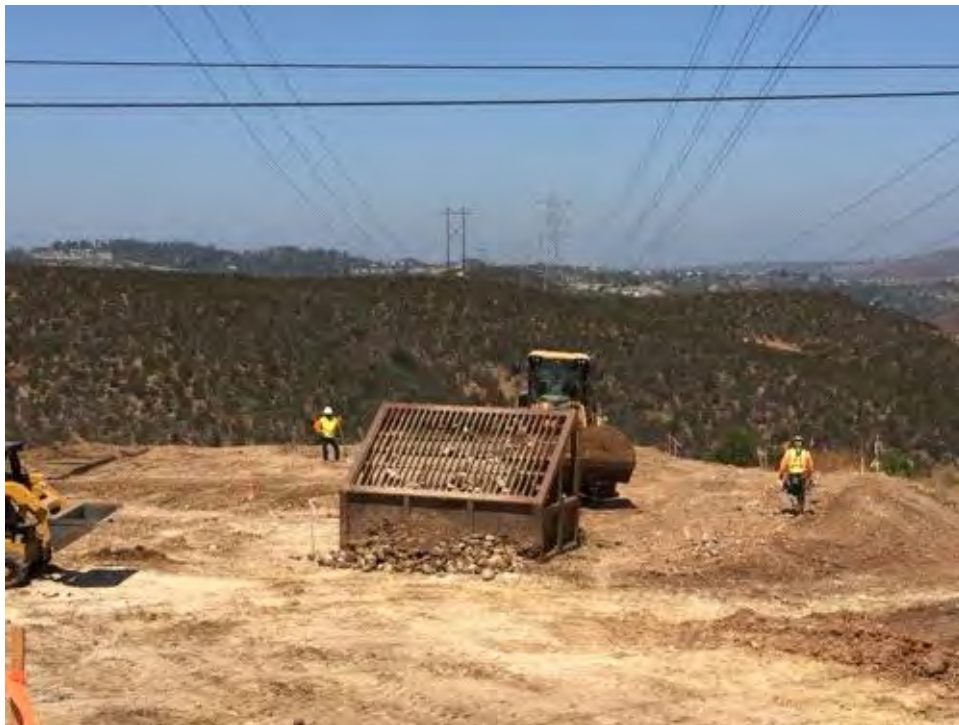
Caption Separator for rock from soil at Pole 03 site .

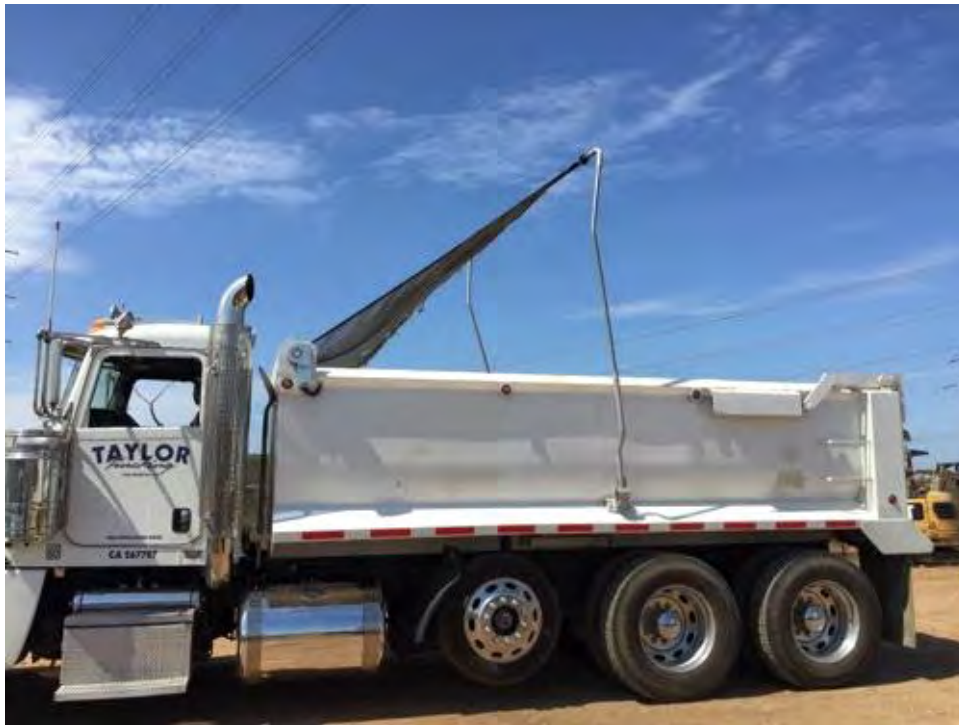
Caption Dump truck covering the fill before exiting Pole 03 site .

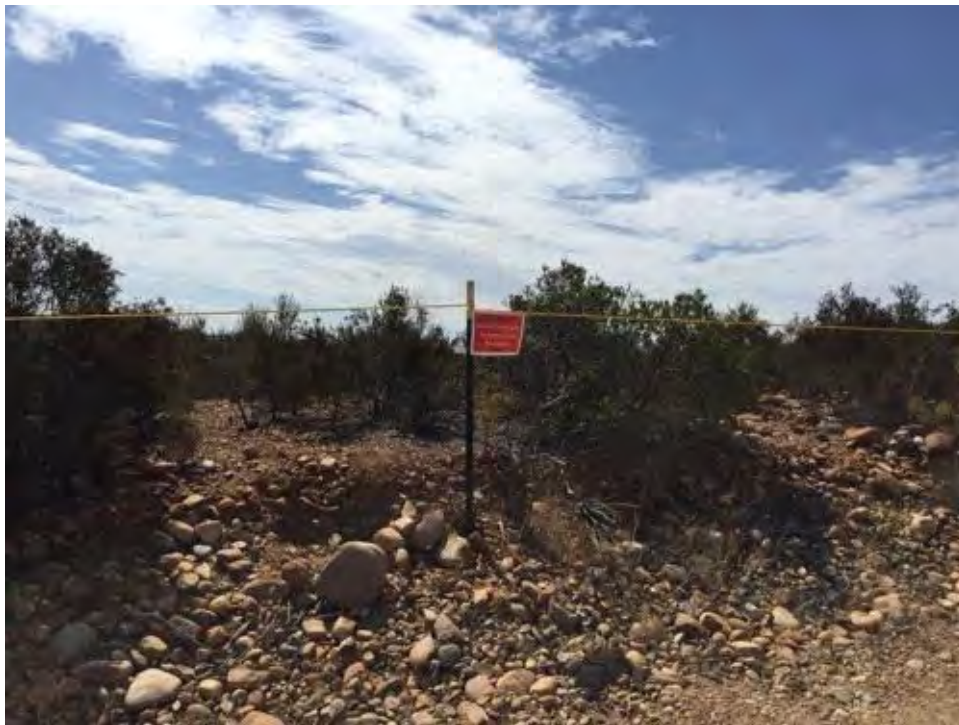
Caption Restricted area clearly marked along access road to Pole 04 site .

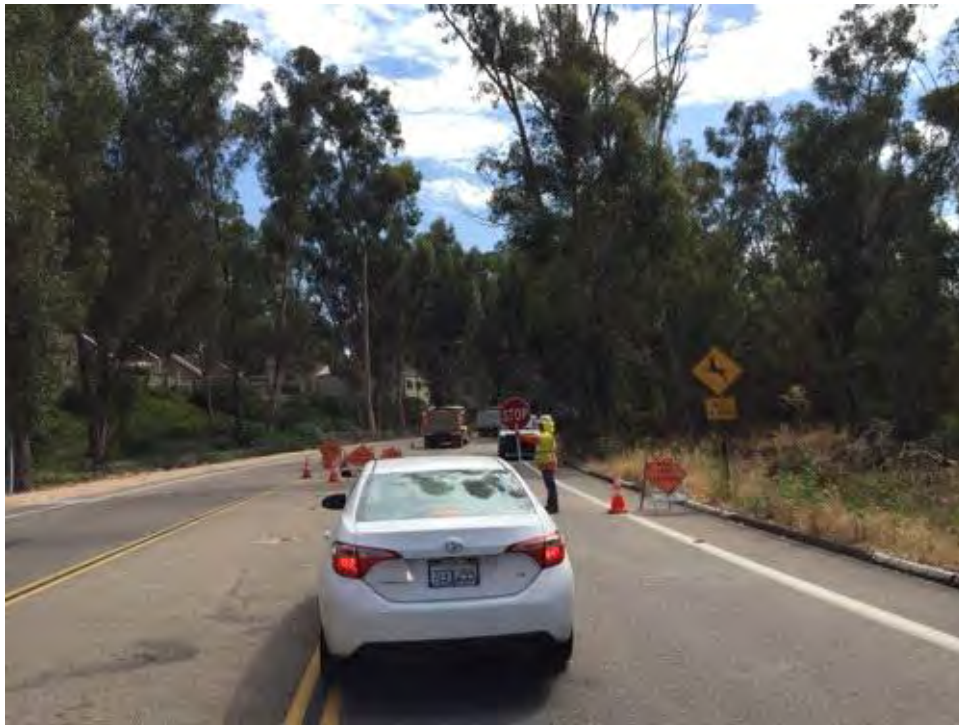
Caption Traffic flaggers in place on Pomerado Road.
