PROJECT MEMORANDUM SYCAMORE-PEÑASQUITOS 230-KV TRANSMISSION LINE PROJECT

Date: October 13, 2017
To: Billie Blanchard, CPUC Project Manager
From: Sheila Hoyer, CPUC Monitoring Supervisor
Subject: Weekly Report #40 – October 1 to October 7, 2017

SDG&E Sycamore-Peñasquitos 230-kV Transmission Line Project: Daily Inspection Report

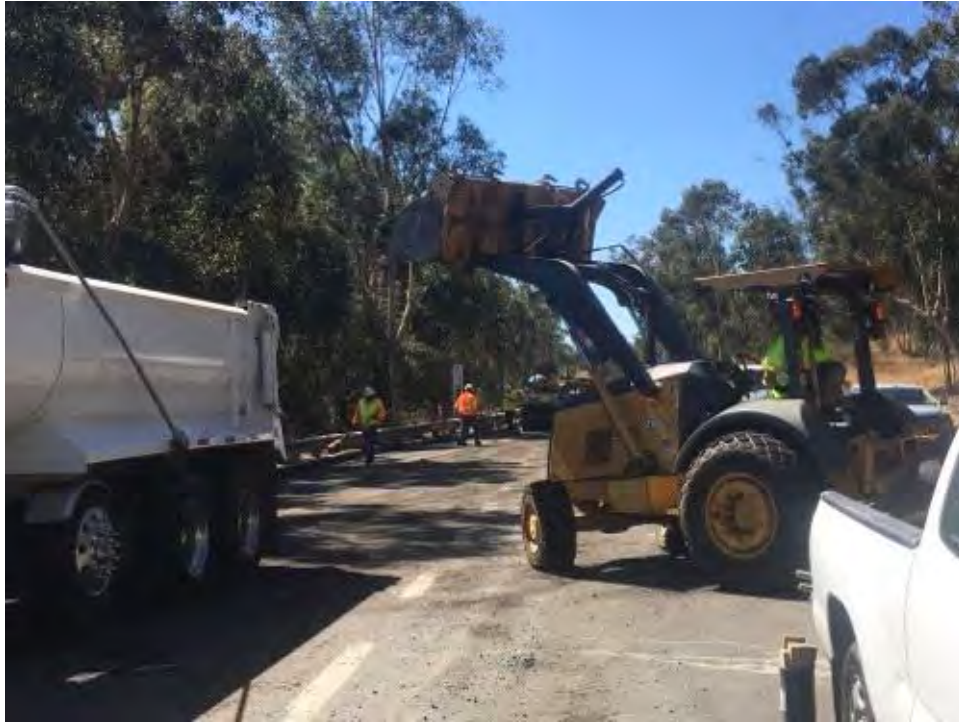
Caption Paving on Pomerado Road west of Chabad Center.

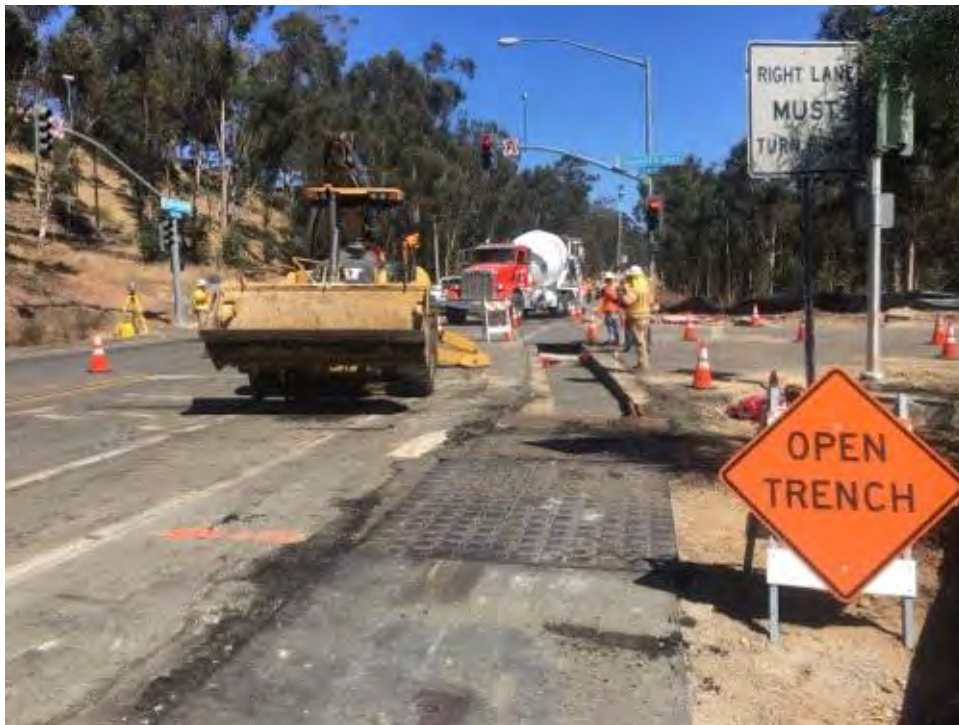
Caption Backfill at Chabad Center and Pomerado Road.

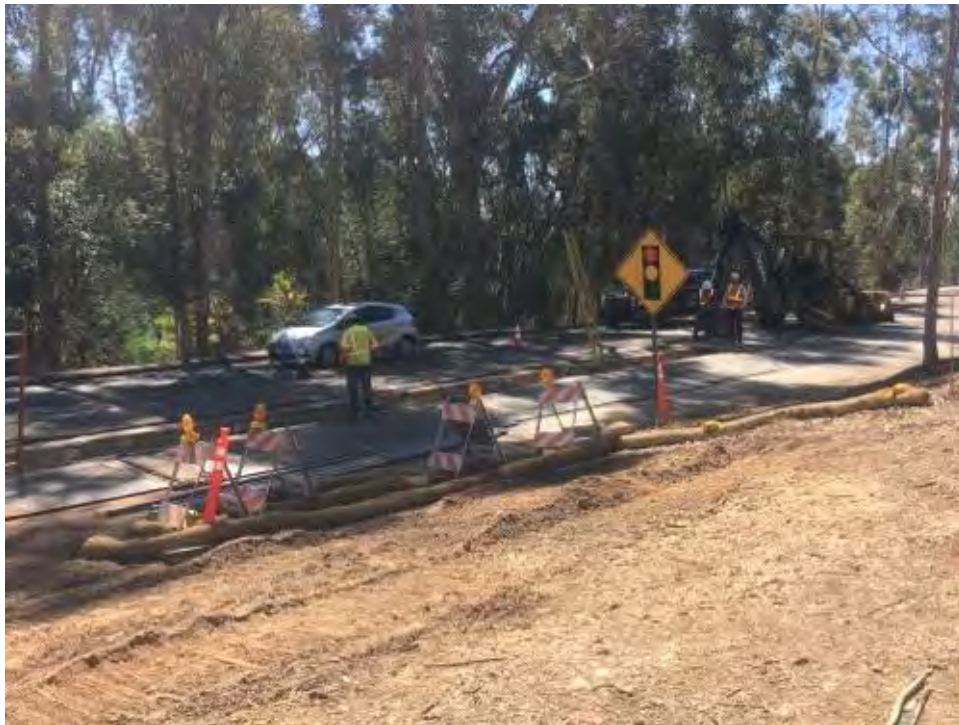
Caption Conduit install east of Chabad Center.

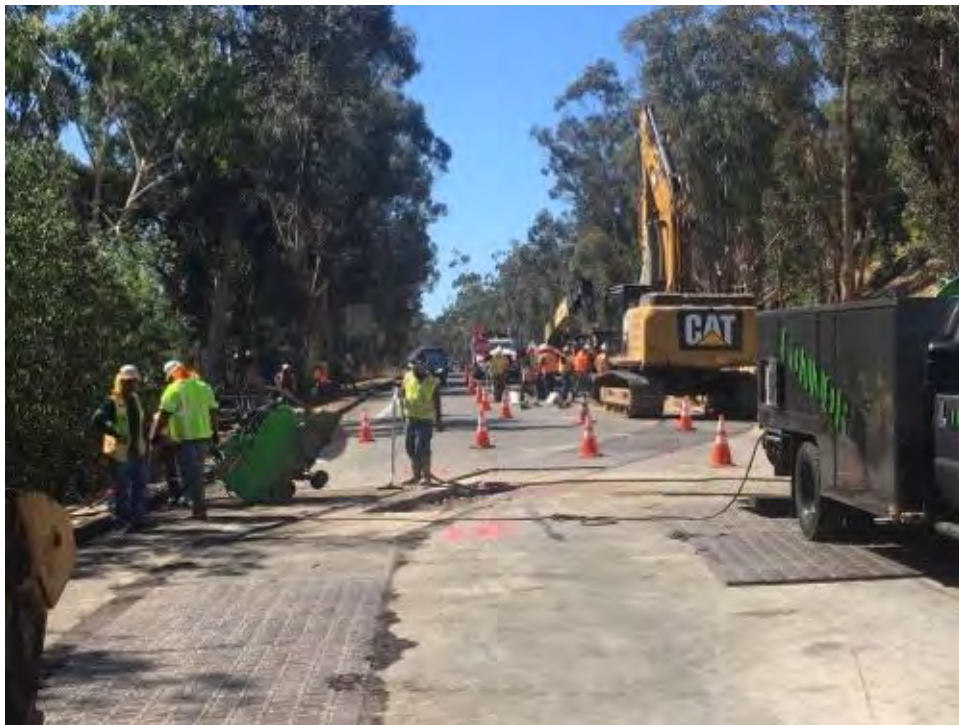
Caption Concrete work on Pomerado Road.

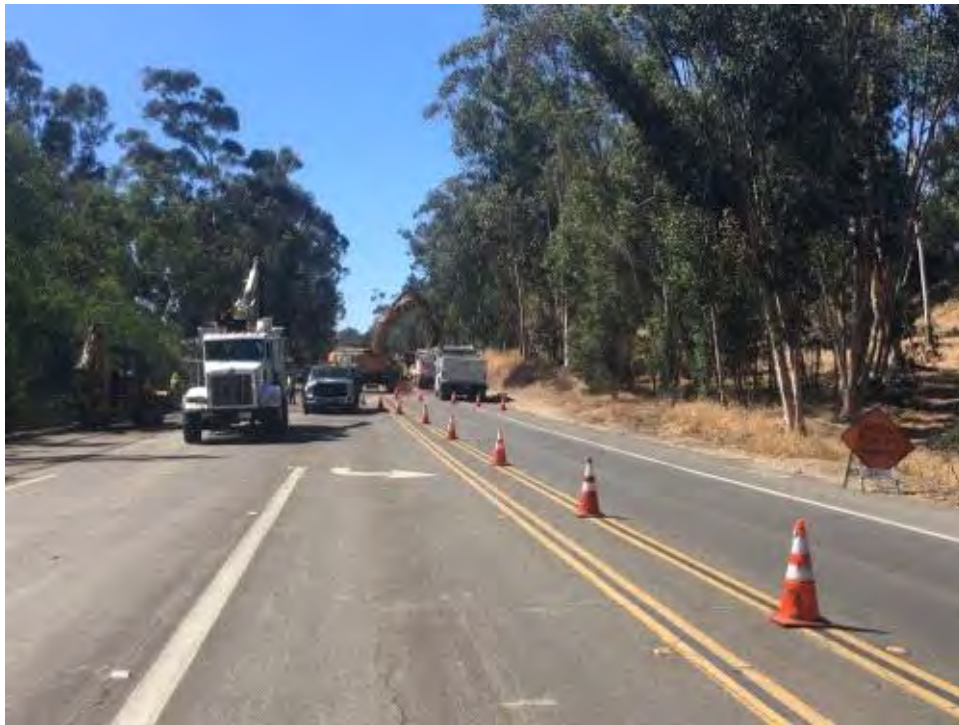
Caption Excavation west of Avenida Magnifica.

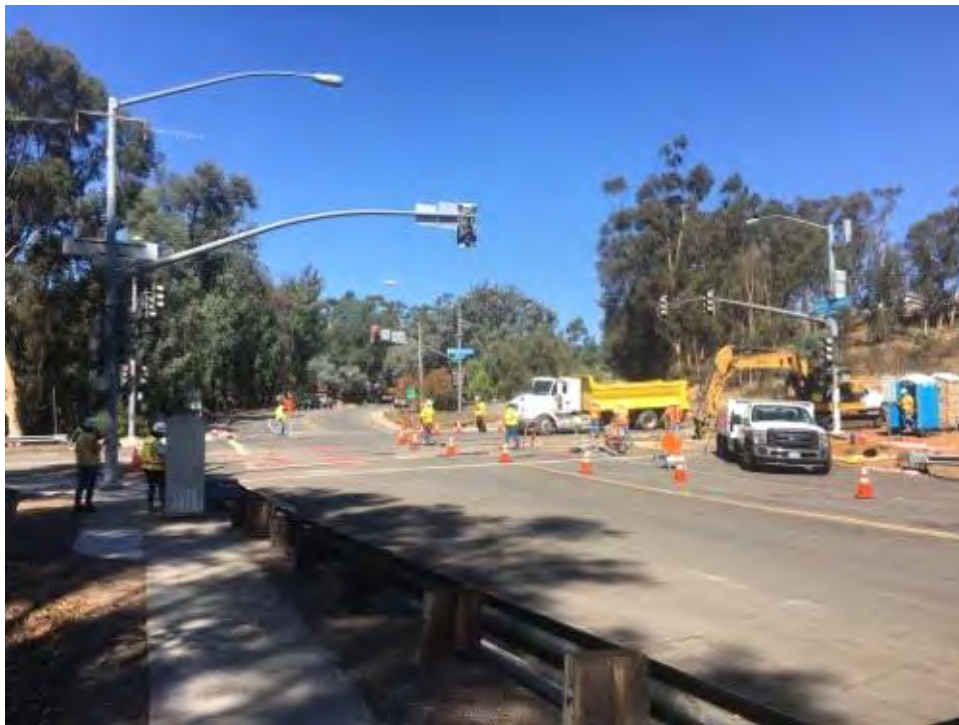
Caption Avenida Magnifica and Pomerado Road, excavation monitors are onsite.

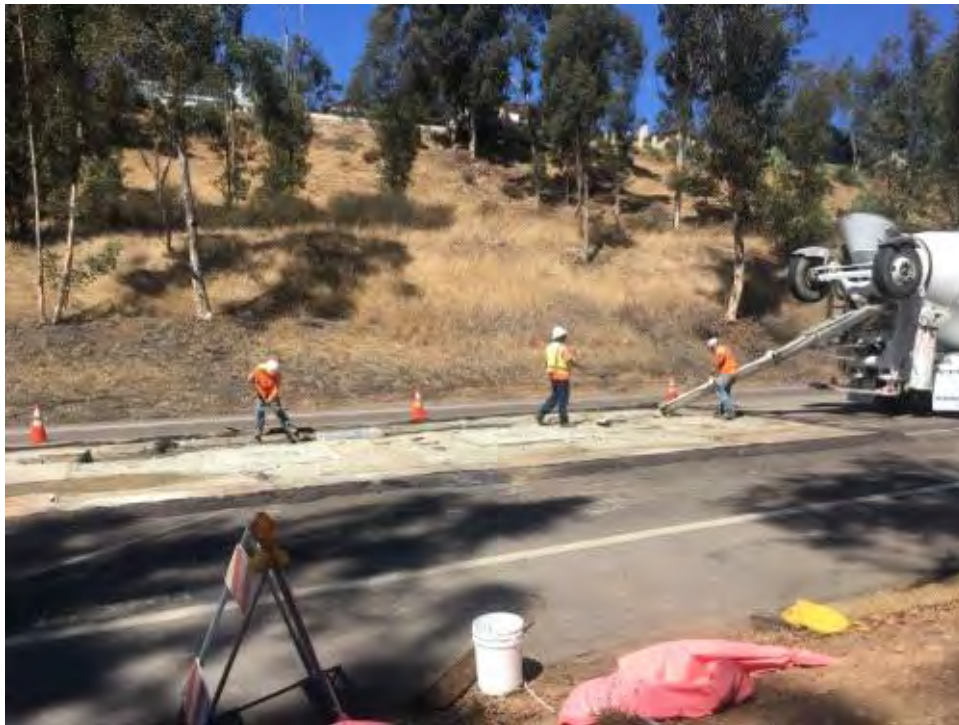
Caption Vault concrete work east of Fairbrook Road.

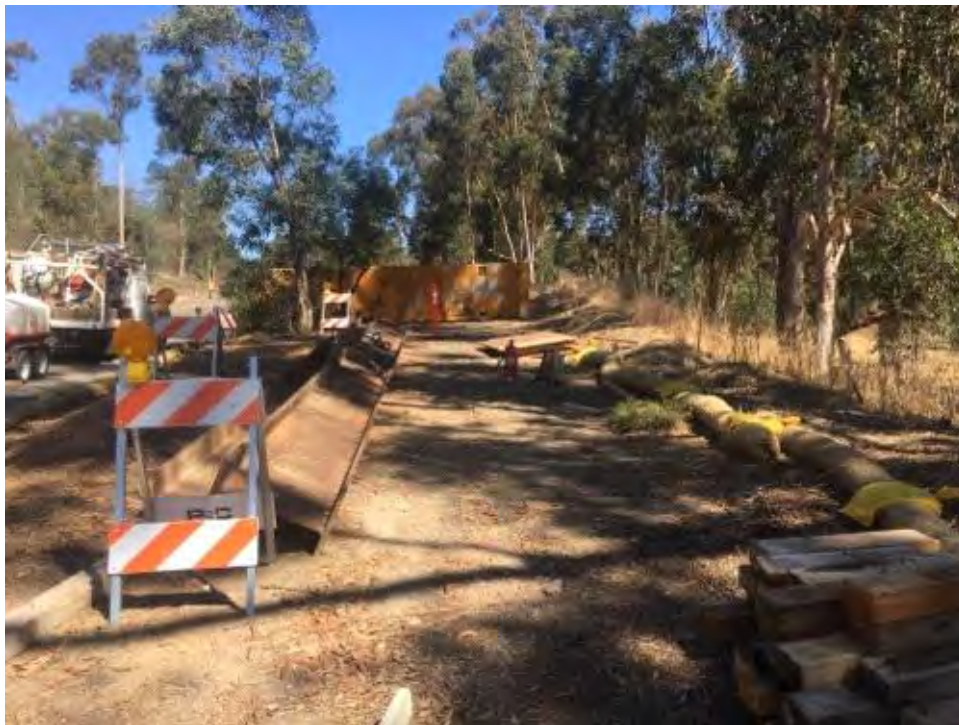
Caption Fairbrook Road and Pomerado Road work site. Note fire tools.

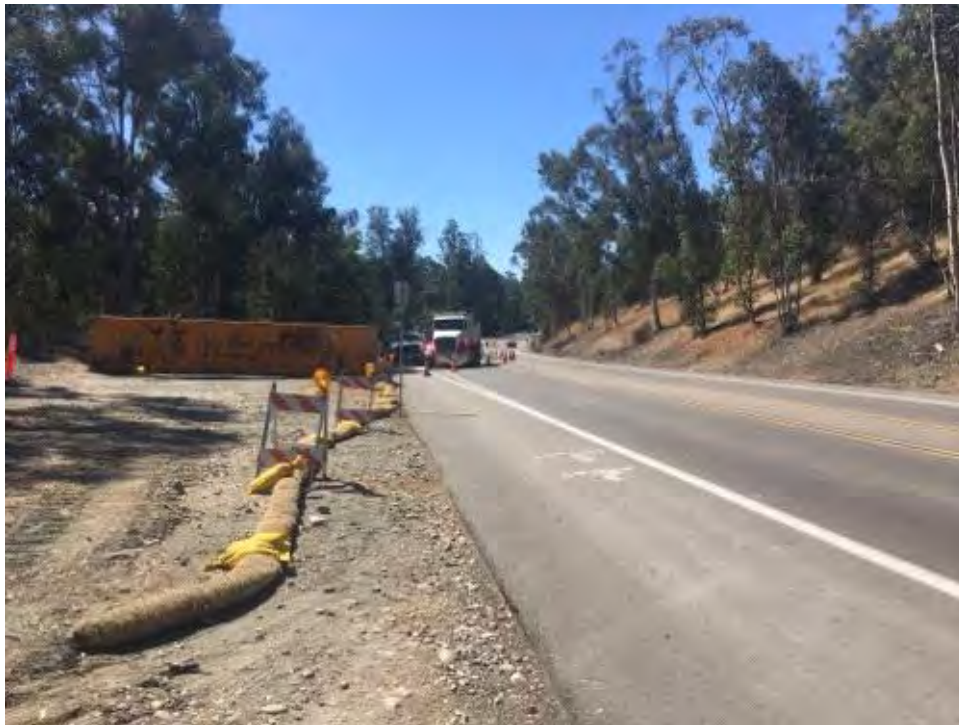
Caption Pomerado Road east of Fairbrook Road.

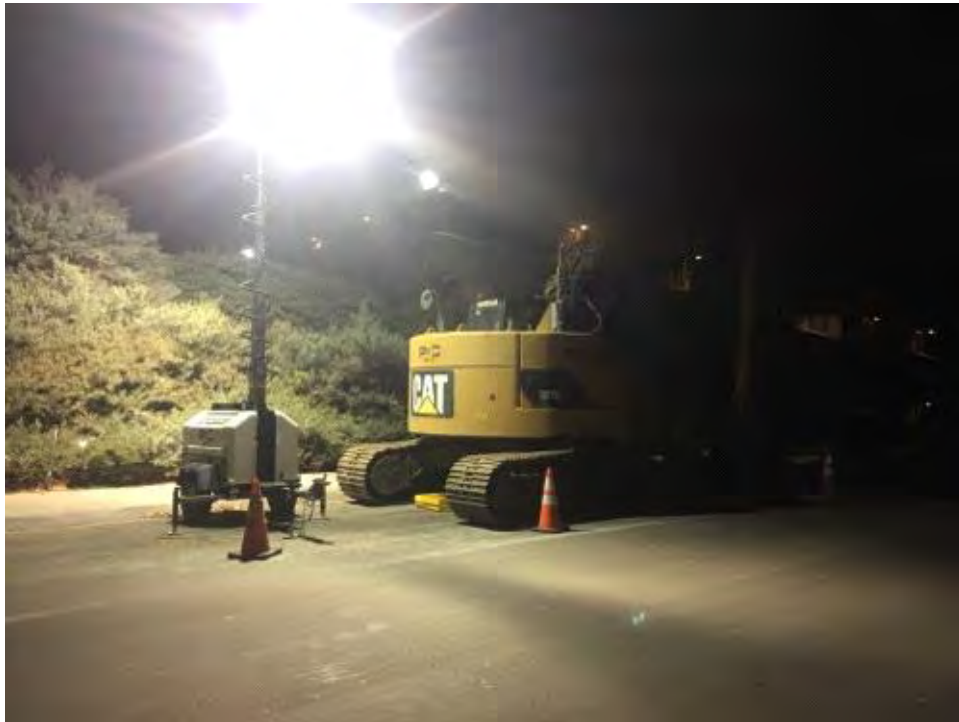
Caption Equipment stored on Youngtown Way.

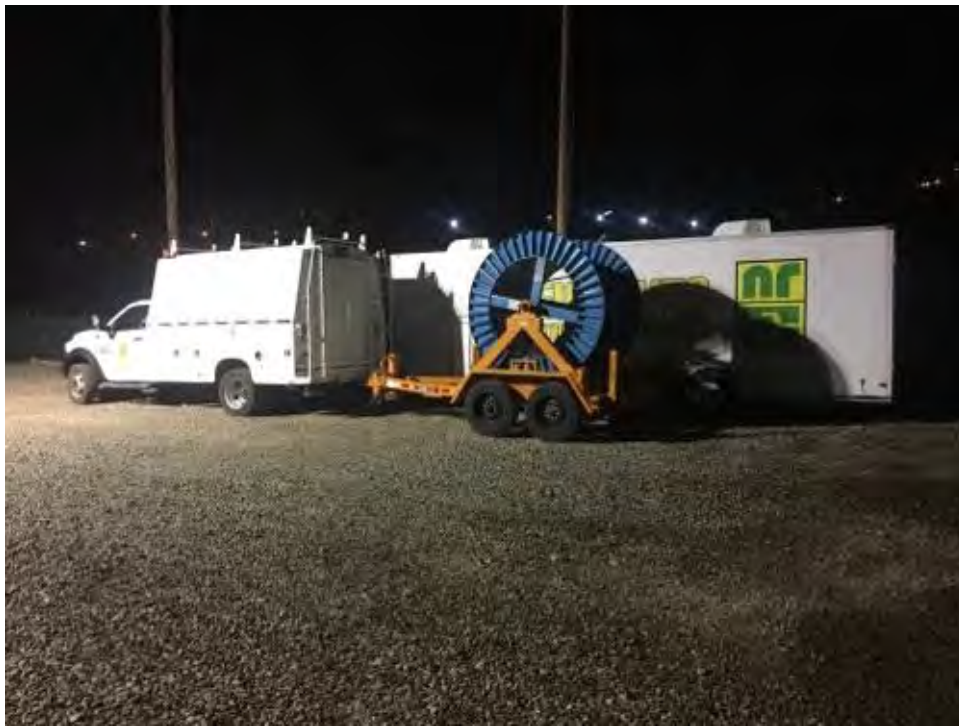
Caption New River contractor (cable install contractor) with parked vehicles at Driving Range Yard.

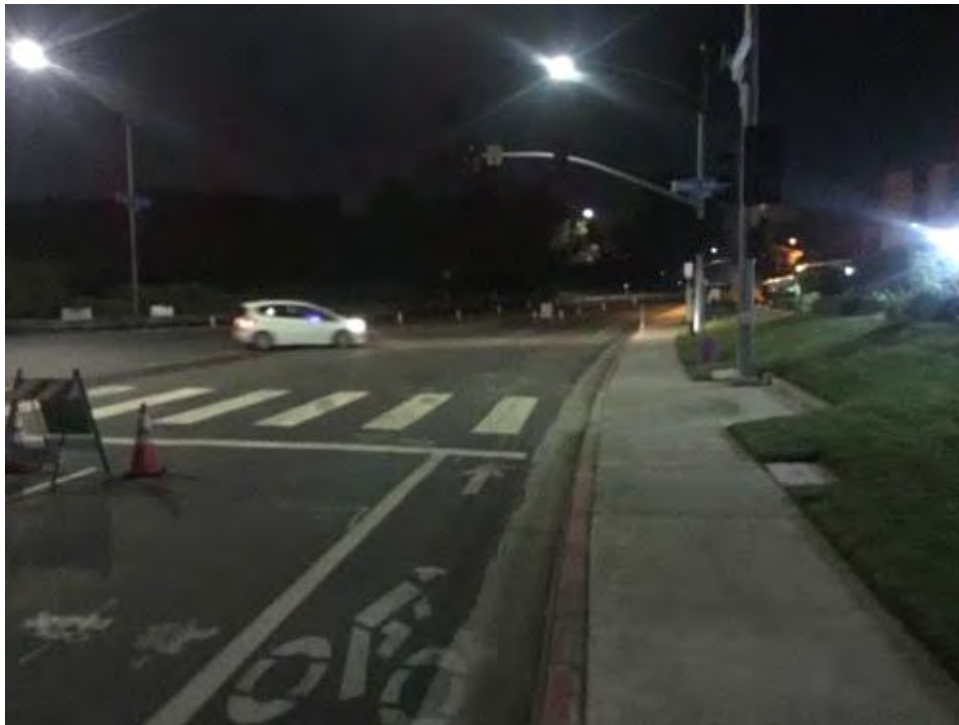
Caption Traffic light at Nancy Ridge Drive and Carroll Canyon Road. Road has been backfilled and paved.

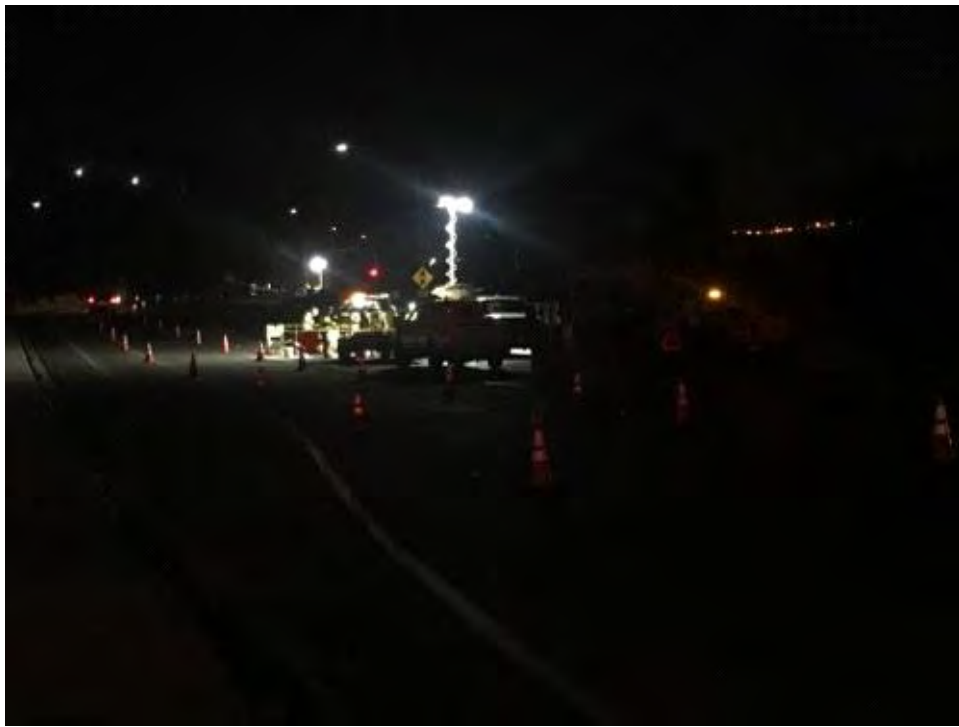
Caption Vault work on Carroll Canyon Road.

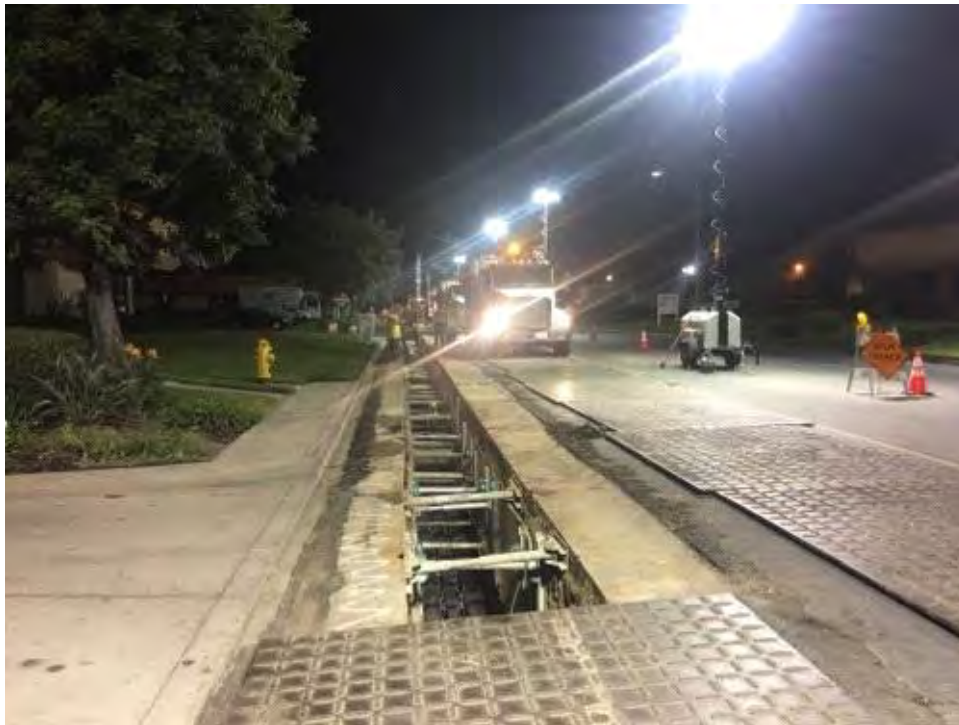
Caption Trench work on Activity Road.

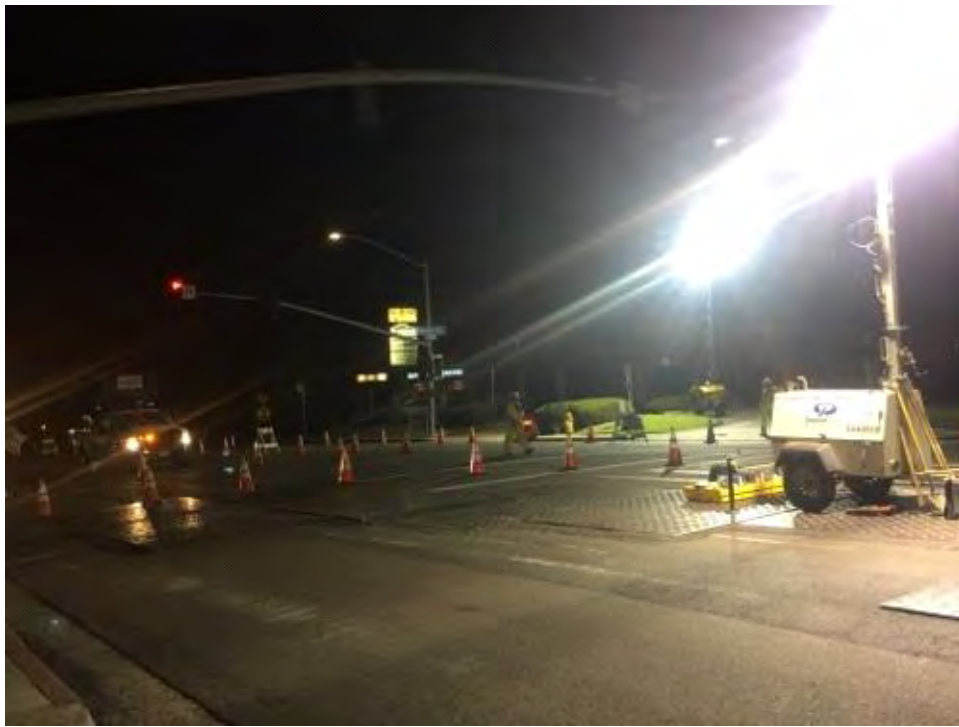
Caption Traffic control at Activity Road and Black Mountain Road.

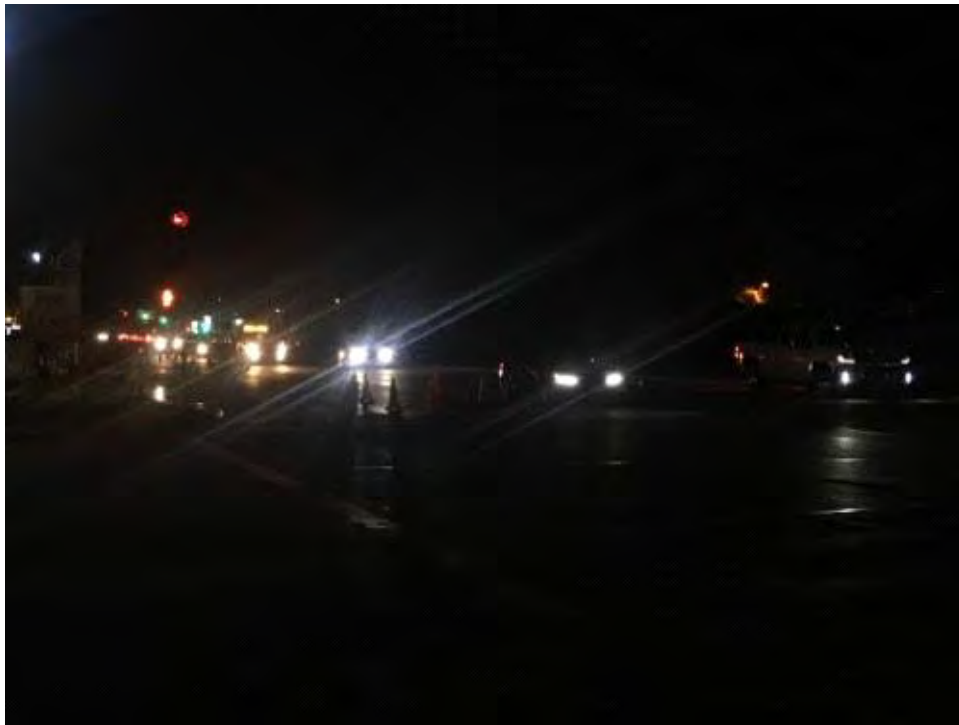
Caption Normal traffic flow on Miramar Road. View looking east.

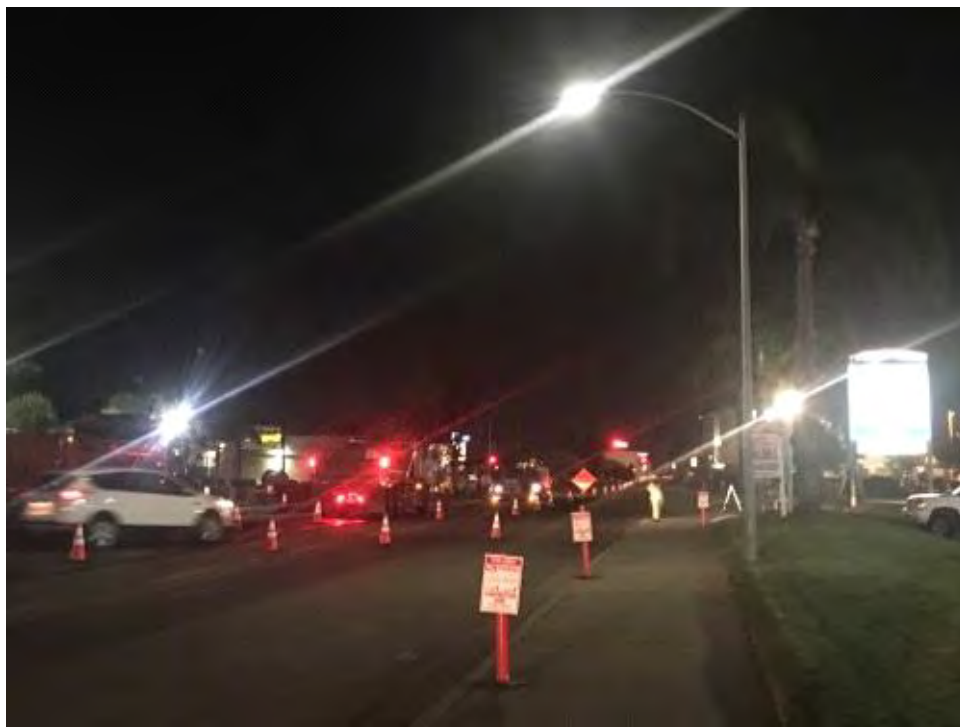
Caption Truck staging and traffic control on southern portion of Black Mountain Road.

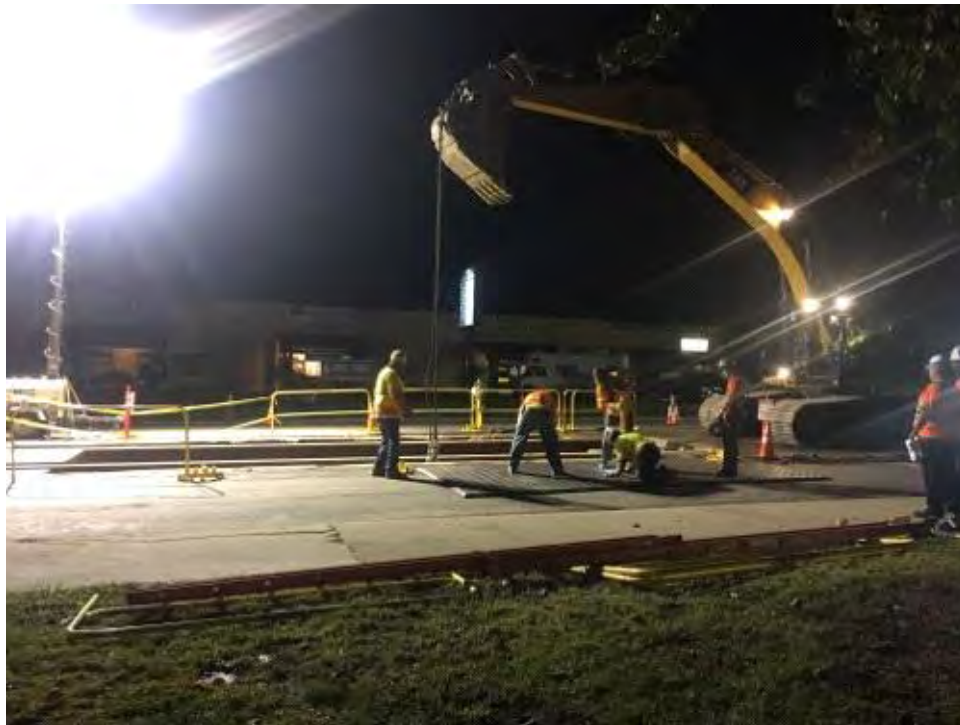
Caption Site prep for vault location.

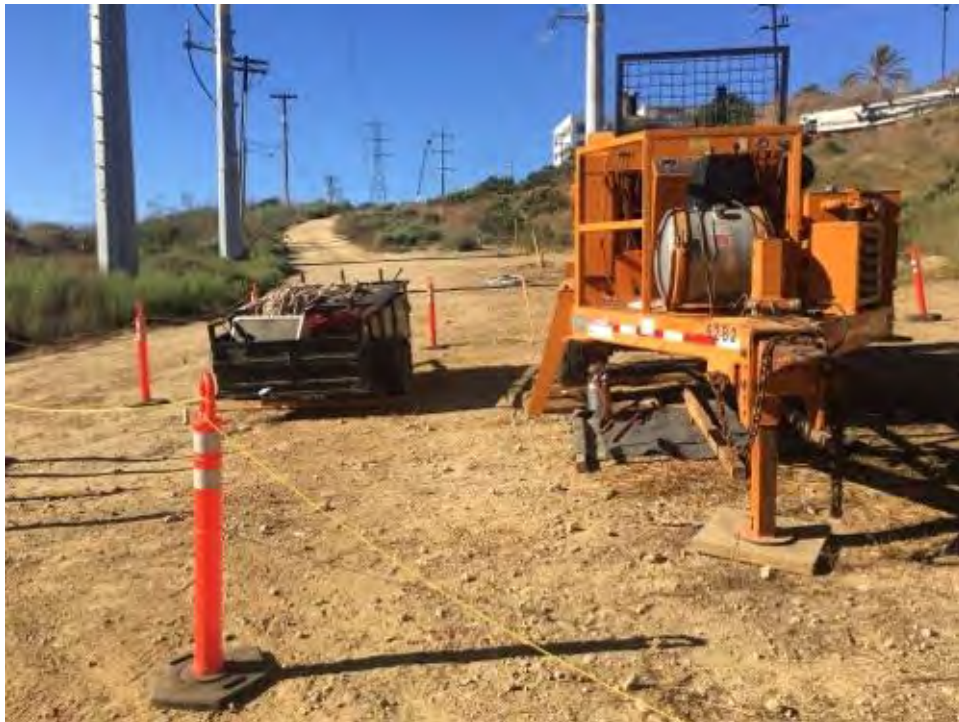
Caption Fire tools with wire rig.

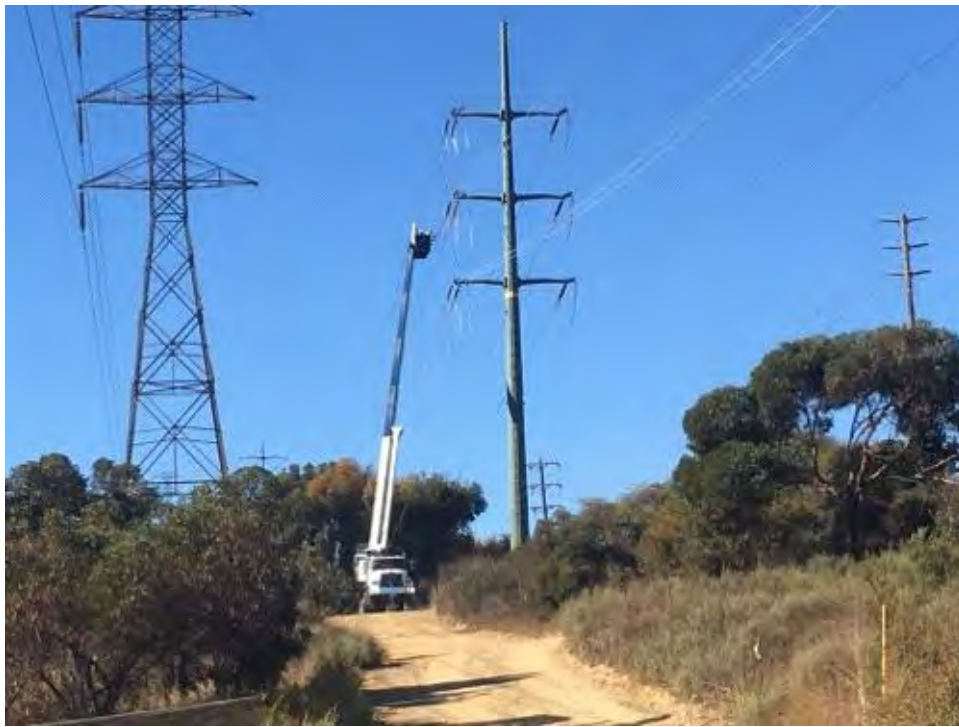
Caption Wire work on middle arm of pole north of CC MM CP.

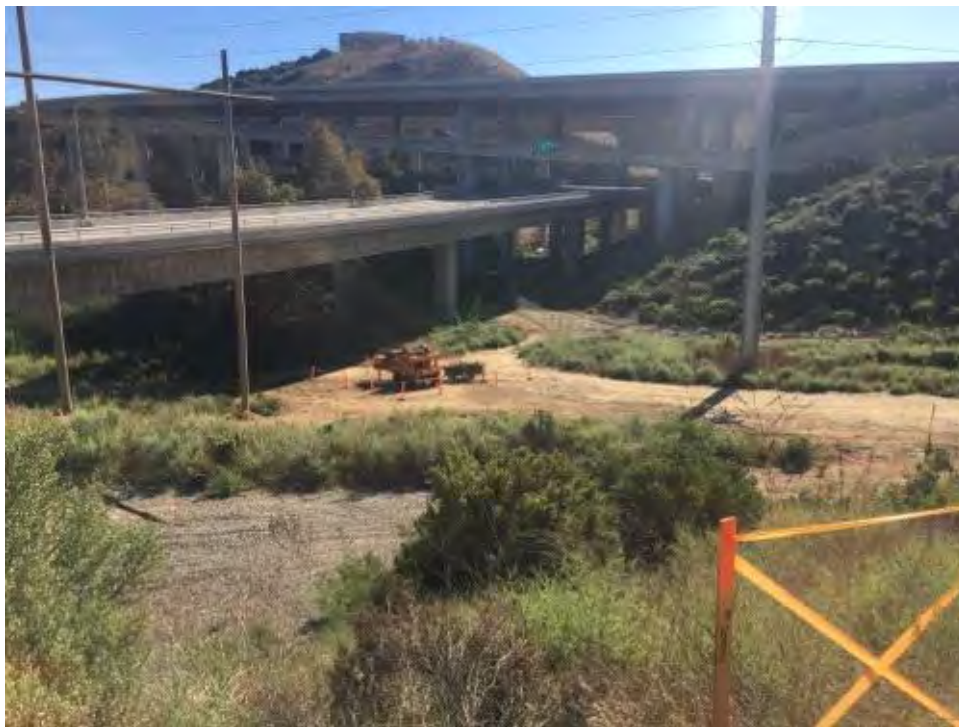
Caption Wire machine not in use and staged just north of Carroll Canyon Road bridge.

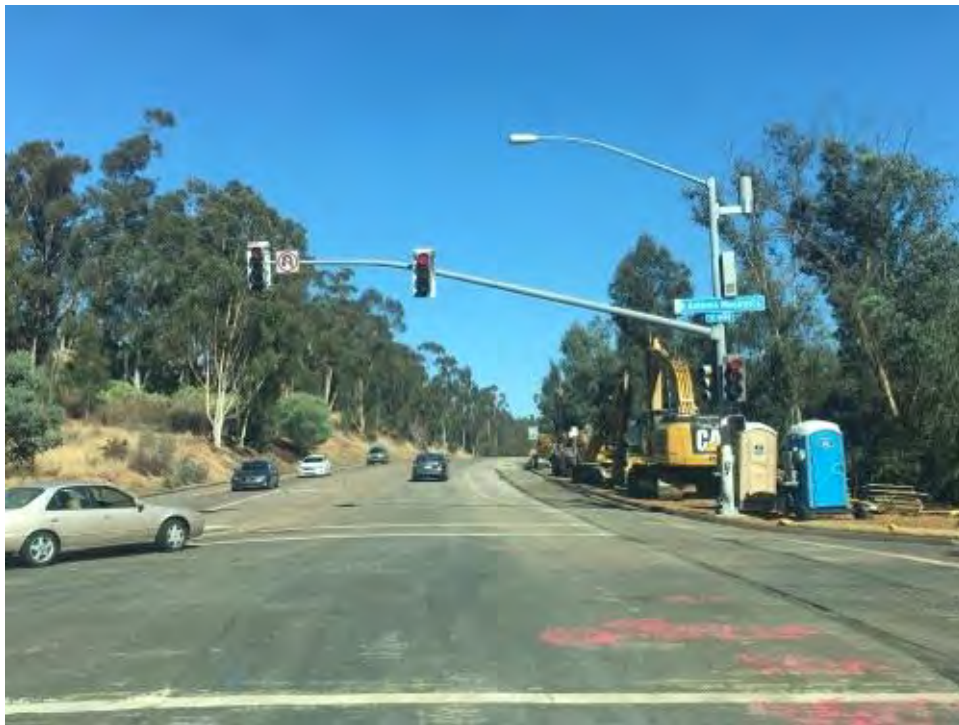
Caption Normal traffic flow at Avenida Magnifica just prior to 3pm.

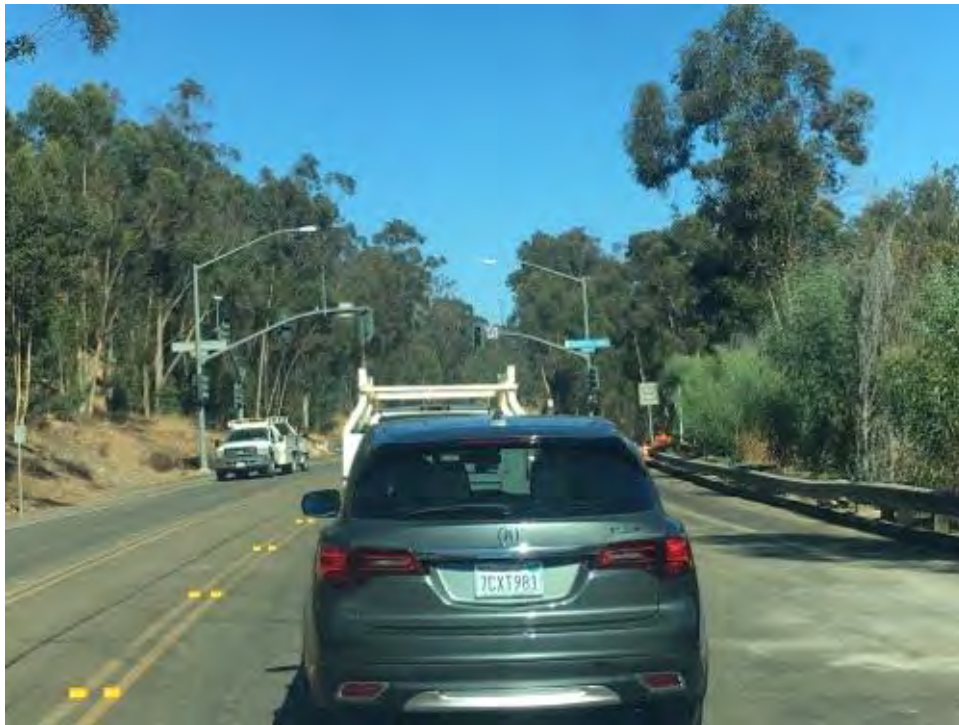
Caption Traffic control west of Chabad Center just prior to 3pm.

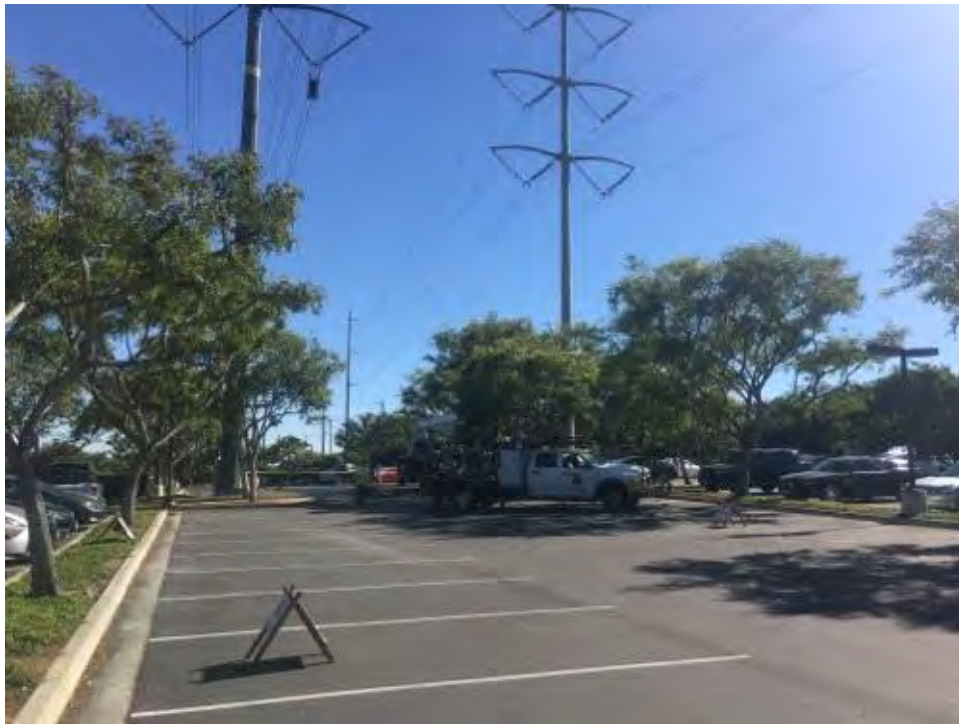
Caption Wire crew south of Lusk Blvd.

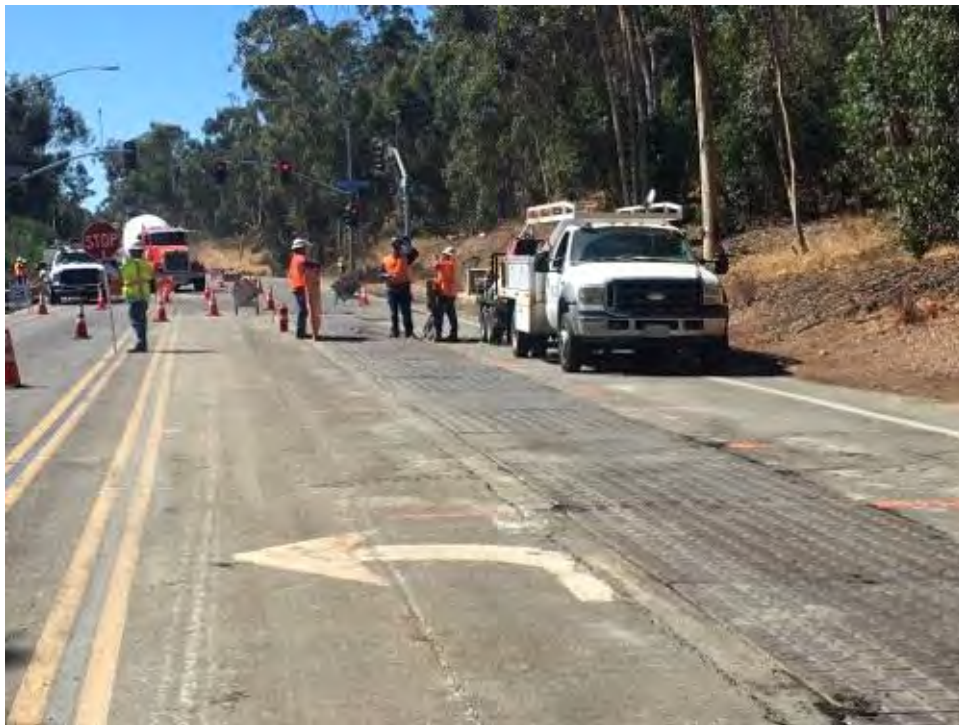
Caption Steel plate welding, note fire shield in use.

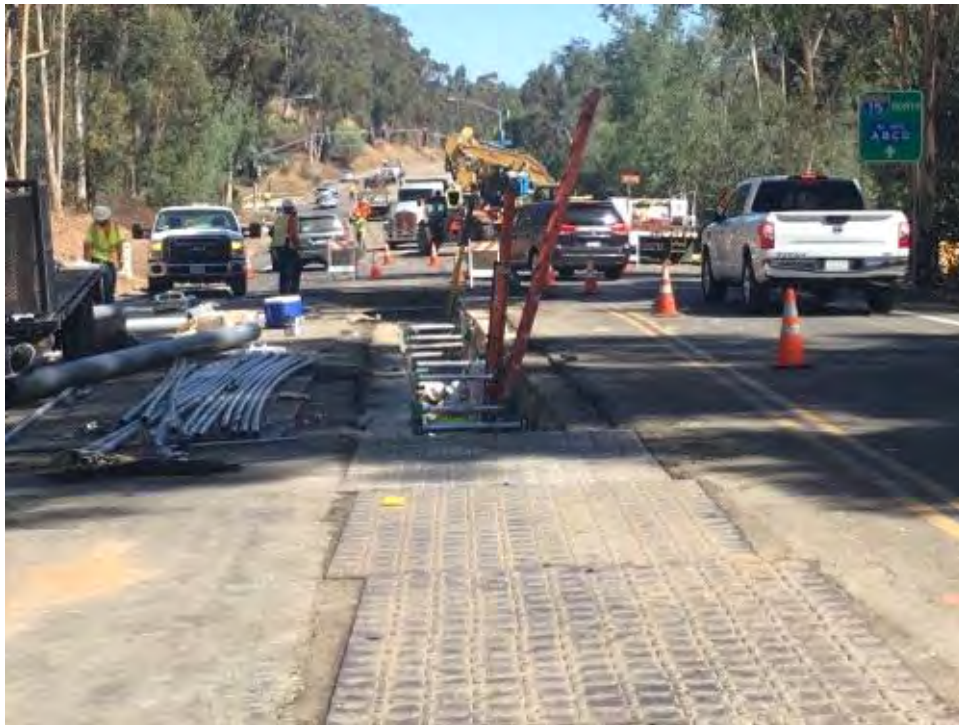
Caption Conduit install on Pomerado Road.

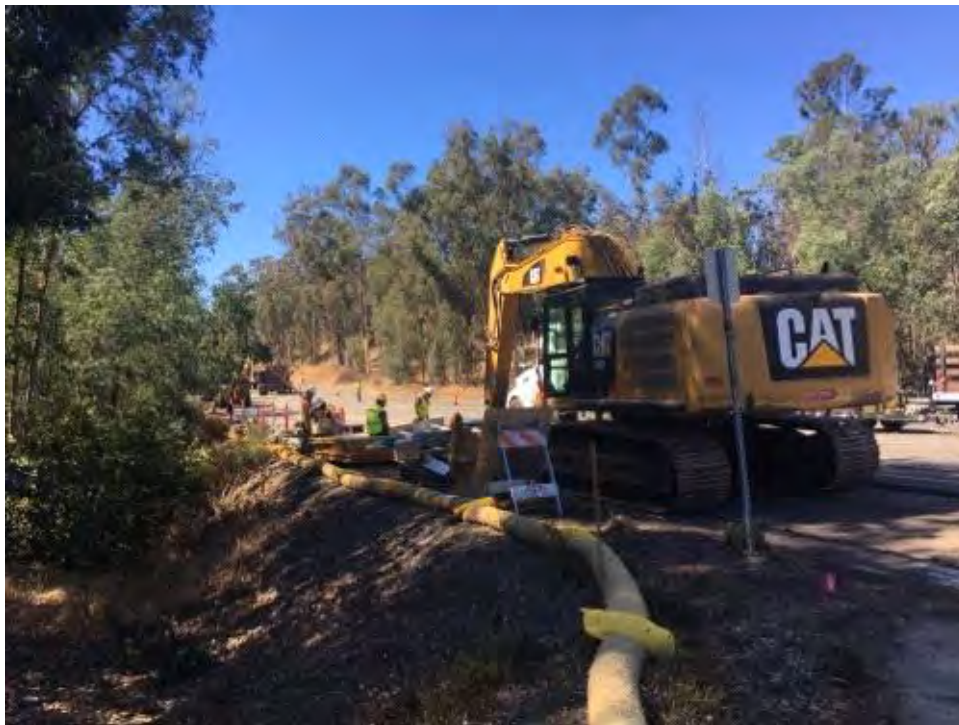
Caption Monitors, BMPs and fire safety personnel onsite at excavation on Pomerado Road.

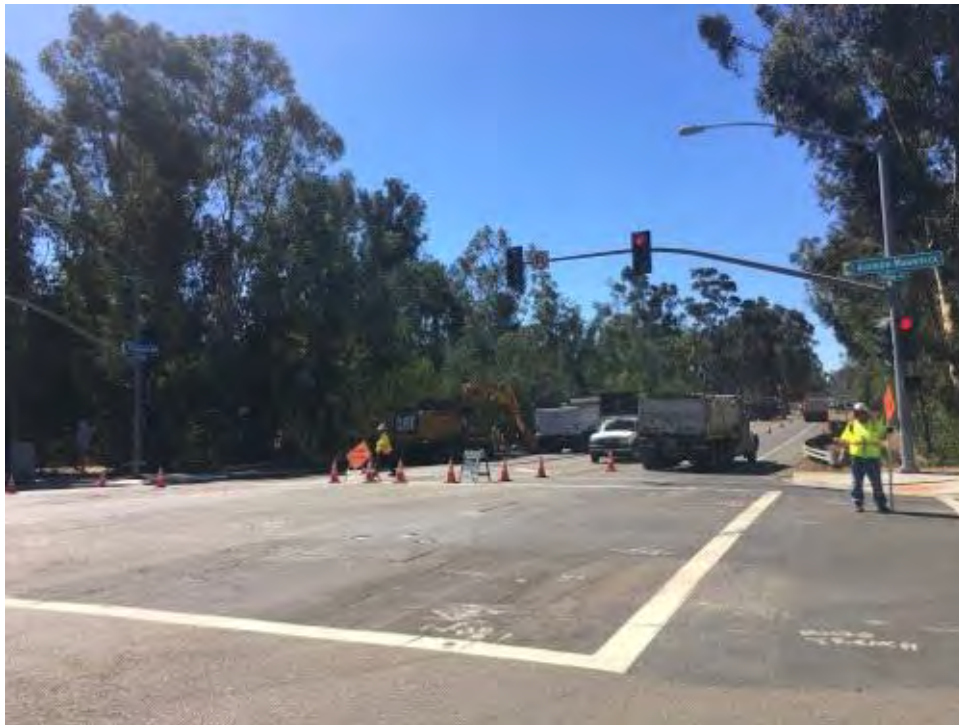
Caption Excavation on Pomerado Road, monitors onsite.

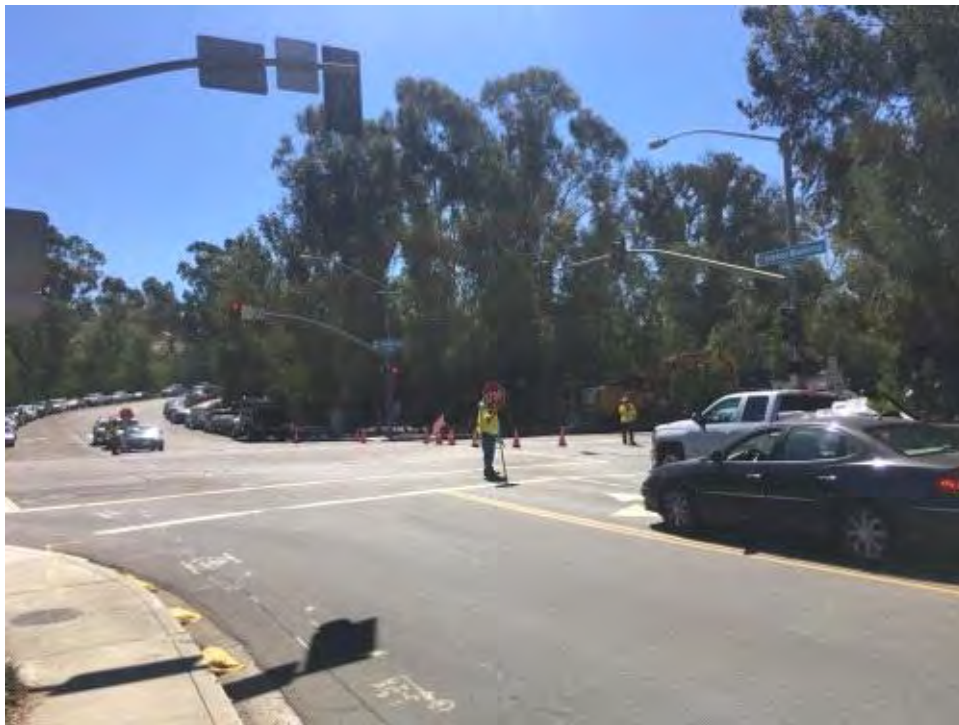
Caption Traffic control at Pomerado Road and Avenida Magnifica.

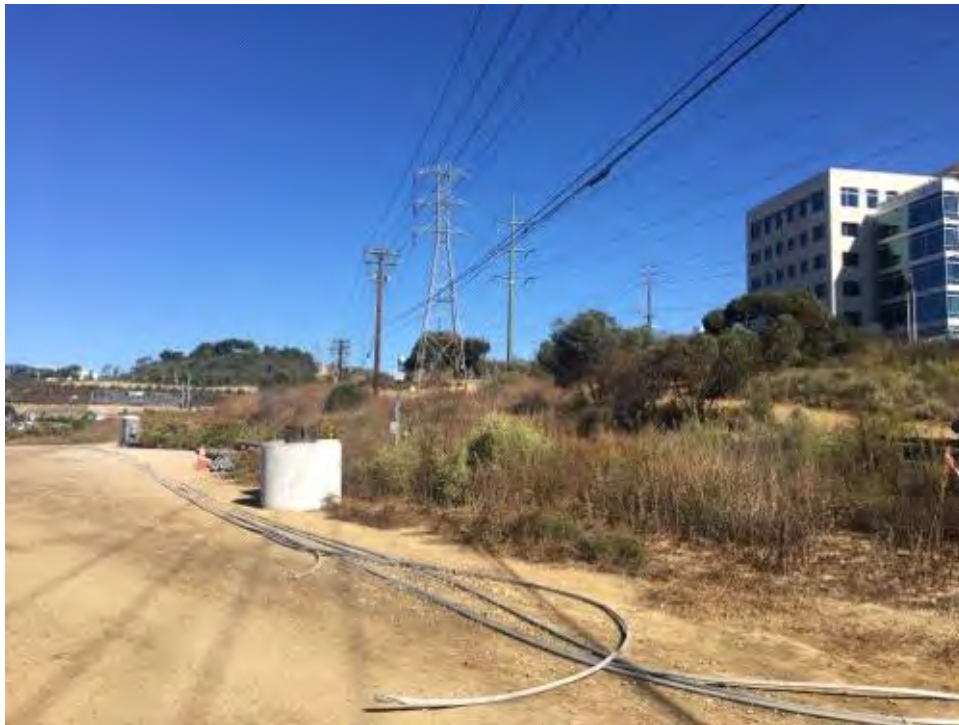
Caption No wire work north of CC MM CP.

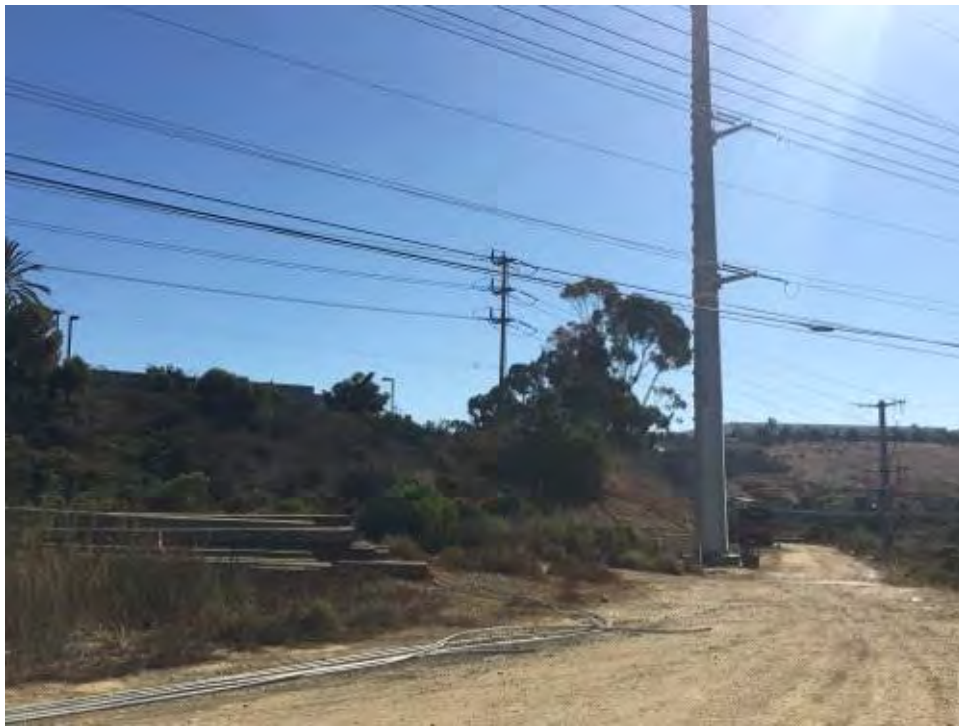
Caption CC MM CP pole site, no active work.

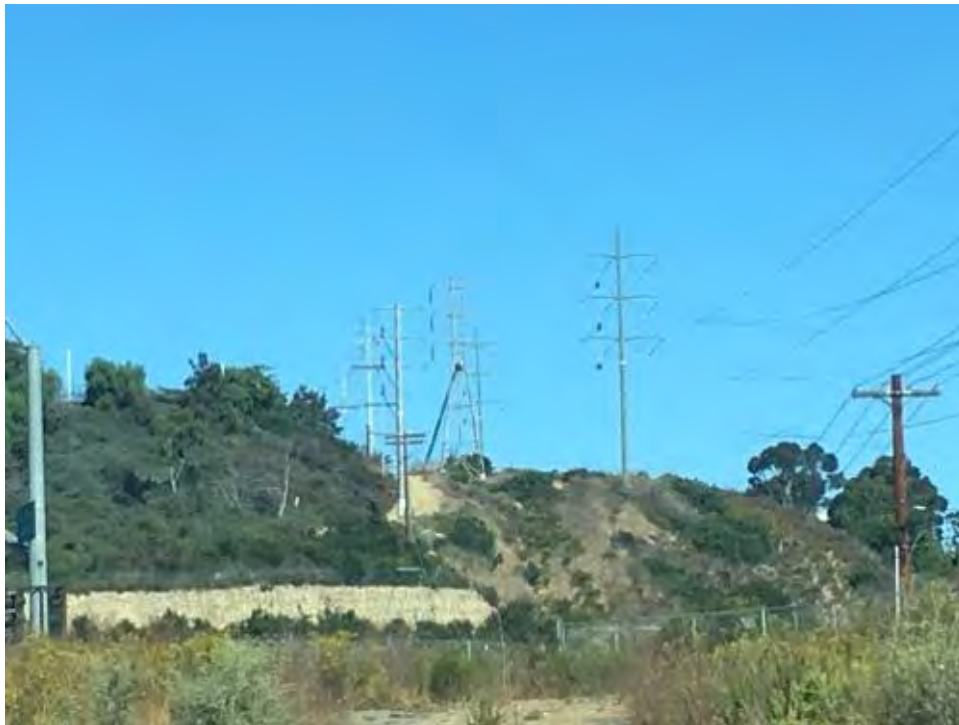
Caption Wire work north of Penasquitos substation.
