PROJECT MEMORANDUM SYCAMORE-PEÑASQUITOS 230-KV TRANSMISSION LINE PROJECT

Date: March 09, 2018
To: Billie Blanchard, CPUC Project Manager
From: Sheila Hoyer, CPUC Monitoring Supervisor
Subject: Weekly Report #61 – February 26 to March 3, 2018

SDG&E Sycamore-Peñasquitos 230-kV Transmission Line Project: Daily Inspection Report

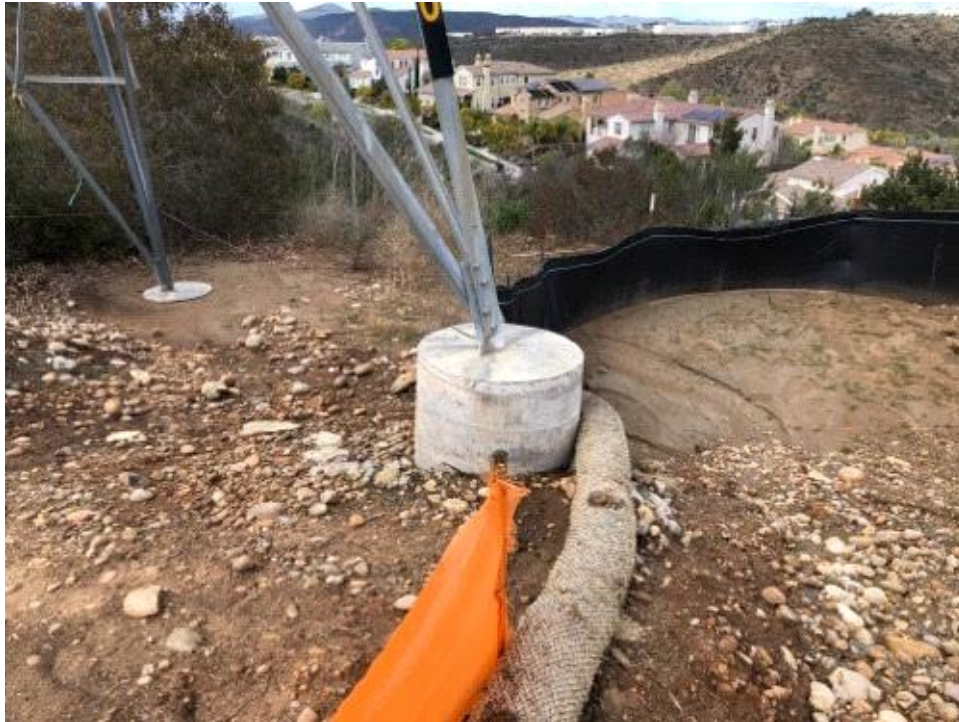
Caption BMPs just north of P05 adjacent to existing tower.

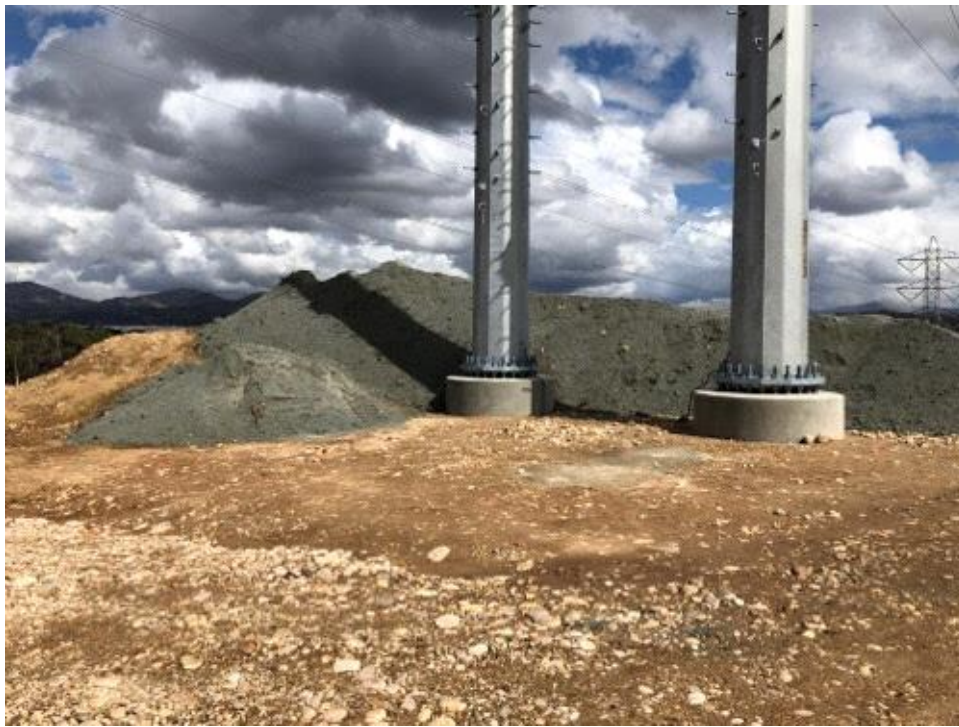
Caption Stockpiles uncovered at P06.

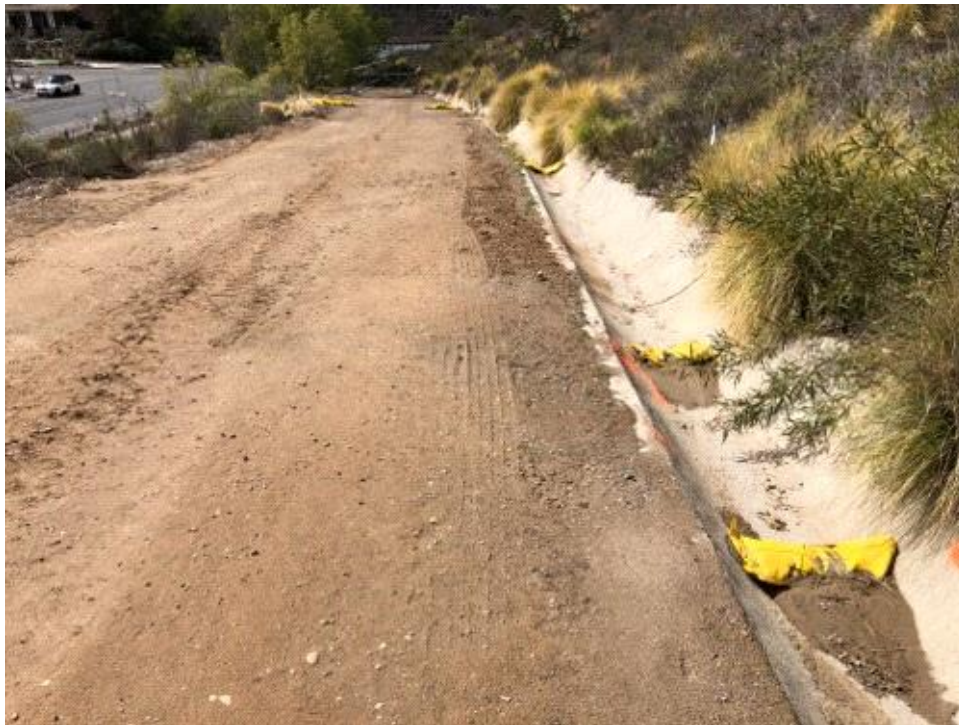
Caption Sand bags catching sediment on access road to P05.

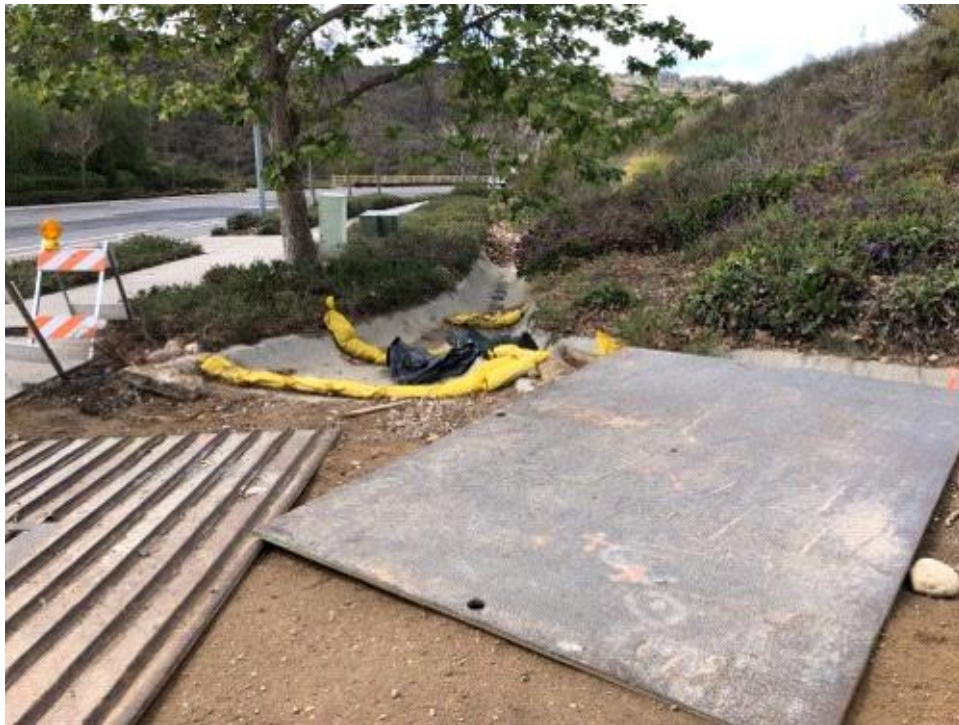
Caption BMPs at entrance to P05.

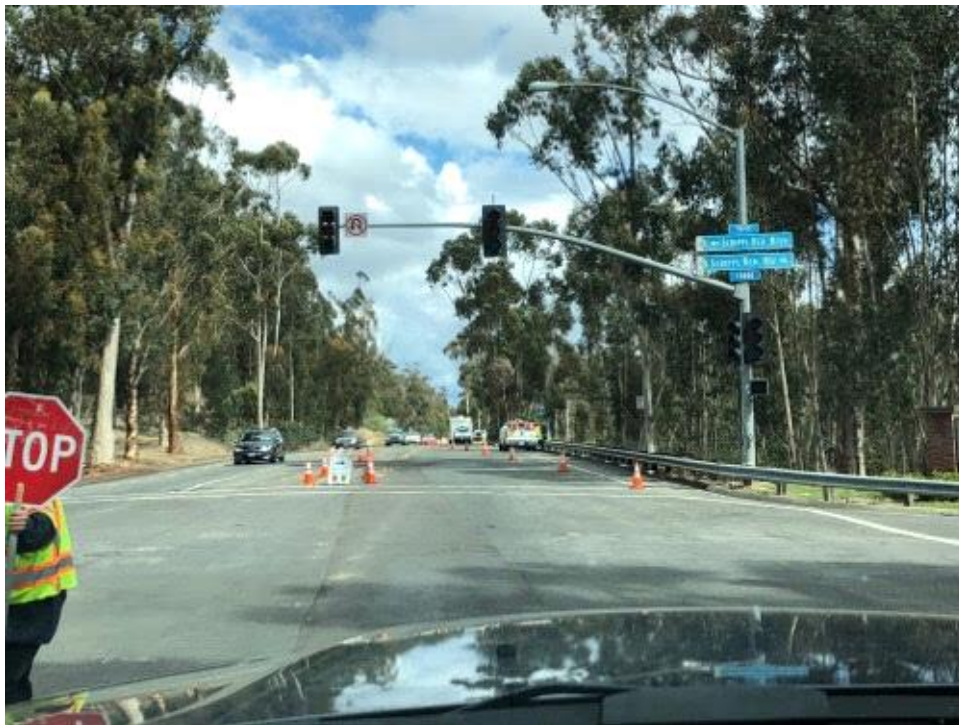
Caption Vault work and traffic control on Pomerado Road.

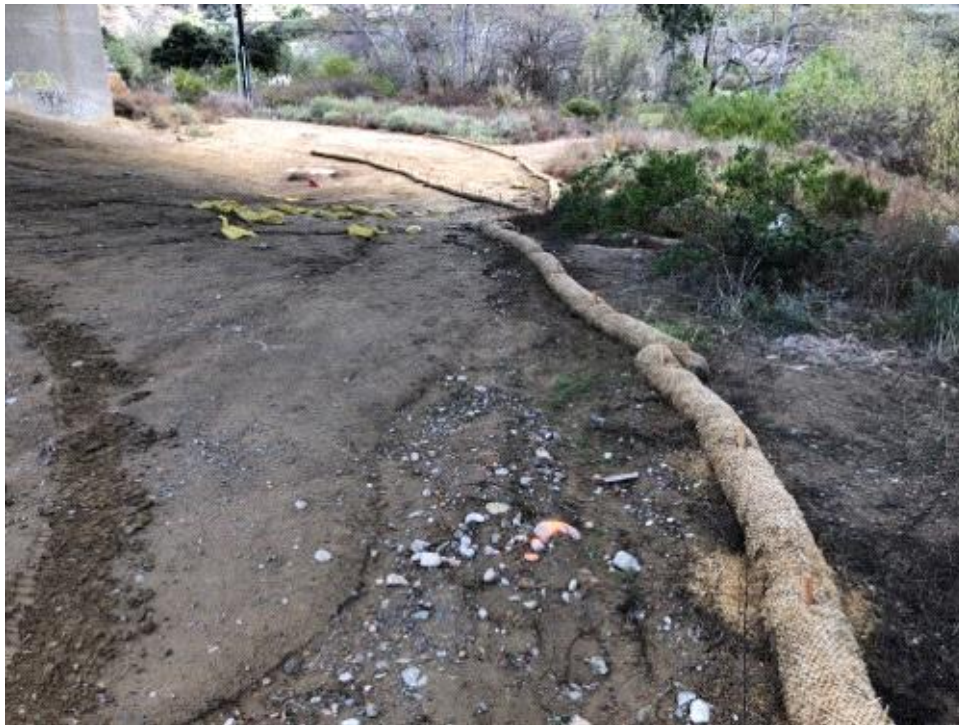
Caption Erosion along fiber roll at CC MM CP.

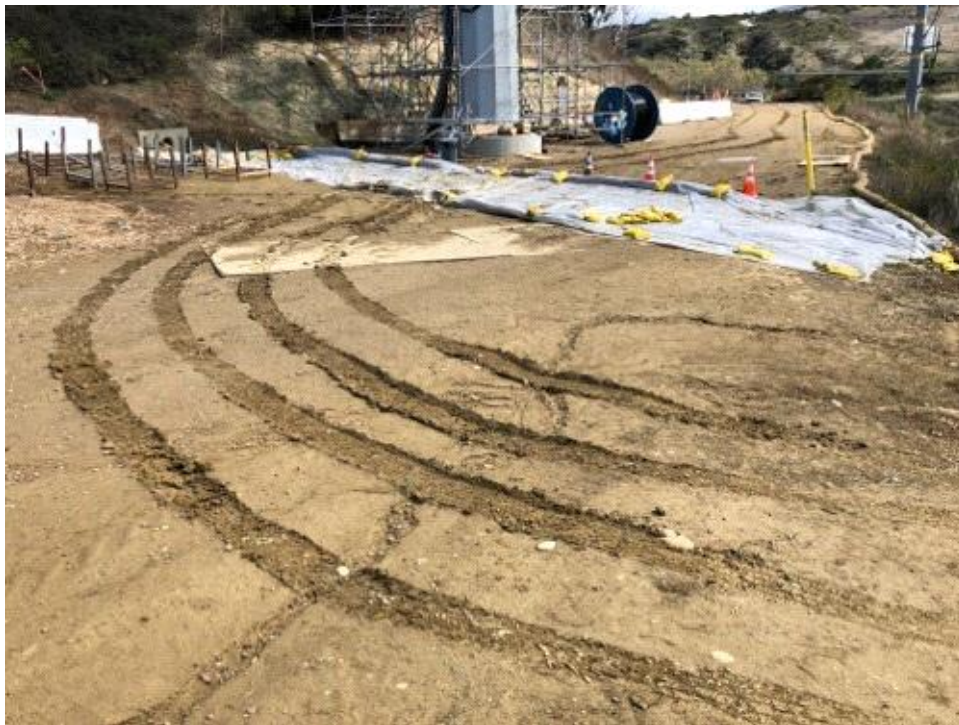
Caption Vehicles tracks at CC MM CP.

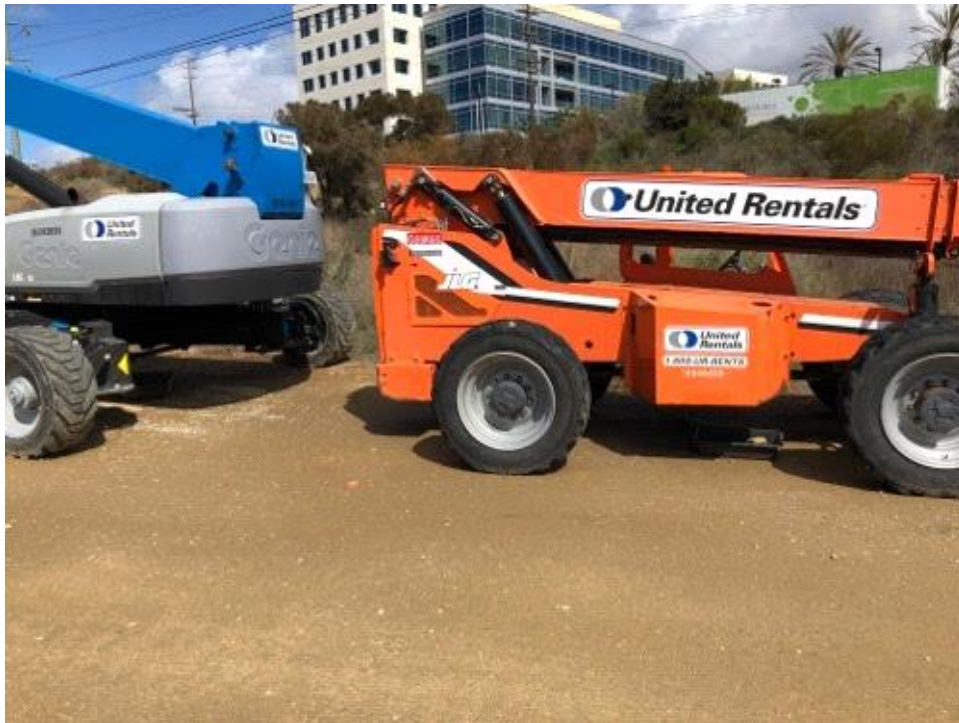
Caption Drip pan present.

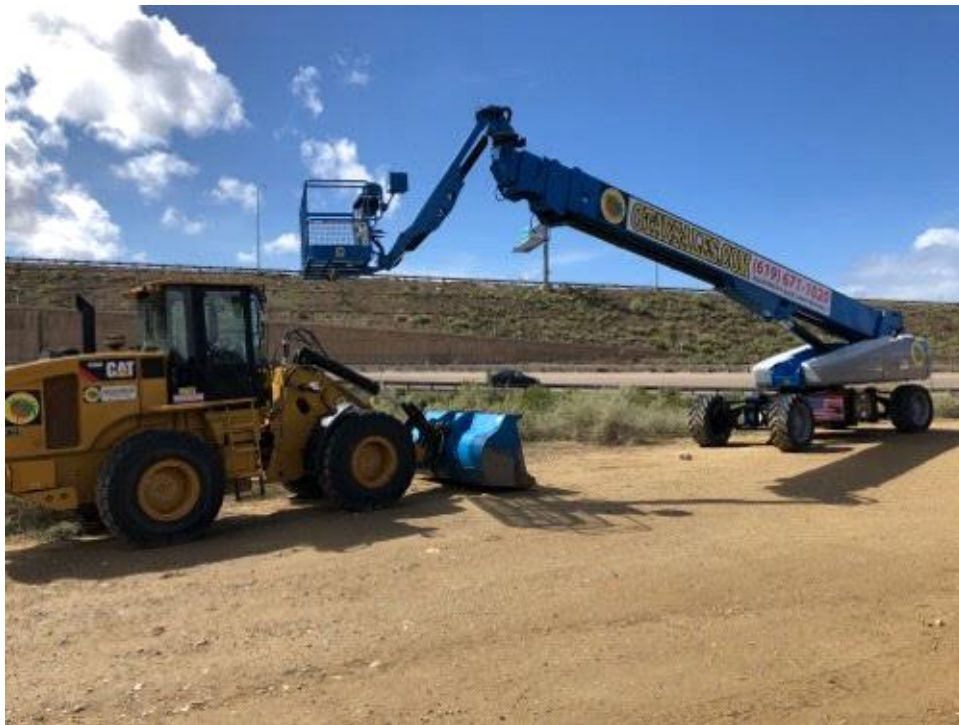
Caption No drip pan on either piece of equipment.

Q6 – Water Features and Aquatic Habitat: Were water features avoided?	Met Requirements
Q7 – Stormwater, Erosion, and Sediment Control: (a) Were erosion and sediment control BMPs in place and functioning properly? (b) Were inactive or completed work areas stabilized and/or restored adequately?	Corrections Required
Q7 Notes	BMPs were installed and maintained throughout the ROW but there was one dirt/crushed rock stockpile uncovered at P06.
Q8 – Invasive Weed Control: Were procedures to prevent the spread of invasive weeds implemented adequately?	Met Requirements
Q9 – Hazardous Materials and Waste Management: (a) Were hazardous materials stored and labeled properly? (b) Was hazardous material waste disposed of appropriately? (c) Were any spills or leaks addressed adequately? (d) Was solid waste collected and disposed of adequately?	Corrections Required
Q9 Notes	Drip pans were not in place on two vehicles parked within the ROW near CC MM CP. LEI states that the equipment did not belong to SDGE or the contractors but instead was related to adjacent Caltrans work.

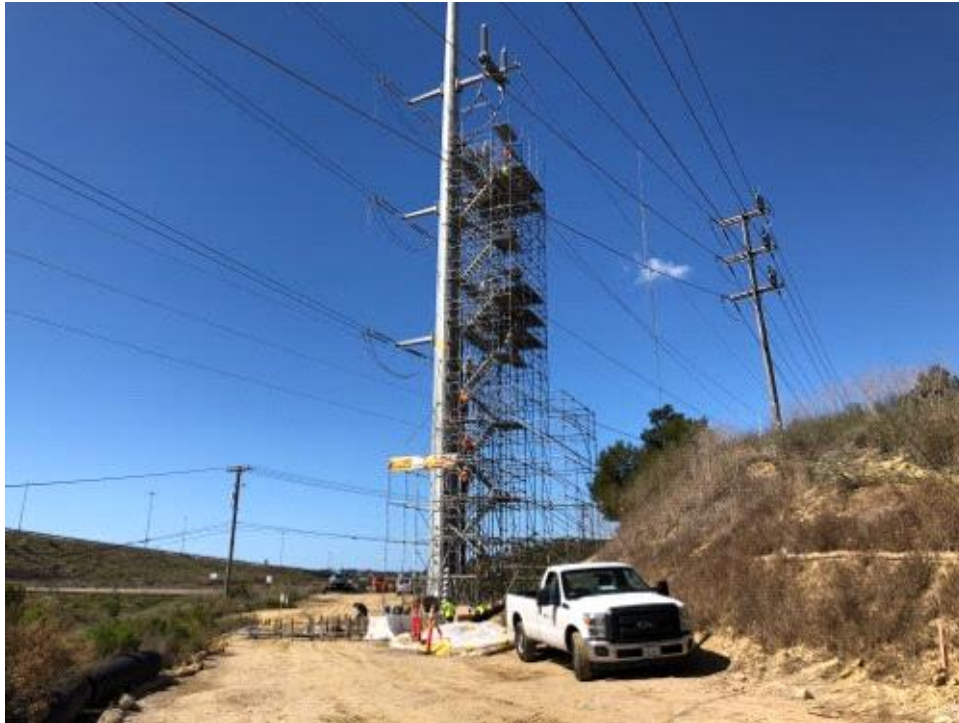
Caption Crew dismantling scaffolding at CC MM CP.

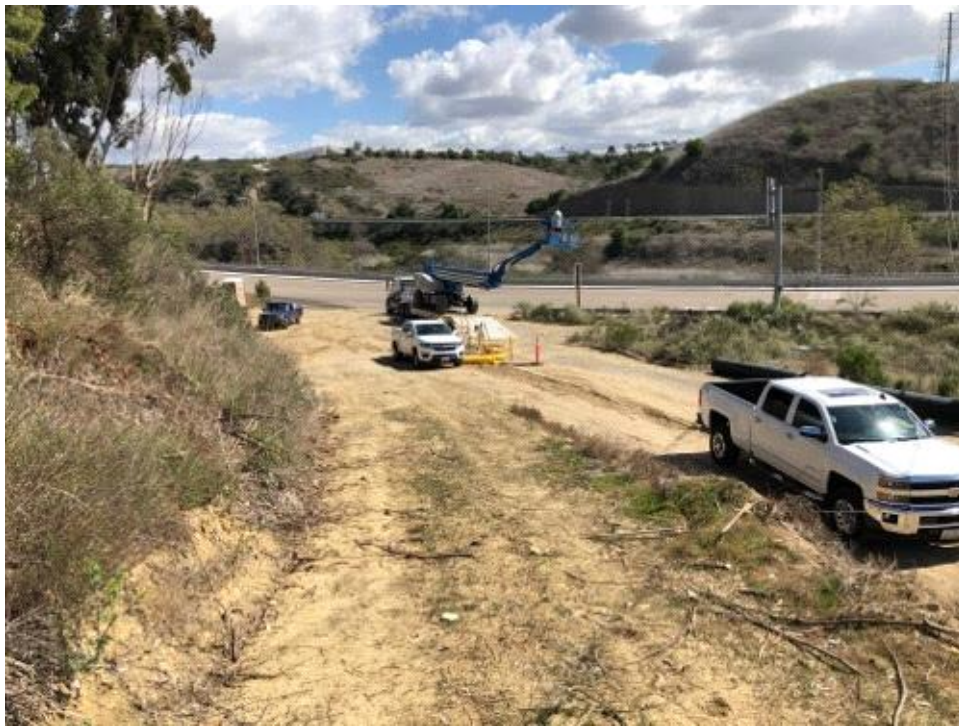
Caption Vault work south of CC MM CP.

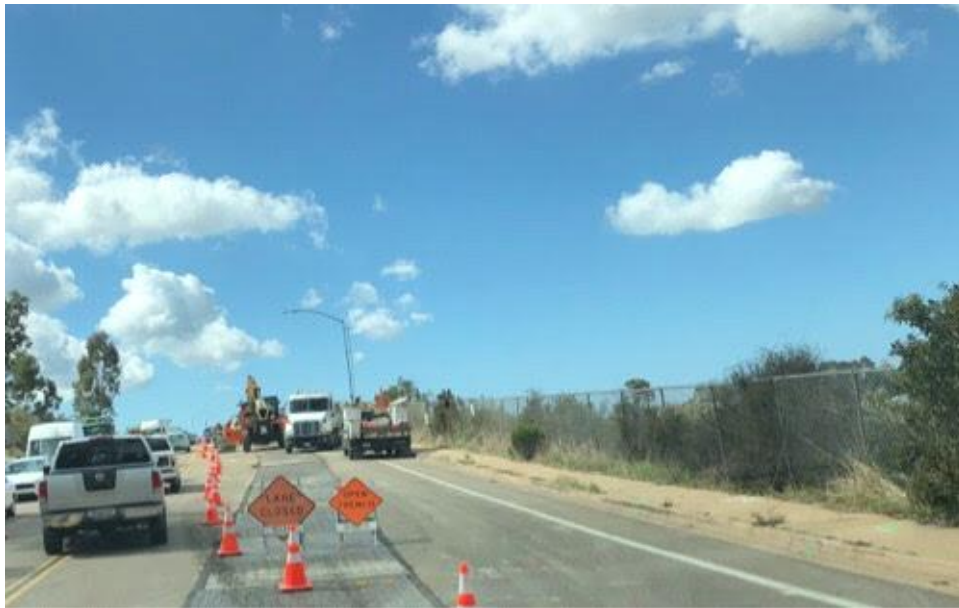
Caption Trench work on Pomerado Road.

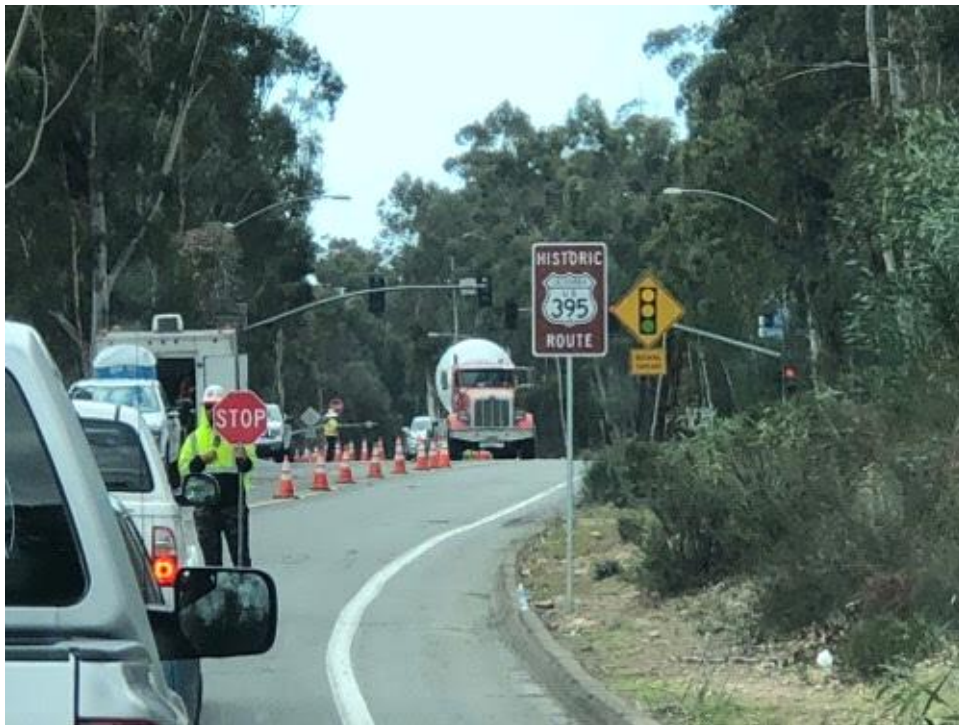
Caption Traffic control and vault work on Pomerado Road.

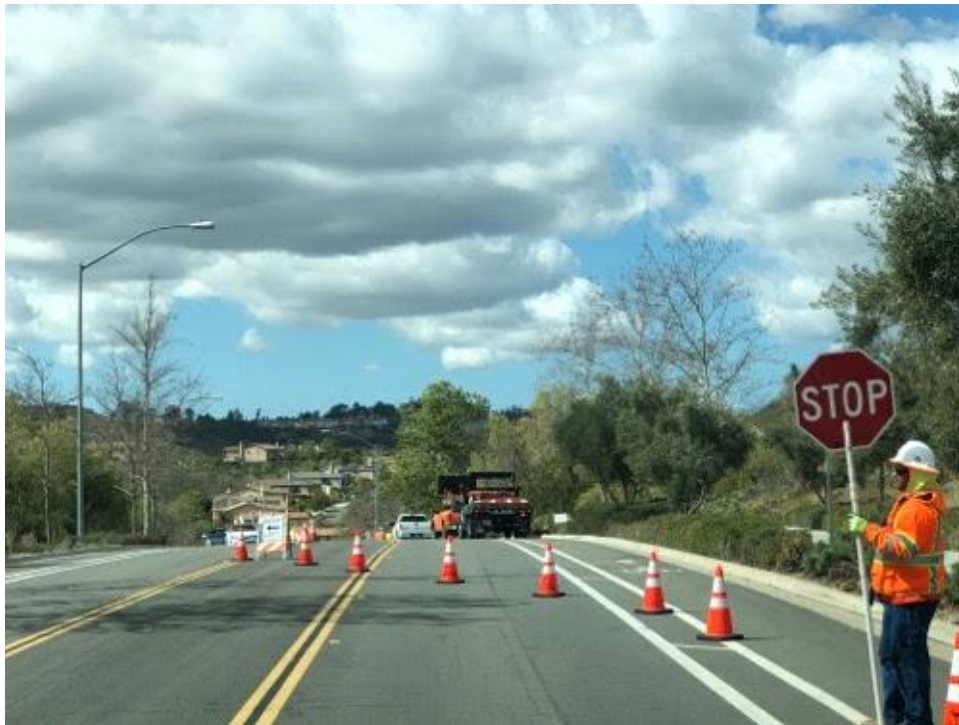
Caption Traffic control on Stonebridge Parkway.
