PROJECT MEMORANDUM SYCAMORE-PEÑASQUITOS 230-KV TRANSMISSION LINE PROJECT

Date: March 23, 2018
To: Billie Blanchard, CPUC Project Manager
From: Sheila Hoyer, CPUC Monitoring Supervisor
Subject: Weekly Report #63 – March 12 to March 17, 2018

SDG&E Sycamore-Peñasquitos 230-kV Transmission Line Project: Daily Inspection Report

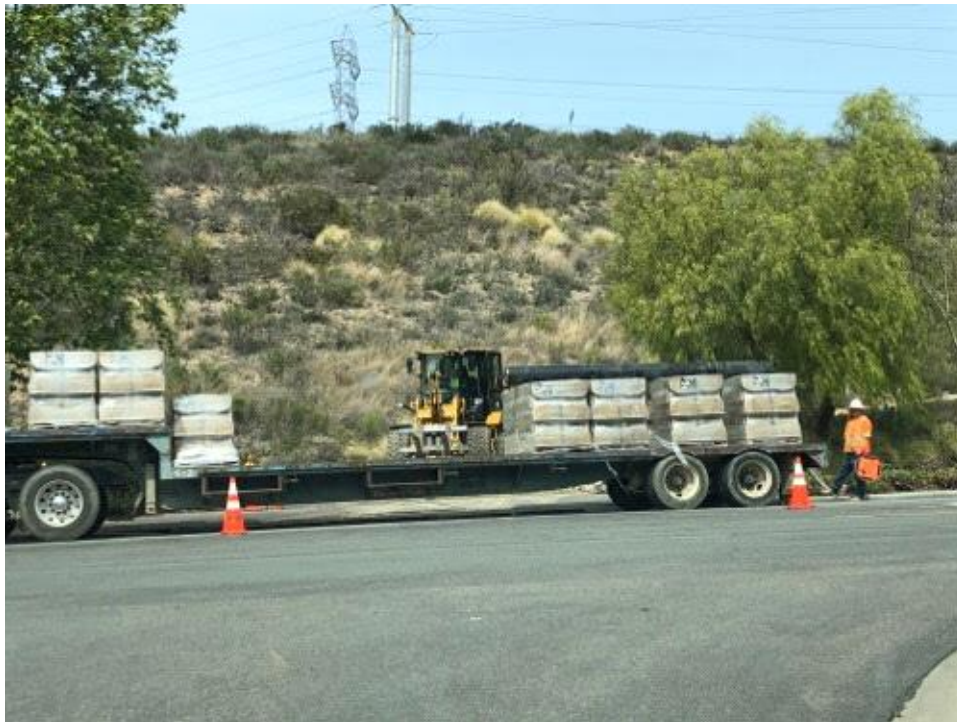
Caption Stone/brick unloading on Stonebridge Parkway for P05.
Photo Attributes Capture Date/Time: Mon Mar 12 2018 13:42:19 GMT-0700 (PDT)
Coordinates: 32.921689, -117.044177
View Direction: North

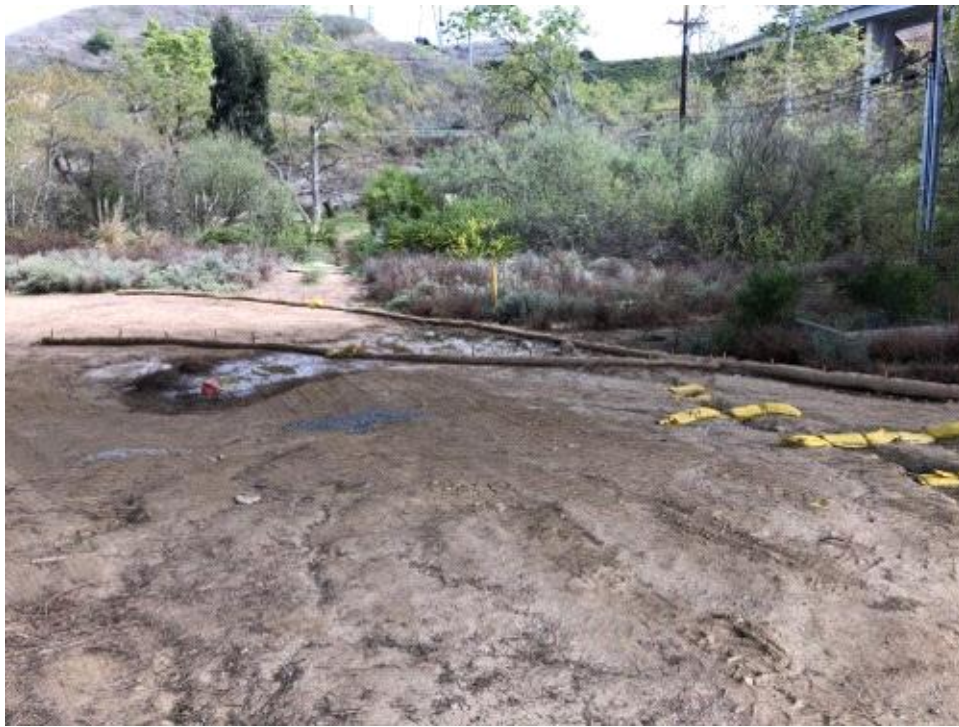
Caption BMPs beneath Carroll Canyon Bridge.

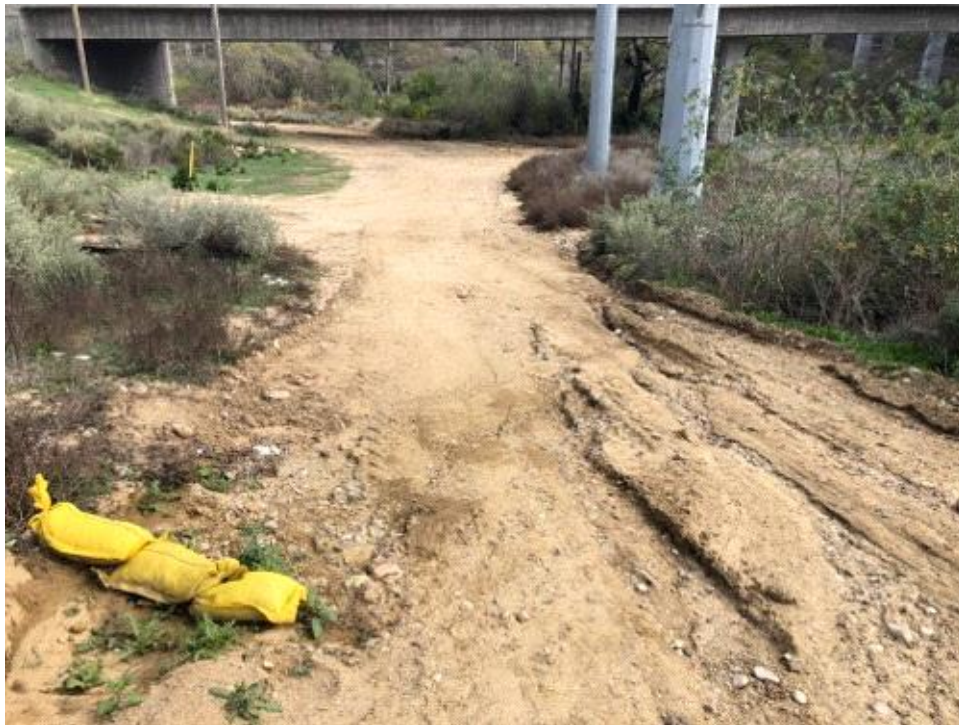
Caption Water rilling on road west of CC MM CP.

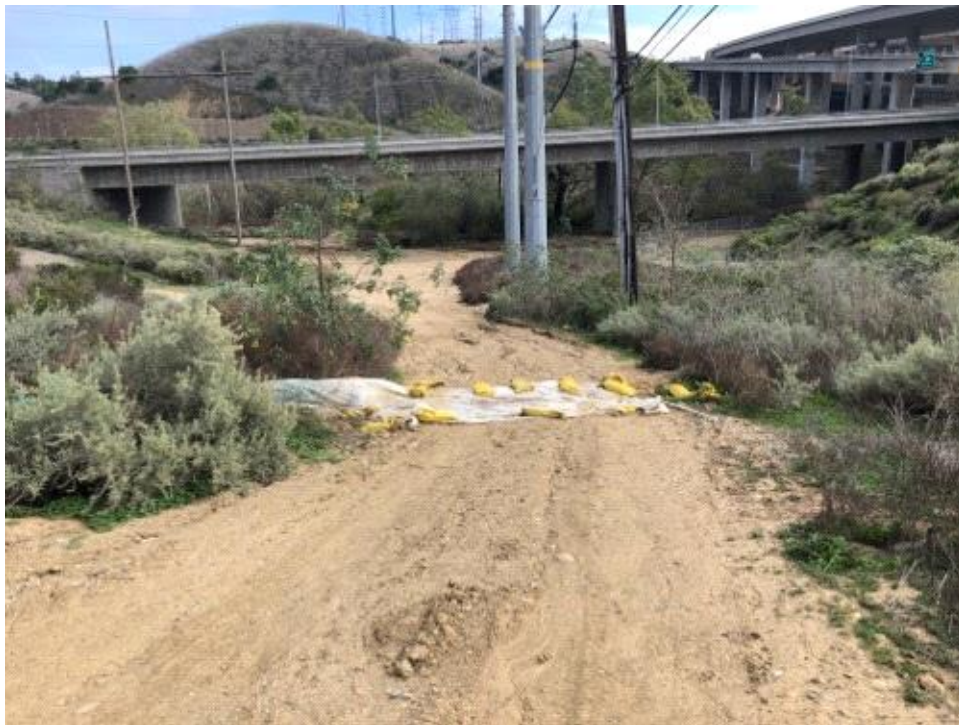
Caption Water berm/bar on road west of CC MM CP.

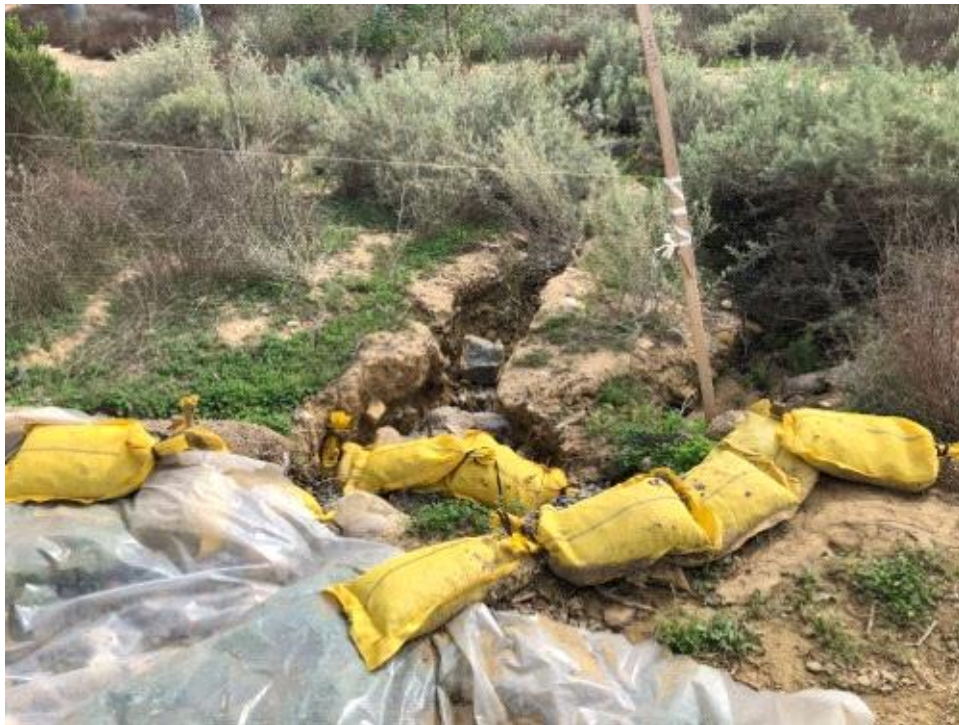
Caption Incised channel west of culvert outlet CC MM CP.

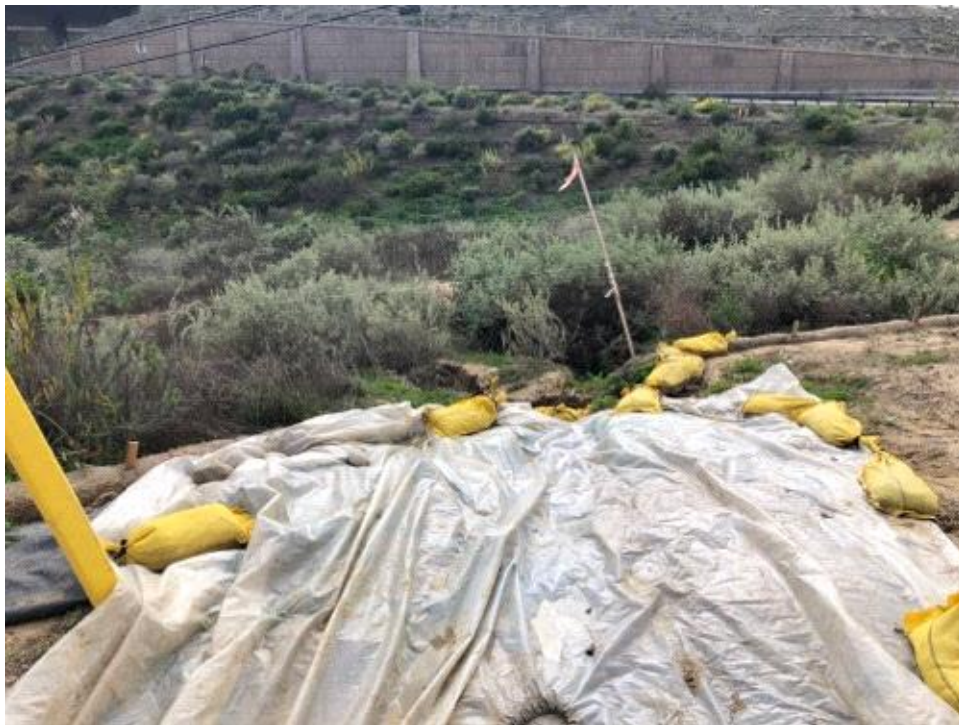
Caption Outlet to habitat west of access road.

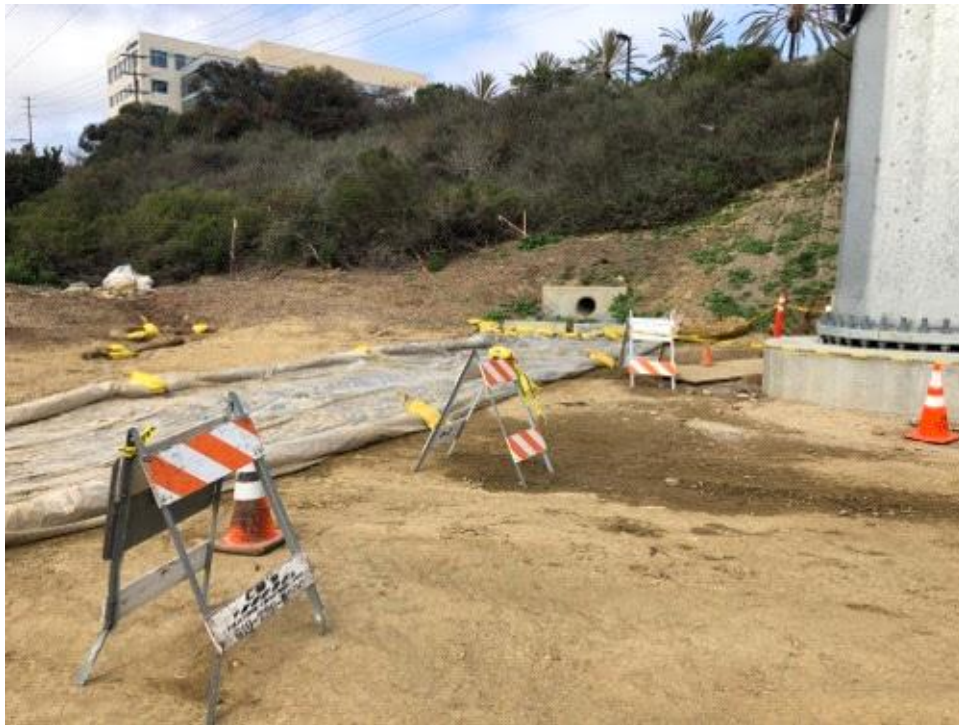
Caption Culvert outlet at CC MM CP.

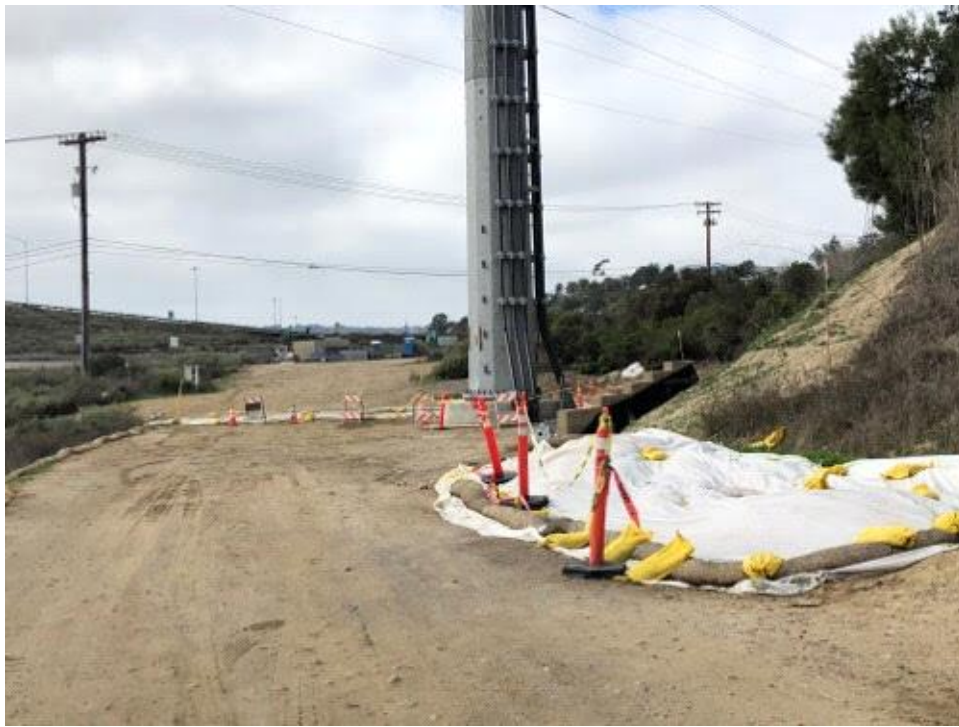
Caption CC MM CP BMPs.

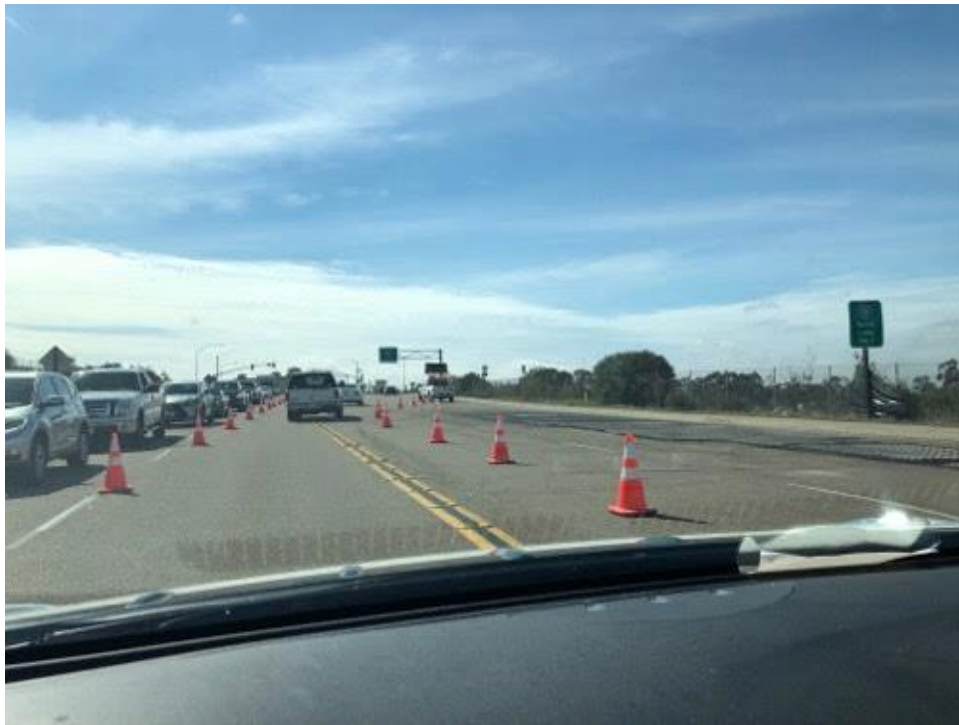
Caption Traffic control just east of I-15 on Pomerado Road.

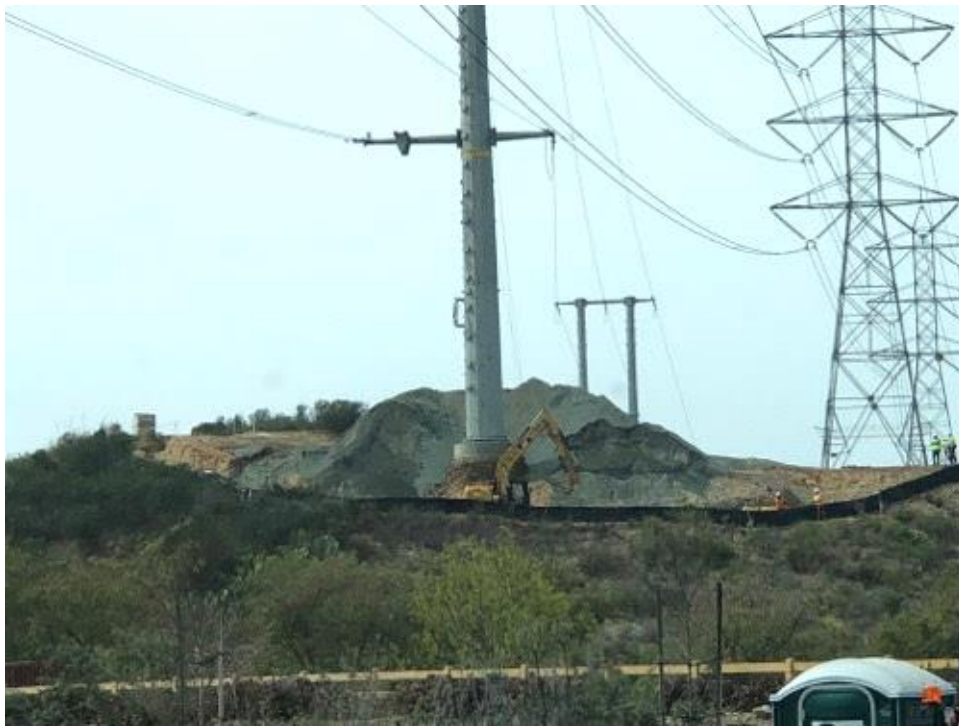
Caption P05 work area overview.

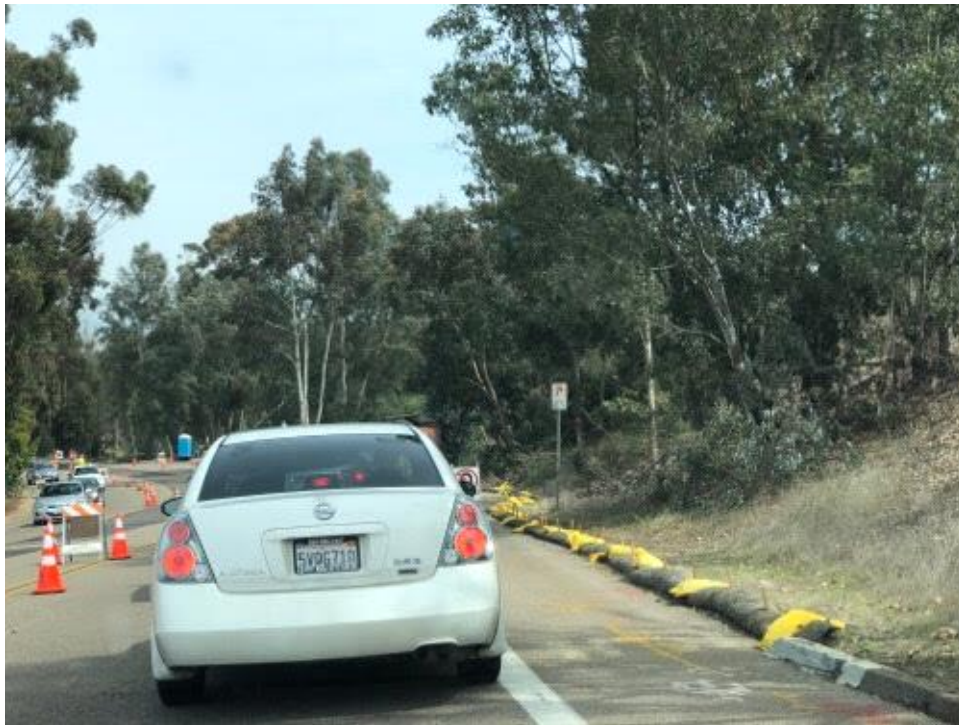
Caption Pomerado Road traffic control and BMPs.

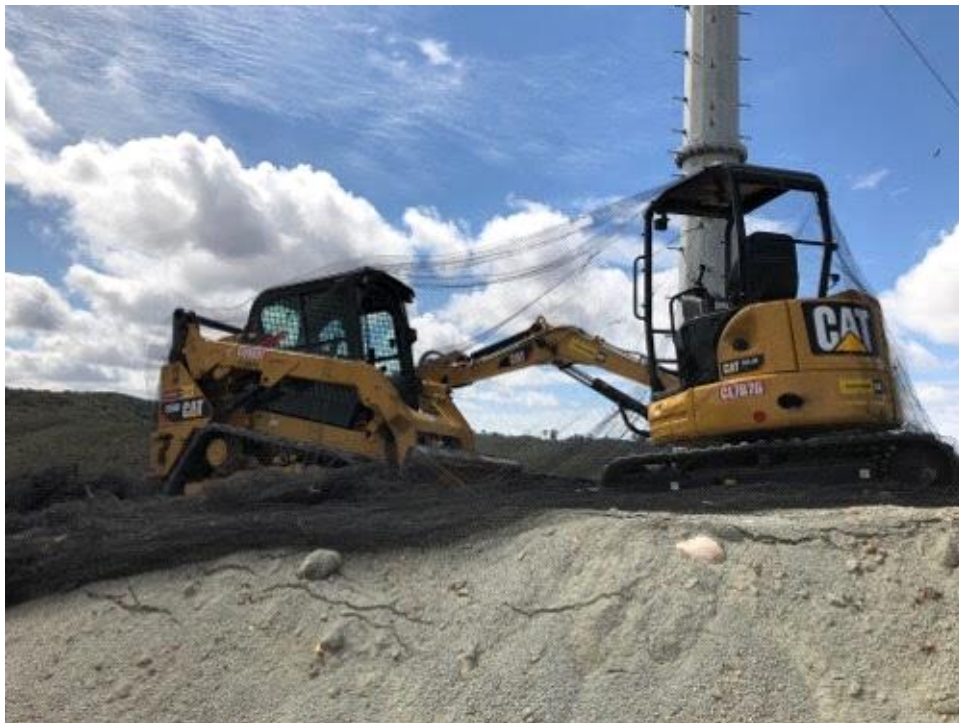
Caption Equipment at P06 with netting to prevent birds from nesting.

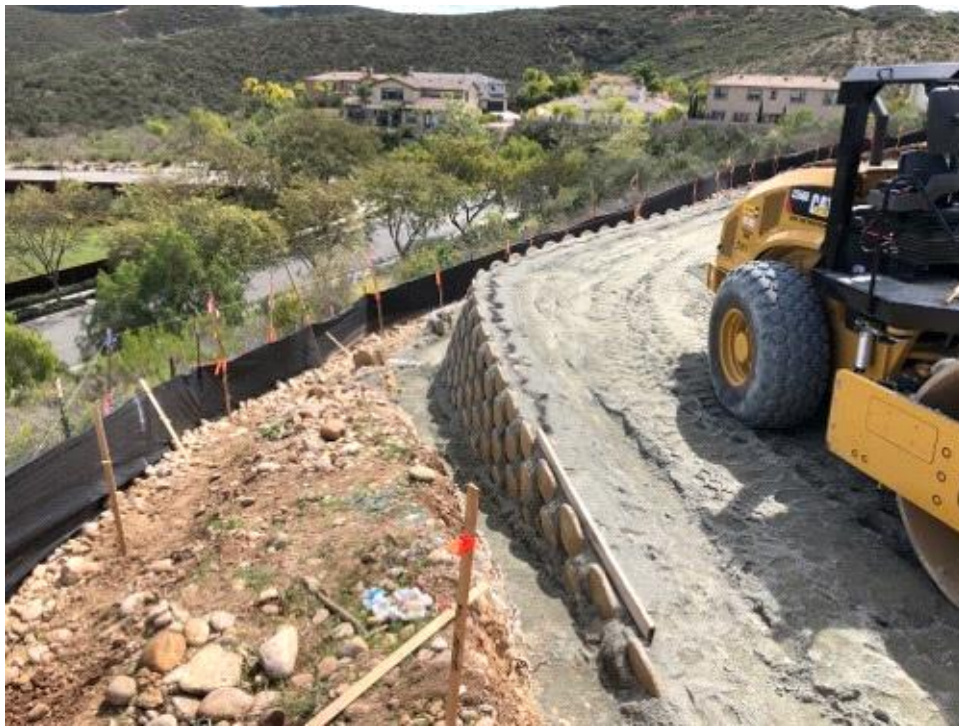
Caption Retaining Wall at P05.

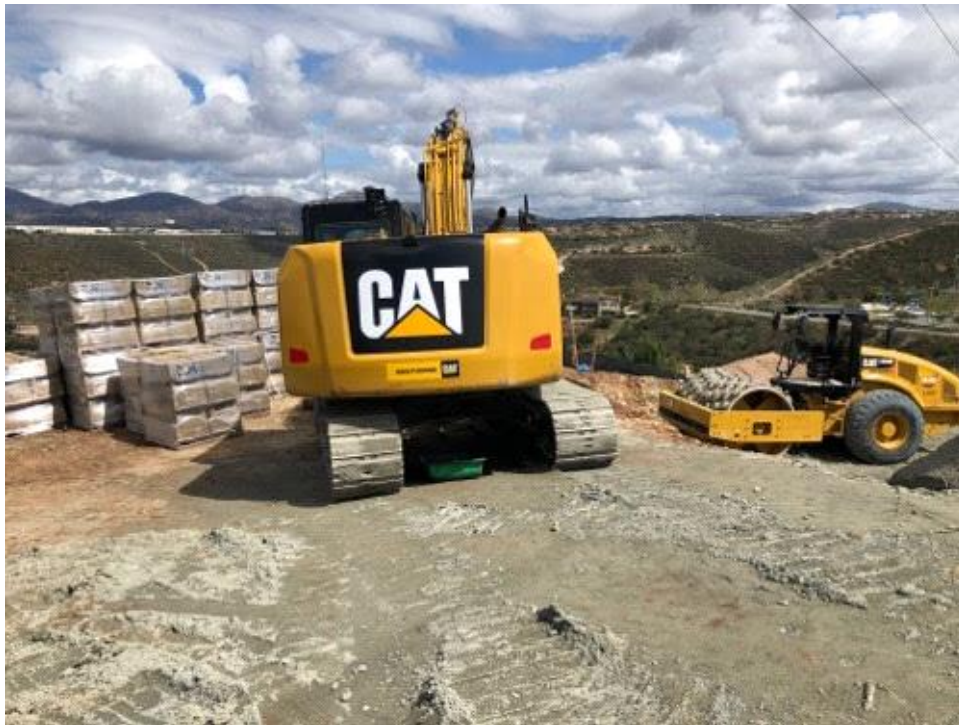
Caption Excavator with drip pan.

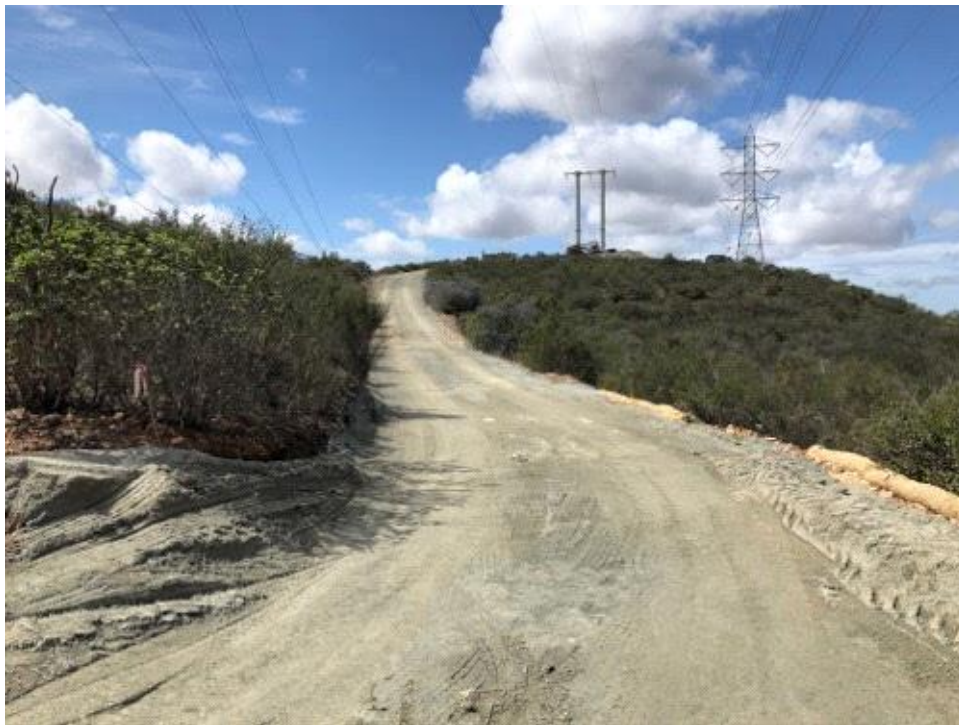
Caption Access Road to P06.

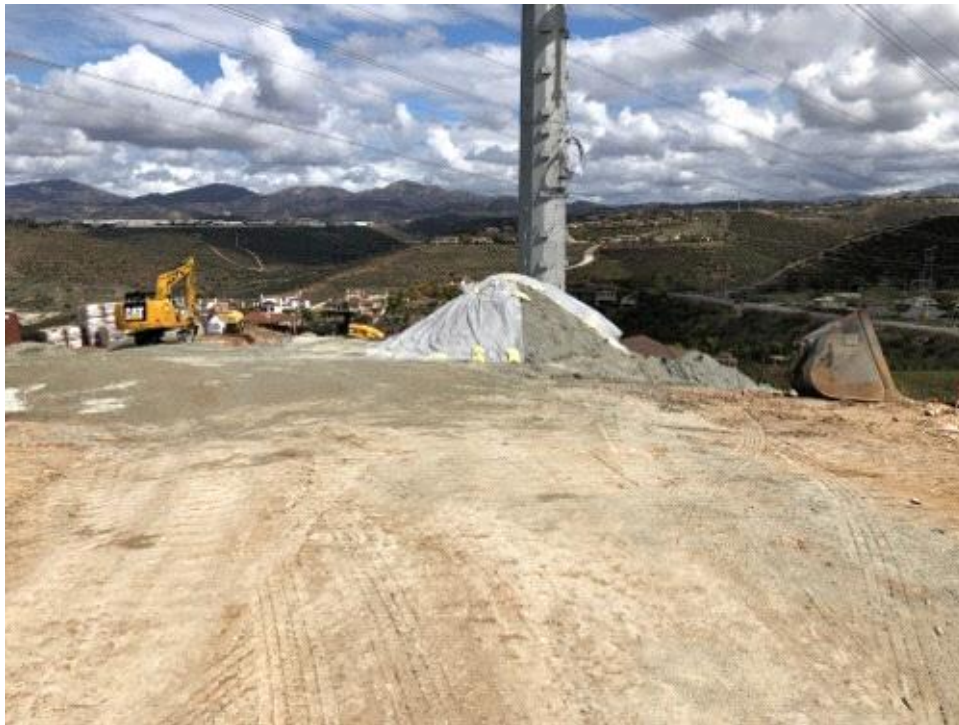
Caption P05 work area.

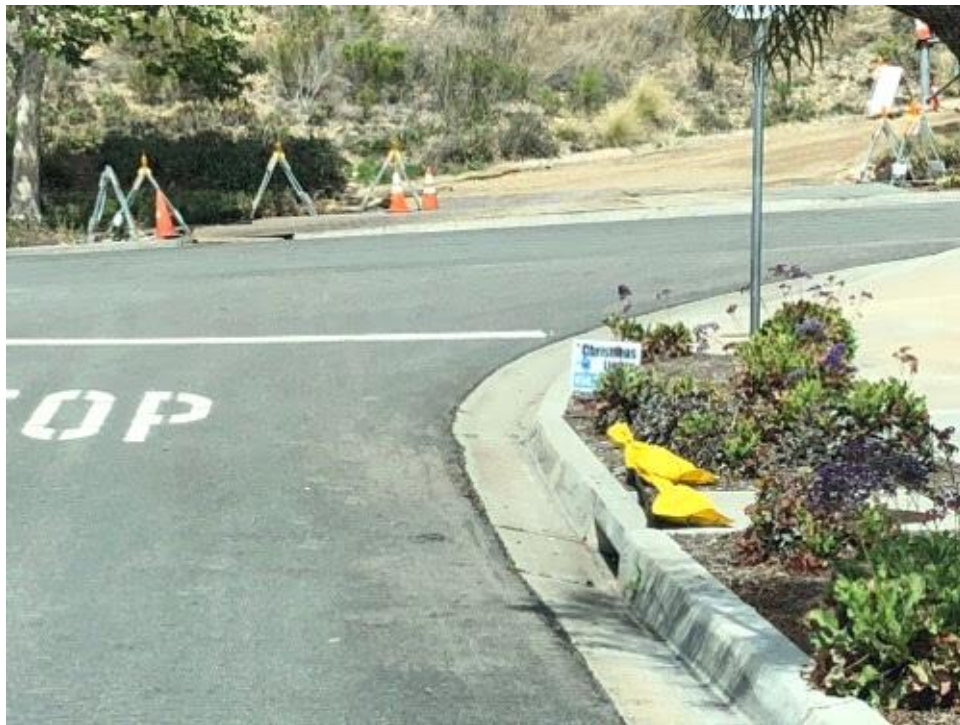
Caption BMPs pulled away from storm inlet to allow normal water flow during storm event.

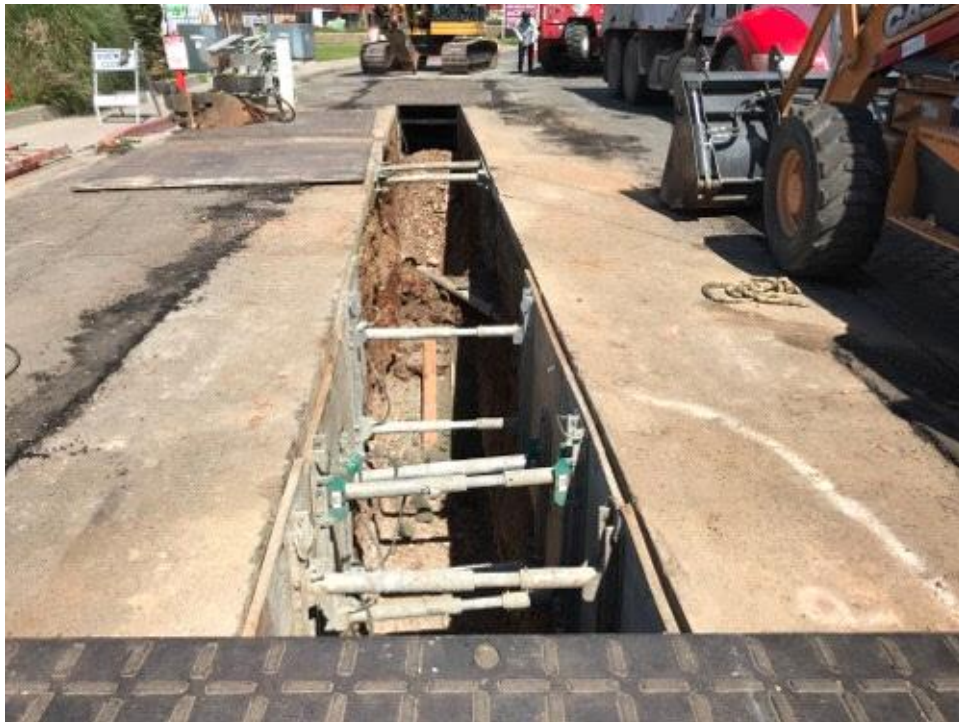
Caption Kearney Mesa Road trench being excavated with vacuum truck due to existing electric utility.

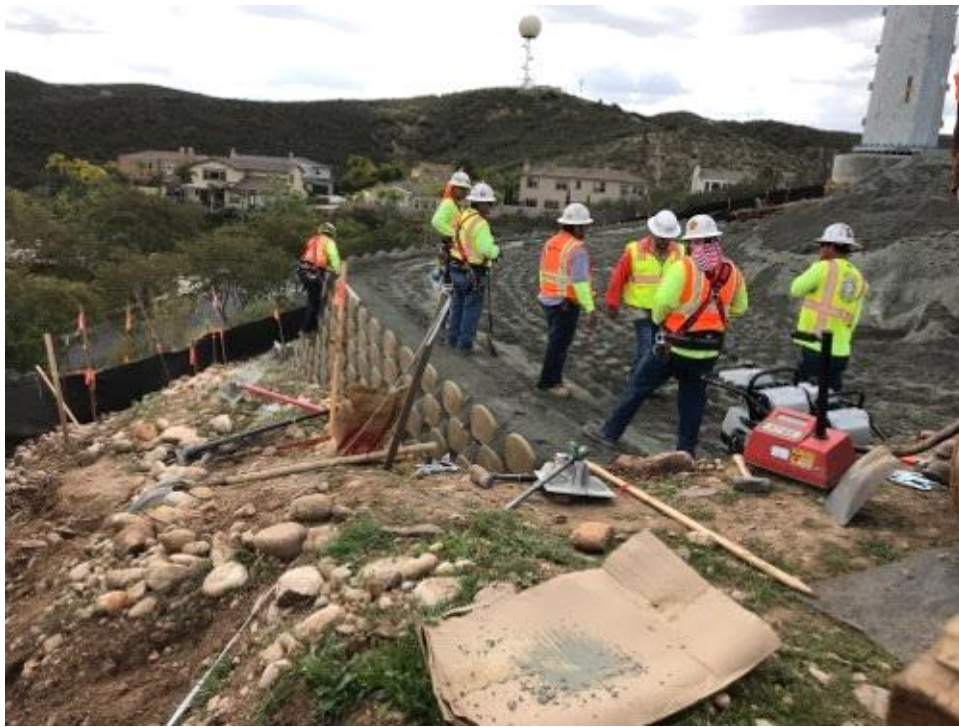
Caption Installing Verdura block retaining wall at P05.

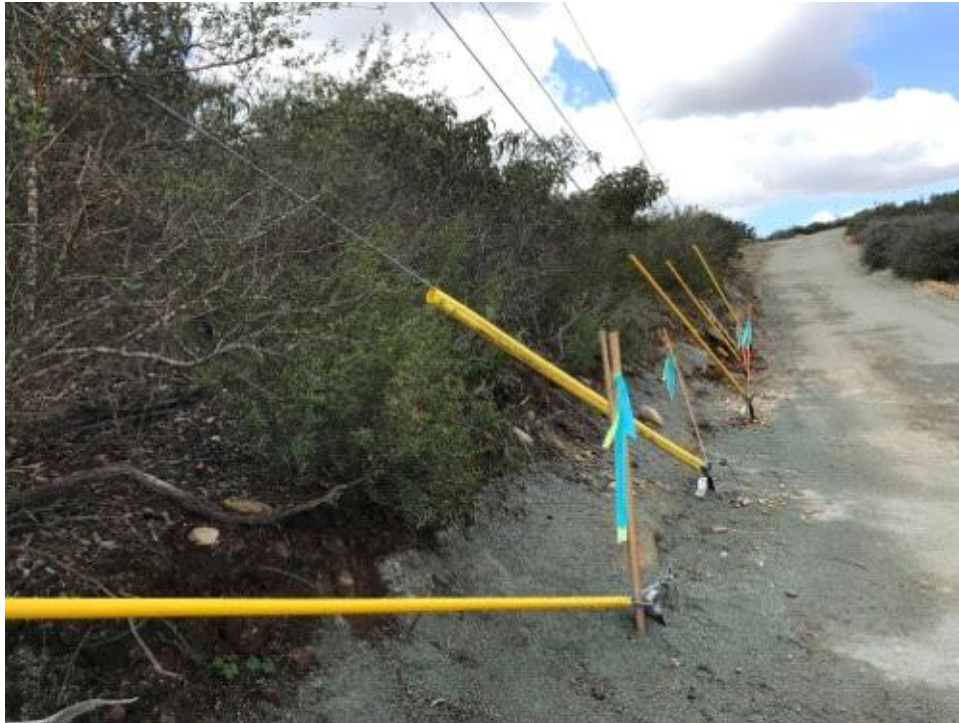
Caption Anchor wires for P05.

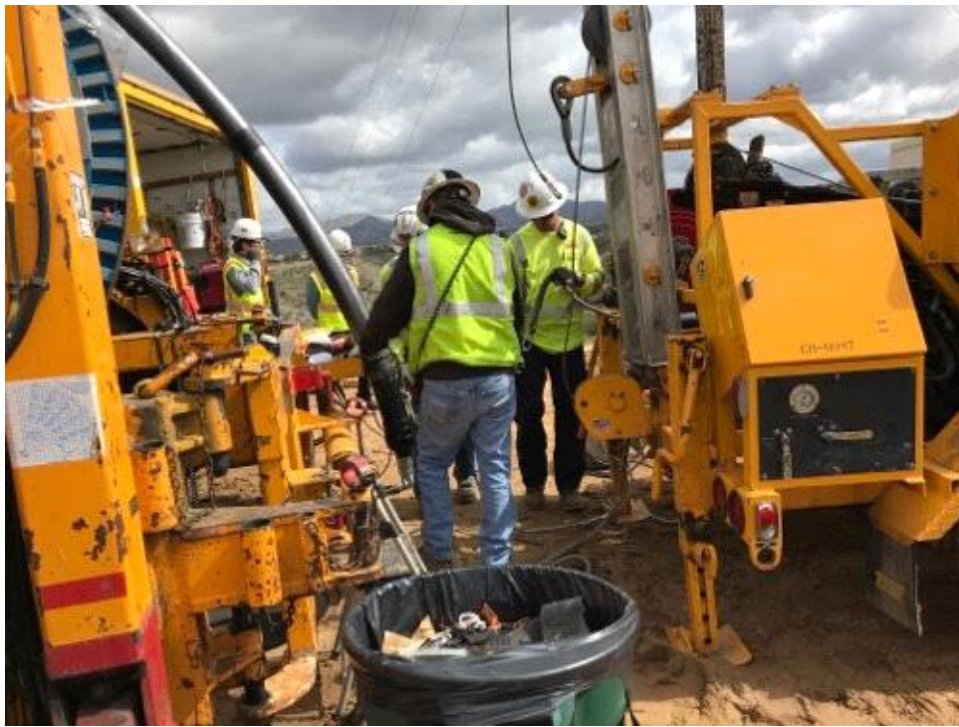
Crew getting ready to pull the cable in the vault at P03.

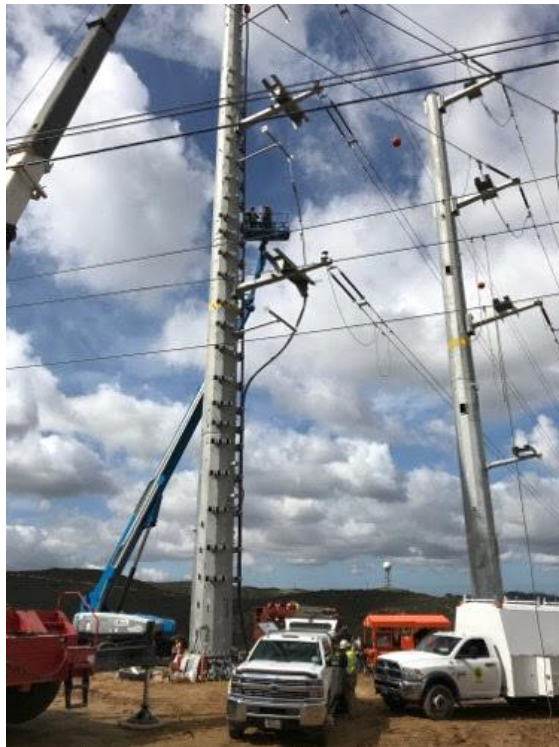
P03 with one line getting positioned for the transformer.

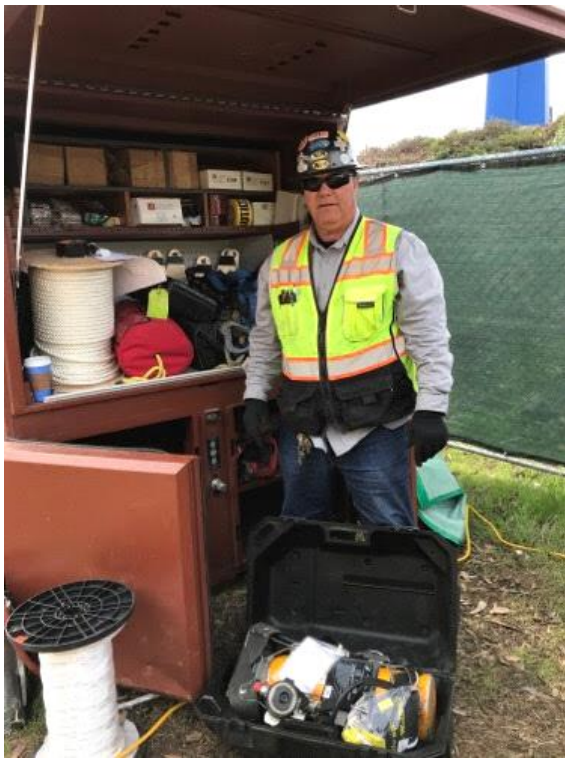
Caption Rescue equipment for bore workers.

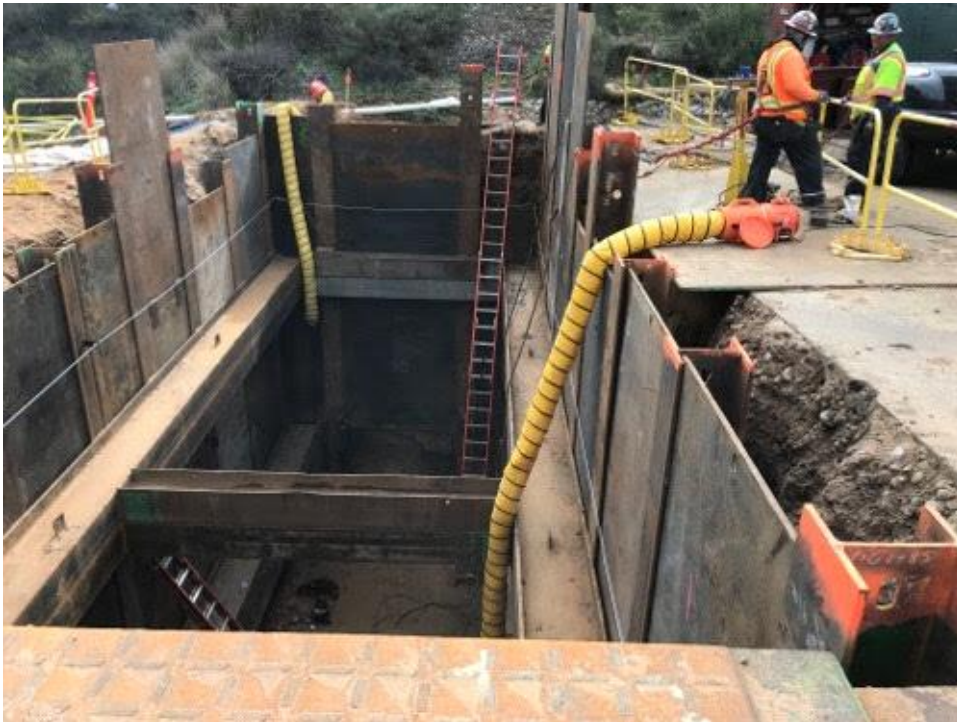
Caption Sending bore pit on west side of I-15.

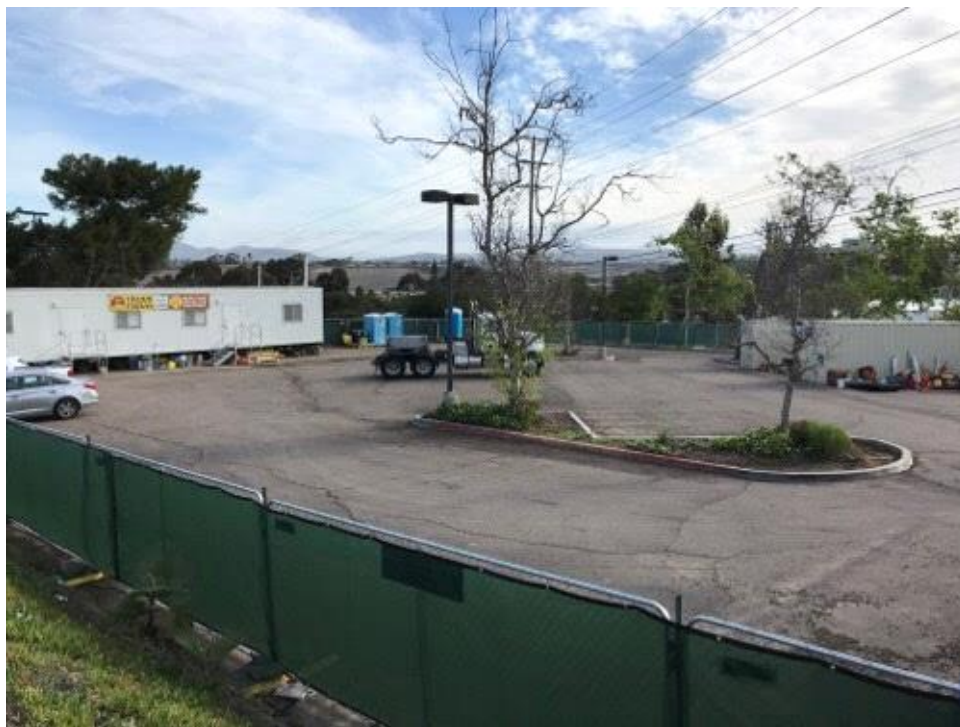
Crestmar staging yard.
