PROJECT MEMORANDUM SYCAMORE-PEÑASQUITOS 230-KV TRANSMISSION LINE PROJECT

Date: April 25, 2018
To: Billie Blanchard, CPUC Project Manager
From: Sheila Hoyer, CPUC Monitoring Supervisor
Subject: Weekly Report #67 – April 9 to April 14, 2018

2018-04-10 AM Inspection Report

SDG&E Sycamore-Peñasquitos 230-kV Transmission Line Project: Daily Inspection Report

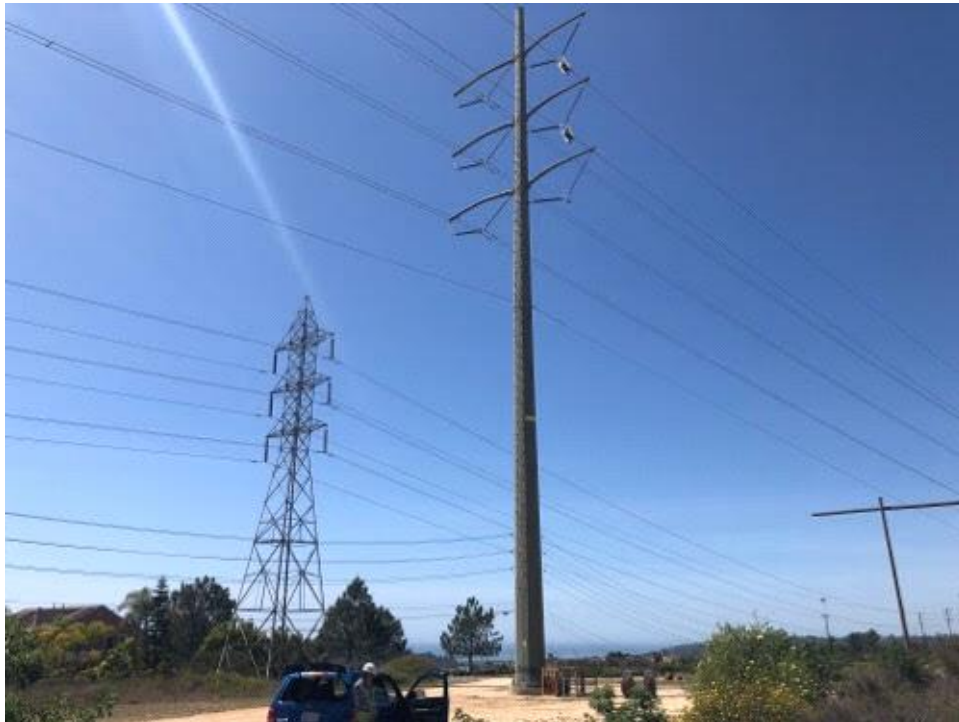
Caption Nest monitor at Pole E40.

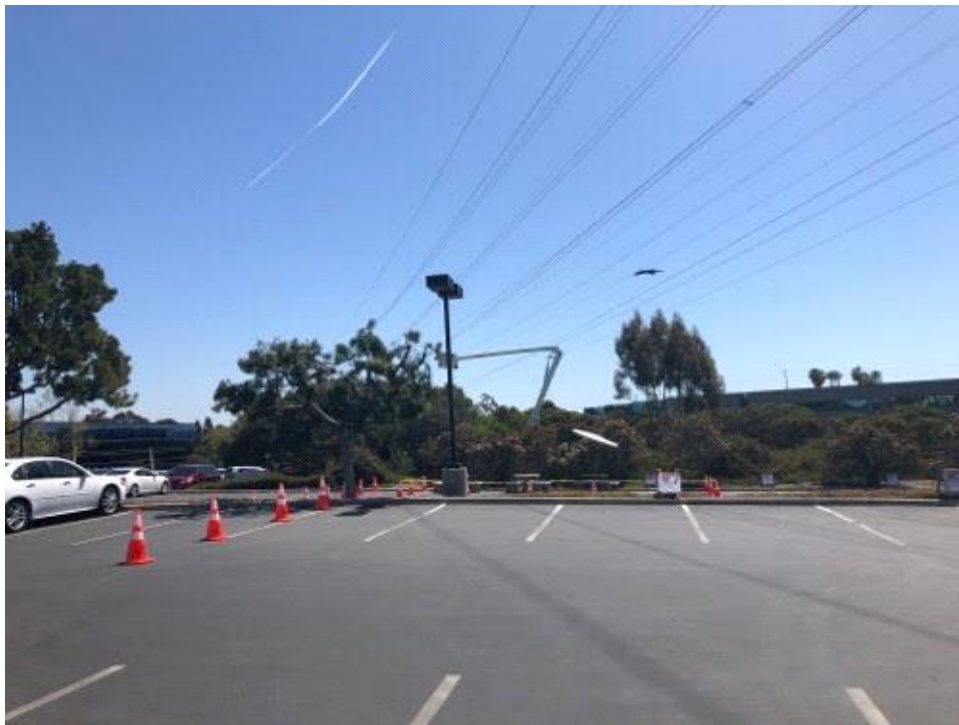
Caption Safety and traffic control measures implemented for overhead work.

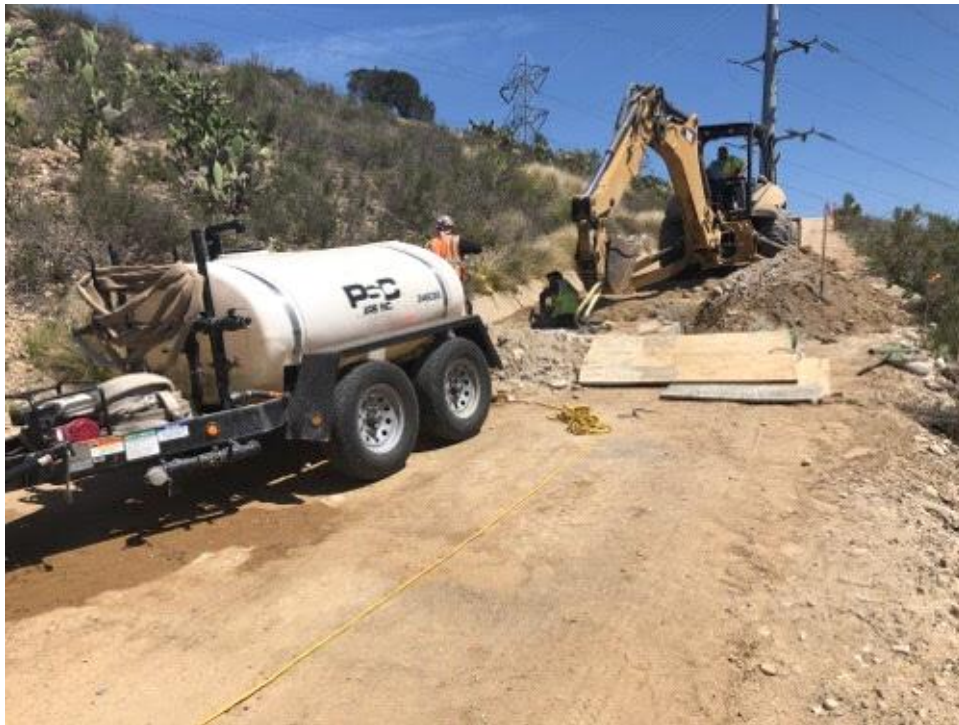
Caption Vault leveling in access road to P05. Note fire equipment on site.

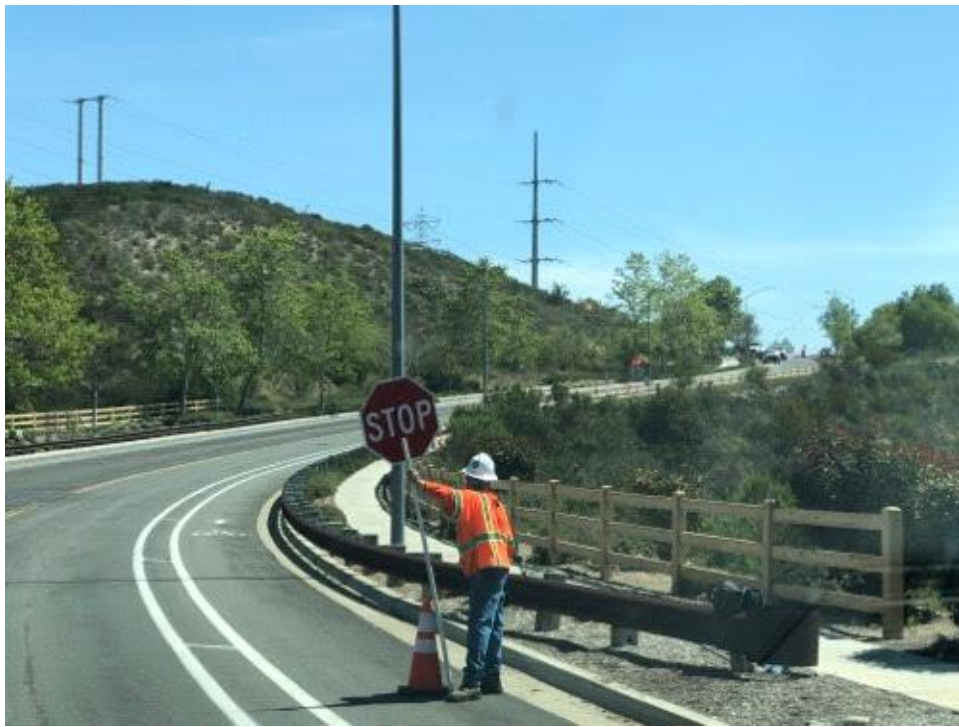
Caption Traffic control on Stonebridge Parkway.

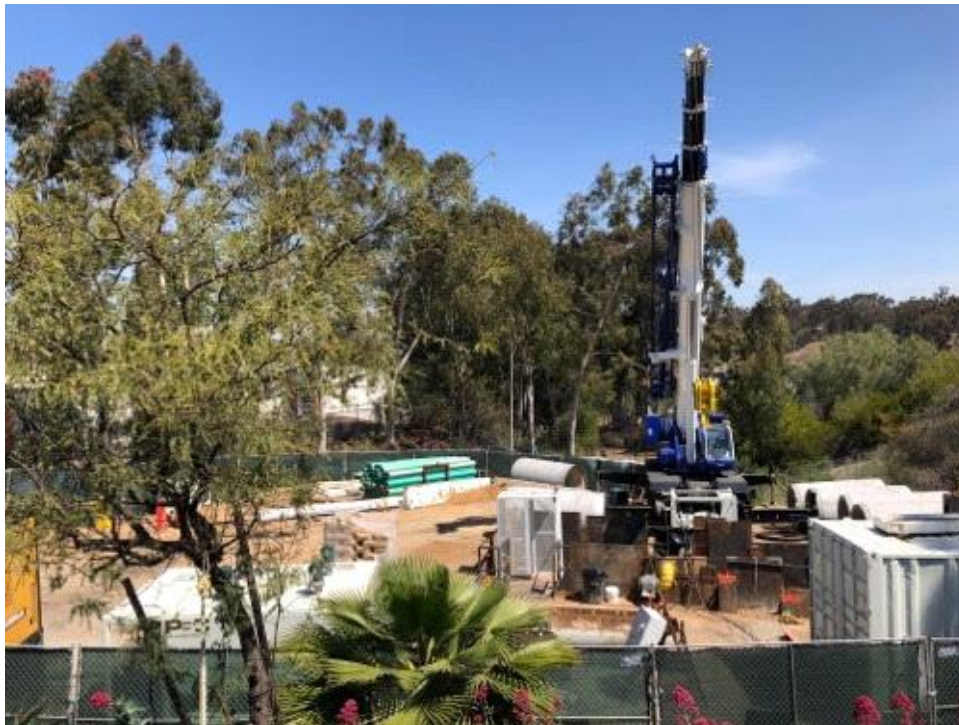
Caption West I-15 bore pit staging area.

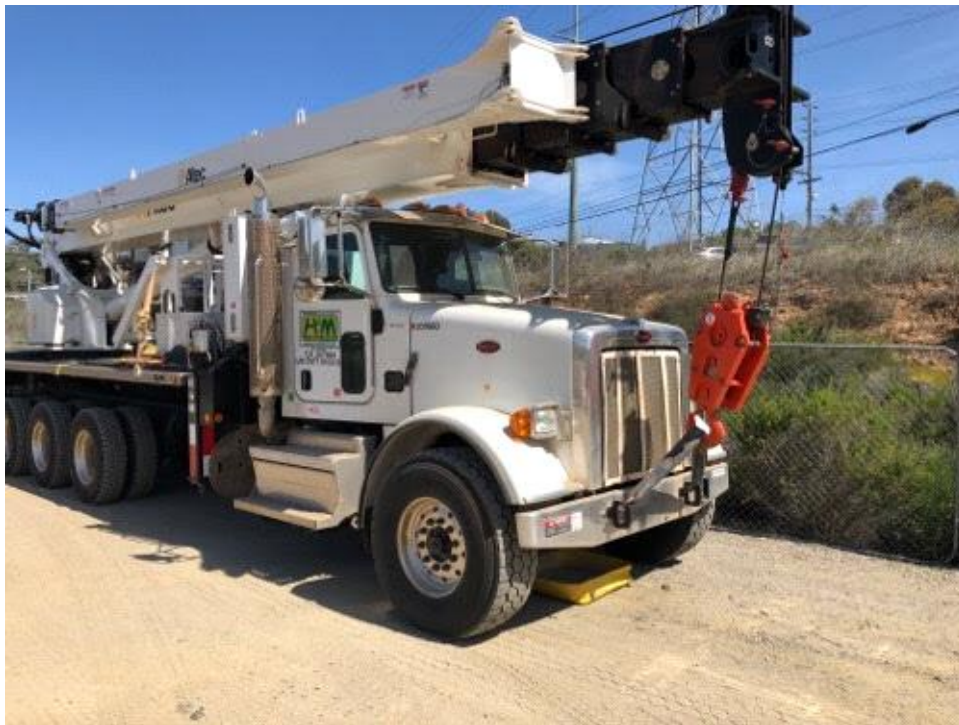
Caption Henkel crane with drip pan.

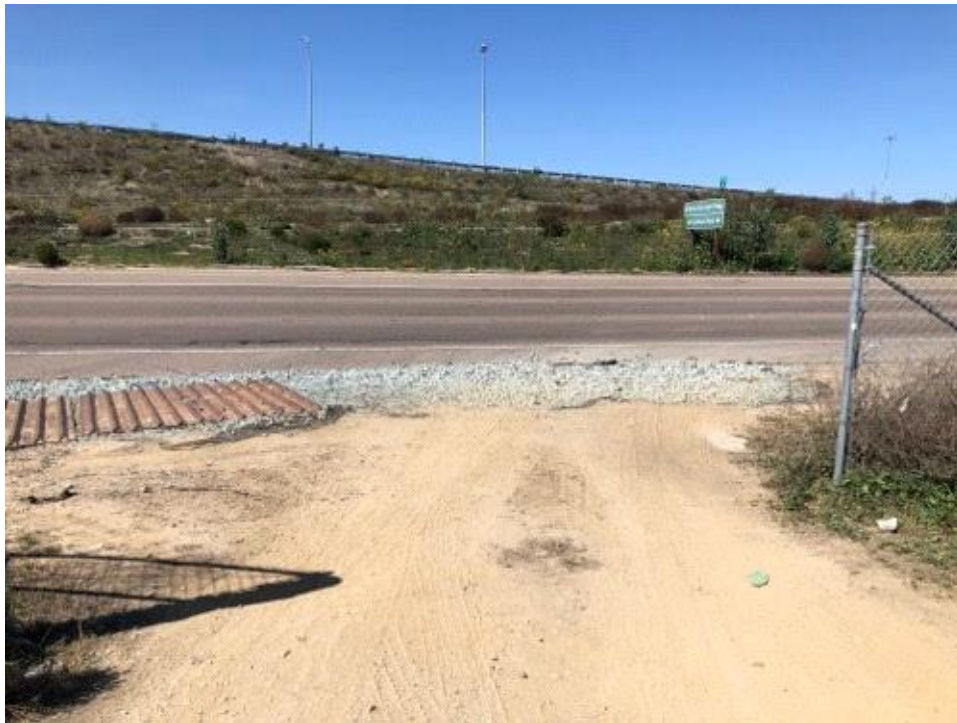
Caption Access gate for staging area north of CC MM CP. Note rumble plates not present at gate entrance. Plates are aligned for adjacent fenced storage area.

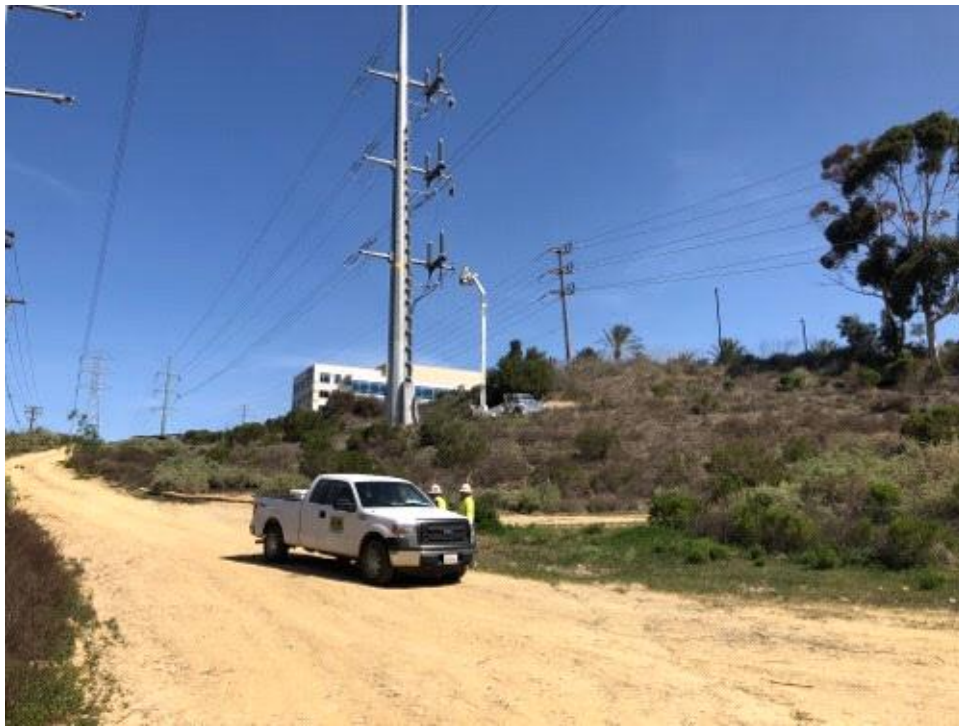
Caption Wire pull prep work with lift at CC MM CP.

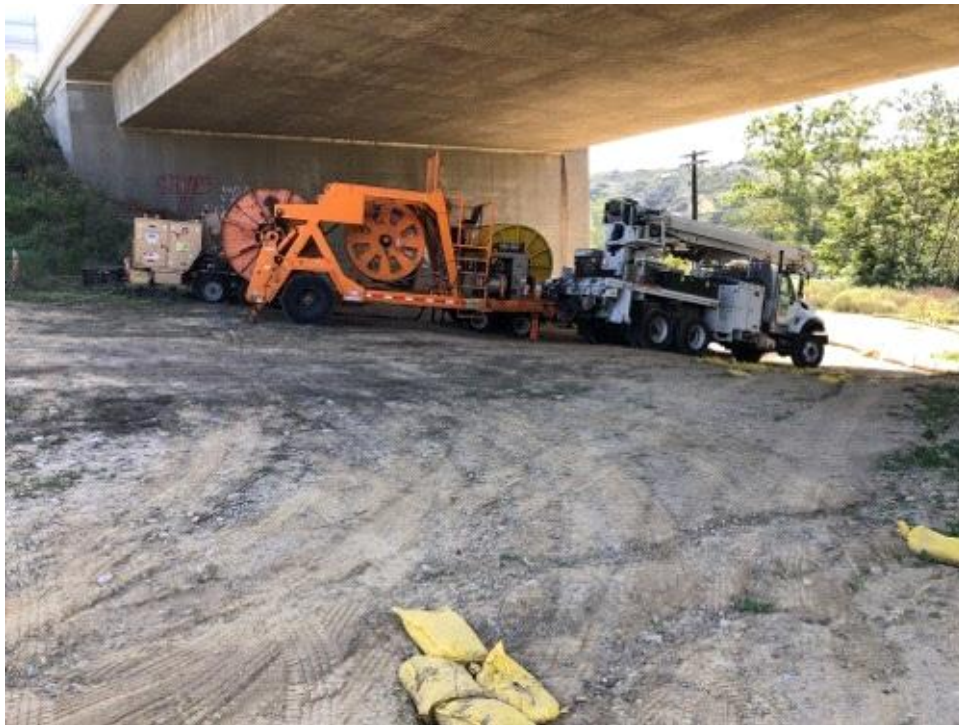
Caption Wire pull equipment beneath Carroll Canyon Road bridge.

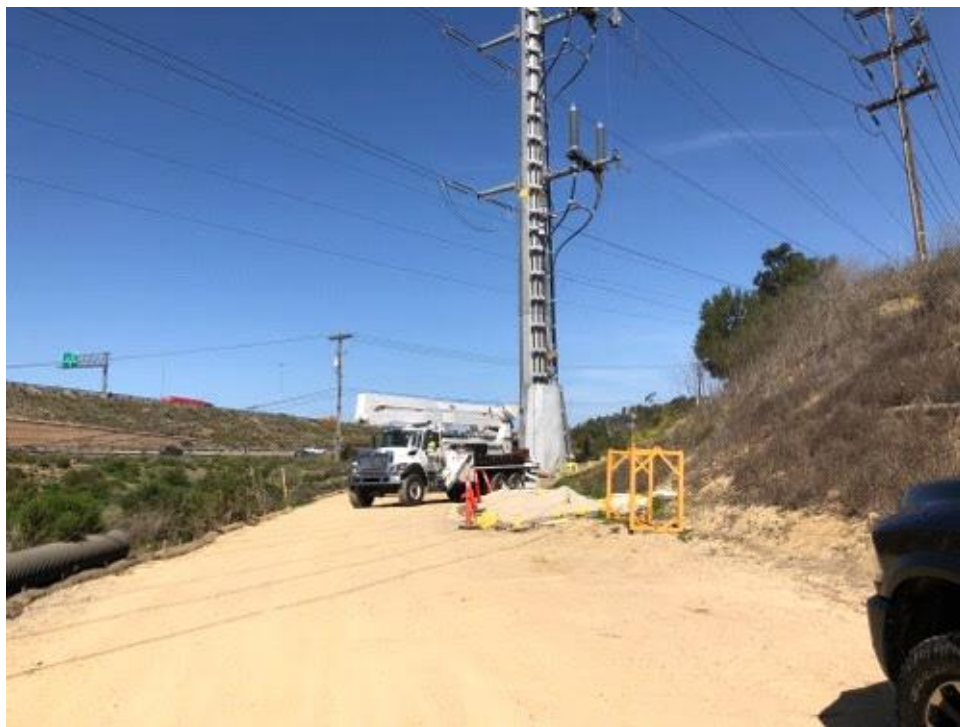
Caption Overhead work at CC MM CP.
