BVCI Project: 161060 File: 40.1000

MEMORANDUM

Re: Mitigation Measure H-8a: Scour and Erosion Protection at Creek Crossings

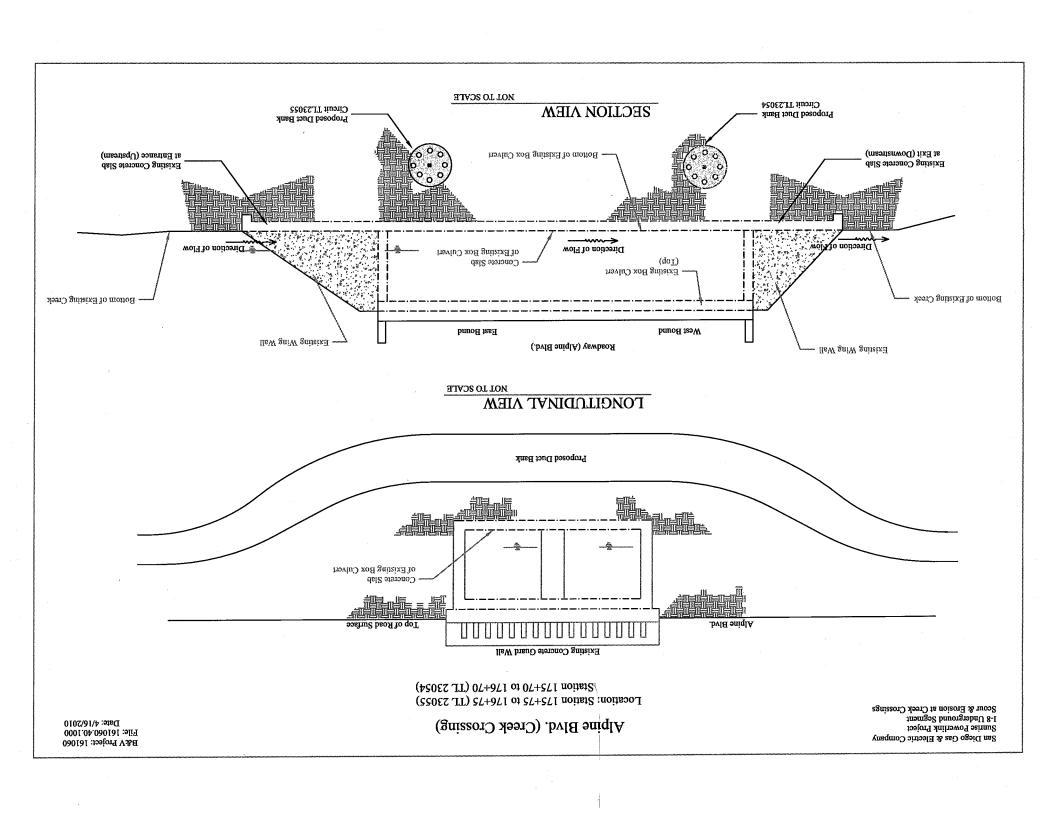
as noted in the data request on 3/23/10. Please see attached revised sketch B&V also corrected the typo error on the drawing and included the direction of water flow
